From: [Bratcher, Mike, EMNRD](#)
To: heather.dolphin@memorialrd.com
Cc: [Morales, Tony, EMNRD](#); [Patterson, Heather, EMNRD](#)
Subject: FW: Leak-Stained Area 32.8436040/103.9618074 Holly Energy Partners
Date: Monday, October 05, 2015 8:37:13 AM
Attachments: 001.jpg
002.jpg
003.jpg
004.jpg
005.jpg
006.jpg

LEAK AREA 32.8436040/103.9618074 STAINED AREA APPROXIMATELY 5' X 45' LEAK RAN INTO GULLY-WASH OUT AREA. NEAREST LOCATION LOCO HILLS FEDERAL A 002 . LEAK WAS NOT FROM THAT LOCATION. THANK YOU.

2. Incident Summary					
Please do not use all capital letters. Attach documents if more space is needed.					
The injection line going to the Loco Hills A-2 developed a hole due to corrosion. The line is buried about 4ft. deep. The fluid bubbled up to surface and ended up spilling approx. 25bbls of PW in the pasture. The fluid was a 60'x1' stream with a 10ft. Pool at the end. Most of the spill was on location with about 20' of it in the pasture. Line was replaced. BLM has been notified. Waiting on clean-up instructions from BLM/OCD.					
Working Activity:		Operations-Field Production		Incident related to: Tools/Equipment

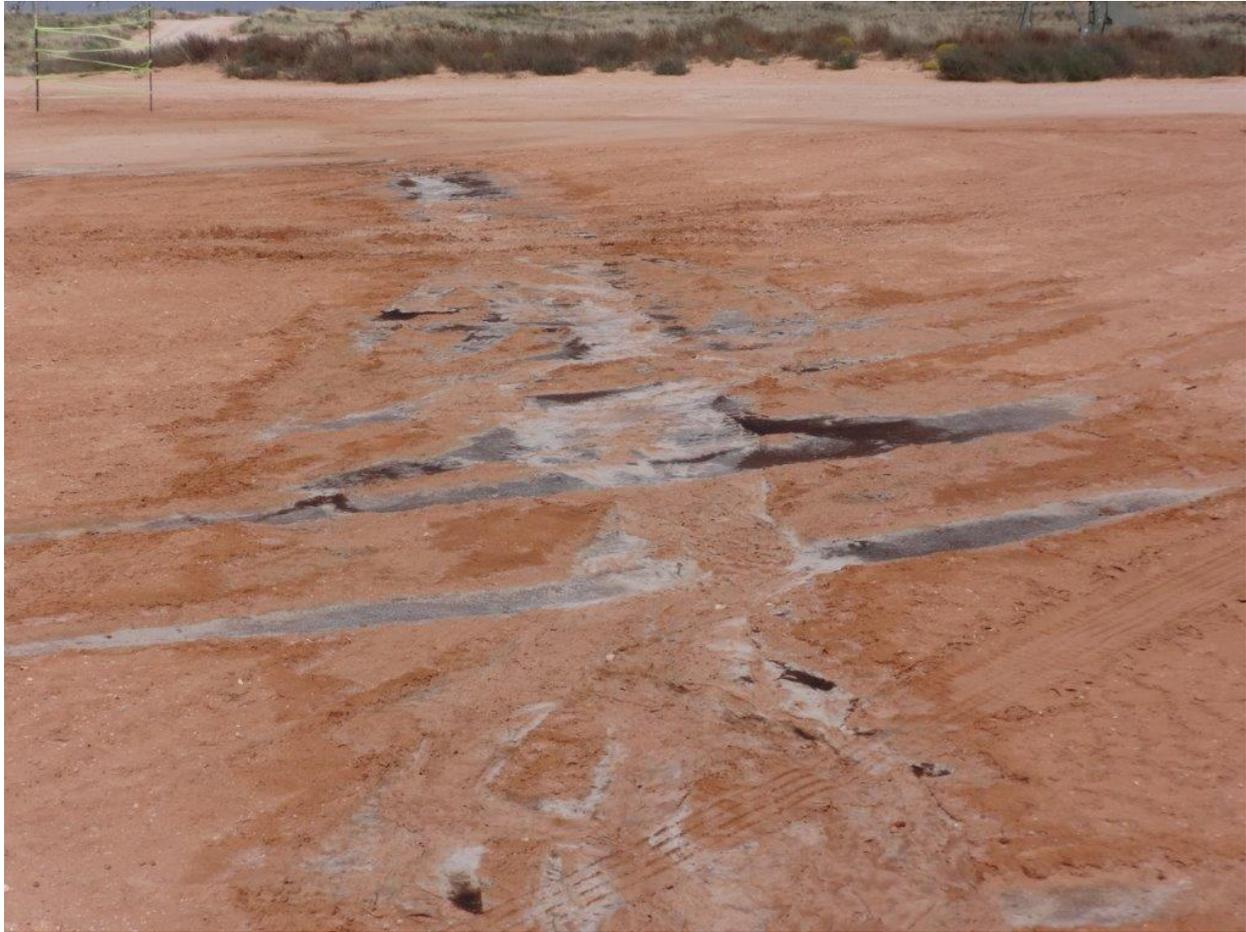
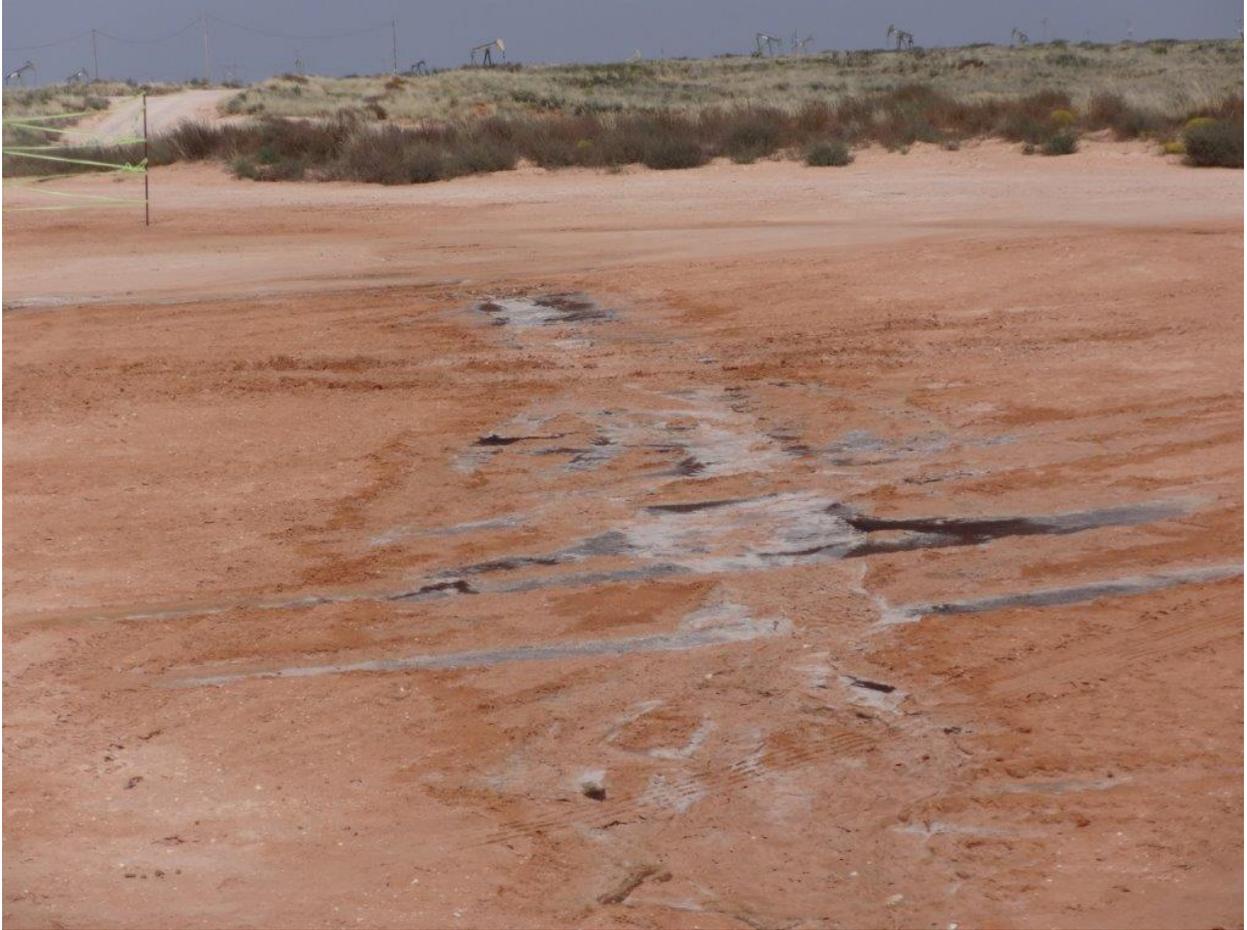
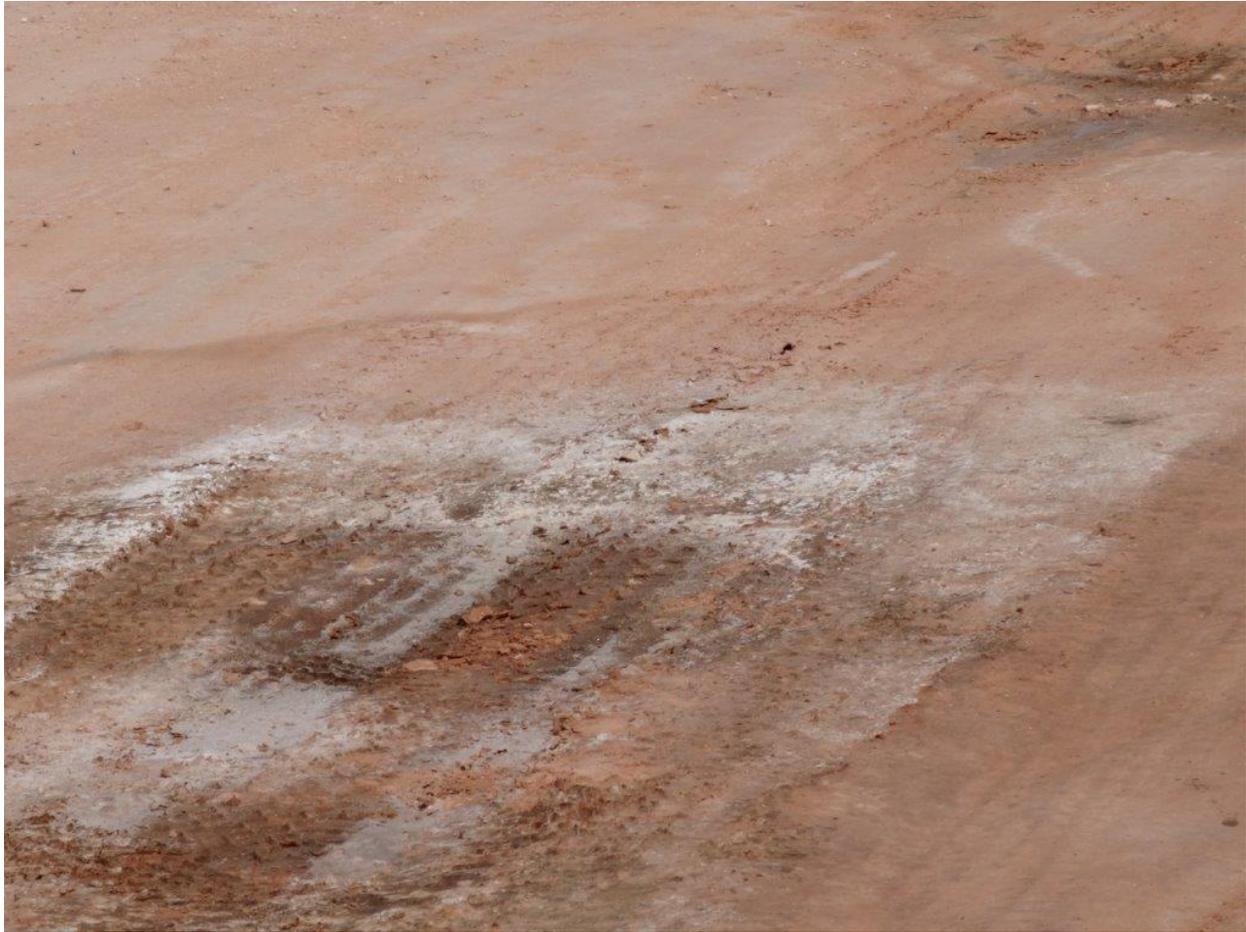
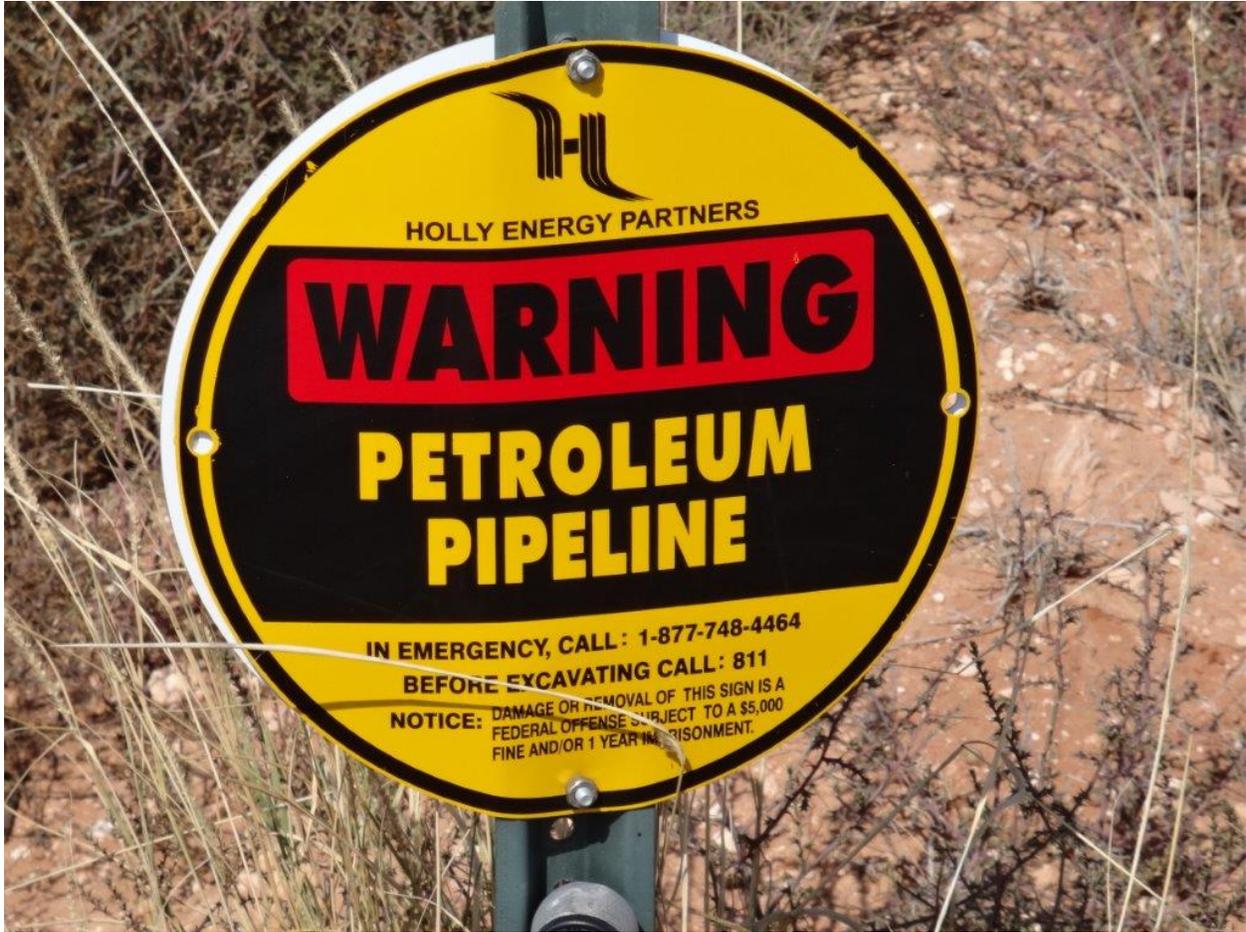
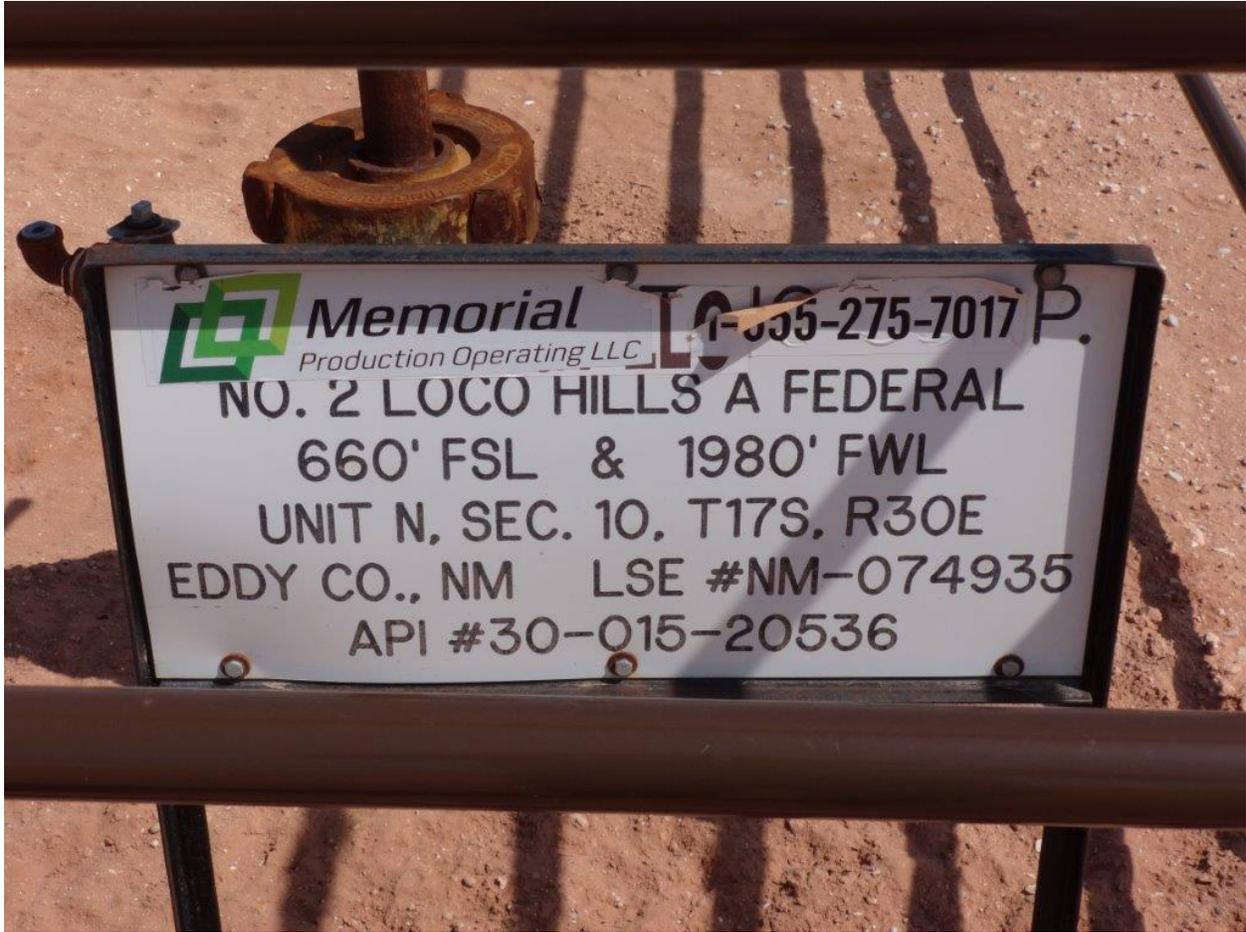
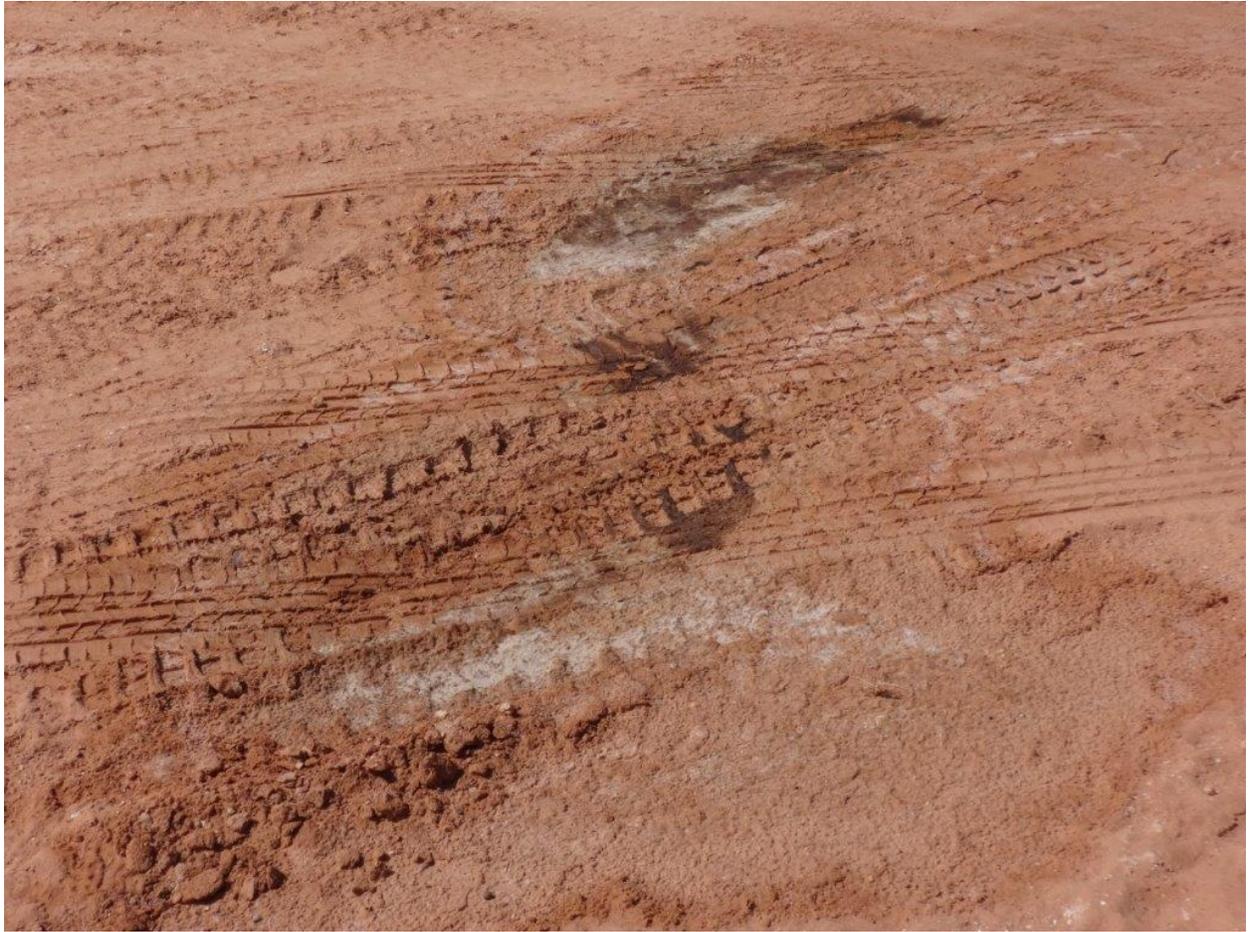
001.jpg
002.jpg
003.jpg
004.jpg
005.jpg
006.jpg

One of our field inspectors came across this release last week near a Memorial well site. He thought it may be from an adjacent Holly line, but typically, Holly will have oil only and this looks to be mostly produced water. Would you please have your field folks check it out or give me contact information for someone here that could help?

9. Equipment Damage		MRD	Non-MRD
10. Spills and Air Releases		Cause: Mechanical Failure	
Materials Released	Oil No	Produced Water Yes	Gas No
Quantity released:	Oil	Produce Water	Quantity recovered
(report all liquids in bbls)	Chemical	Other:	Chemical
Size of Affected area:	60'x1' stream w/ 10ft pool		Chemicals Spilled:
Total Time of Air Release:	Start:	End:	Gas Released:
Describe area, Property, and Wildlife impacted:			
Some of the fluid got into the pasture and sand			
Immediate Concern:	Wildlife Affect	Reportable to Regulator?	Yes
Describe Immediate Actions Taken:			
Line was shut off that night. Replaced the next day.

11. Corrective Actions- Number Corrective Actions (1,2,3...)			
Control box is for Controls/Events	Preventive/Corrective Action	Responsible MRD Employee	Due Date
Supervision	Injection line was replaced in the corroded area.	Emory Mann, Sr. / Foreman / 575.420.8393	9/26/2015
			Completion Date
			9/26/2015
