**Re: Closure Request  
PLU Phantom Banks 25-25-30 USA Battery  
Incident Number nAPP2415551510  
Eddy County, New Mexico**

Ensolum, LLC (Ensolum), on behalf of XTO Energy, Inc (XTO), has prepared this *Closure Request* to document the findings of a liner integrity inspection conducted at the PLU Phantom Banks 25-25-30 USA Battery (Site) following a release of crude oil within a lined containment. Based on the liner integrity inspection activities, XTO is submitting this *Closure Request*, describing assessment activities that have occurred and requesting no further action and closure for Incident Number nAPP2415551510.

XTO Energy, Inc  
Closure Request  
PLU Phantom Banks 25-25-30 USA Battery

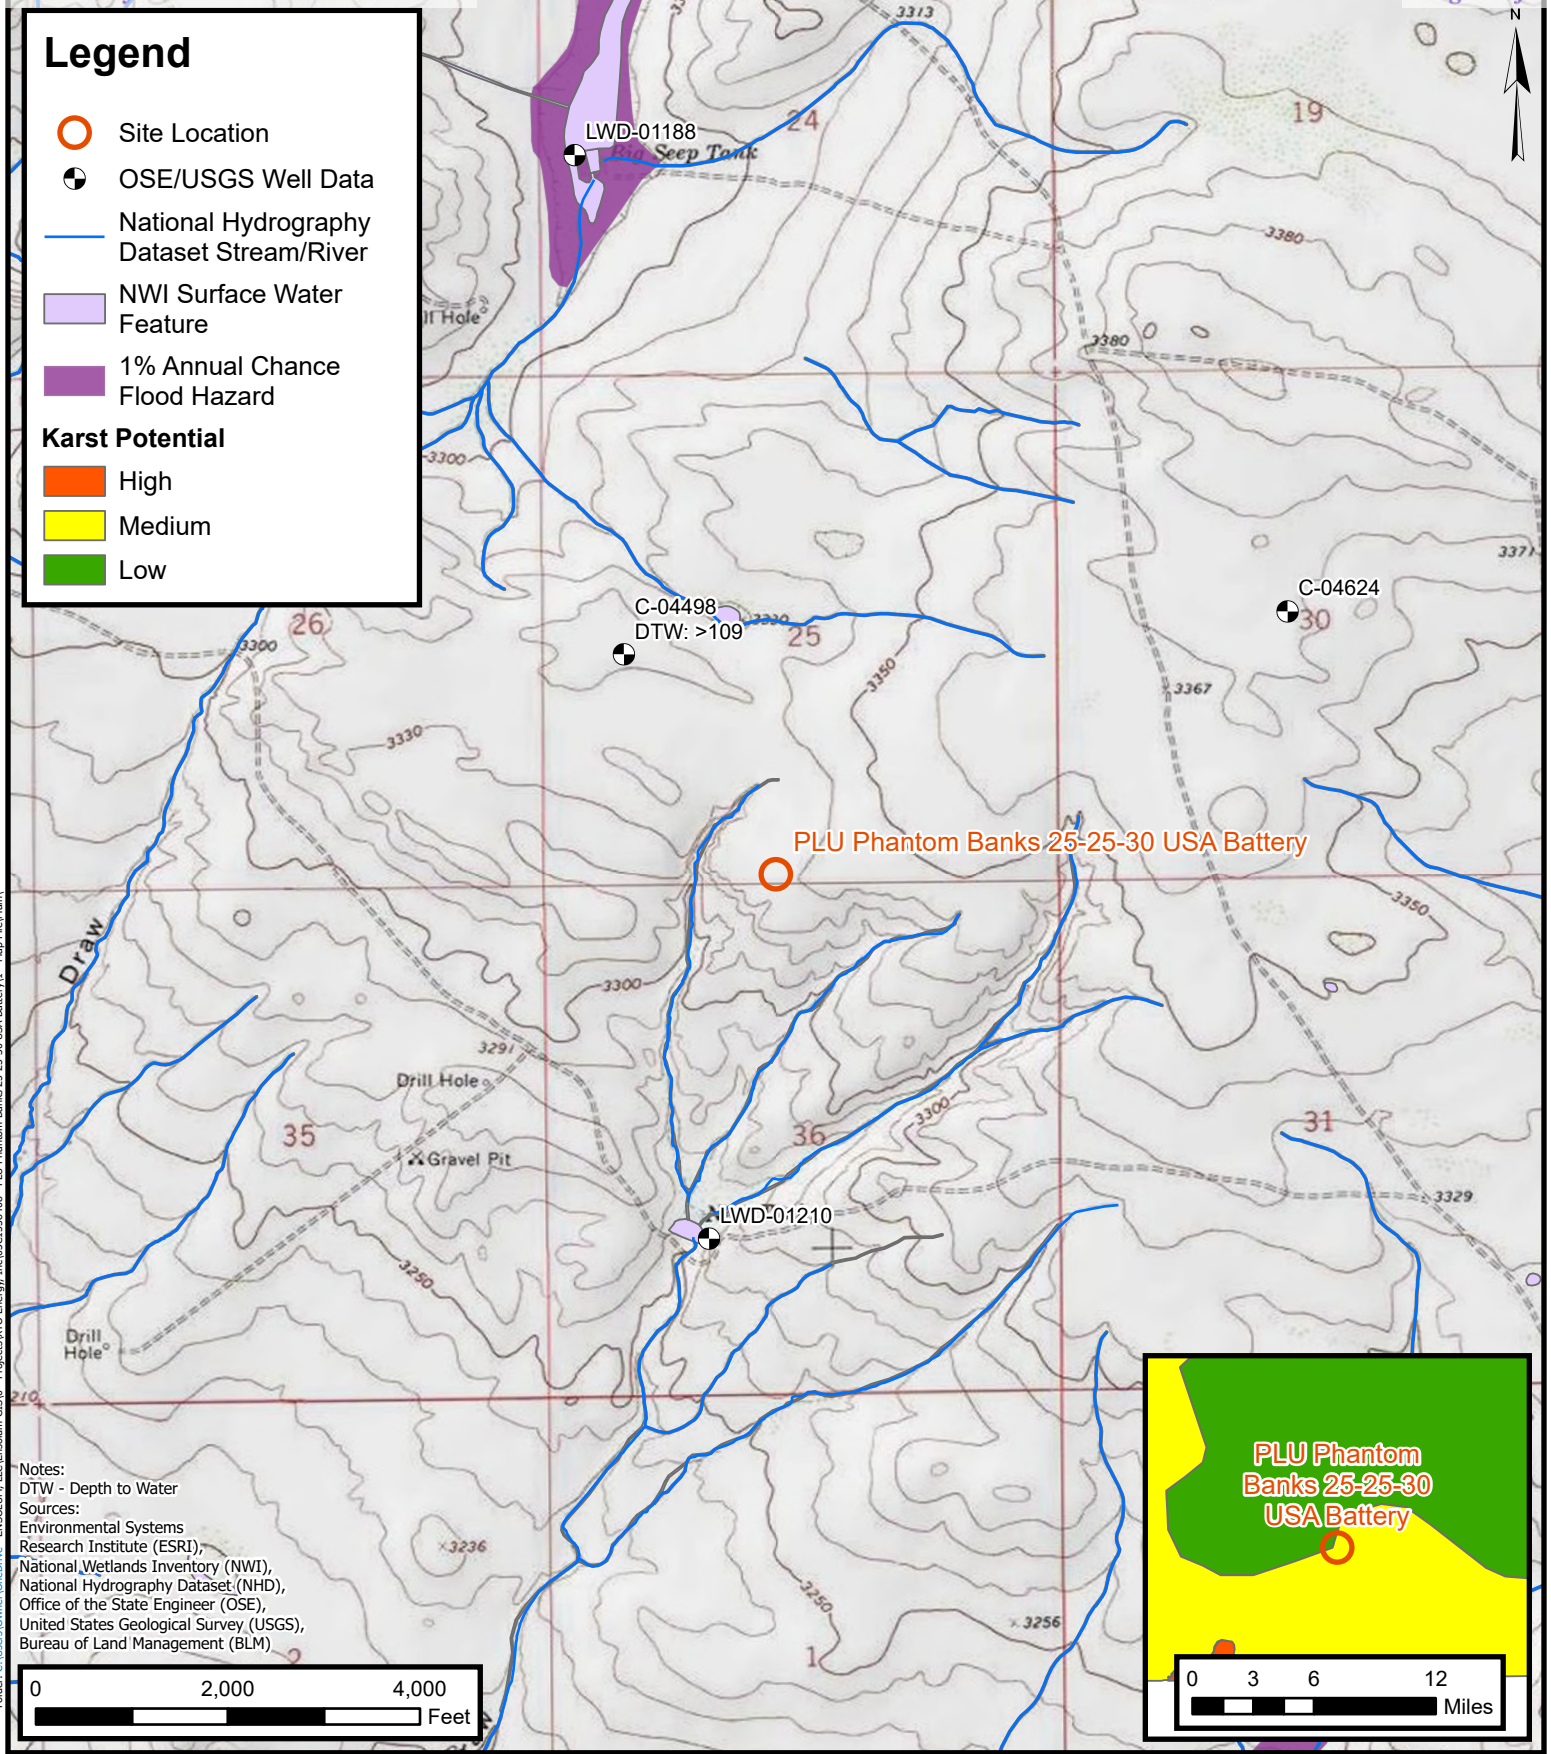
**FIGURE**  
**1**

The closest continuously flowing or significant watercourse to the Site is a drywash, located approximately 674 feet northwest of the Site. The Site is greater than 200 feet from a lakebed, sinkhole, or playa lake and greater than 300 feet from an occupied residence, school, hospital, institution, church, or wetland. The nearest wetland is approximately 2,550 feet north of the Site. The Site is greater than 1,000 feet to a freshwater well or spring and is not within a 100-year floodplain or overlying a subsurface mine. The Site is not underlain by unstable geology (medium potential karst designation area). Site receptors are identified on Figure 1.

**Site Receptor Map**  
XTO Energy, Inc  
PLU Phantom Banks 25-25-30 USA Battery  
Incident Number: nAPP2415551510  
Unit N, Sec 25, T25S. R30E  
Eddy County, NM

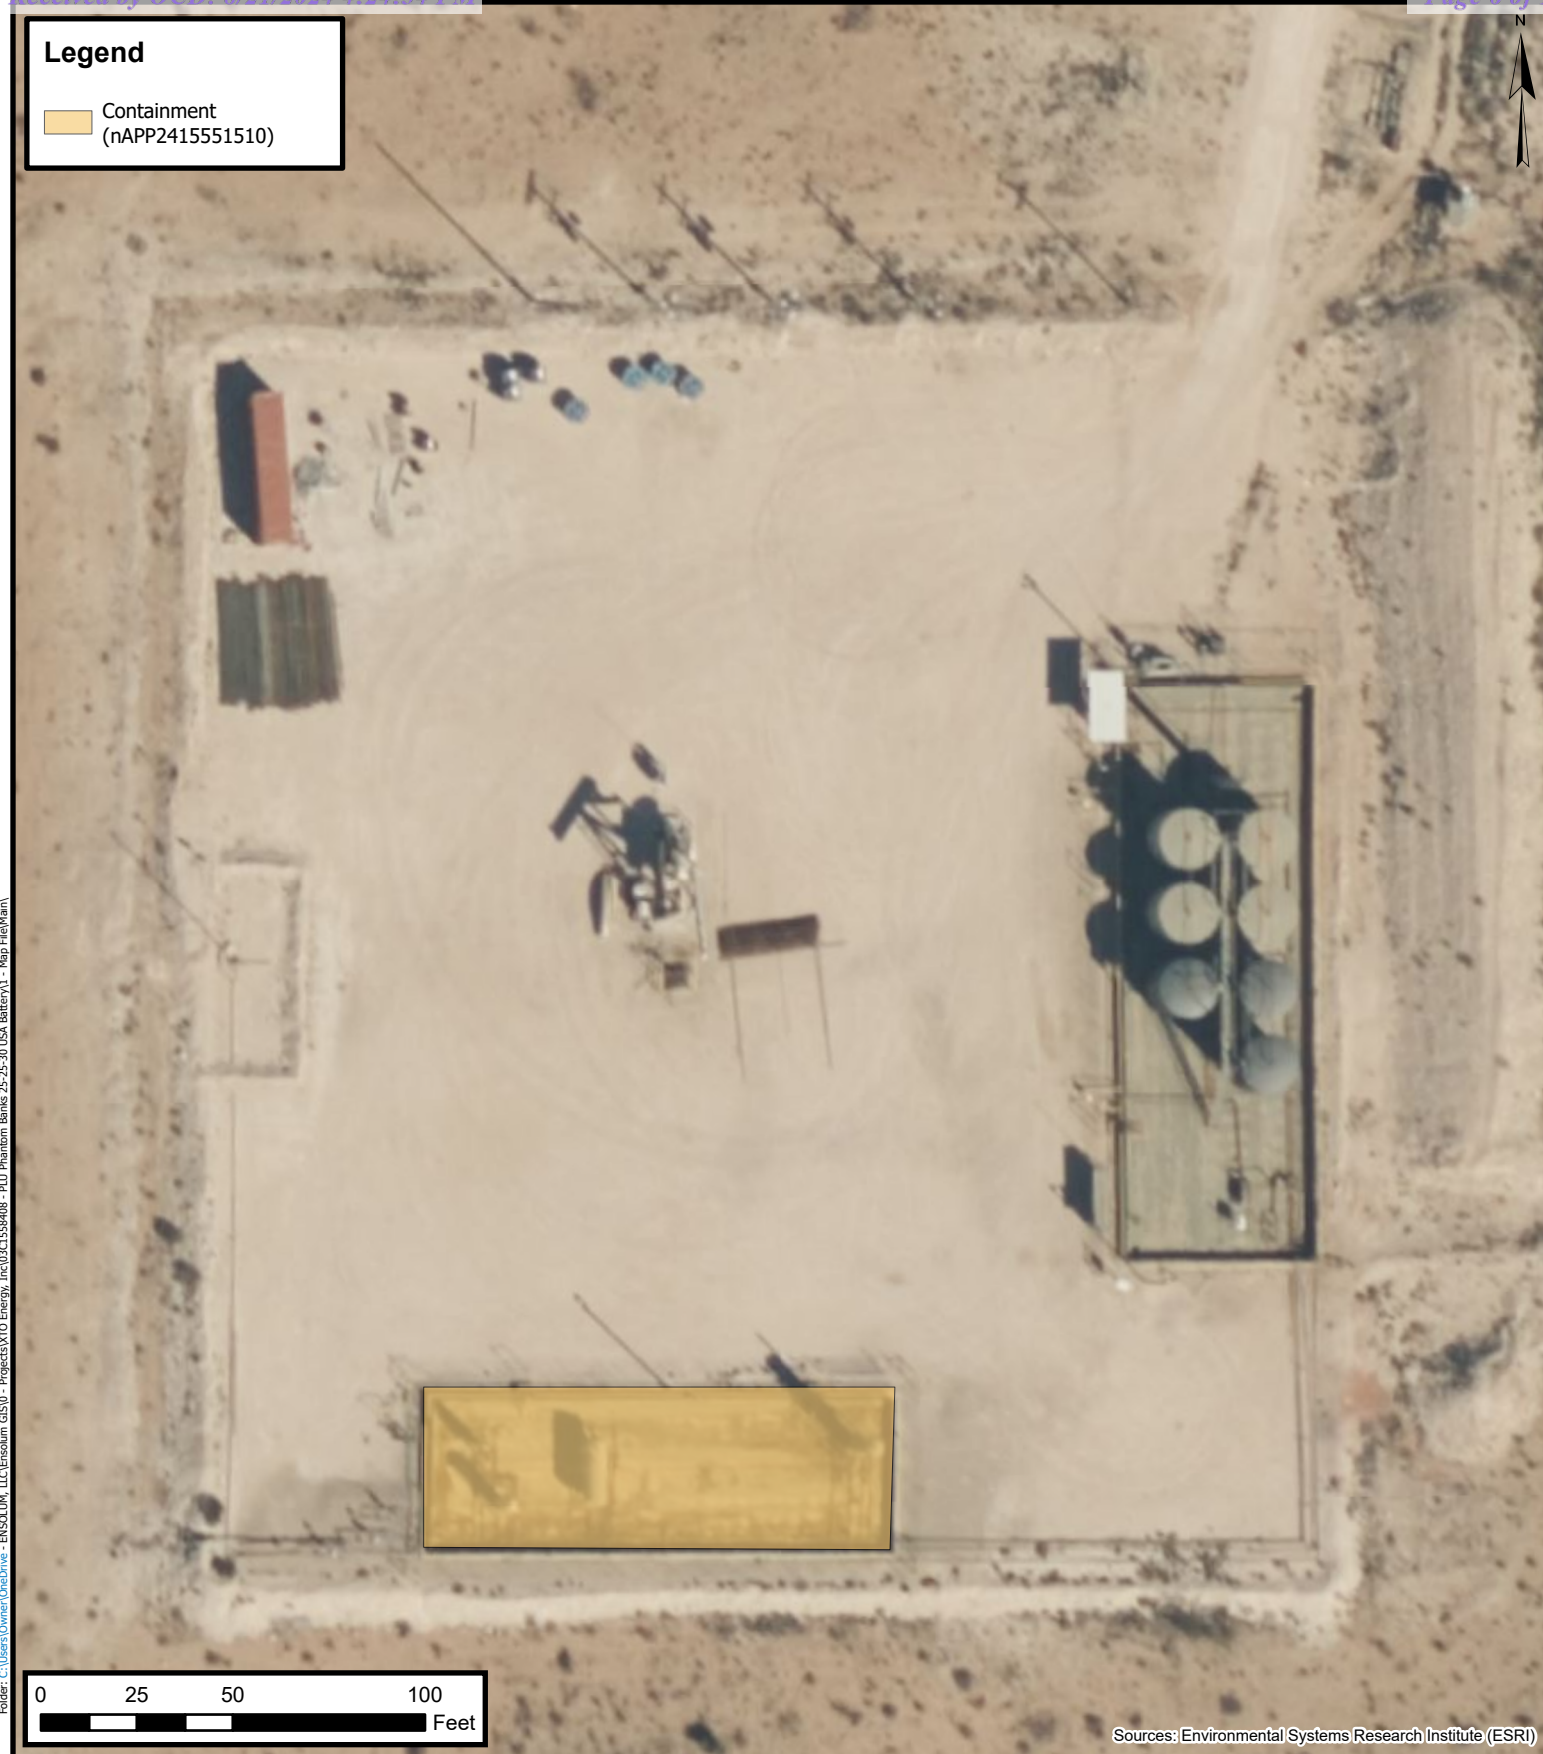
2

## Site Map

XTO Energy, Inc  
PLU Phantom Banks 25-25-30 USA Battery  
Incident Number: nAPP2415551510  
Unit N, Sec 25, T25S. R30E  
Eddy County, NM

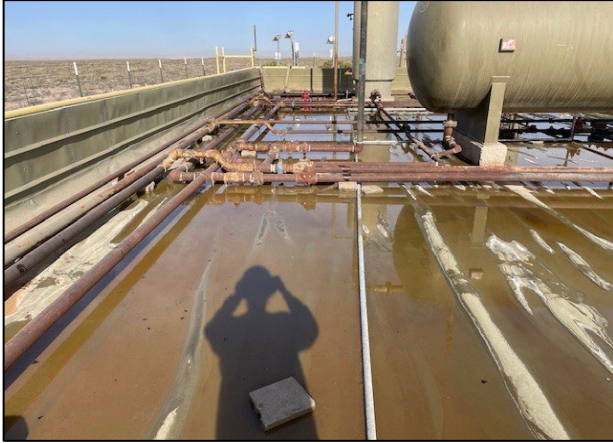
Photograph: 1                      Date: 5/25/2024  
Description: Release extent inside liner.  
View: West

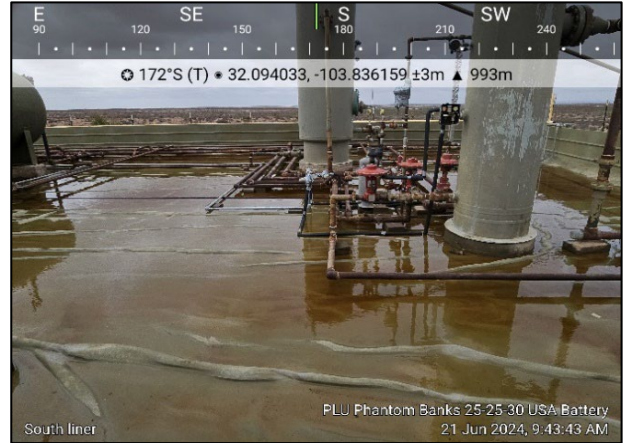
A 48-hour advance notice of the liner inspection was submitted on June 17, 2024. A liner integrity inspection was conducted by Ensolum personnel on June 21, 2024. Due to recent rainfall at the Site, the lined containment had standing rainwater, limiting the ability to conduct a proper liner inspection. A vacuum truck was immediately dispatched to remove the rainwater. Ensolum personnel conducted the liner inspection after completion of rainwater removal. Upon inspection, no rips, tears, holes, or damage were observed. The liner was determined to be operating as designed. Photographic documentation of the inspection is included in Appendix B.

Photograph: 2                      Date: 6/21/2024  
Description: Pooled liquid in liner.  
View: South

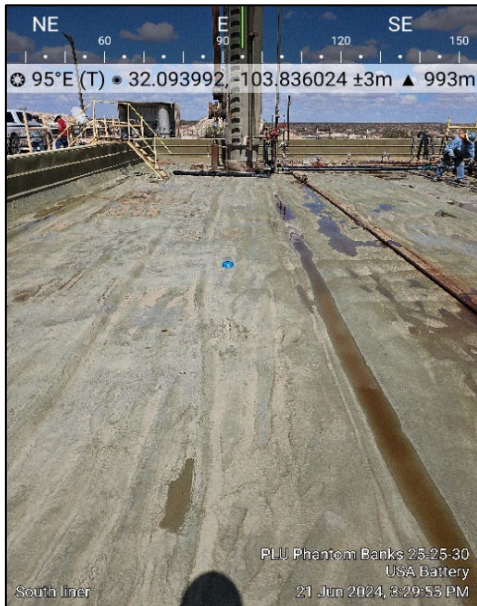
Photograph: 3                      Date: 6/21/2024  
Description: Liner post vacuum truck activities.  
View: East

Liner integrity inspection activities were conducted following a release of crude oil within a lined containment at the Site. Following removal of all fluids, a liner integrity inspection was conducted by Ensolum personnel on June 21, 2024. Upon inspection, no rips, tears, holes, or damage were observed, and the liner was determined to be sufficient. The release was contained laterally by the lined containment and the liner was performing as designed. Based on initial response efforts and the liner operating as designed, XTO believes remedial actions completed to address the release were protective of human health, the environment, and groundwater. As such, XTO respectfully requests closure for Incident Number nAPP2415551510.

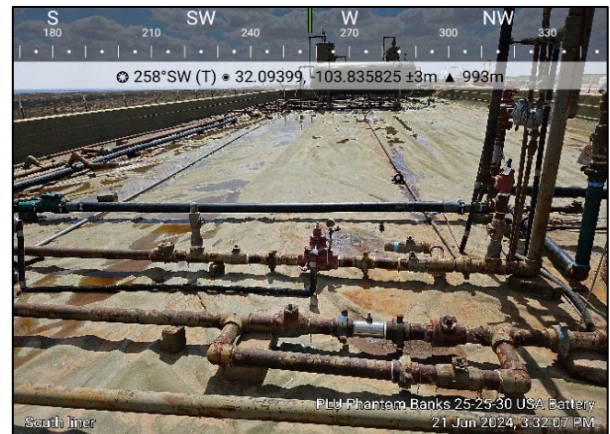
Photograph: 4                      Date: 6/21/2024  
Description: Liner post vacuum truck activities.  
View: West
