**Re: Liner Inspection and Closure Request
BTA Oil Producers, LLC
Vacuum SWD H #35 Release
Unit H, Section 35, Township 17 South, Range 35 East
Lea County, New Mexico
Incident ID# nAPP2426446424**

Liner Inspection and Closure Request
October 15, 2024

**VACUUM SWD H #35
OVERVIEW MAP**

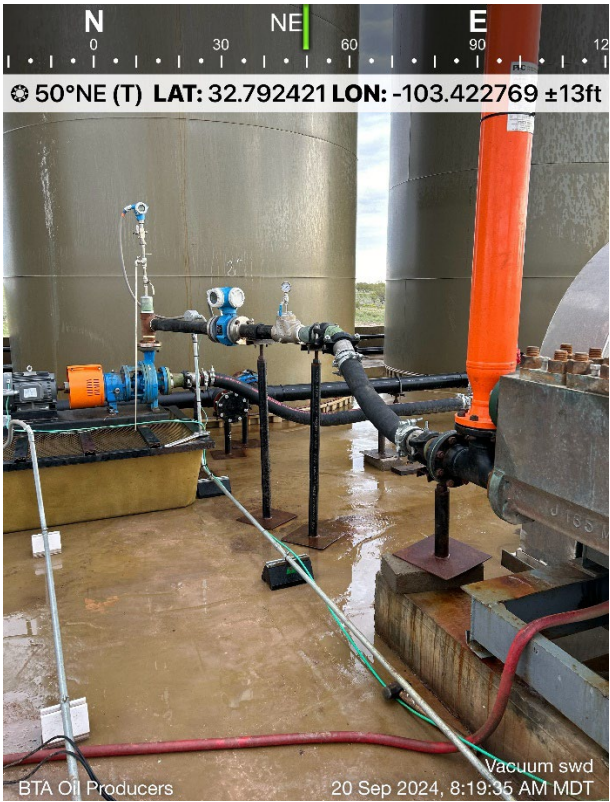
TETRA TECH, INC. PROJECT NO. 212C-MD-03641	DESCRIPTION	View northeast of approximate release extent in secondary containment berm.	1
	SITE NAME	Vacuum SWD H #35 Release	9/20/2024

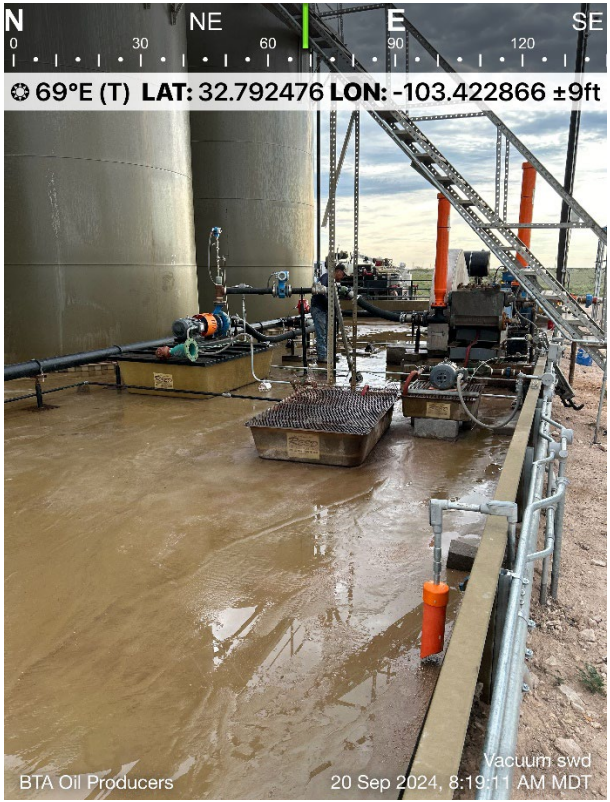
TETRA TECH, INC. PROJECT NO. 212C-MD-03641	DESCRIPTION	View east-northeast of approximate release extent in secondary containment berm.	2
	SITE NAME	Vacuum SWD H #35 Release	9/20/2024

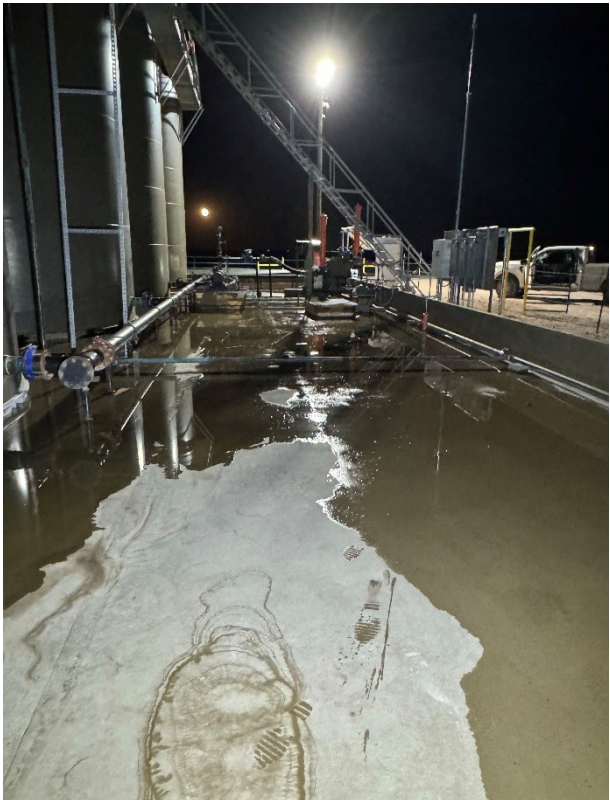
TETRA TECH, INC. PROJECT NO. 212C-MD-03641	DESCRIPTION	View of approximate release extent in secondary containment berm.	4
	SITE NAME	Vacuum SWD H #35 Release	N/A

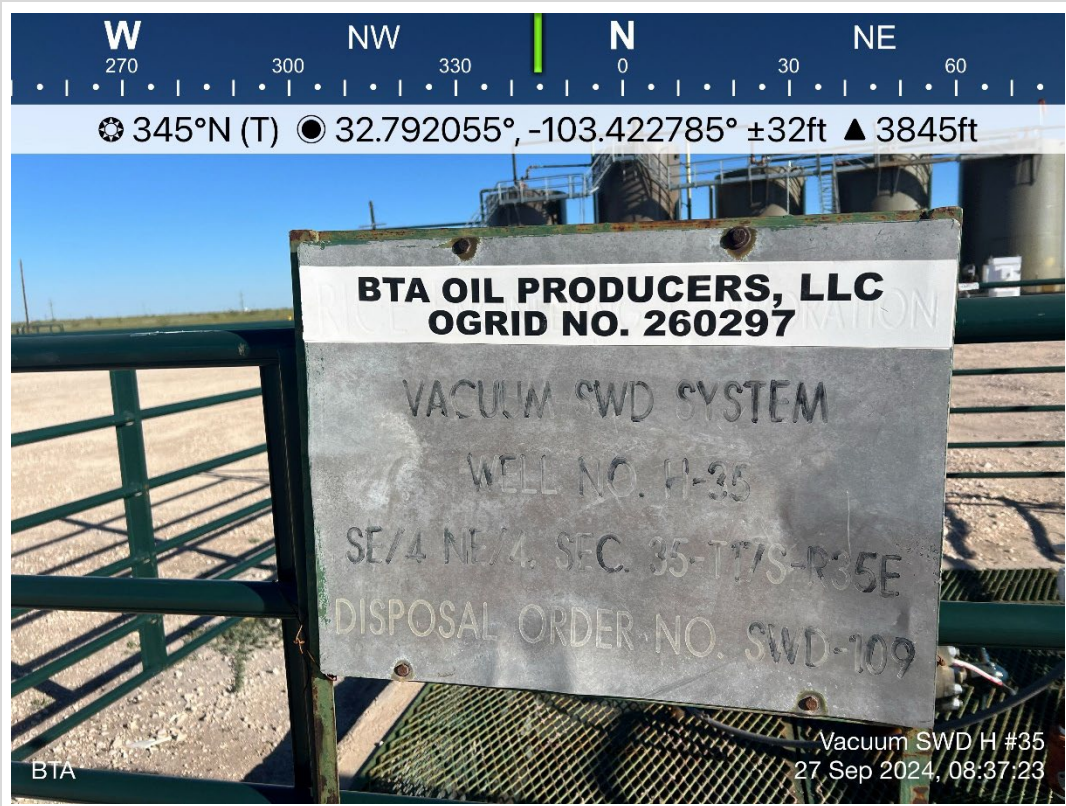
TETRA TECH, INC. PROJECT NO. 212C-MD-03641	DESCRIPTION	View north-northwest of site signage. Vacuum SWD System.	5
	SITE NAME	Vacuum SWD H #35 Release	9/27/2024

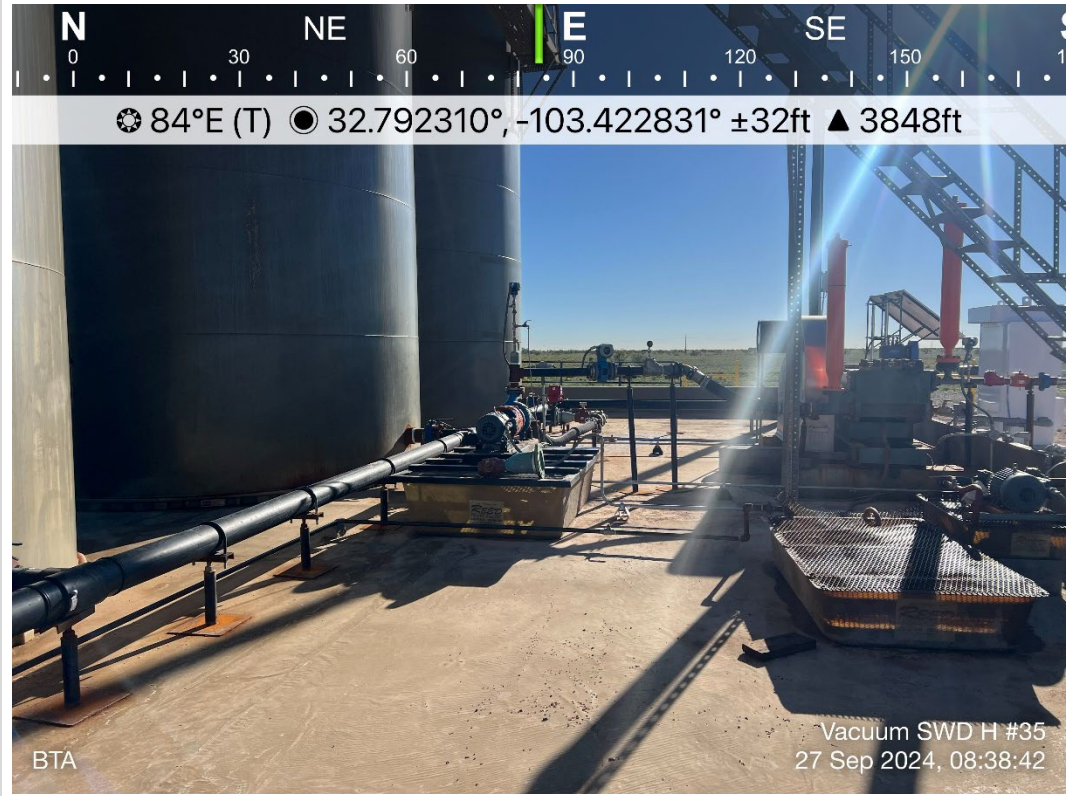
On September 27, 2024, Tetra Tech personnel performed an inspection of the liner within the containment area of the Vacuum SWD H #35 Battery. This work was completed to verify the integrity of the liner. The liner was observed to underlie the entirety of the tank battery containment area. The liner was intact with no visible rips or tears and encompassed by an approximately 2-foot-tall muscle wall. The liner was

anchored on the interior. At the time of the inspection, the liner was intact and had the ability to contain the documented release. Photographic documentation of the liner inspection is included in Appendix D.

TETRA TECH, INC. PROJECT NO. 212C-MD-03641	DESCRIPTION	View east. Current lined containment area conditions: no rips, holes, or tears observed.	6
	SITE NAME	Vacuum SWD H #35 Release	9/27/2024

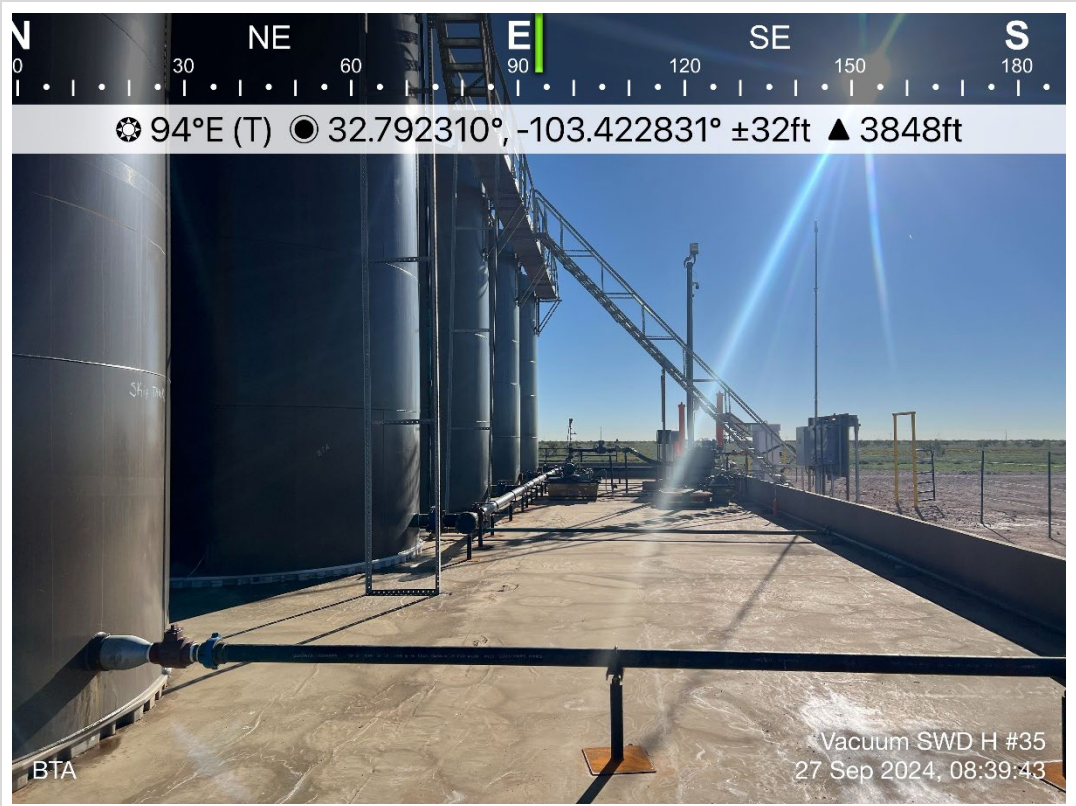
TETRA TECH, INC. PROJECT NO. 212C-MD-03641	DESCRIPTION	View east. Current lined containment area conditions: no rips, holes, or tears observed.	7
	SITE NAME	Vacuum SWD H #35 Release	9/27/2024

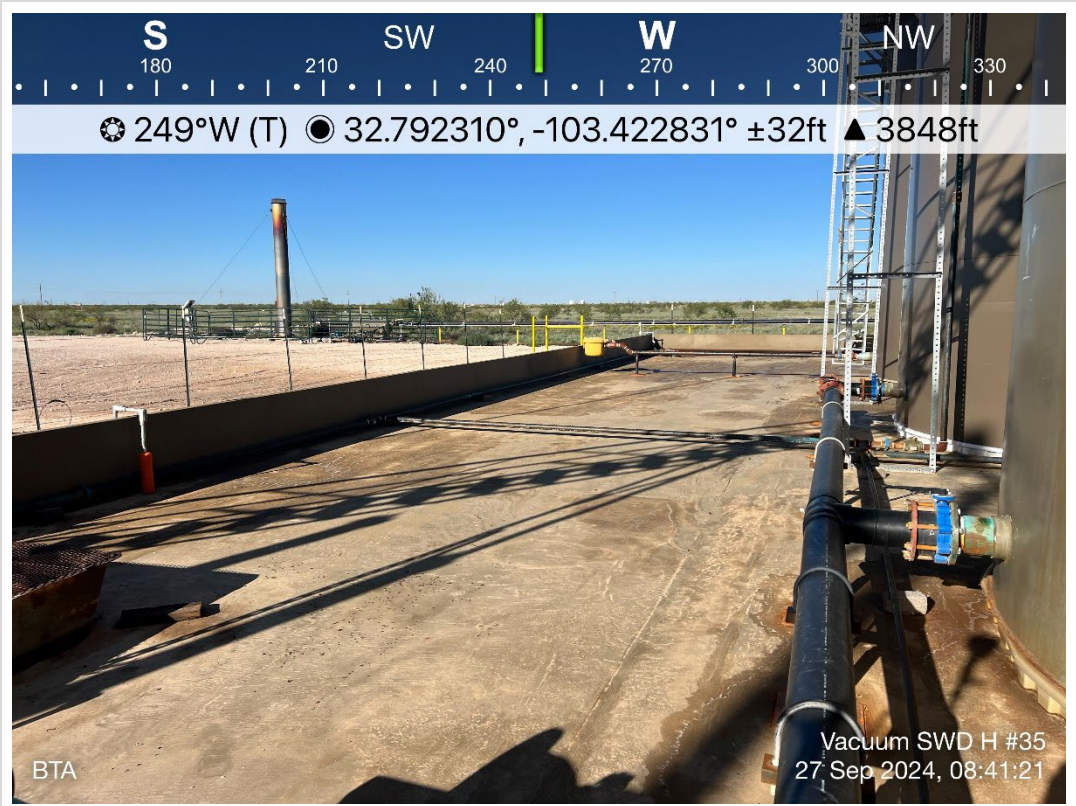
TETRA TECH, INC. PROJECT NO. 212C-MD-03641	DESCRIPTION	View west-southwest. Current lined containment area conditions: no rips, holes, or tears observed.	9
	SITE NAME	Vacuum SWD H #35 Release	9/27/2024
