Re: NMOCD #nAPP2425548355 Rojo Toro #3 Purge Event 32.21421, -103.443883 U/L K, Section 14, Township 24 South, Range 34 East

Section 1: Event Details

NMOCD Incident ID #nAPP2425548355 pertains to a residue gas purge event that occurred post processing and prior to custody transfer on January 15, 2024. There were no liquids released during the residue purge event. Please see the photos attached as Appendix C, showing no staining below the release point. This event was originally reported on a C-129 form on January 17, 2024 and assigned incident ID nAPP2401759525. Upon further review and per NMOCD direction, nAPP2401759525 did not meet the requirements of Part 27 or Part 28 NMAC, therefore the C-129 was cancelled using a C-129C form and an Initial C-141 submitted being assigned incident ID #nAPP2425548355. Reasoning for the venting event is summarized below.

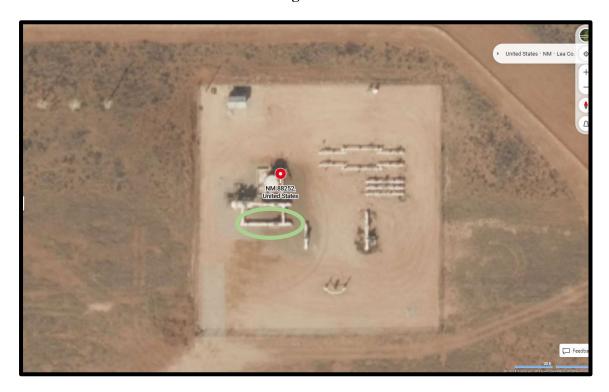
Gas was vented to atmosphere to purge the pipeline of off-spec residue gas. It was necessary to purge the line to bring the residue gas line back within specification. Third party gas producers delivered off spec gas to the inlet of the processing facilities which resulted in off spec gas in the residue line. Gas was vented until the pipeline was purged. Once the residue gas was back within spec, the emission event ended. Please see Figure 9 illustrating the purge point.

Green Circle Indicates Purge Point at Rojo Toro Facility

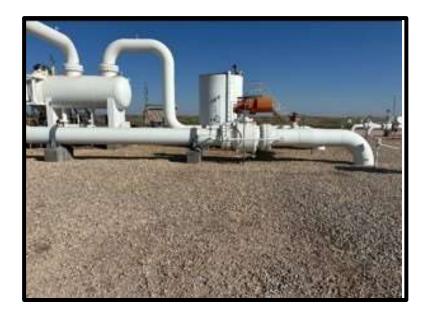
This was an above ground residue gas only purge to atmosphere event due to off-spec gas being sent from producers. The purge event did not release any liquids to the ground, photographs are shown in Appendix C illustrating no staining to soil. Per NMOCD direction on September 6, 2024, Targa is respectfully requesting a variance to NMAC Part 29 sampling requirements due to the absence of liquids released.

Photo of Purge Point facing North

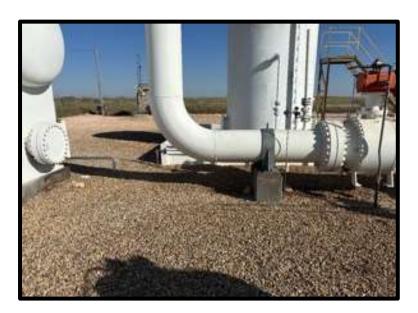
Photo of Purge Point facing North
