Operator: CIMAREX ENERGY CO. 6001 Deauville Blvd Midland, TX 79706	OGRID: 215099
	Action Number: 424736
	Action Type: [NOTIFY] Notification Of Release (NOR)

Location of Release Source <i>Please answer all the questions in this group.</i>	
Site Name	TRISTE DRAW 25 FEDERAL 3H
Date Release Discovered	01/25/2025
Surface Owner	Federal

Prerequisites	
Incident ID (n#)	nAPP2502572957
Incident Name	NAPP2502572957 TRISTE DRAW 25 FEDERAL 3H @ 0
Incident Type	Produced Water Release
Incident Status	Initial C-141 Received
Incident Facility	[fAPP2201752988] TRISTE DRAW 25 FEDERAL 3H

Liner Integrity Certification

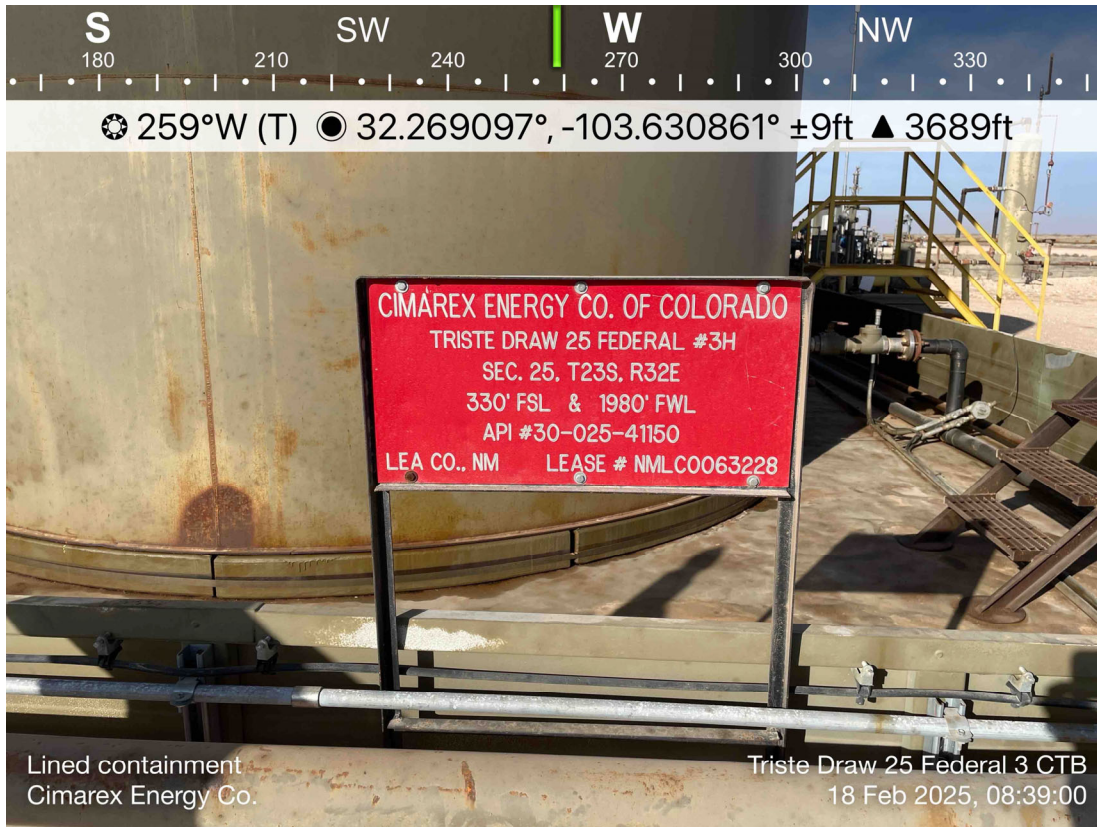
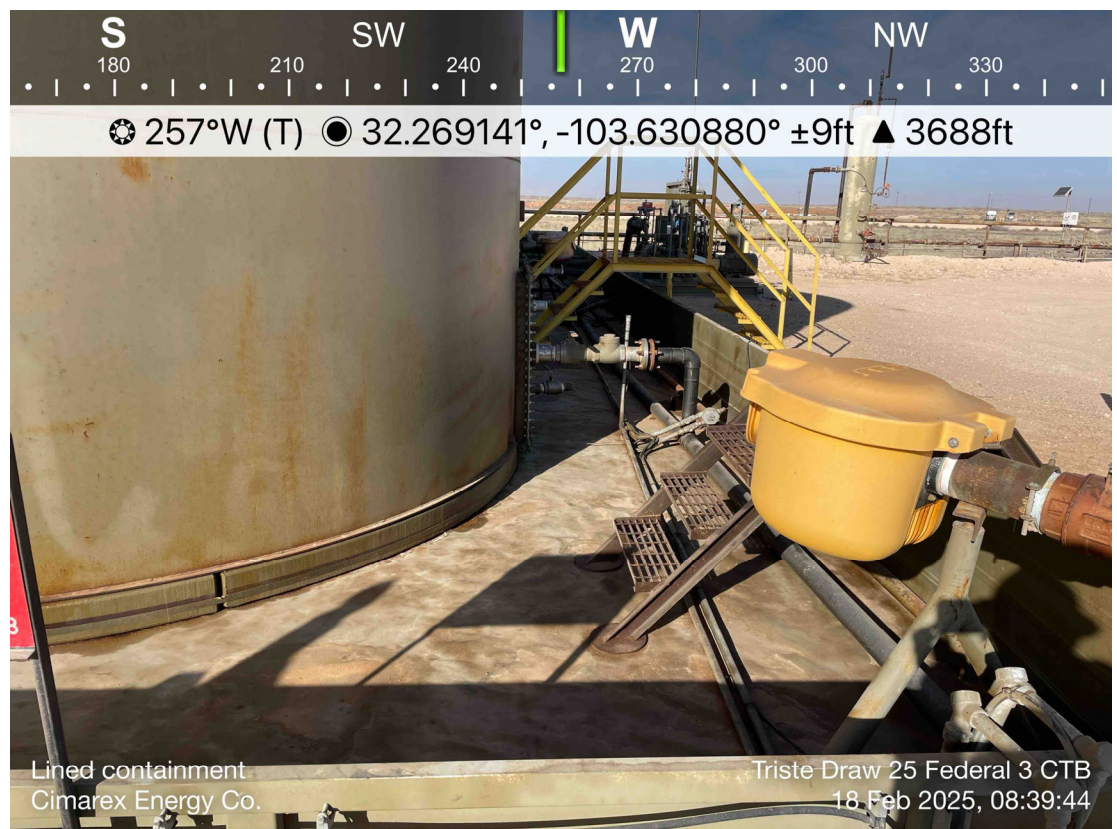
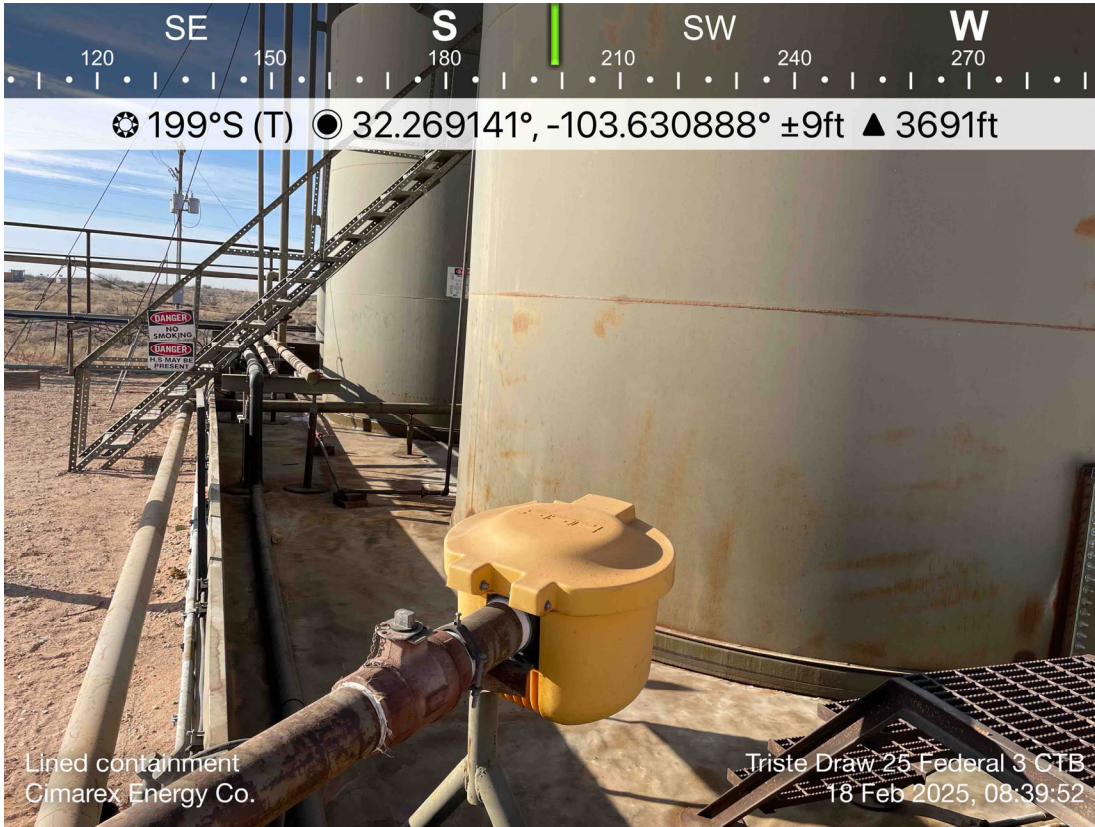
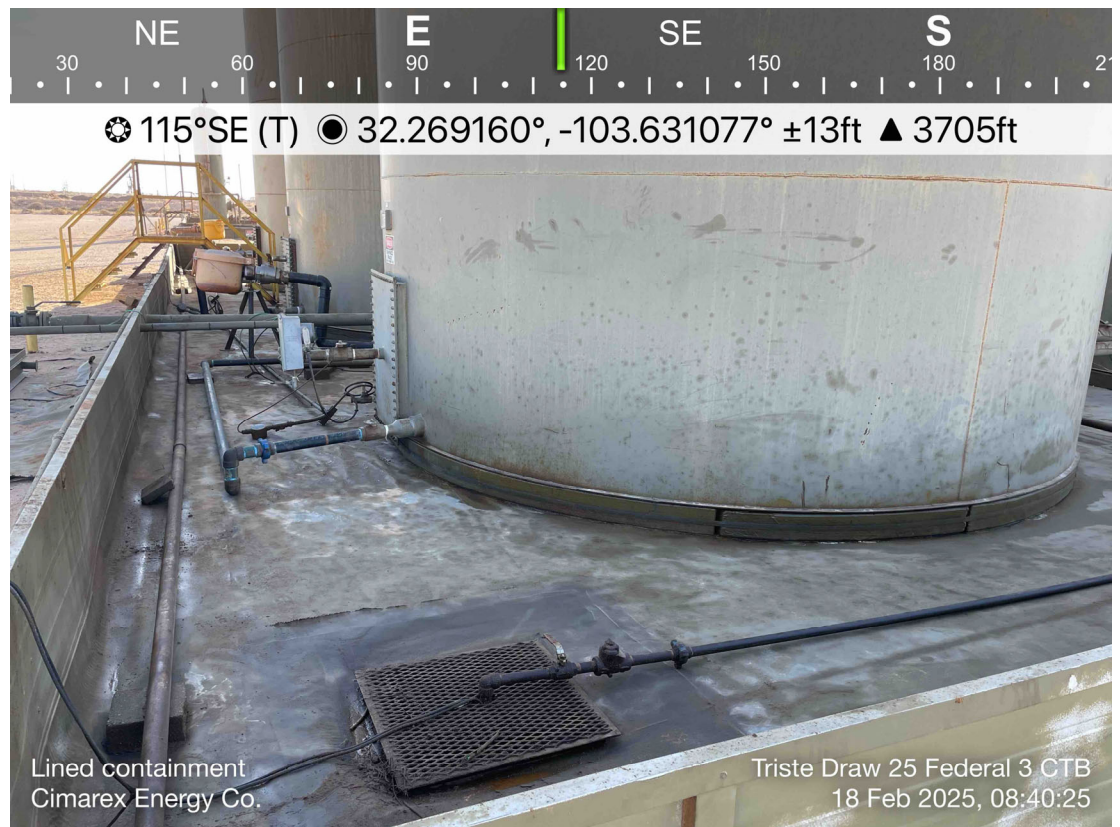
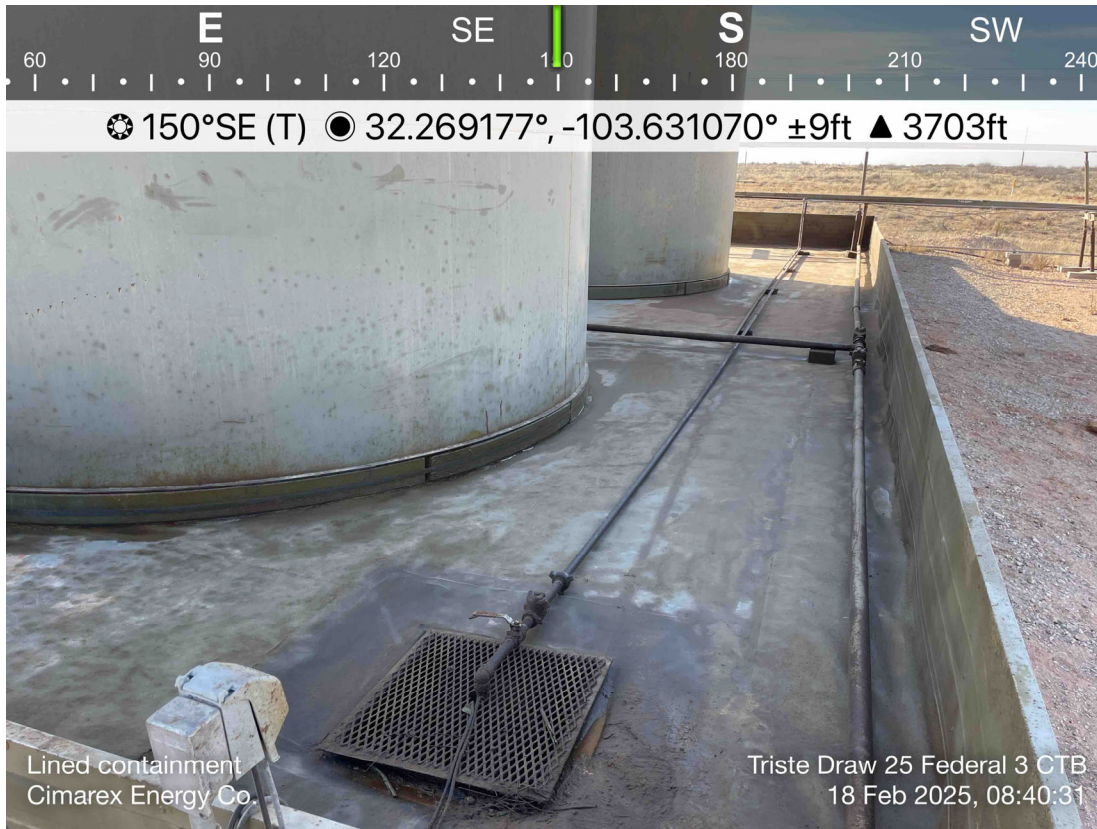
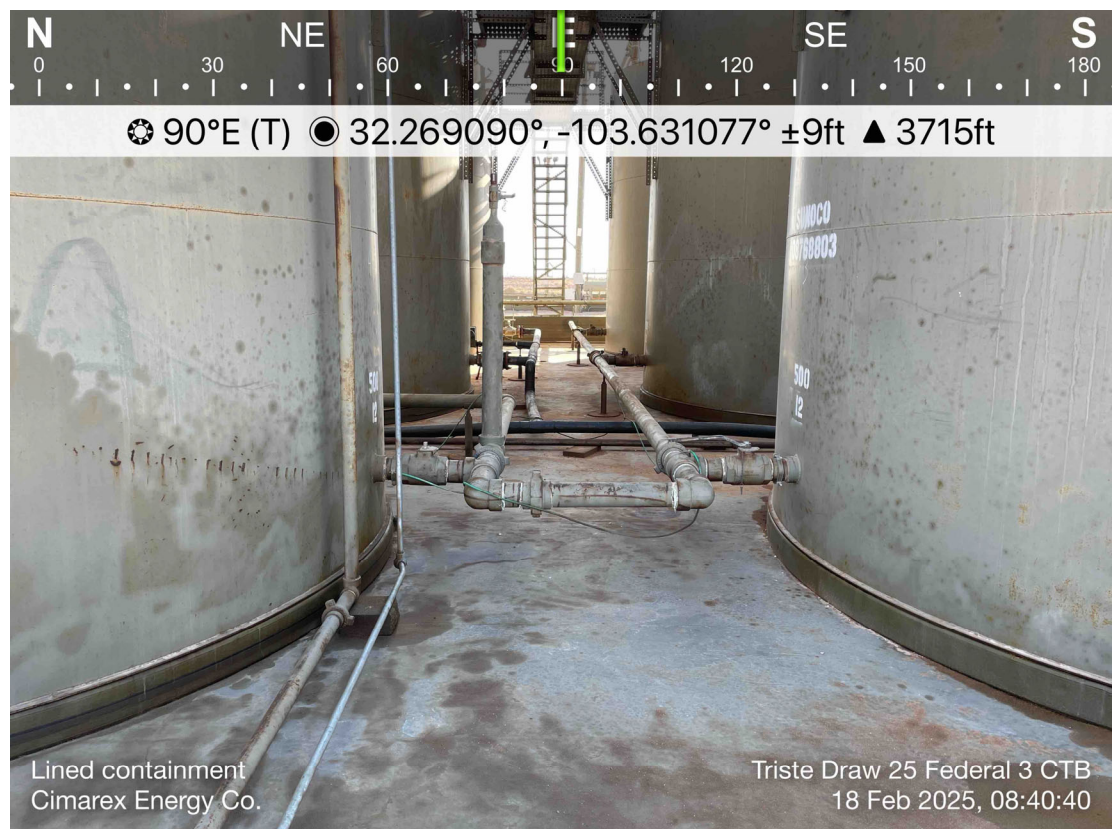
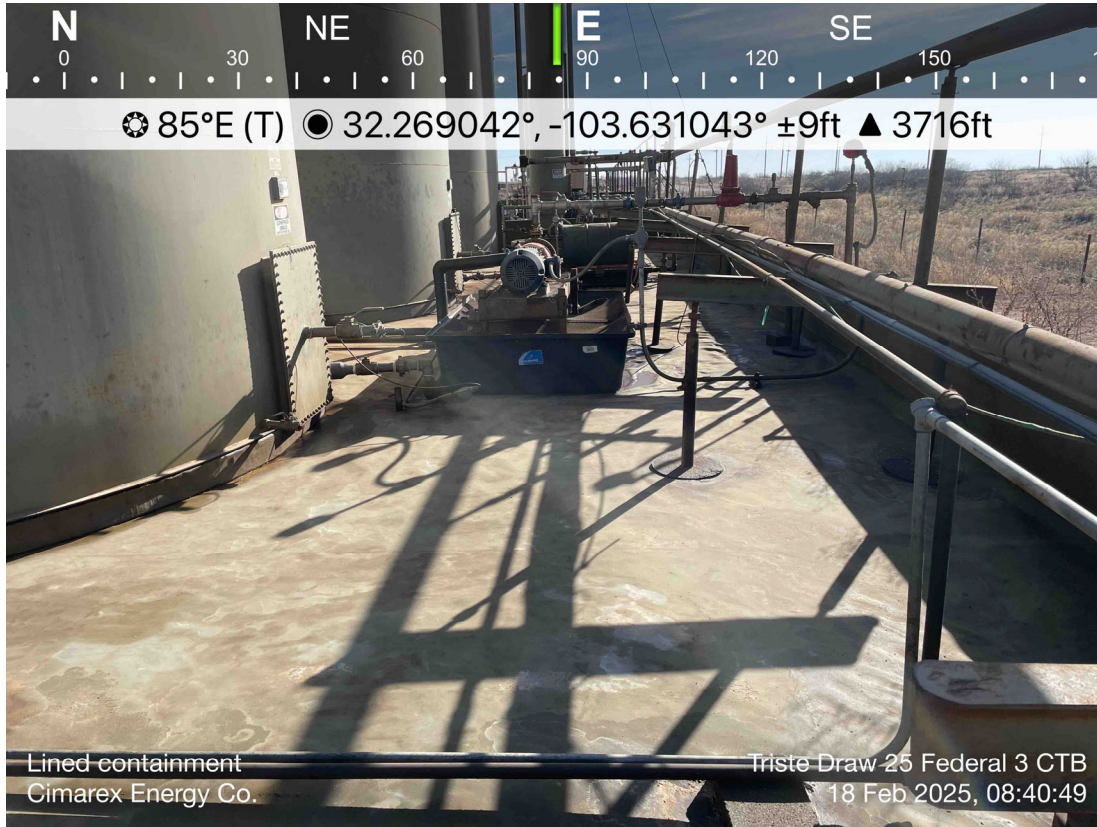
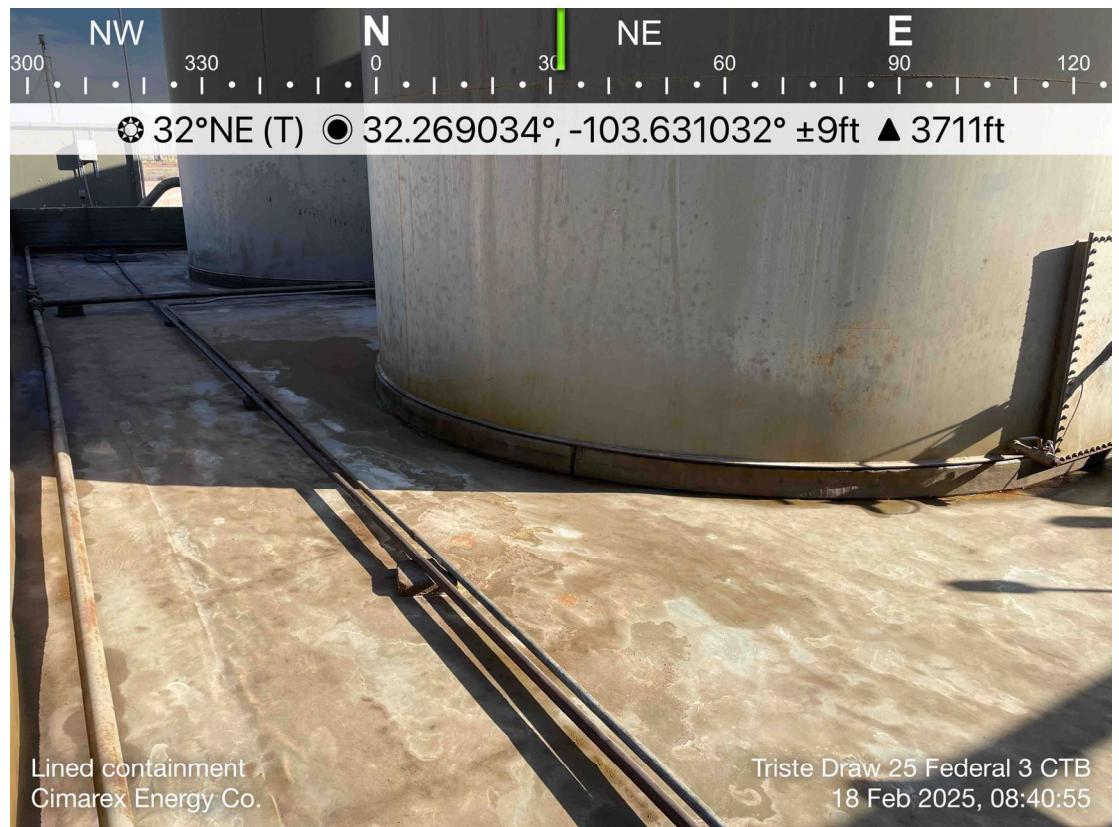
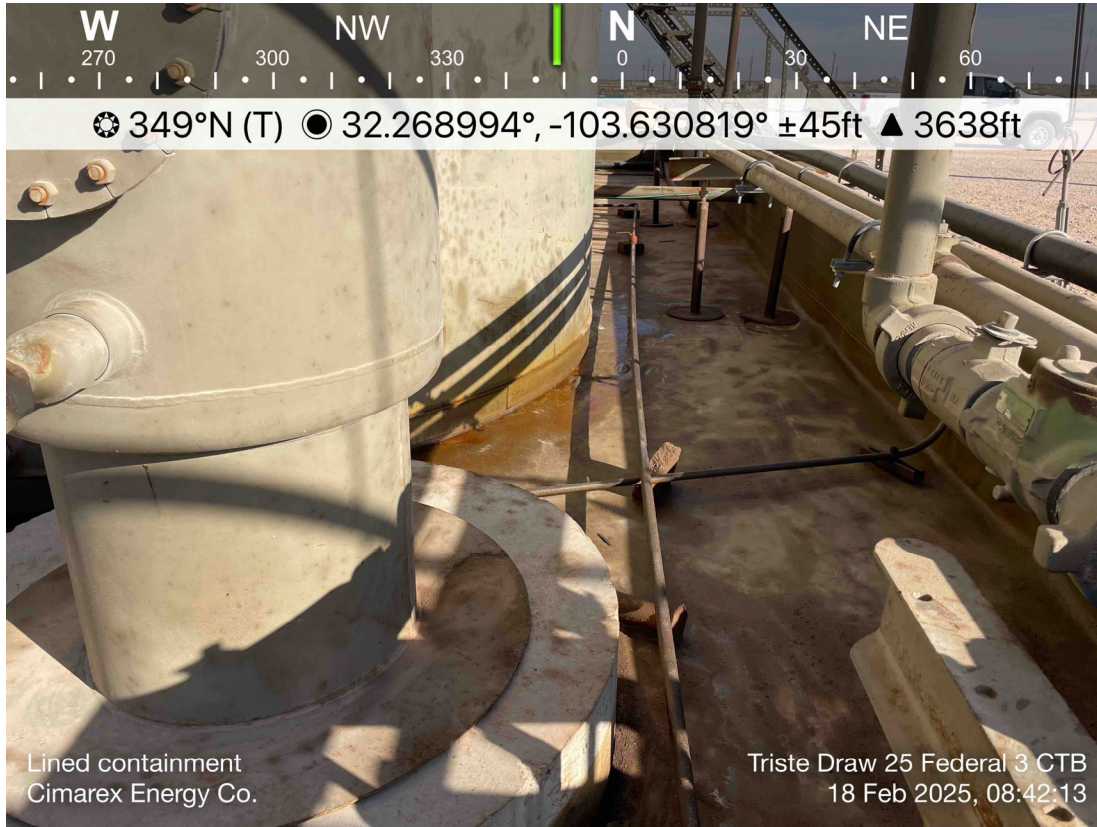
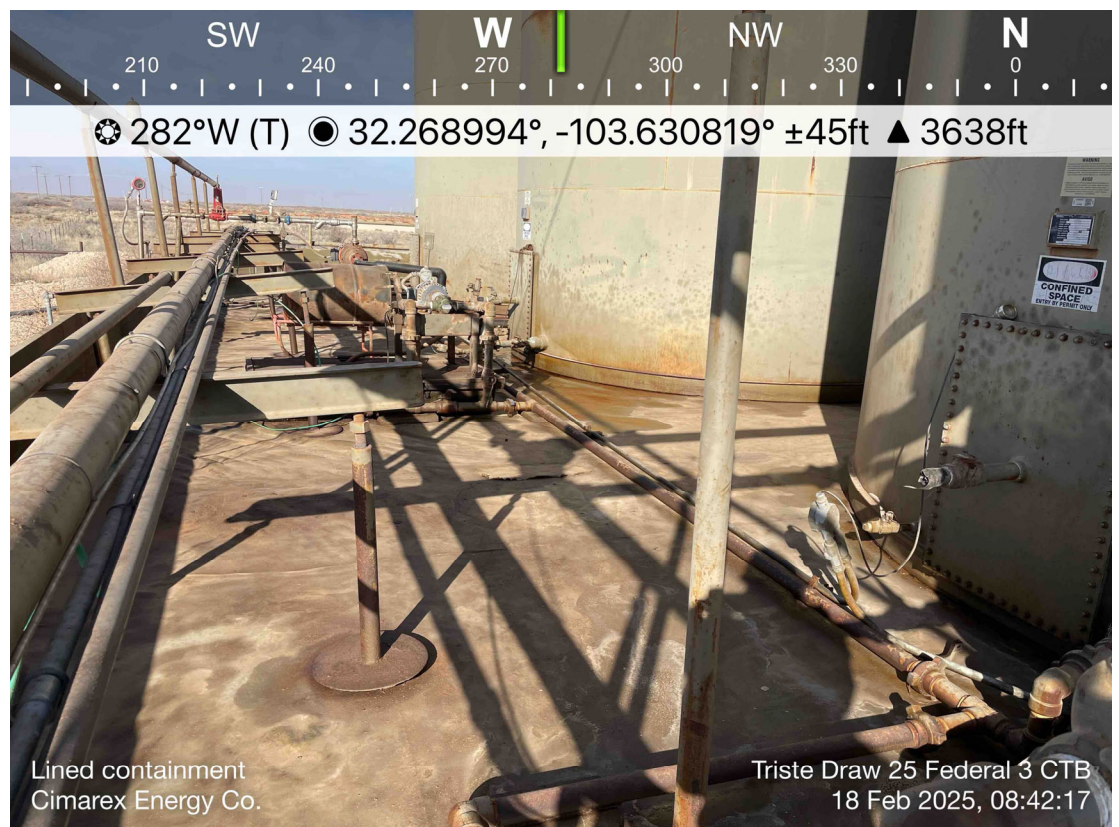
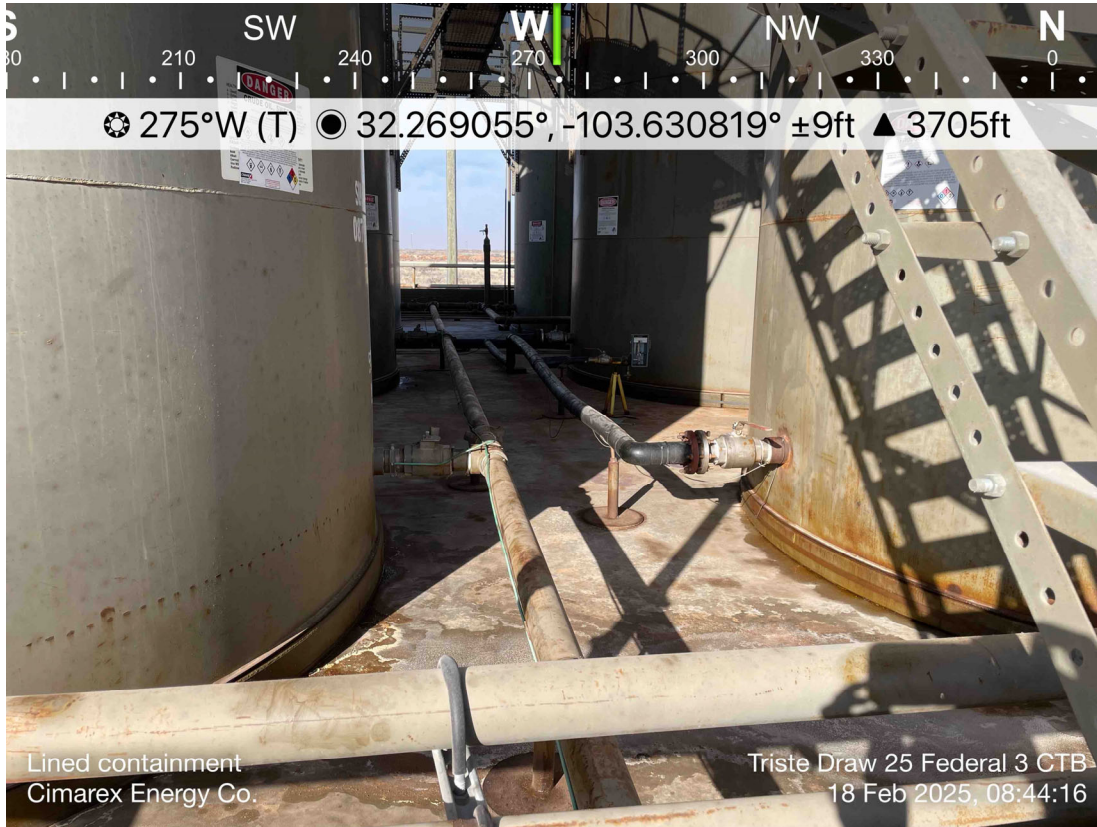
The following serves to verify that the affected liner has been inspected and found to be in serviceable condition in accordance with 19.15.29.11 A.(5)(a)(i-ii) of the New Mexico Administrative Code.

- ☒ Responsible Party has visually inspected the liner.
- ☒ Liner remains intact and was able to contain the leak in question.
- ☒ At least two business days' notice was given to the appropriate division district office before conducting the liner inspection.
- ☒ Photographs illustrating liner integrity are included.

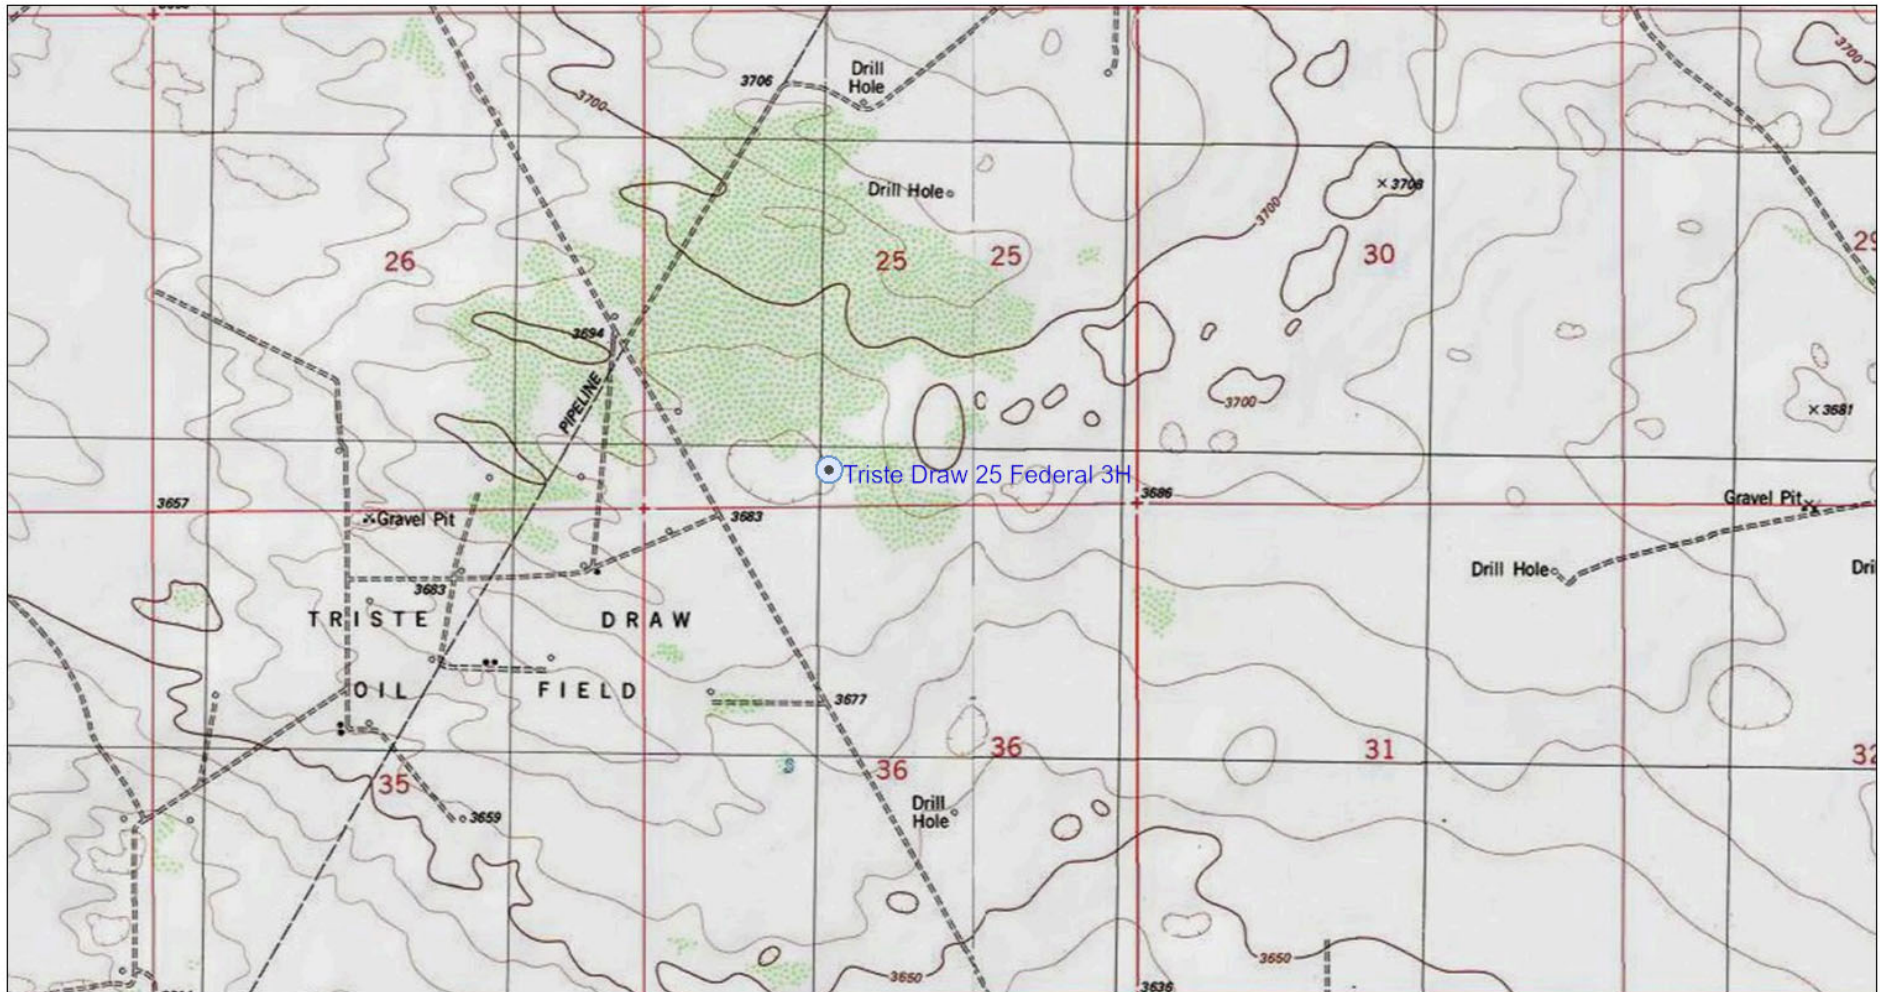
Site Map

Containment Area
