TEXLAND PETROLEUM-HOBBS, LLC

Final Remediation/Reclamation Report

This report documents the remediation activities conducted at the BOWERS A FEDERAL BATTERY, API# 3002536837. On behalf of Texland Petroleum-Hobbs, LLC (Texland), Diamondback Disposal Services, Inc. (Diamondback) undertook the cleanup (remediation) and reclamation of release number nAPP2414147581. The release was caused by equipment failure at a coupling, resulting in the discharge of 52 barrels (BBL) of crude oil. Of the total discharged, 40 BBL were successfully recovered, leaving 12 BBL unrecovered and necessitating remediation. The site is located in Unit Letter P, Section 30, Township 18S, Range 38E, at coordinates 32.71419699, -103.18367097. Remediation and reclamation activities were carried out in accordance with the New Mexico Oil Conservation Division (NMOCD) and regulations 19.15.29 and 19.2.100.67 of the New Mexico Administrative Code (NMAC), effective August 14, 2018.

Bowers A Fed CTB
NAPP2414147581
Final Excavation Photos

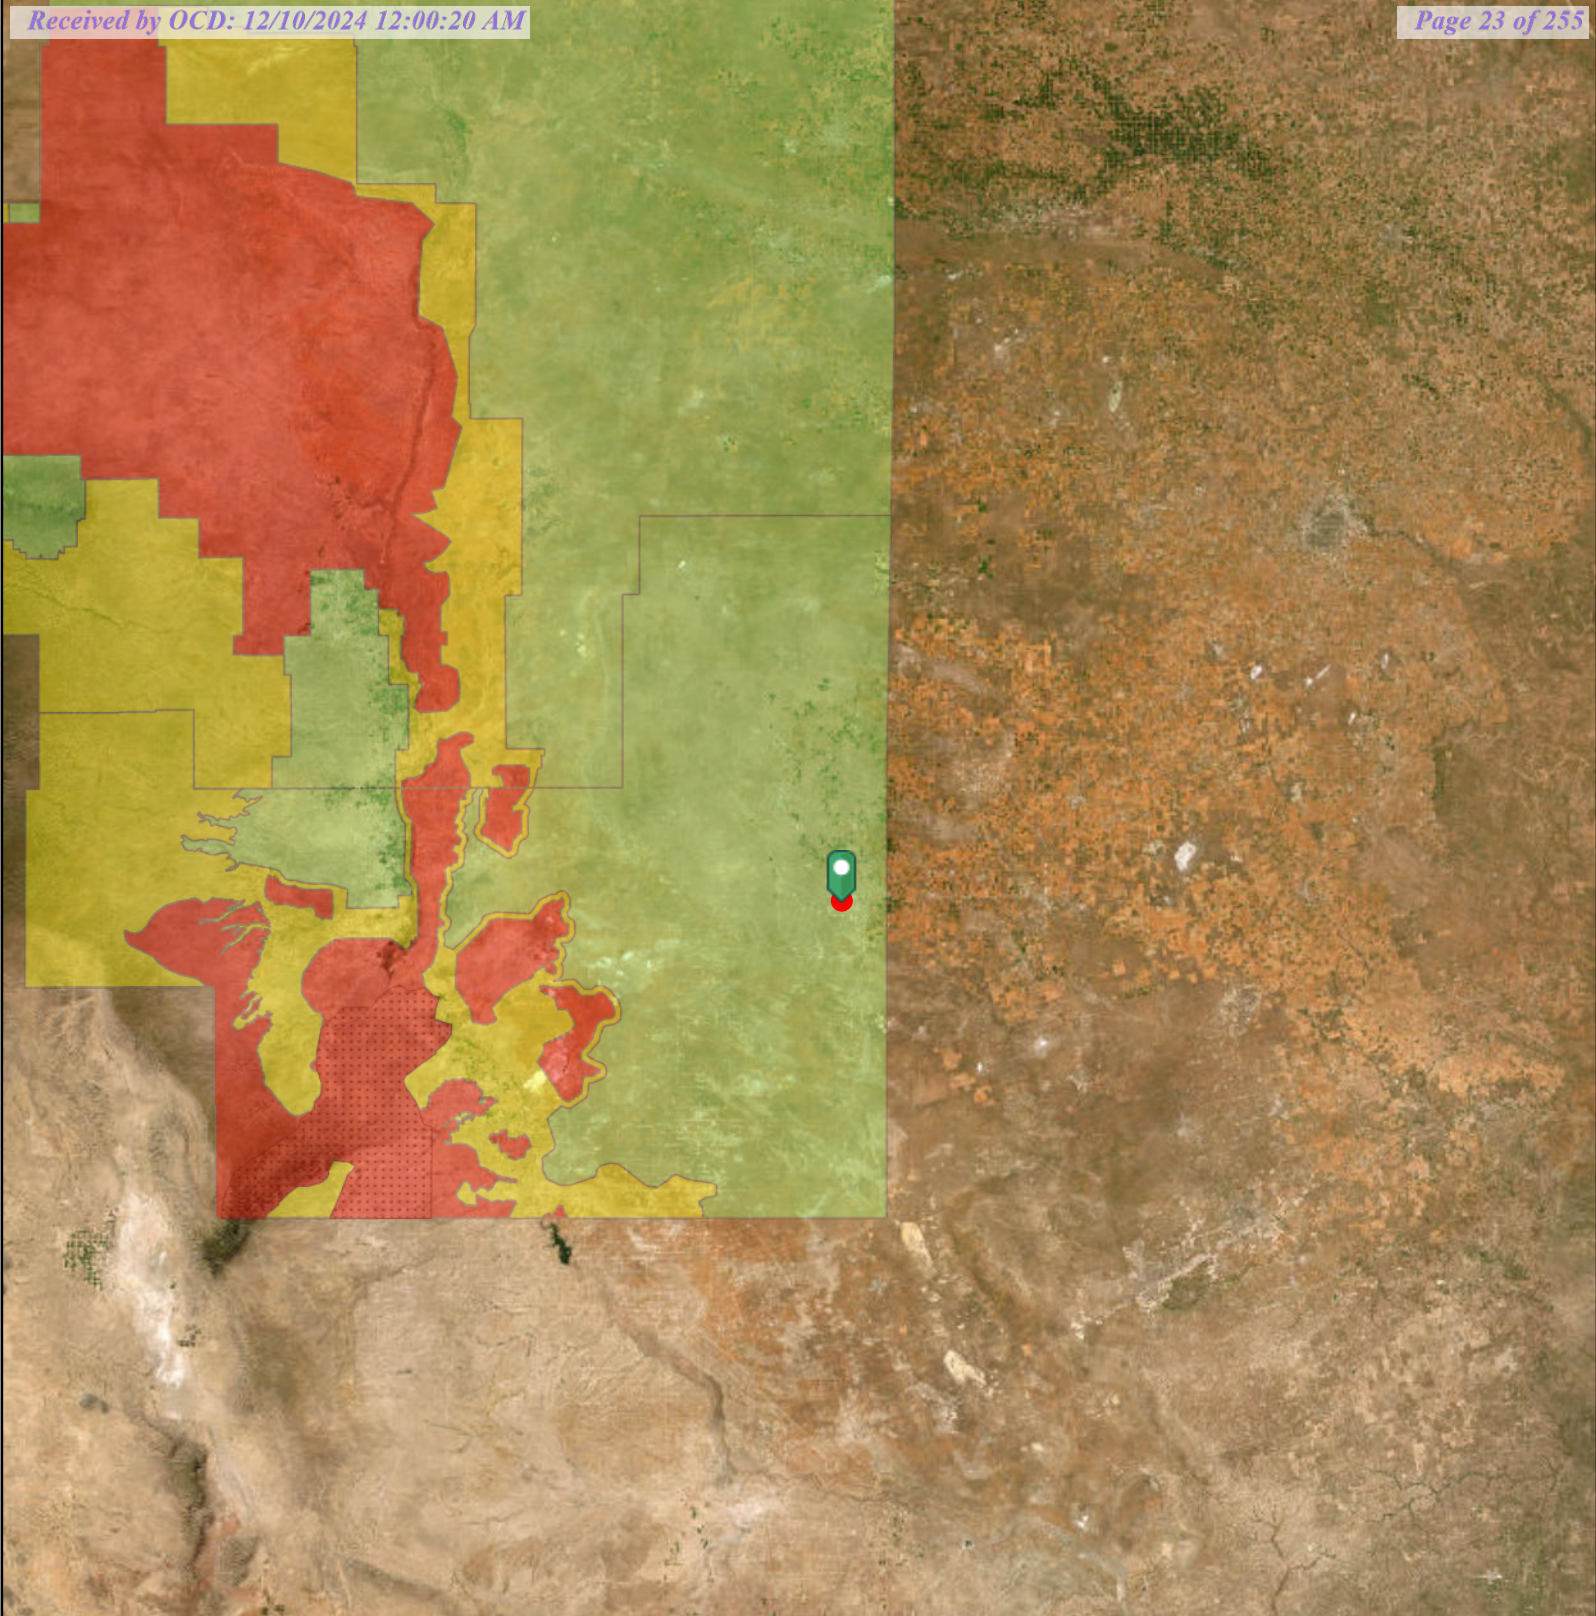
Bowers A Karst Potential

- User drawn points
- Karst_Potential_NM
- Potential
 - High
 - Medium
 - Low
- Critical_Karst_Zone_NM

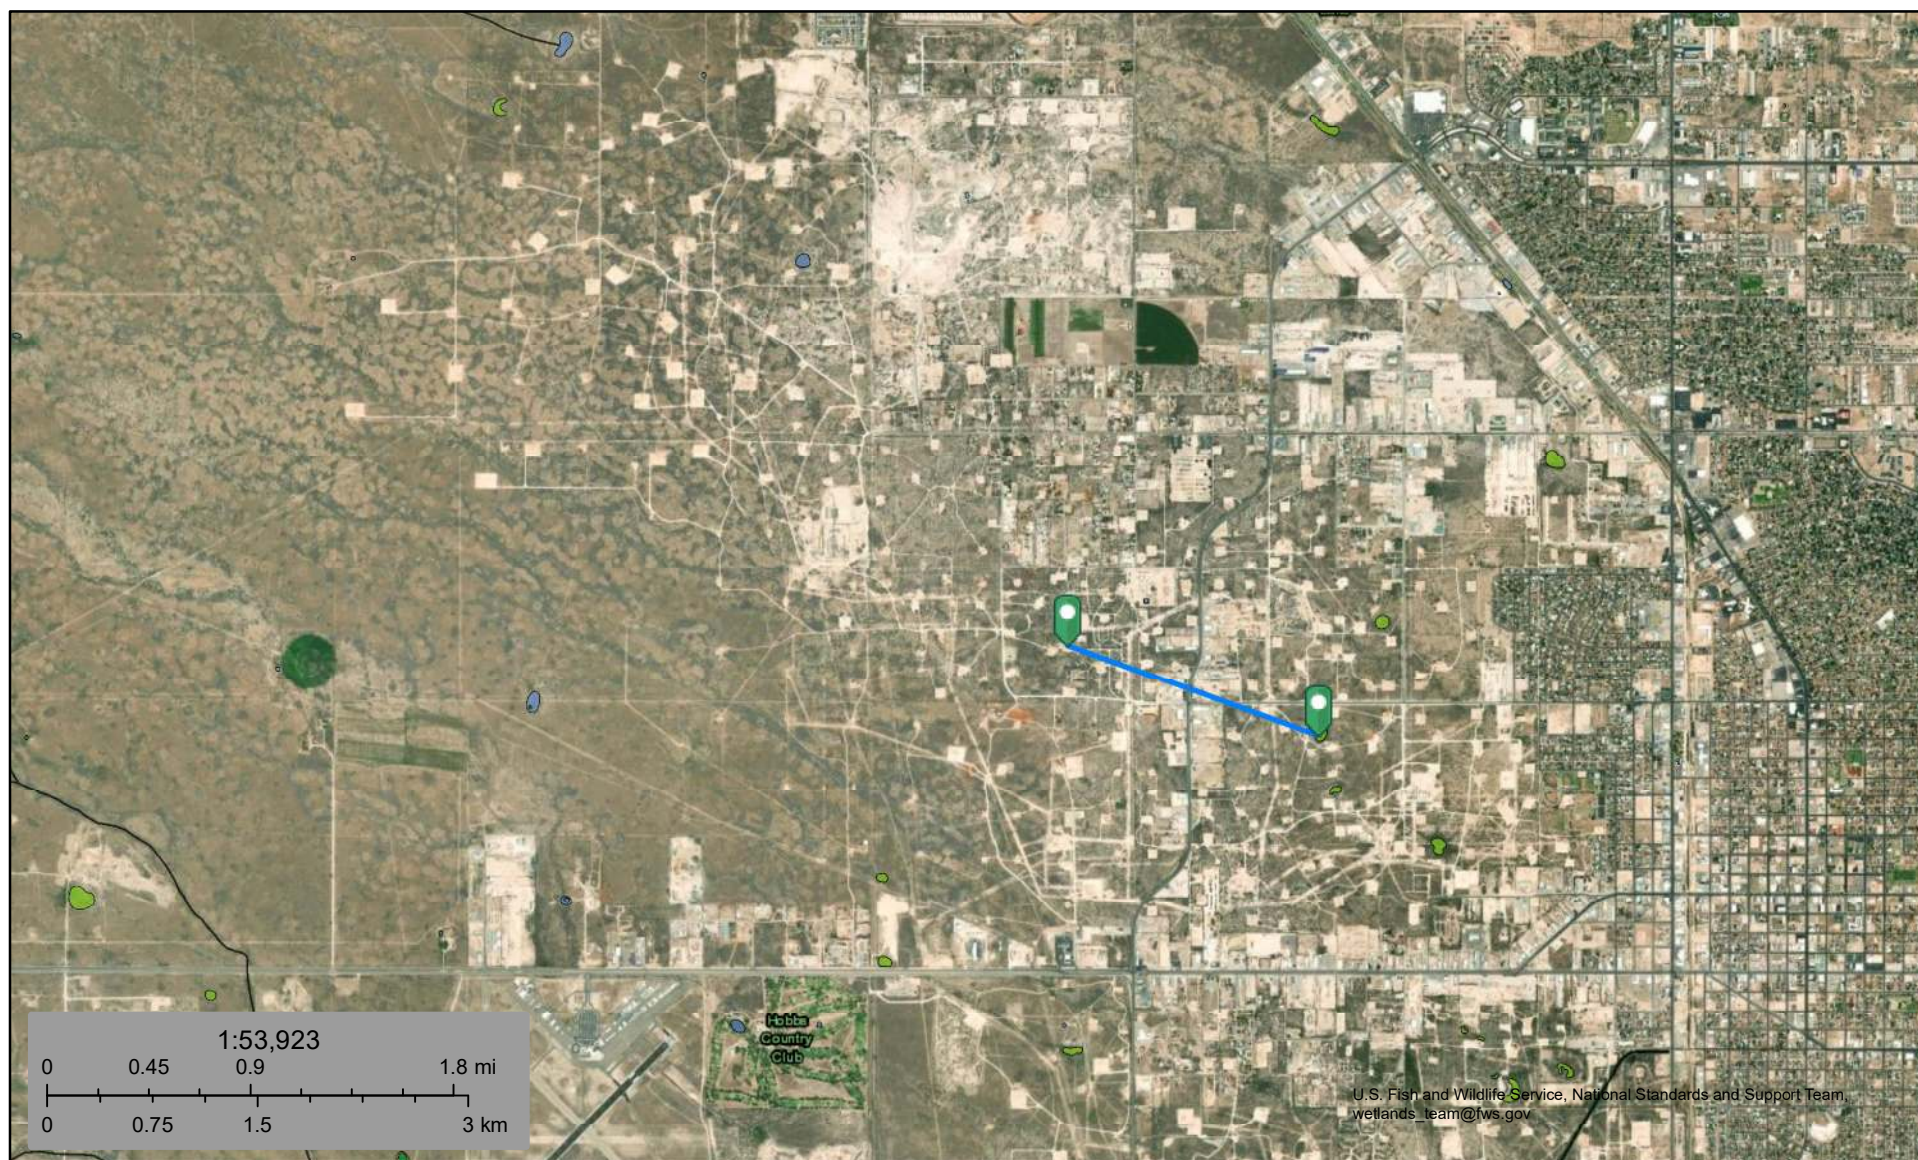
Bowers A Wetland

Wetlands

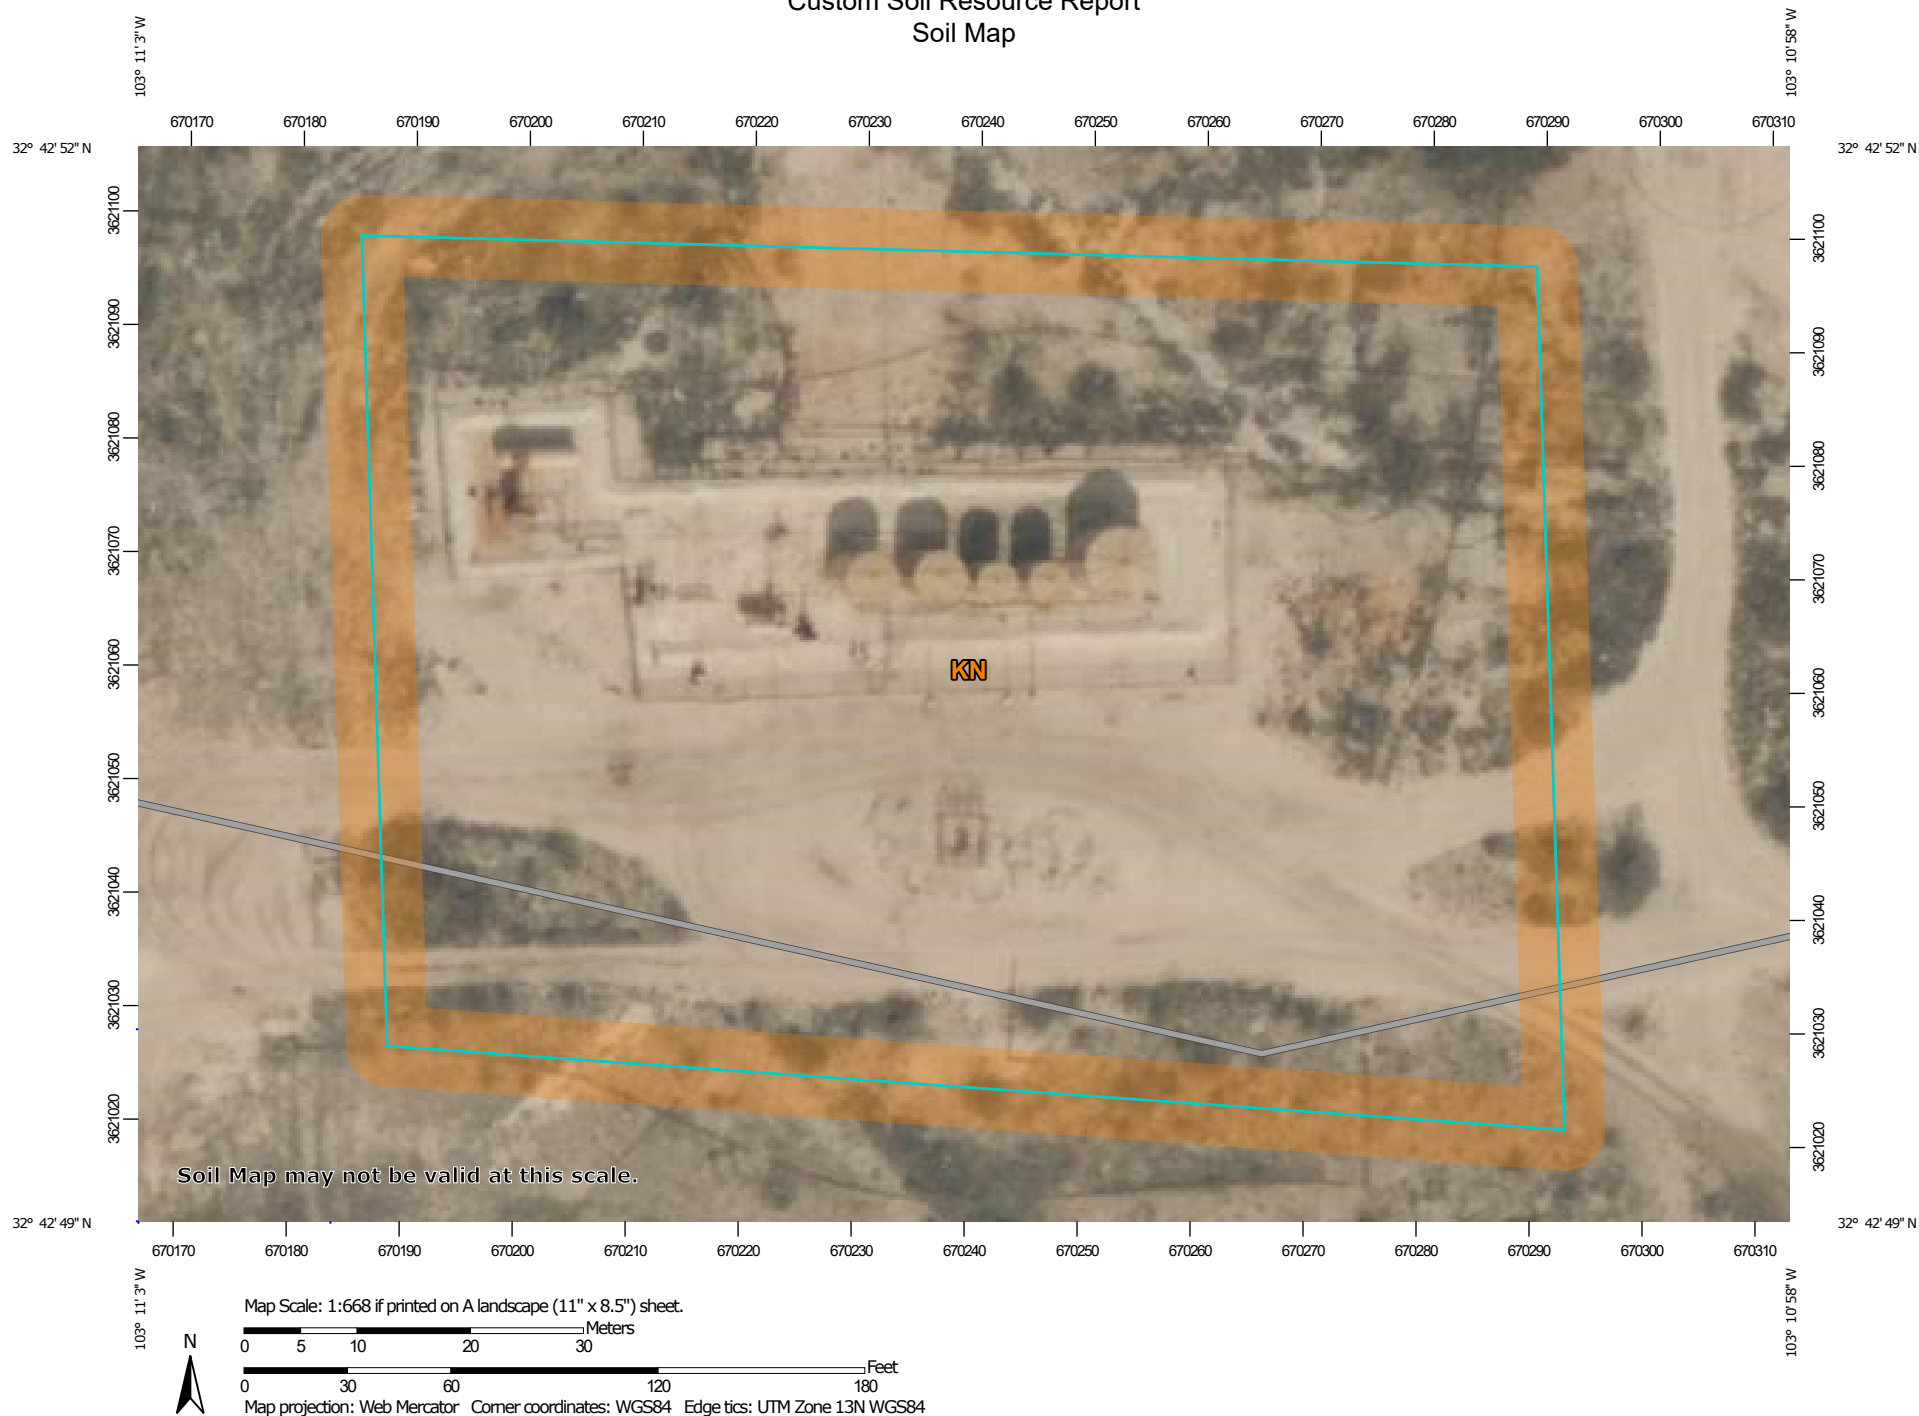
Custom Soil Resource Report Soil Map

The soil map section includes the soil map for the defined area of interest, a list of soil map units on the map and extent of each map unit, and cartographic symbols displayed on the map. Also presented are various metadata about data used to produce the map, and a description of each soil map unit.

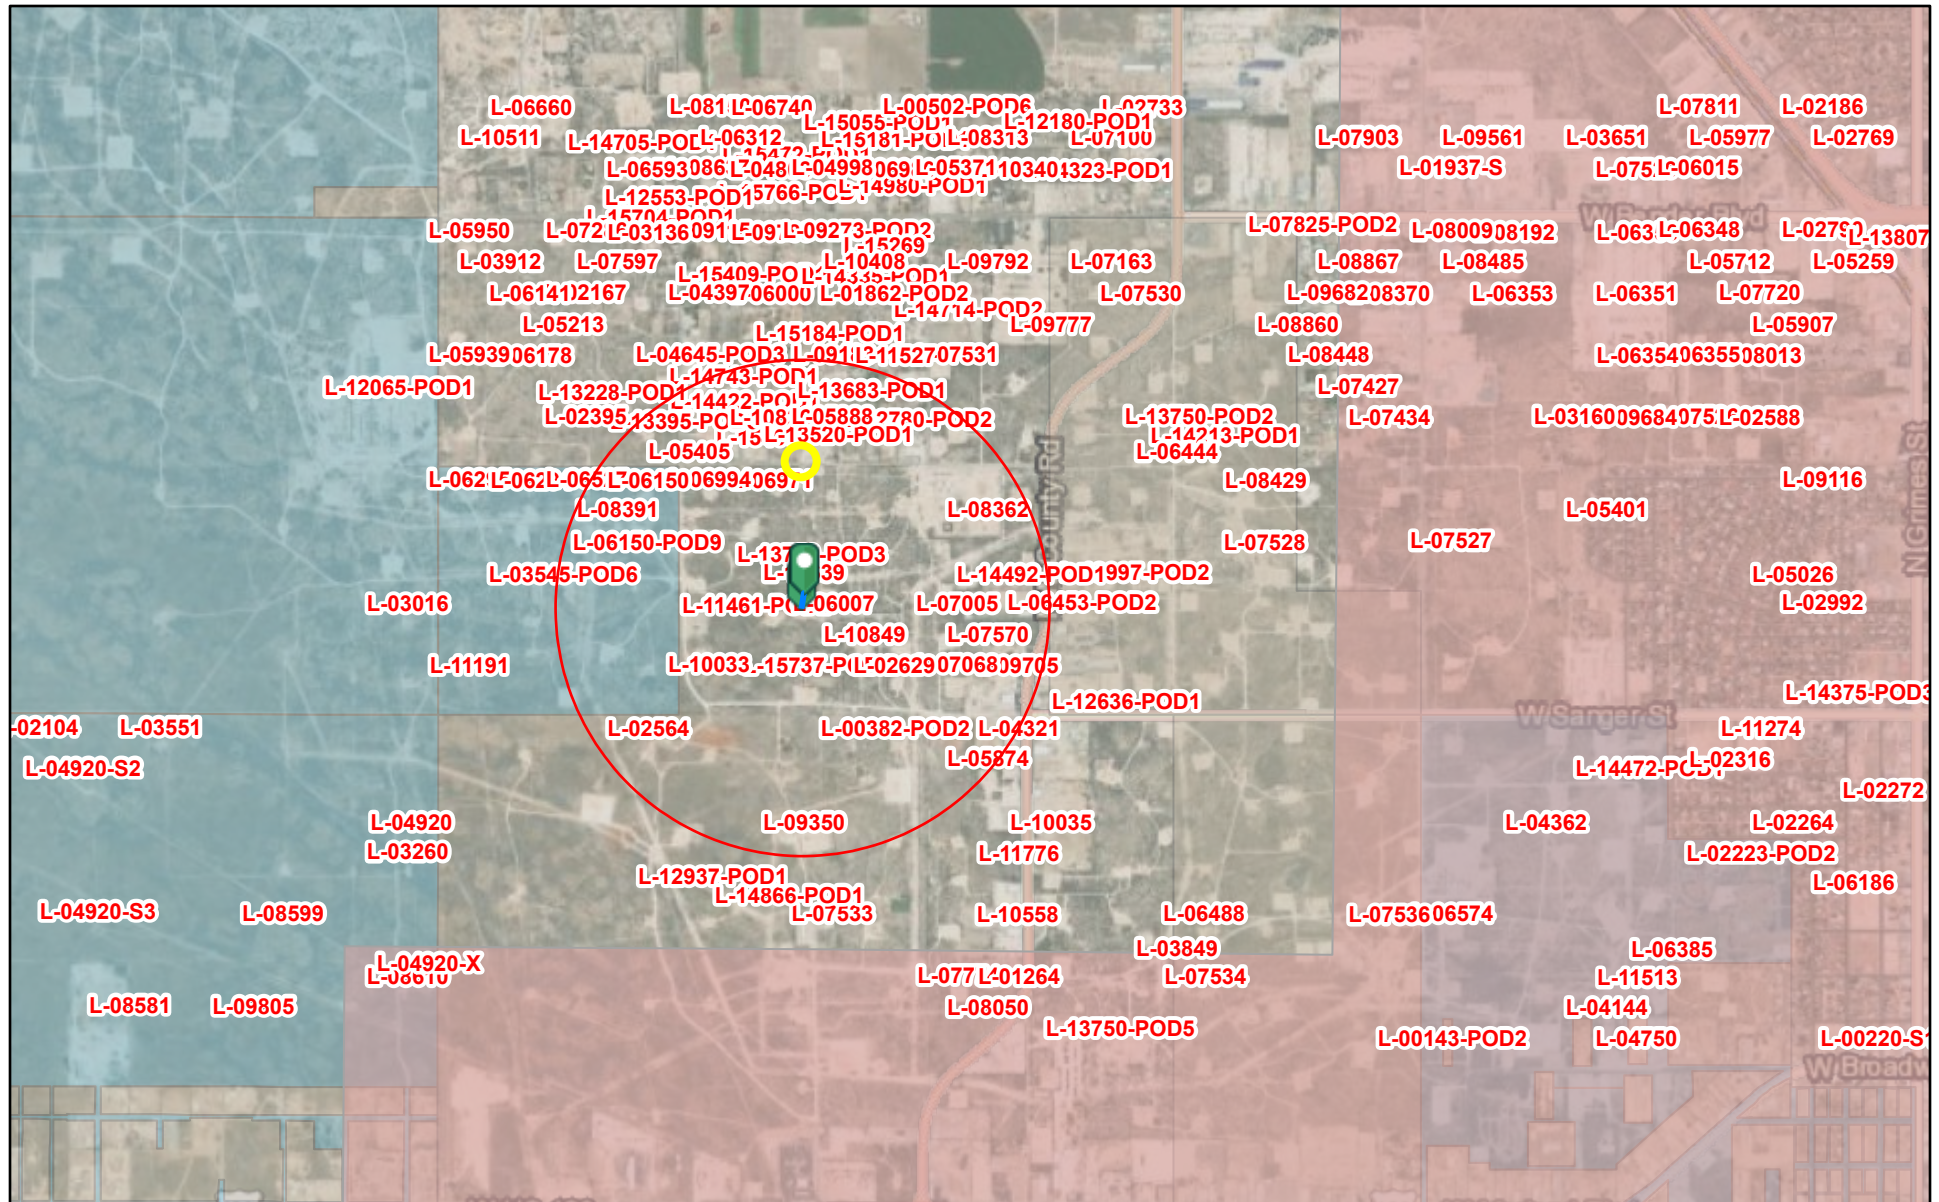
Bowers 1/2 Mile Radius

-   Override 1
   Closure Area
   Both Estates
-   OSE District Boundary
   Artesian Planning Area
- Water Right Regulations
 New Mexico State Trust Lands
-   Critical Management Area - Guidelines
   Subsurface Estate

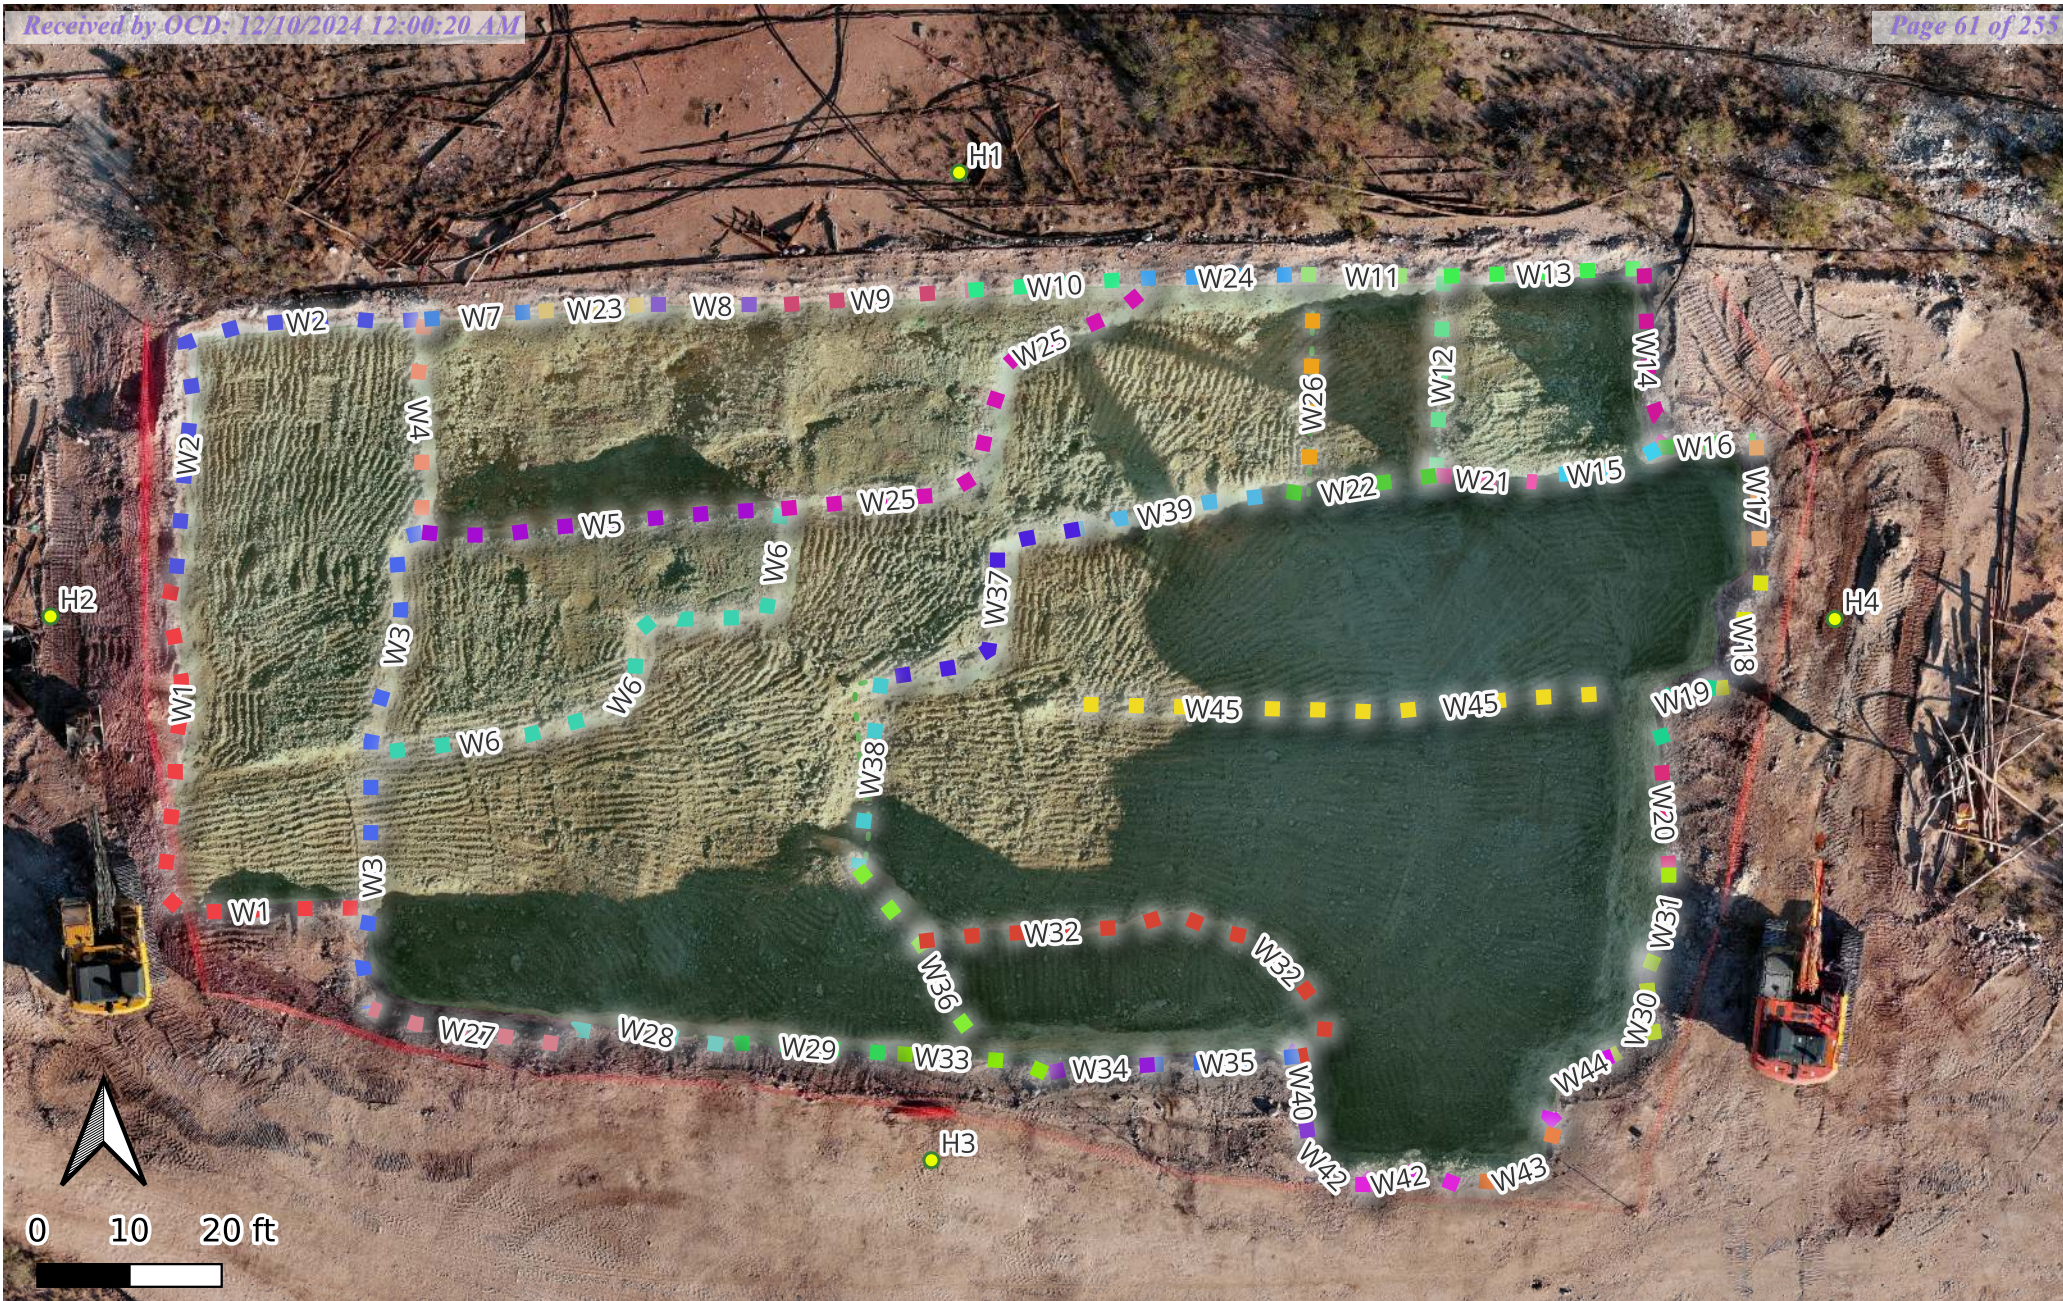
BOWERS A FEDERAL BATTERY
@ 3002536837
NAPP2414147581
Wall Sample Map

- Bottoms "B"
- Horizontal Sample "H"

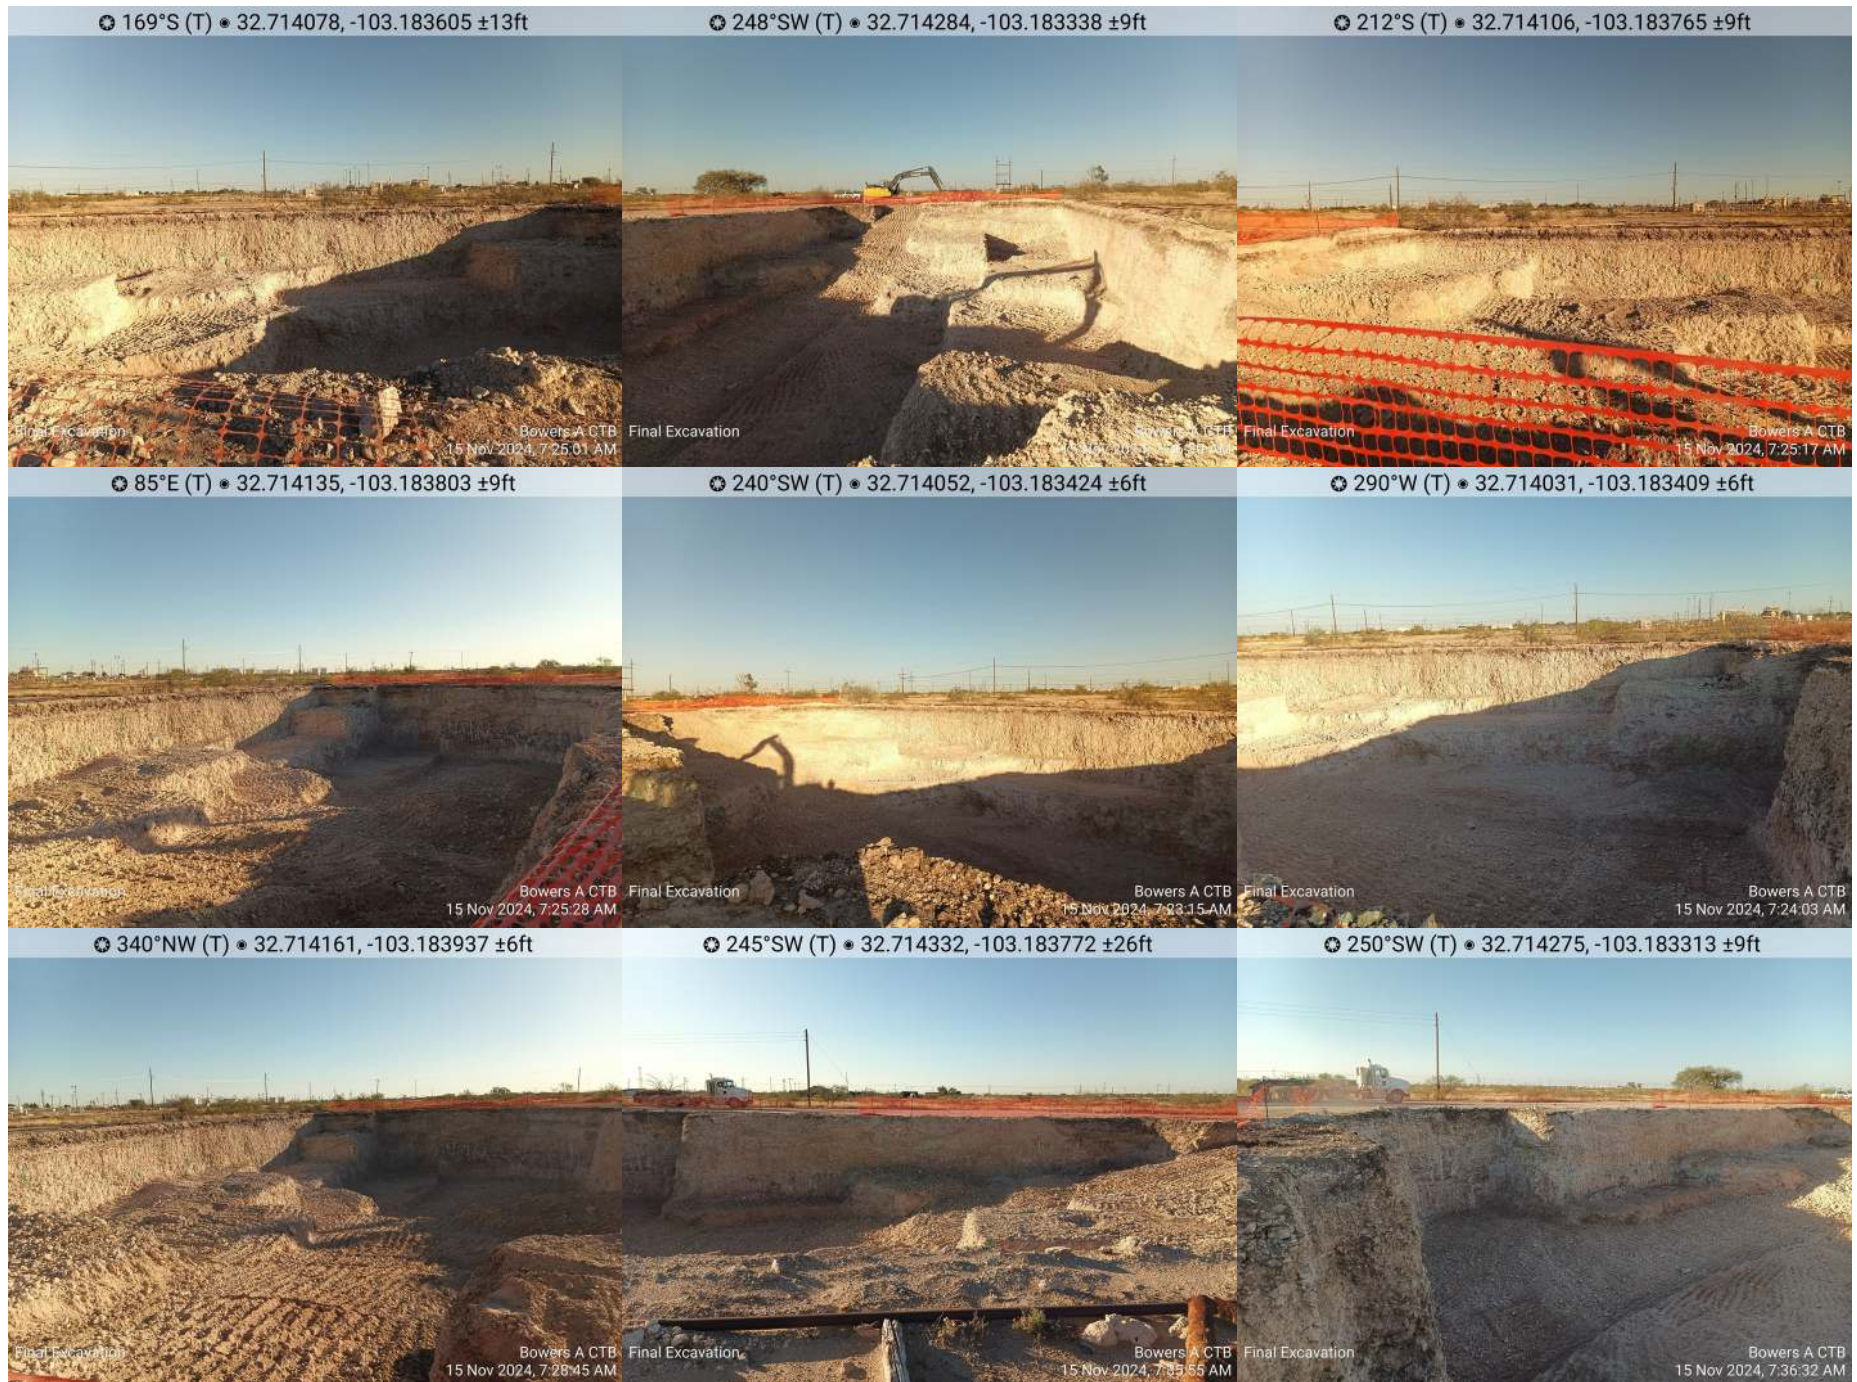
<u>Sample ID</u>	<u>Soil</u>	<u>Water</u>	<u>Ratio</u>	<u>AgNO3</u>	<u>Cl Result</u>	<u>MR3000</u>	<u>Depth</u>
S1	11.92	32.85	2.76	0.03	83	9.20	
S2	10.66	32.18	3.02	0.04	121	32.20	
S3	10	30.56	3.06	0.02	61	3.70	
S4				0.00		142.90	
S5	10.37	29.2	2.82	0.04	113	1.40	
S6	12.69	30.1	2.37	0.03	71	5.70	
S7	10.18	30.22	2.97	0.04	119	3.00	
S8	10.2	33.29	3.26	0.03	98	0.00	
S9	11.83	32.78	2.77	0.02	55	0.90	
S10	12	29.45	2.45	0.02	49	0.50	
S11	11.89	33.26	2.80	0.05	140	1.10	
S12						77.50	
S13	11.52	30.9	2.68	0.02	54	26.20	
S14	10.55	31.41	2.98	0.02	60	1.40	
S15	12.44	30.75	2.47	0.08	198	3.50	
S16	12.62	30.24	2.40	0.26	623	29.70	
S17	12.13	32.41	2.67	0.07	187	18.90	
S18	12.61	30.31	2.40	0.07	168	44.10	
S19	12.17	28.05	2.30	0.11	253	42.50	
S18						351.20	
S19						121.90	
S20						67.90	4-10'
S21						45.30	4-10'
S19						69.70	0-4'
S18						81.70	4-10'
scratch	11.94	27.22	2.28	0.02	46		
scratch	11.54	29	2.51	0.10	251		
W1	12.95	29.15	2.25	0.12	270	1.00	0-4'

W2	12.7	29	2.28	0.10	228	1.20	0-4'
W3	12.83	30.68	2.39	0.04	96	8.00	4-8'
W4	11	28.37	2.58	0.02	52	5.00	4-12'
W5	12.05	28.7	2.38	0.06	143	10.00	8-12'
W6	11.44	27.57	2.41	0.05	120	6.00	8-12'
W7							
W8							
W9							
W10							
W11							
W12						187.00	
W13						194.00	
W14							
W15							
W16							
W17	11.9	27.21	2.29	0.10	229	1.80	0-20'
W18	11.75	29	2.47	0.04	99	5.00	0-20'
W19	11.53	28.08	2.44	0.02	49	4.90	0-20'
W20	12.22	27.7	2.27	0.15	340	0.80	0-20'
W21						194.00	
W22							0-20'
W23							0
W24	11.74	28.87	2.46	0.10	246	3.00	0-14'
W1	11.55	29.28	2.54	0.05	127	1.00	0-4'

In the first week of December 2024, the site will be backfilled with approximately 9,000 cubic yards of locally sourced caliche. The material will be carefully placed and compacted to restore the pad to operational condition while ensuring proper drainage and preventing stormwater runoff. These activities will help minimize erosion and maintain consistency with existing site conditions.

Upon final review of all analytical data provided by the third-party independent lab, results indicated that all recommended remediation action levels restoration/reclamation criteria were met for all excavated areas. On behalf of Texland Resources, Diamondback Disposal Services respectfully requests that the NMOCD grant closure approval at BOWERS A FEDERAL BATTERY API# 30025-36837 for release number nAPP2414147581. Thank you for your consideration.
