Lario Area 51 SWD Pipeline

Incident #NAPP2506450529

Remediation Workplan

A-22-18S-34E

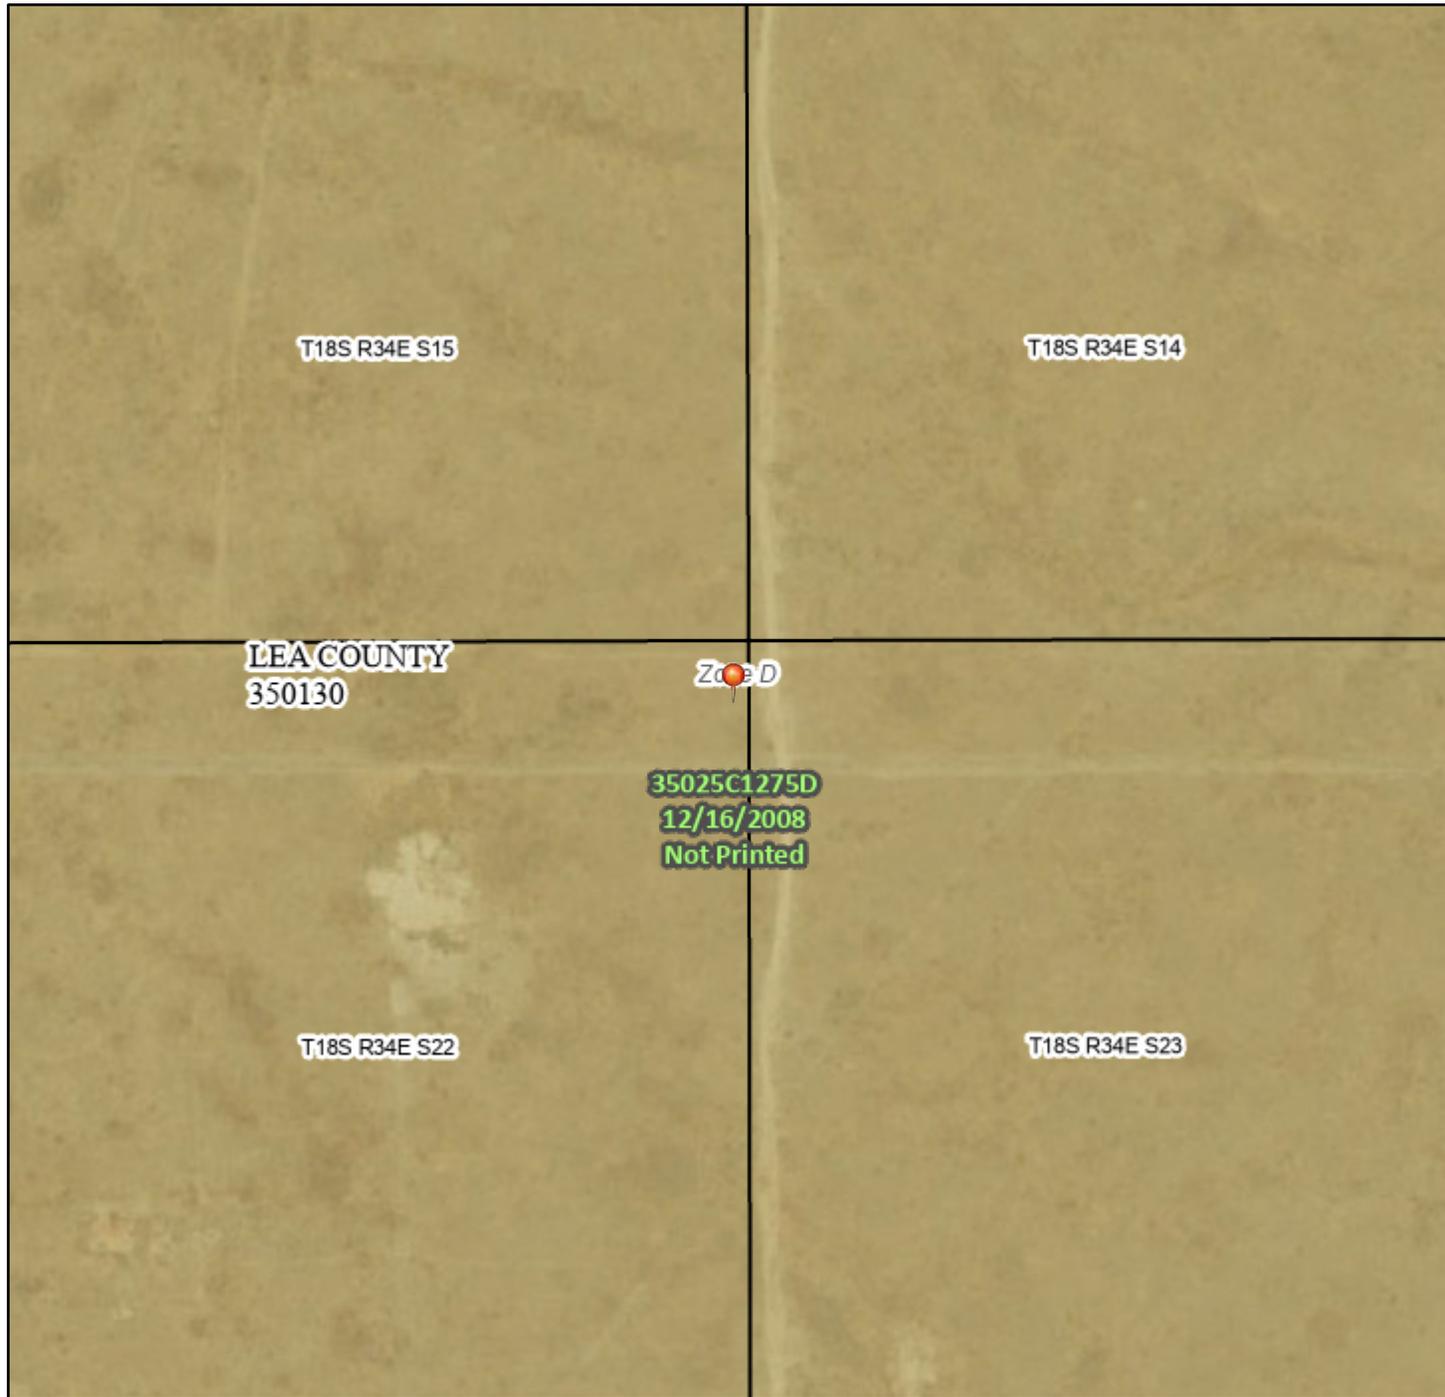
National Flood Hazard Layer FIRMette

The flood hazard information is derived directly from the authoritative NFHL web services provided by FEMA. This map was exported on 3/6/2025 at 7:12 PM and does not reflect changes or amendments subsequent to this date and time. The NFHL and effective information may change or become superseded by new data over time.

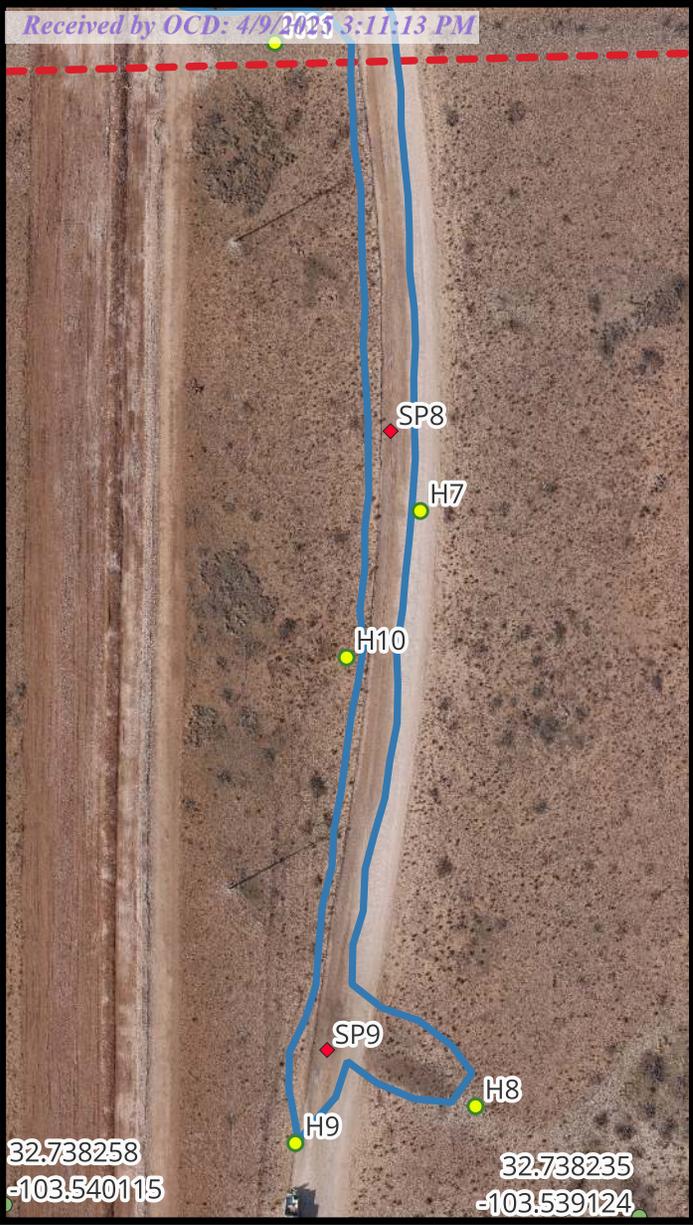
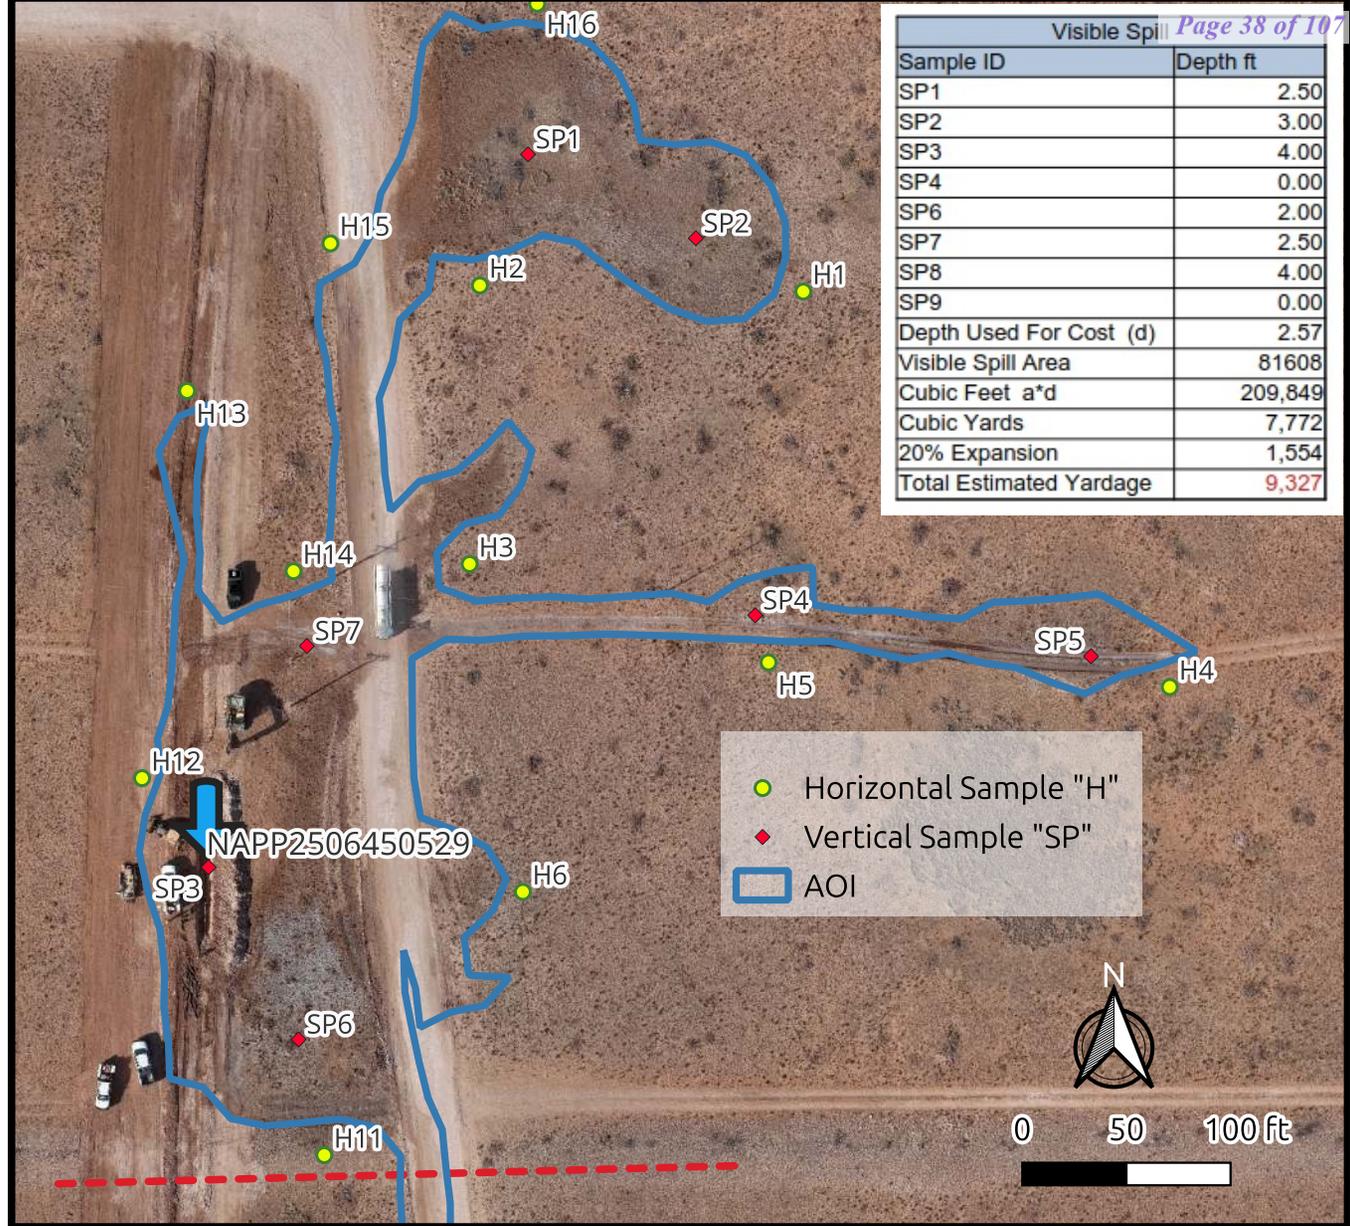
Sample ID	Depth ft
SP1	2.50
SP2	3.00
SP3	4.00
SP4	0.00
SP6	2.00
SP7	2.50
SP8	4.00
SP9	0.00
Depth Used For Cost (d)	2.57
Visible Spill Area	81608
Cubic Feet a*d	209,849
Cubic Yards	7,772
20% Expansion	1,554
Total Estimated Yardage	9,327

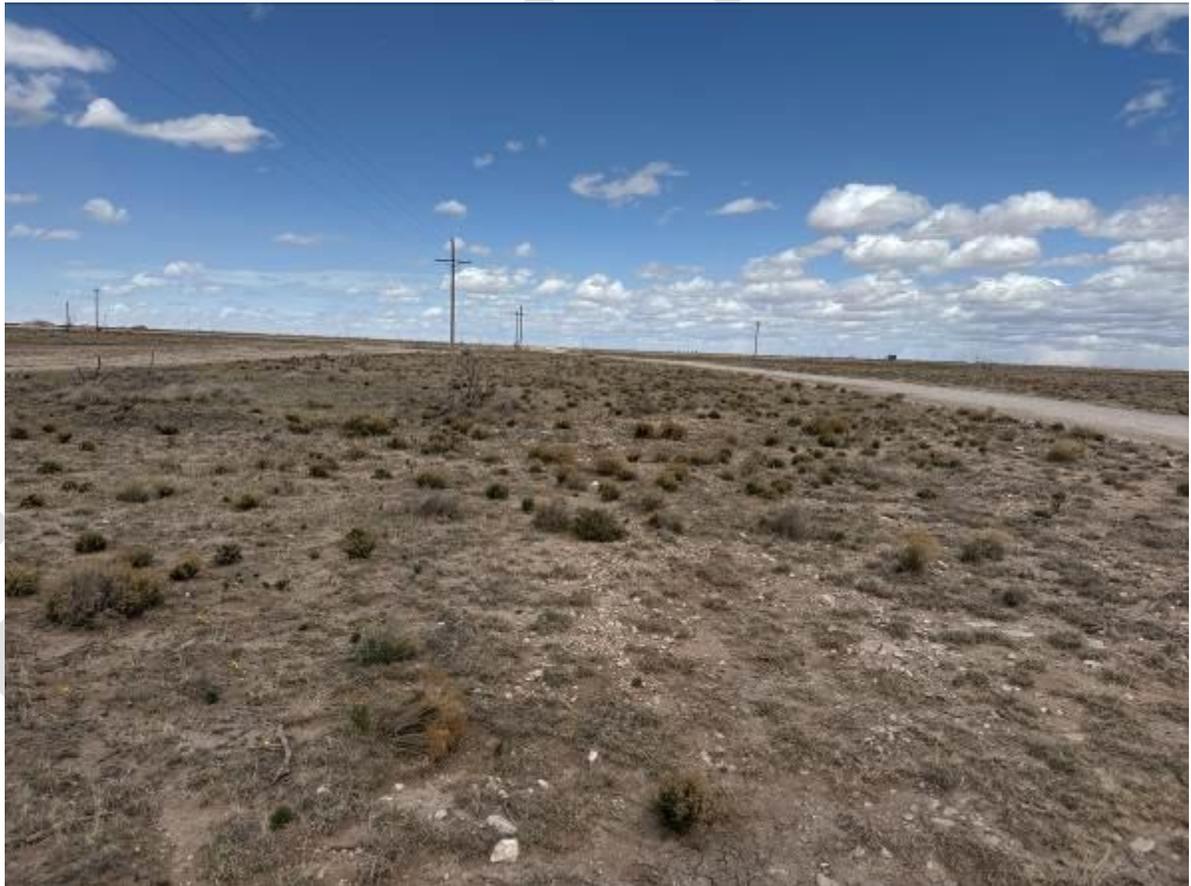
Overview of Spill/ Remediation Area

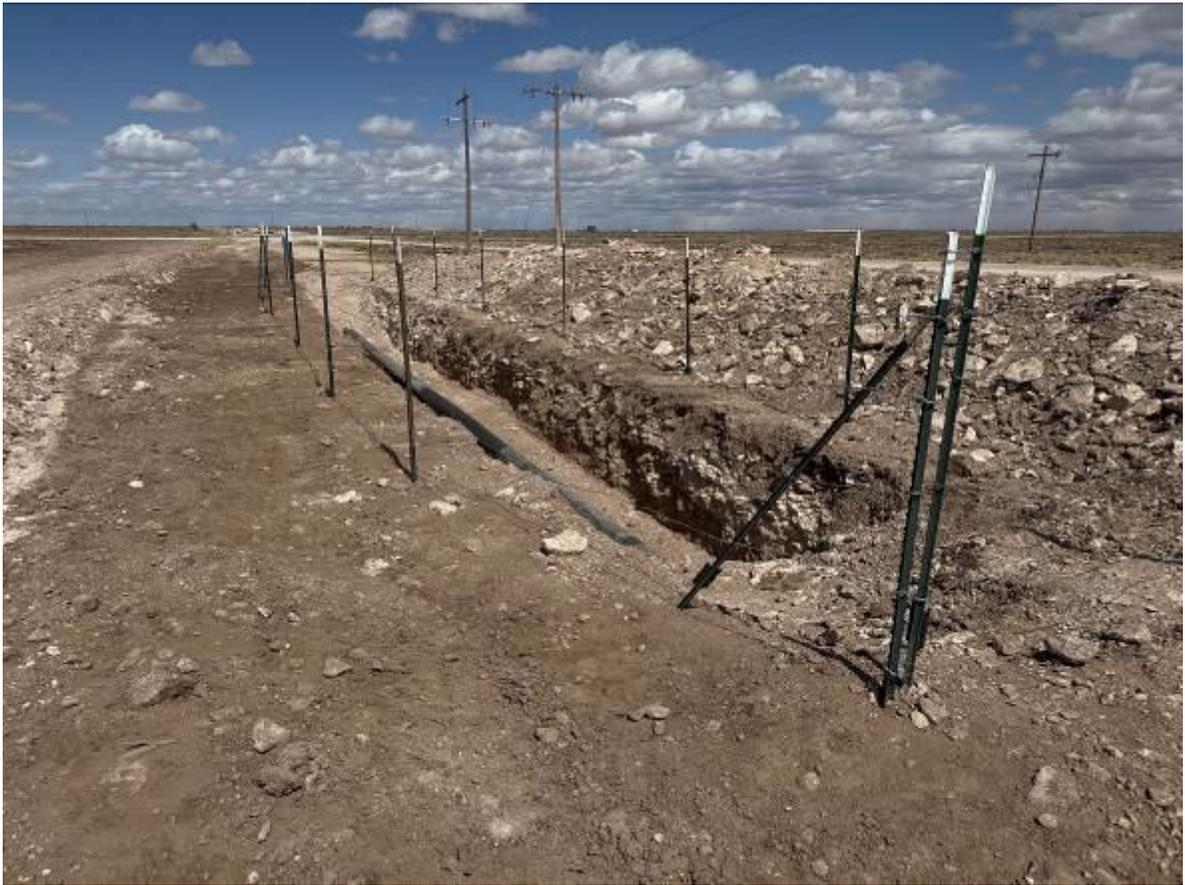
Overview of Spill/ Remediation Area

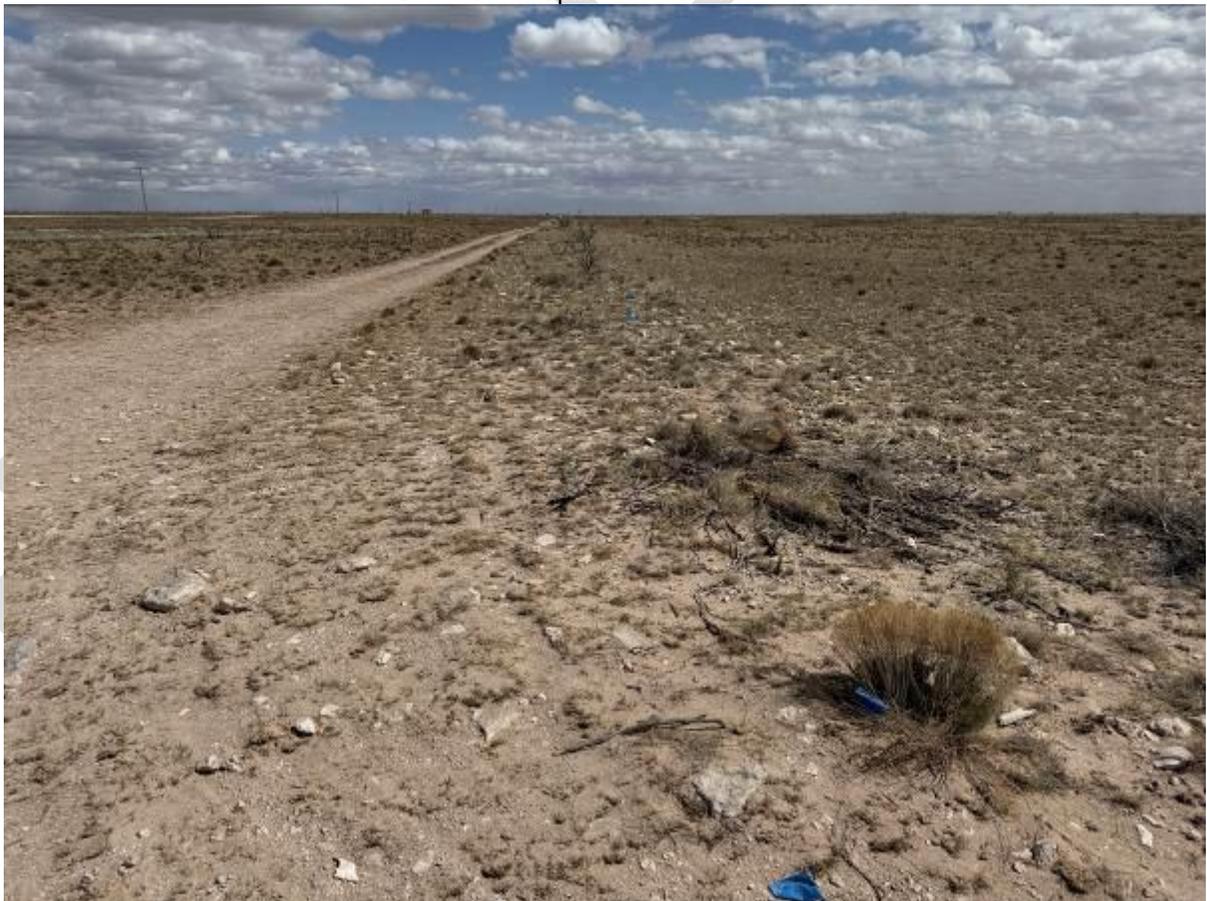
Overview of Spill/ Remediation Area

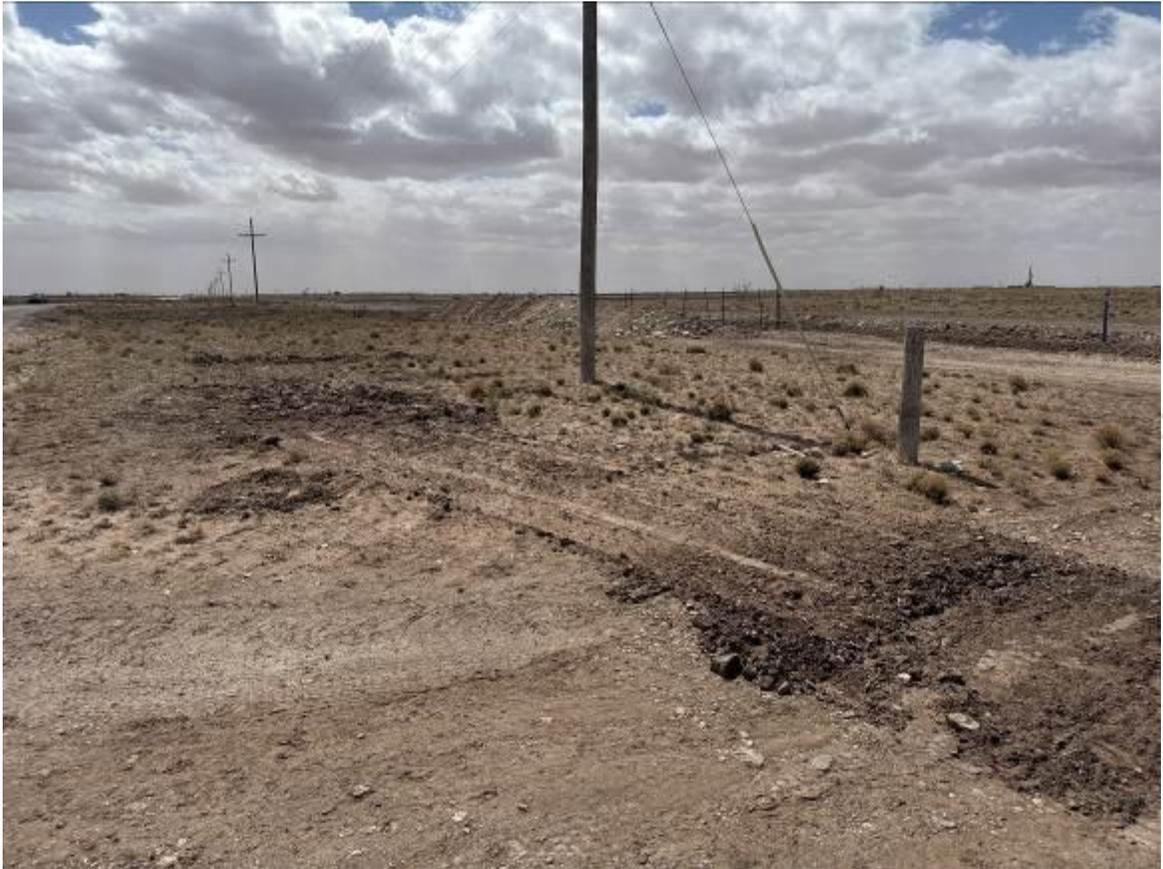
Overview of Spill/ Remediation Area

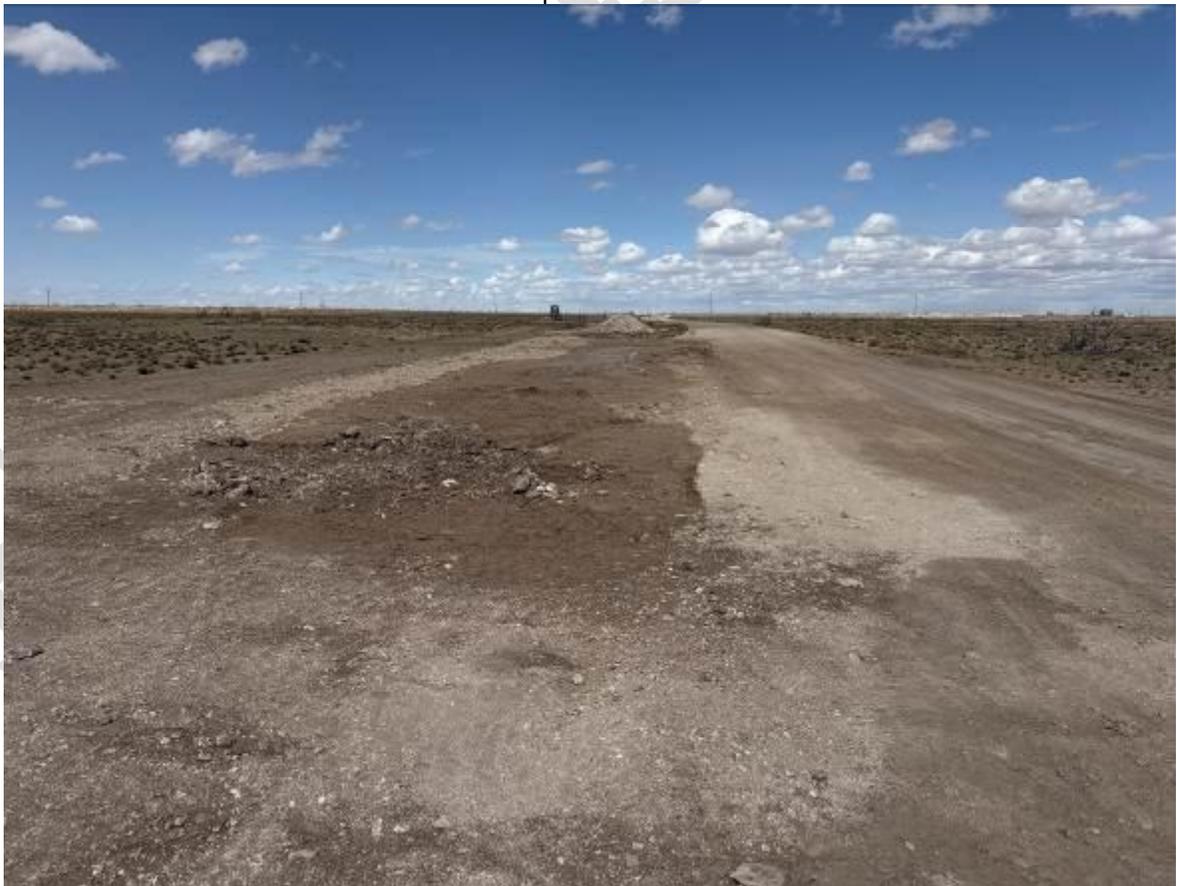
Overview of Spill/ Remediation Area

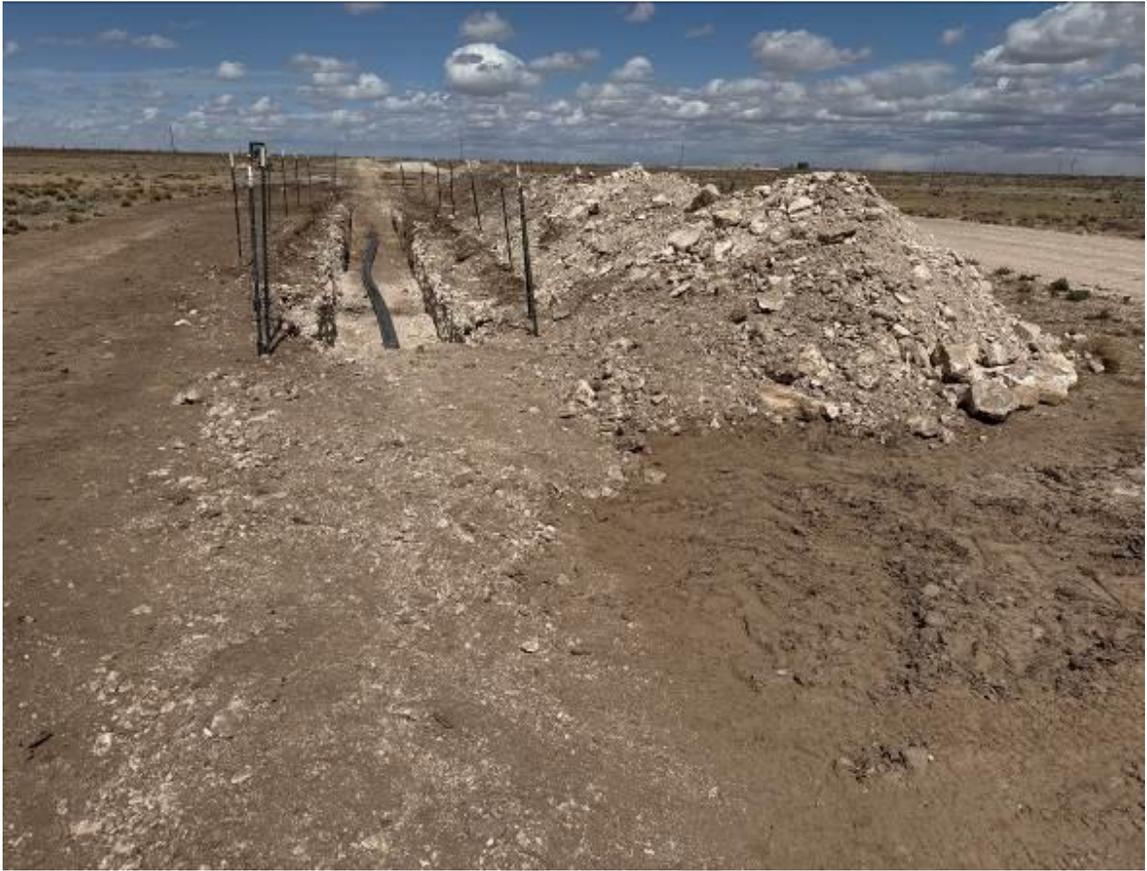
Overview of Spill/ Remediation Area
