RE: **Shaqtus 26 ST 1 Battery - Closure Request Report**  
Incident Number: nAPP2434144241  
GPS: 32.43970°, -103.75201°  
Eddy County, New Mexico  
ESRR Project No. 2728/VP-18302

Earth Systems Response & Restoration (ESRR), on behalf of Devon Energy (Devon), presents the following Closure Request Report (CRR) detailing excavation activities and subsequent soil sampling events associated with an inadvertent release of crude oil and produced water at the Shaqtus 26 ST 1 Battery (Site). Based on completed remedial actions and laboratory analytical results from recent soil sampling events, Devon is requesting No Further Action (NFA) at the Site.

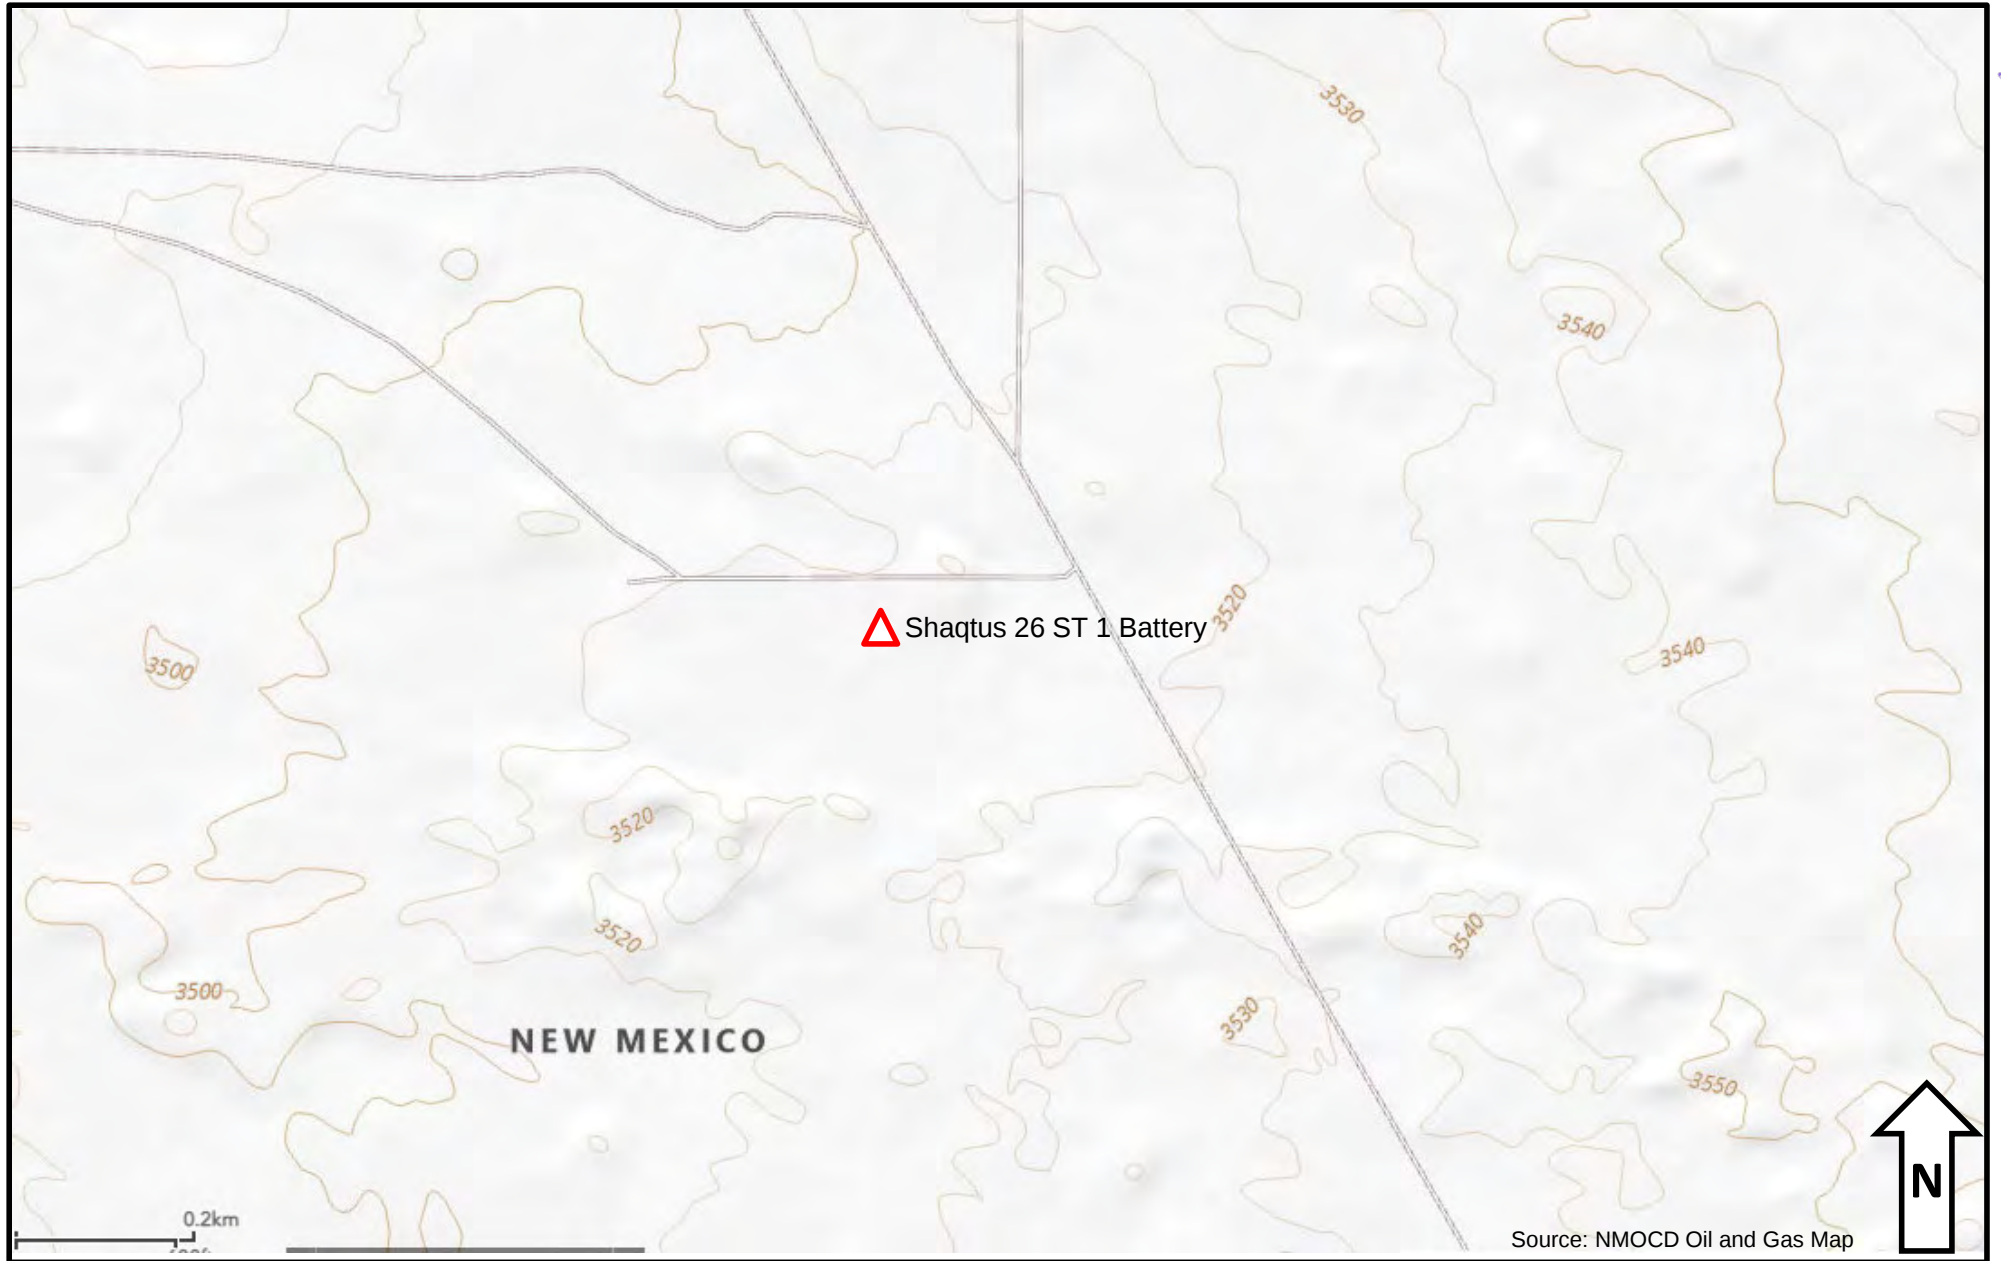
**Figure 1 – Site Map**

Devon Energy Permian – Shaqtus 26 ST 1 Battery  
GPS: 32.439701,-103.75201  
Eddy County, New Mexico

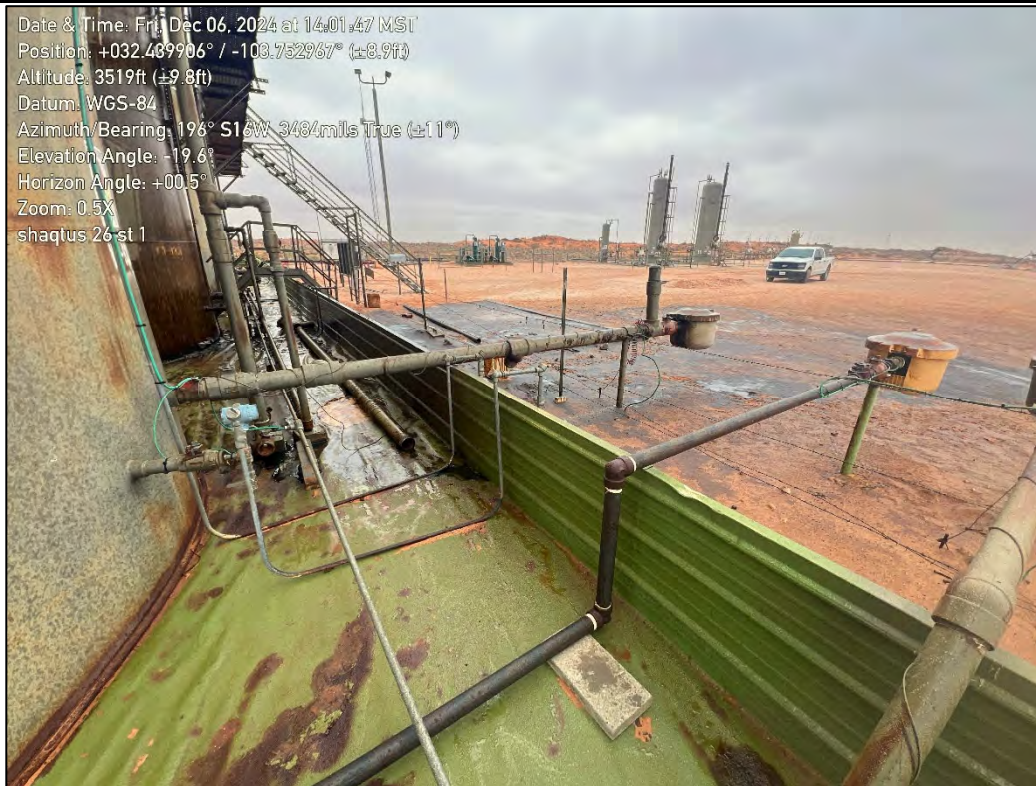
**PHOTO 1:** Southwestern view during initial site assessment activities. 12/6/2024

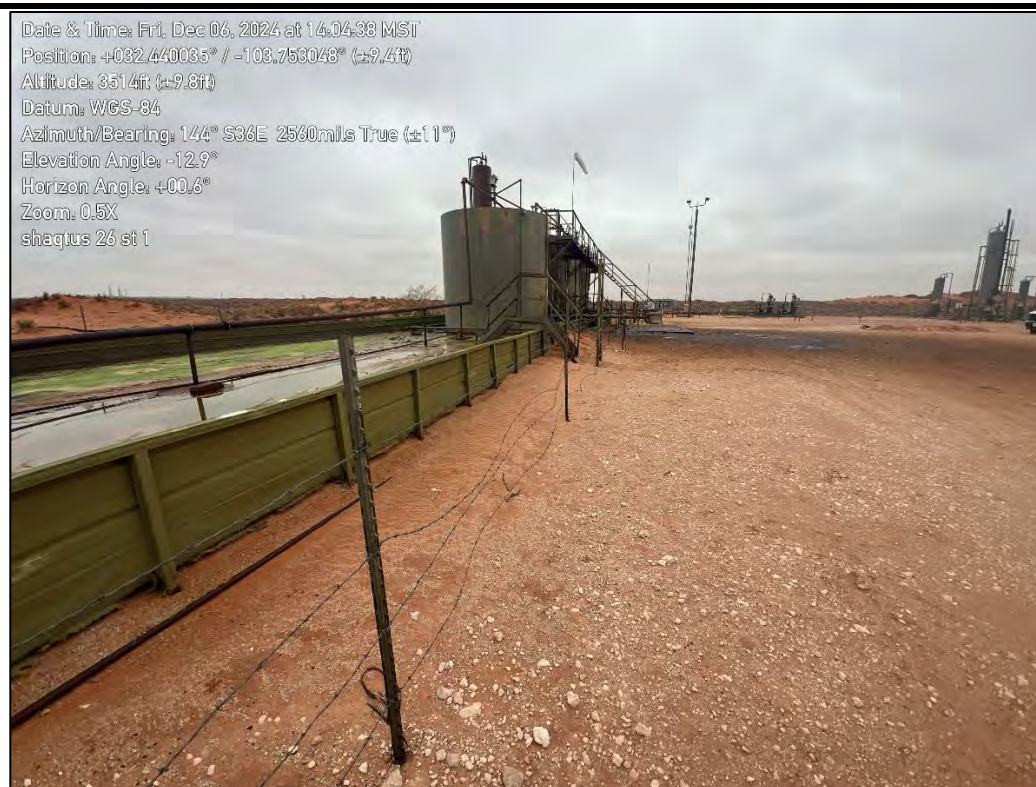
**PHOTO 2:** Southeastern view during initial site assessment activities. 12/6/2024

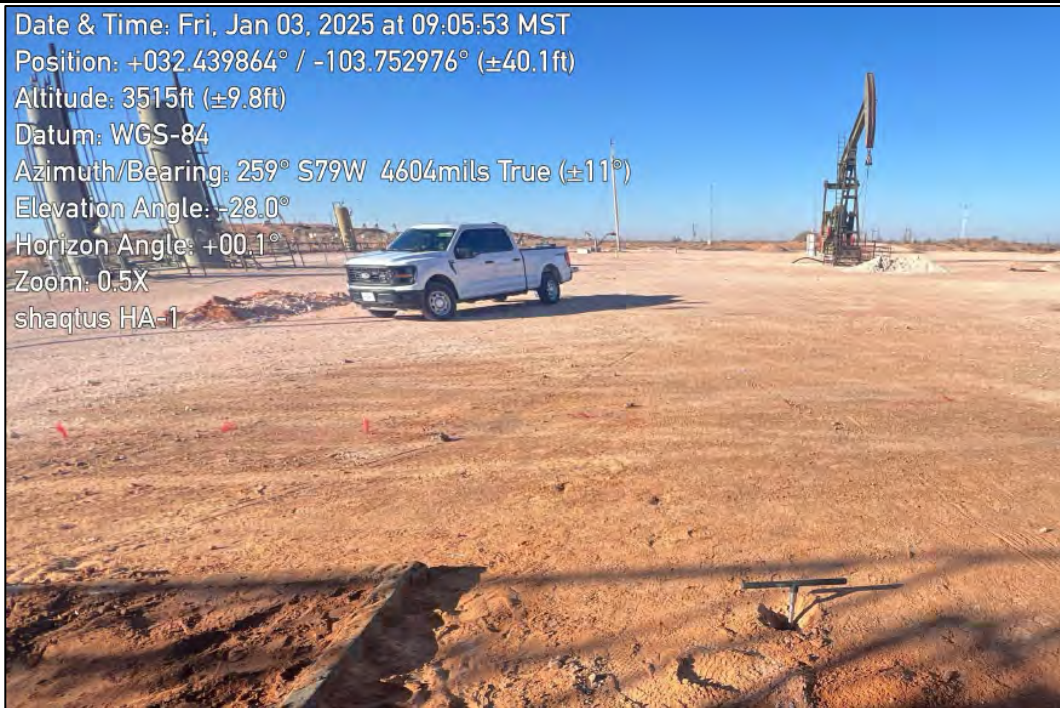
Date & Time: Fri, Jan 03, 2025 at 09:05:53 MST  
Position: +032.439864° / -103.752976° ( $\pm 40.1$ ft)  
Altitude: 3515ft ( $\pm 9.8$ ft)  
Datum: WGS-84  
Azimuth/Bearing: 259° S79W 4604mils True ( $\pm 11^\circ$ )  
Elevation Angle: -28.0°  
Horizon Angle: +00.1°  
Zoom: 0.5X  
shaqtus HA-1

**PHOTO 3:** Southwestern view during delineation activities. 1/3/2025

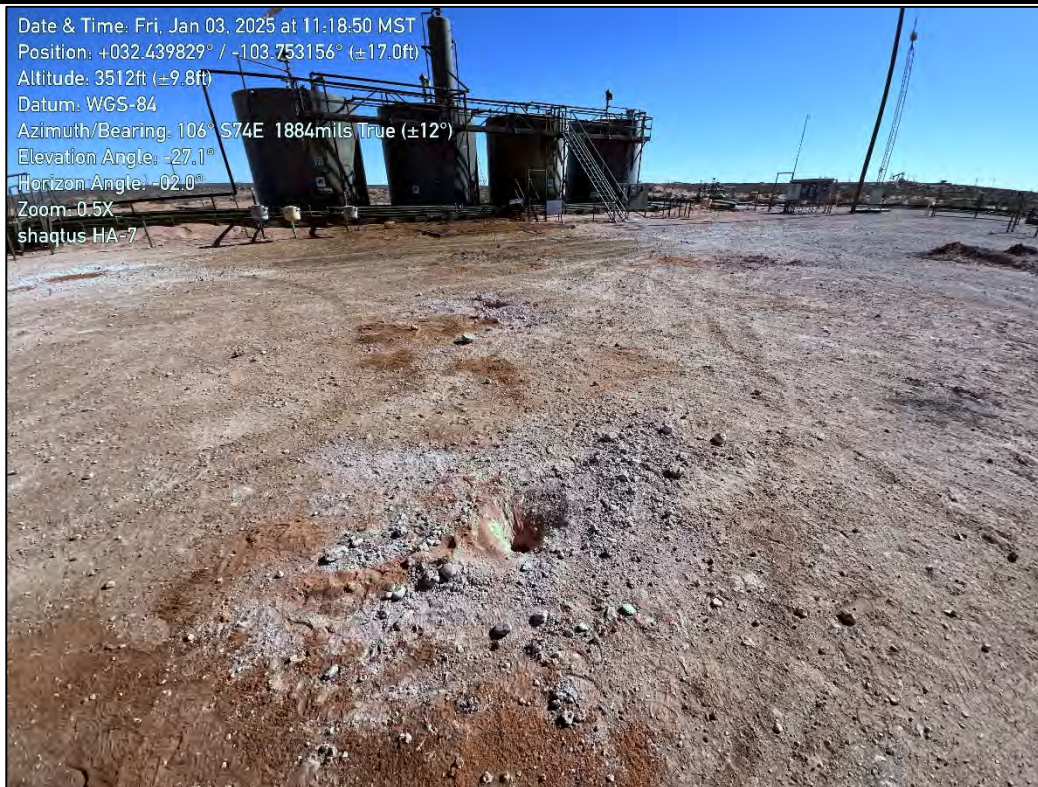
Date & Time: Fri, Jan 03, 2025 at 11:18:50 MST  
Position: +032.439829° / -103.753156° ( $\pm 17.0$ ft)  
Altitude: 3512ft ( $\pm 9.8$ ft)  
Datum: WGS-84  
Azimuth/Bearing: 106° S74E 1884mils True ( $\pm 12^\circ$ )  
Elevation Angle: -27.1°  
Horizon Angle: -02.0°  
Zoom: 0.5X  
shaqtus HA-7

**PHOTO 4:** Southeastern view during delineation activities. 1/3/2025

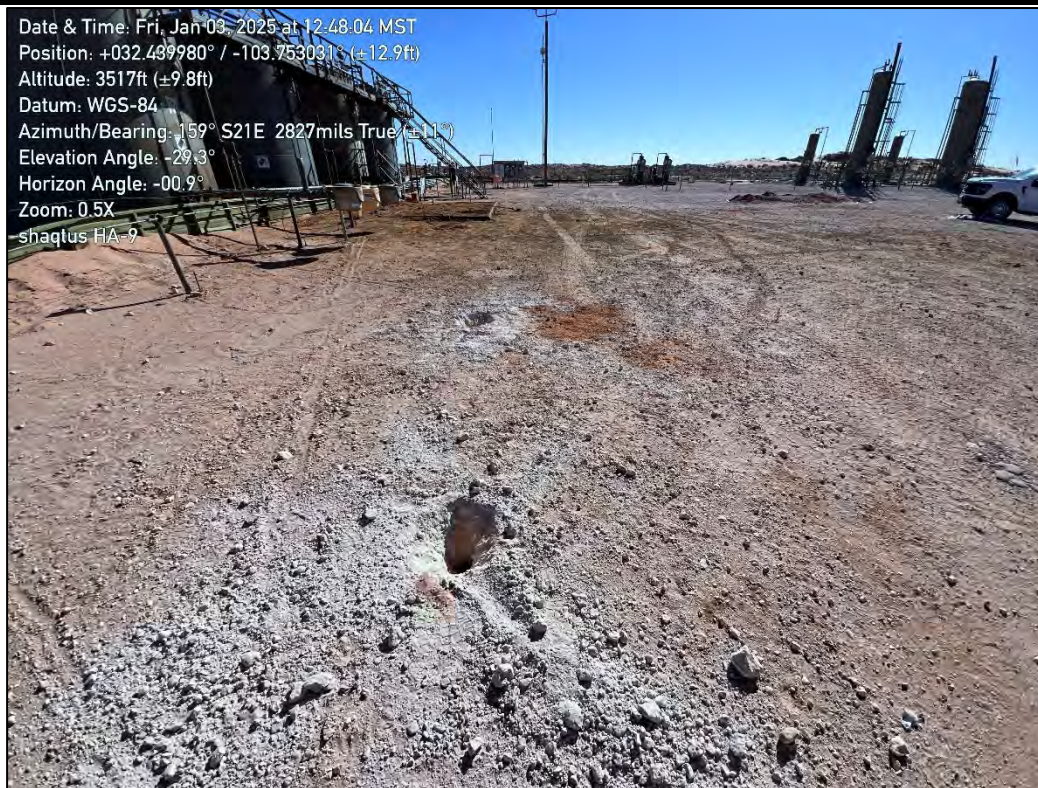
PHOTO 5: Southeastern view during delineation activities. 1/3/2025

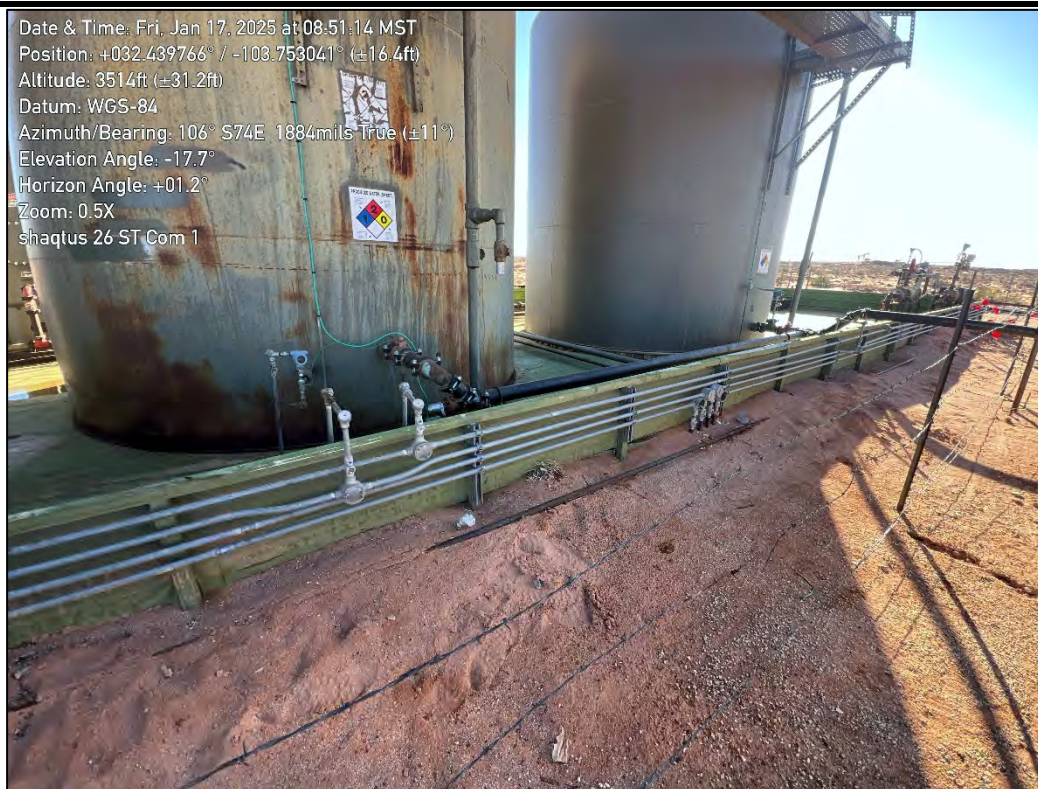
PHOTO 6: Southeastern view outside of containment during liner inspection activities. 1/17/2025

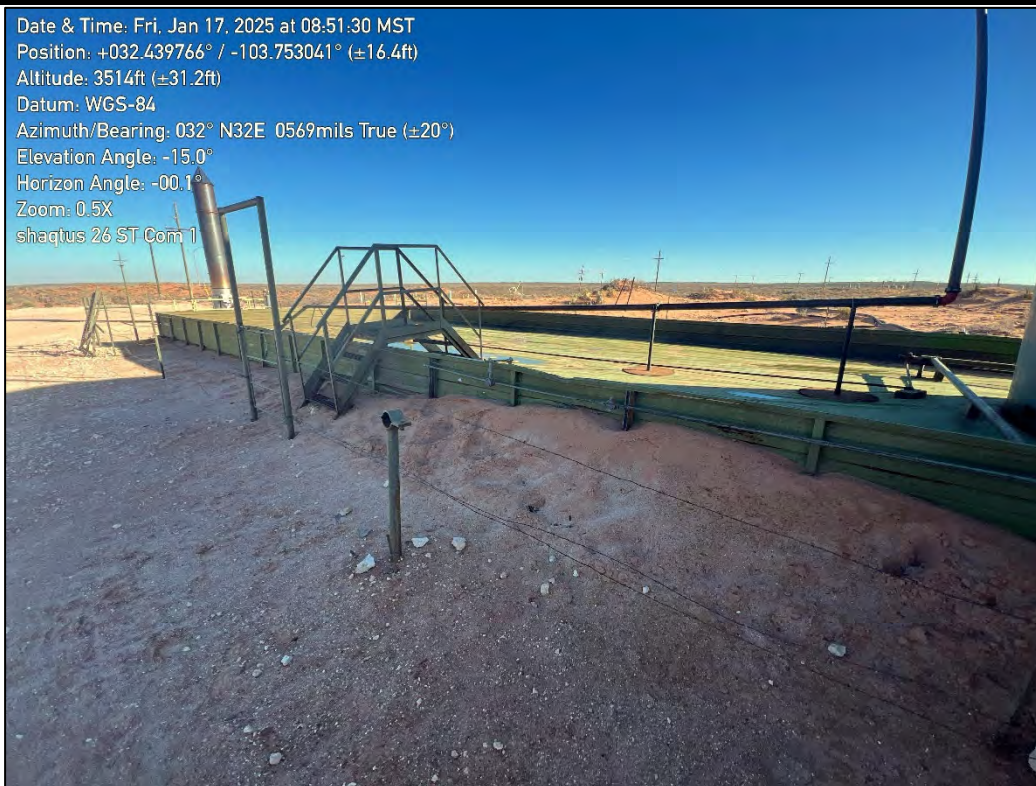
**PHOTO 7:** Northeastern view outside of containment during liner inspection activities. 1/17/2025

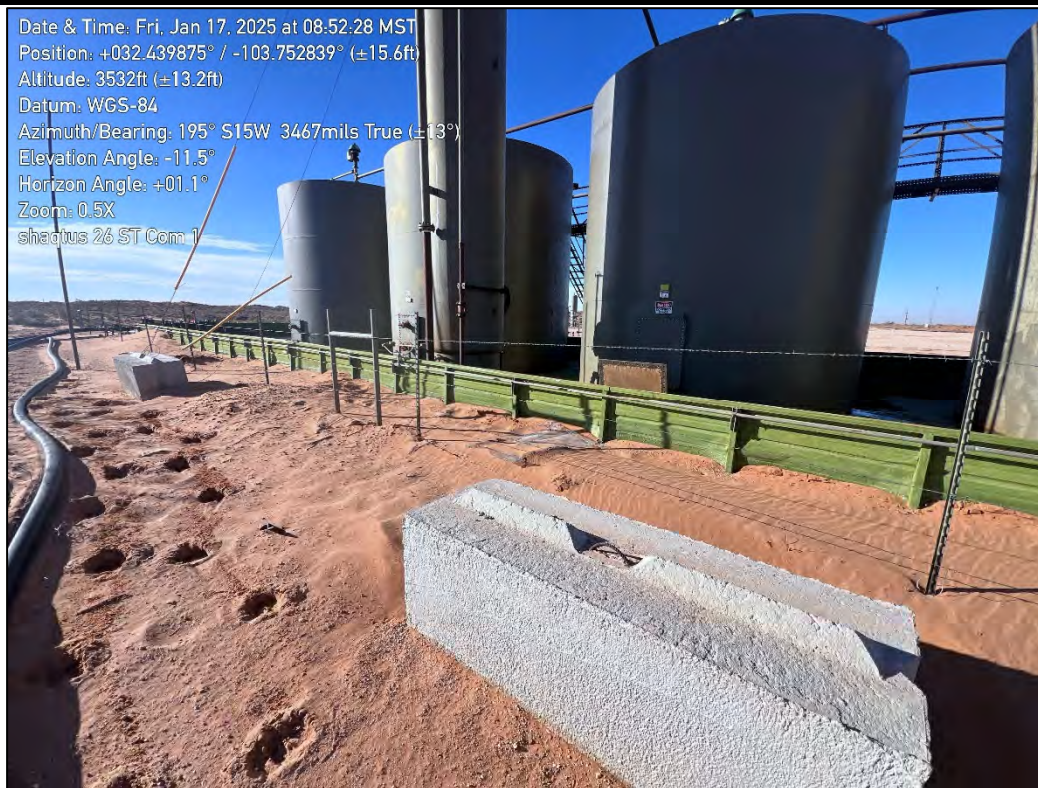
**PHOTO 9:** Southwestern view outside of containment during liner inspection activities. 1/17/2025

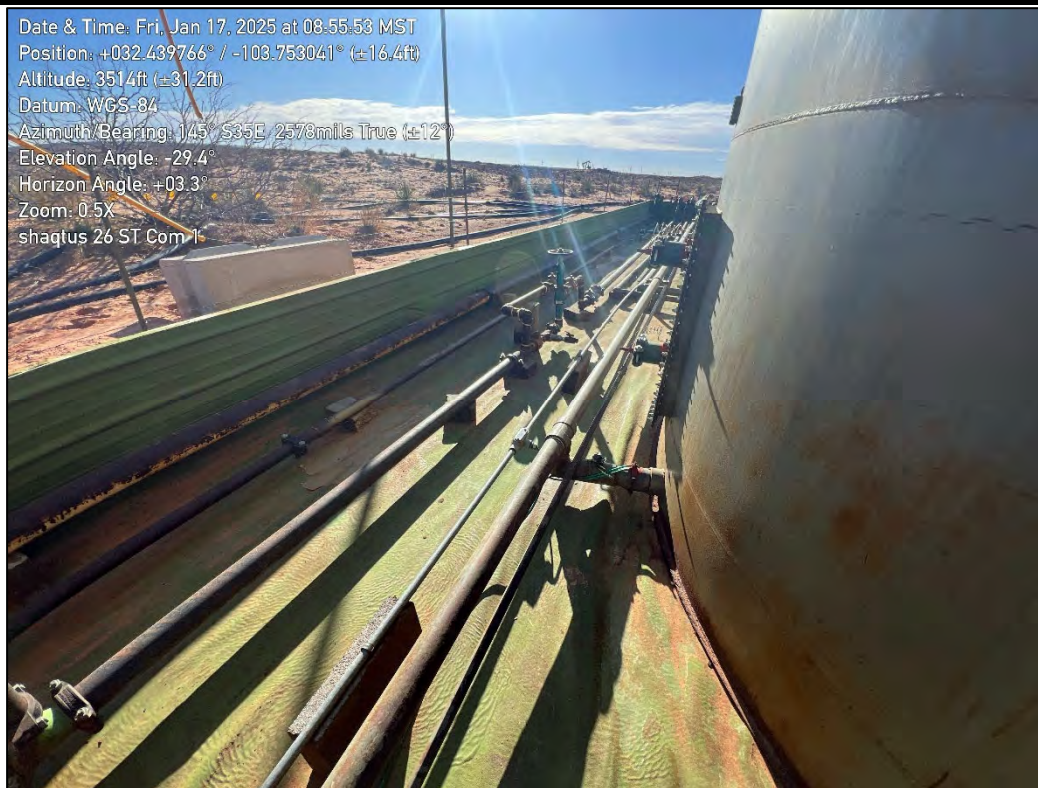
On January 17, 2025, ESRR conducted a thorough visual inspection of the LSC and found no tears, cracks, cuts, breaks, or other signs of damage, directly overlying the mapped AOC within the LSC (**Figure 2**), confirming no evidence of a breach to the LSC. Impacts to the production pad appeared to only have occurred due to windblown overspray of fluids from the vapor recovery tower. **Photographic Documentation** of liner inspection activities is attached.

PHOTO 11: Southeastern view during liner inspection activities. 1/17/2025

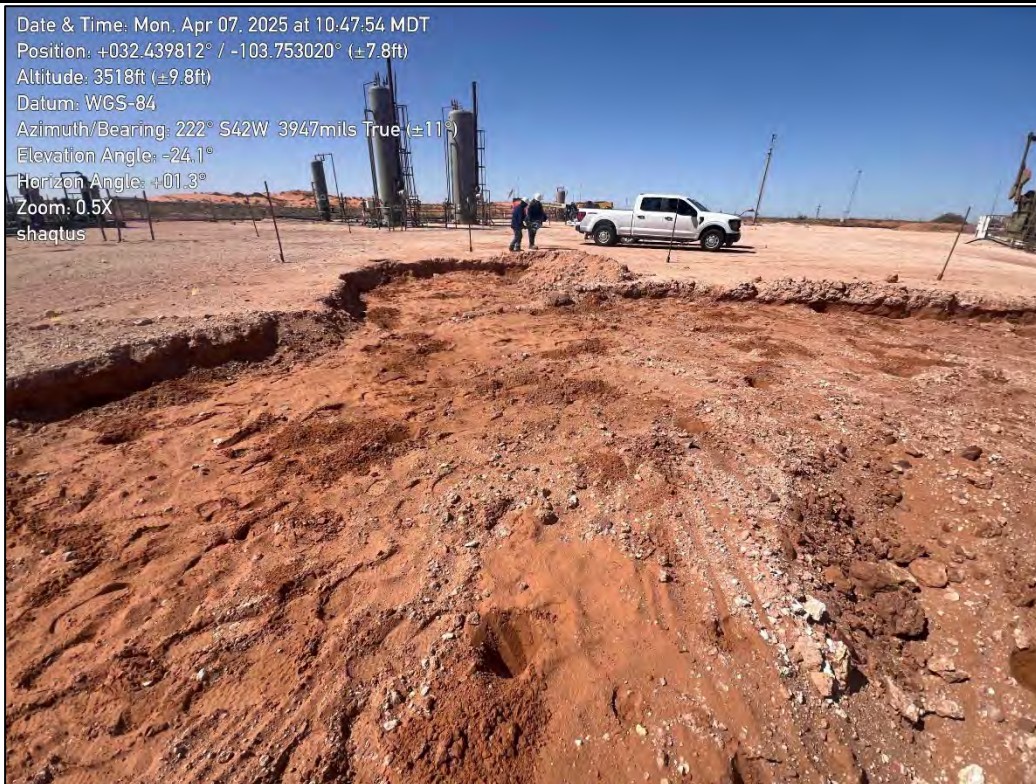
**PHOTO 19:** Southwestern view of excavation extent. 4/7/2025

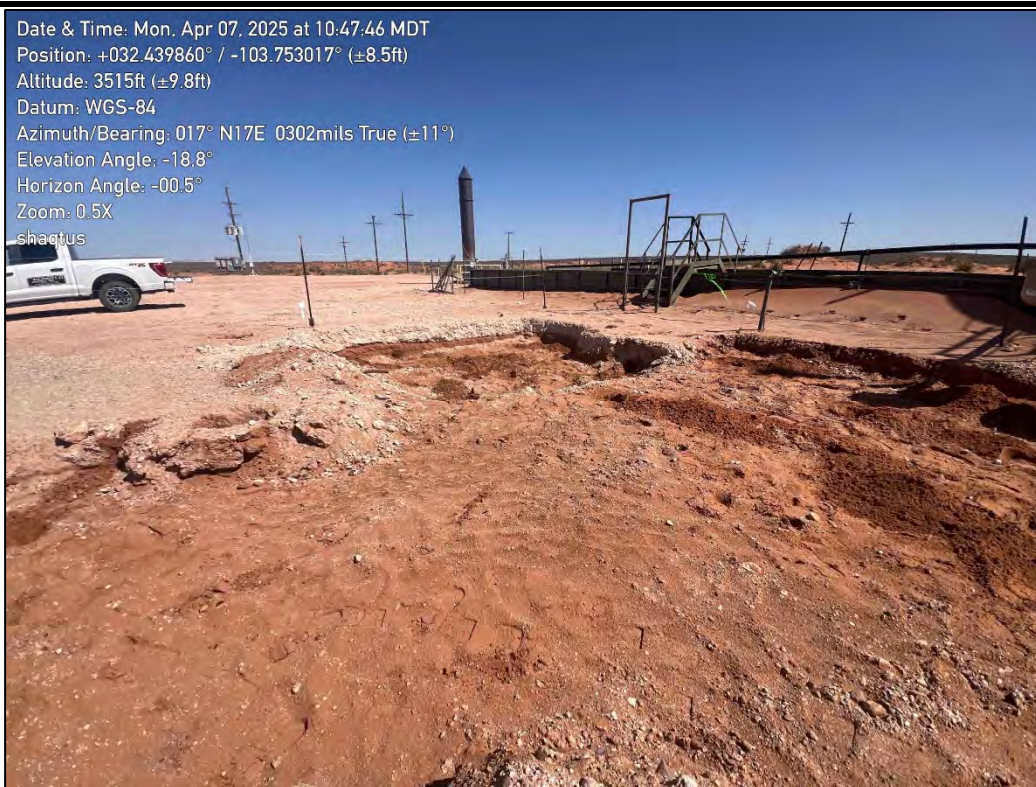
**PHOTO 20:** Northeastern view of excavation extent. 4/7/2025

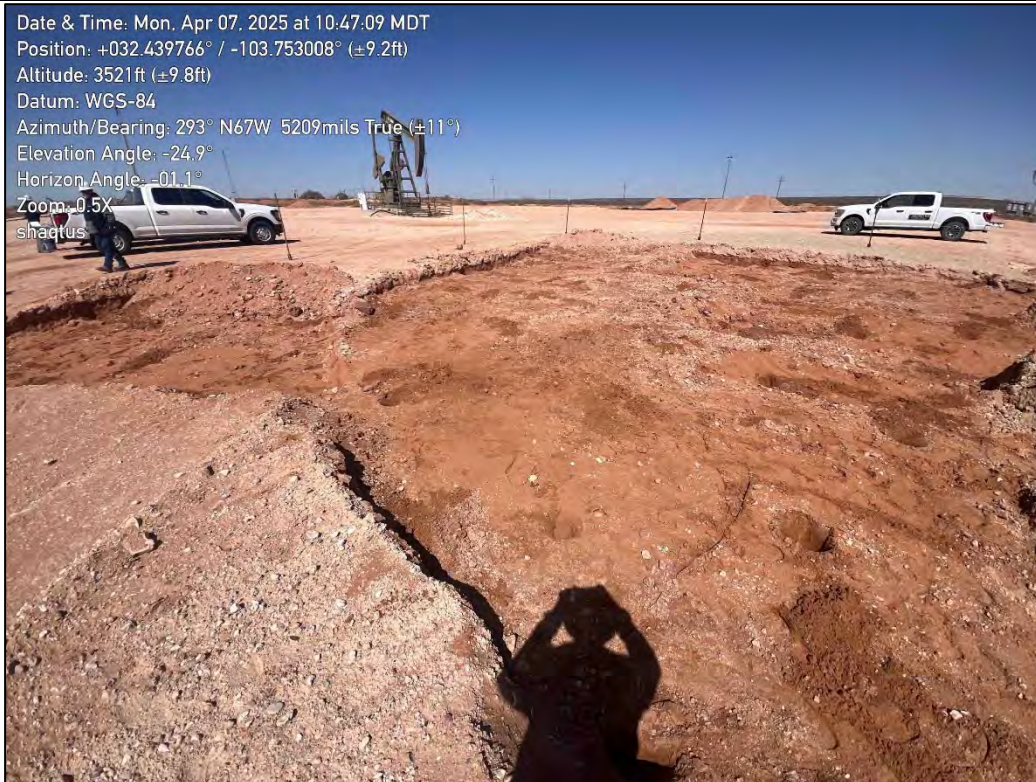
**PHOTO 21:** Northwestern view of excavation extent. 4/7/2025

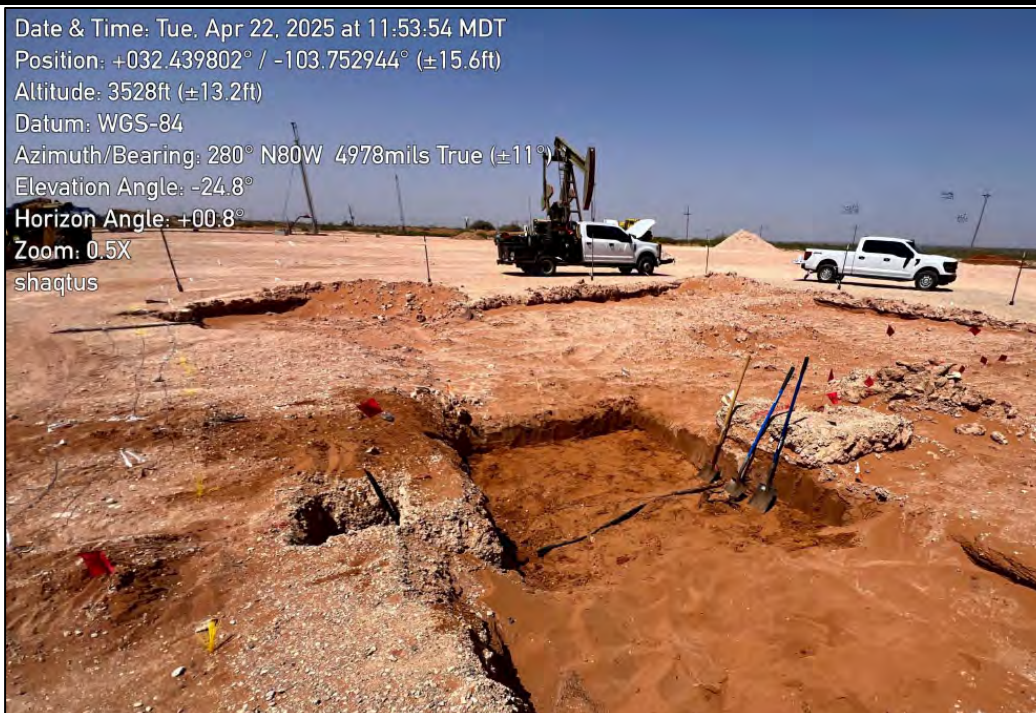
**PHOTO 22:** Northwestern view of excavation extent. 4/22/2025

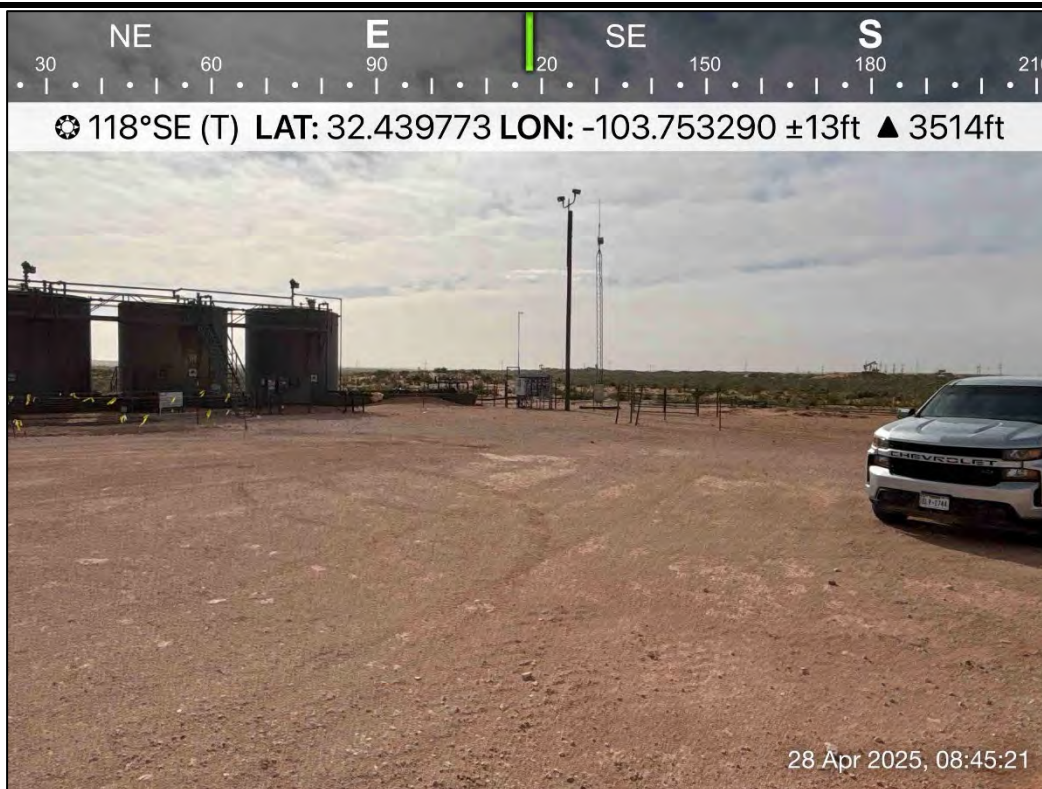
PHOTO 23: Southeastern view after restoration activities. 4/28/2025

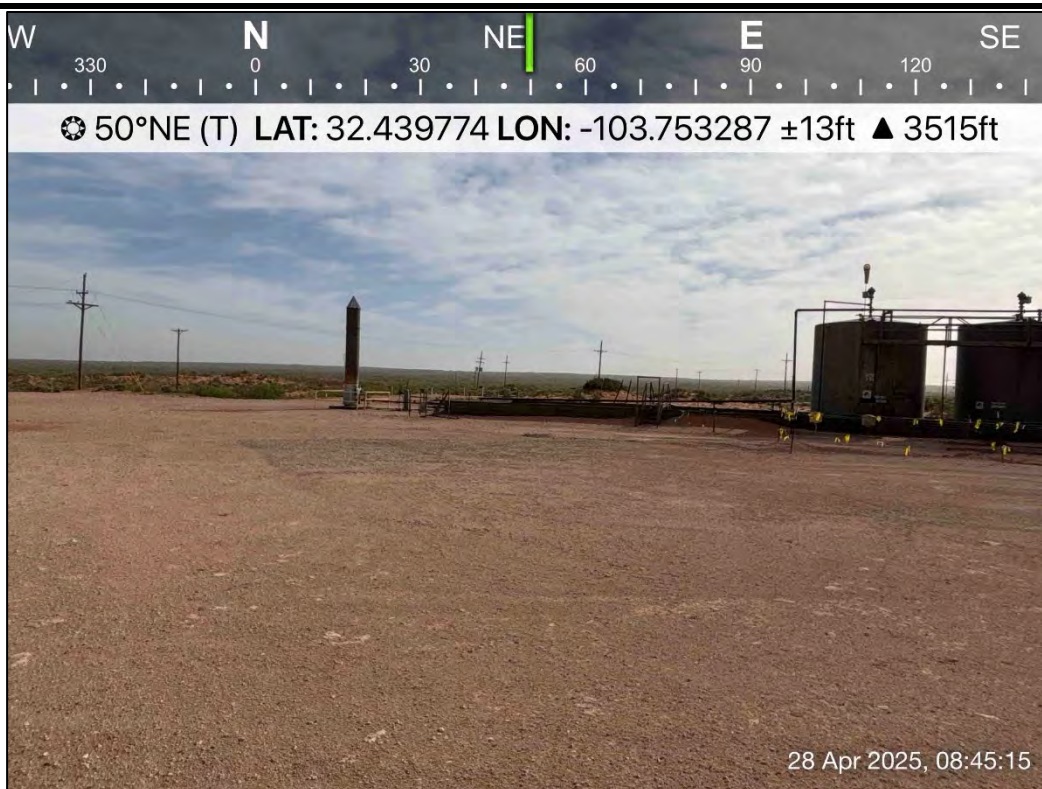
PHOTO 24: Northeastern view after restoration activities. 4/28/2025
