**C-141 - CO2 GAS RELEASE ONLY (No Liquids)**  
**EVENT SUMMARY, VARIANCE REQUEST & CLOSURE REQUEST REPORT**

| <b>Facility ID:</b> | fKJ1518128159 | <b>Incident #:</b> | nAPP2509240291 |
| <b>Facility Name:</b> | North Hobbs NIB | <b>Flare Date:</b> | 3/23/2025 |
| <b>Cause:</b> | controlled release of gas only, no liquids involved - combusted in a flare to reduce emissions; | | |

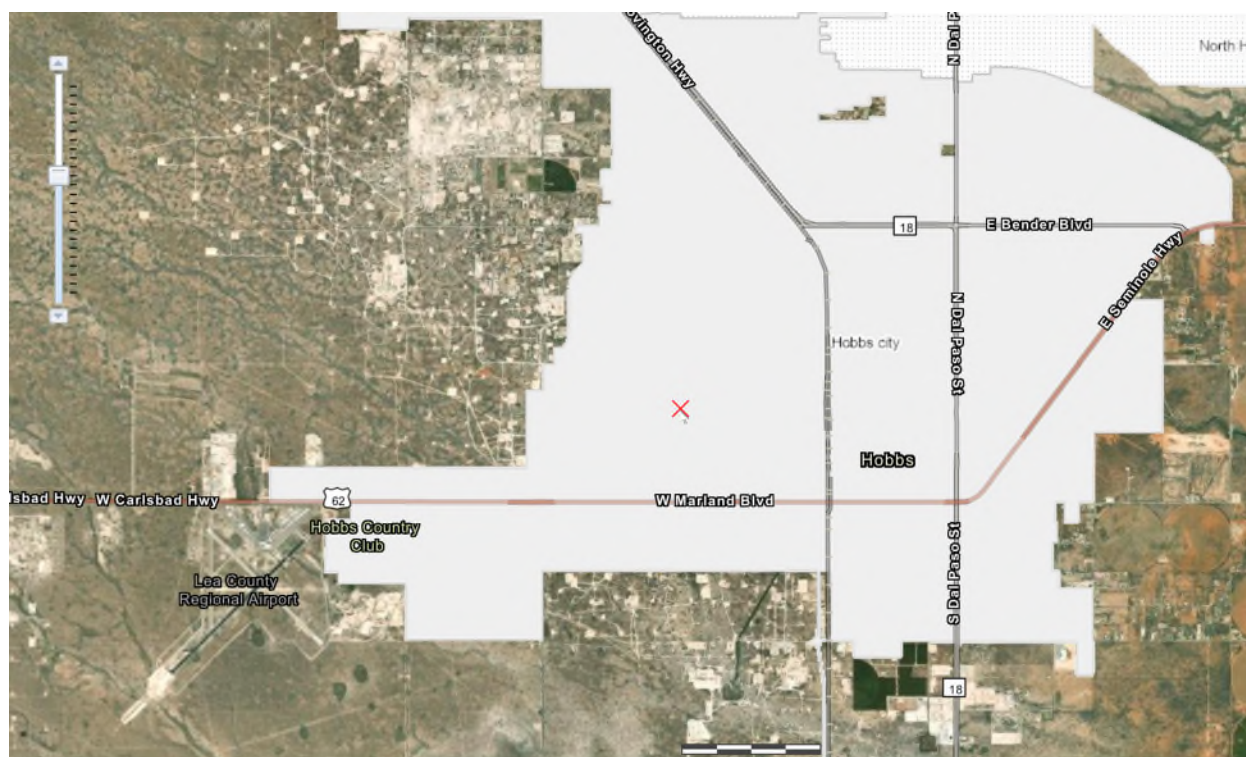
Municipal Boundaries: Zero, within the lying area

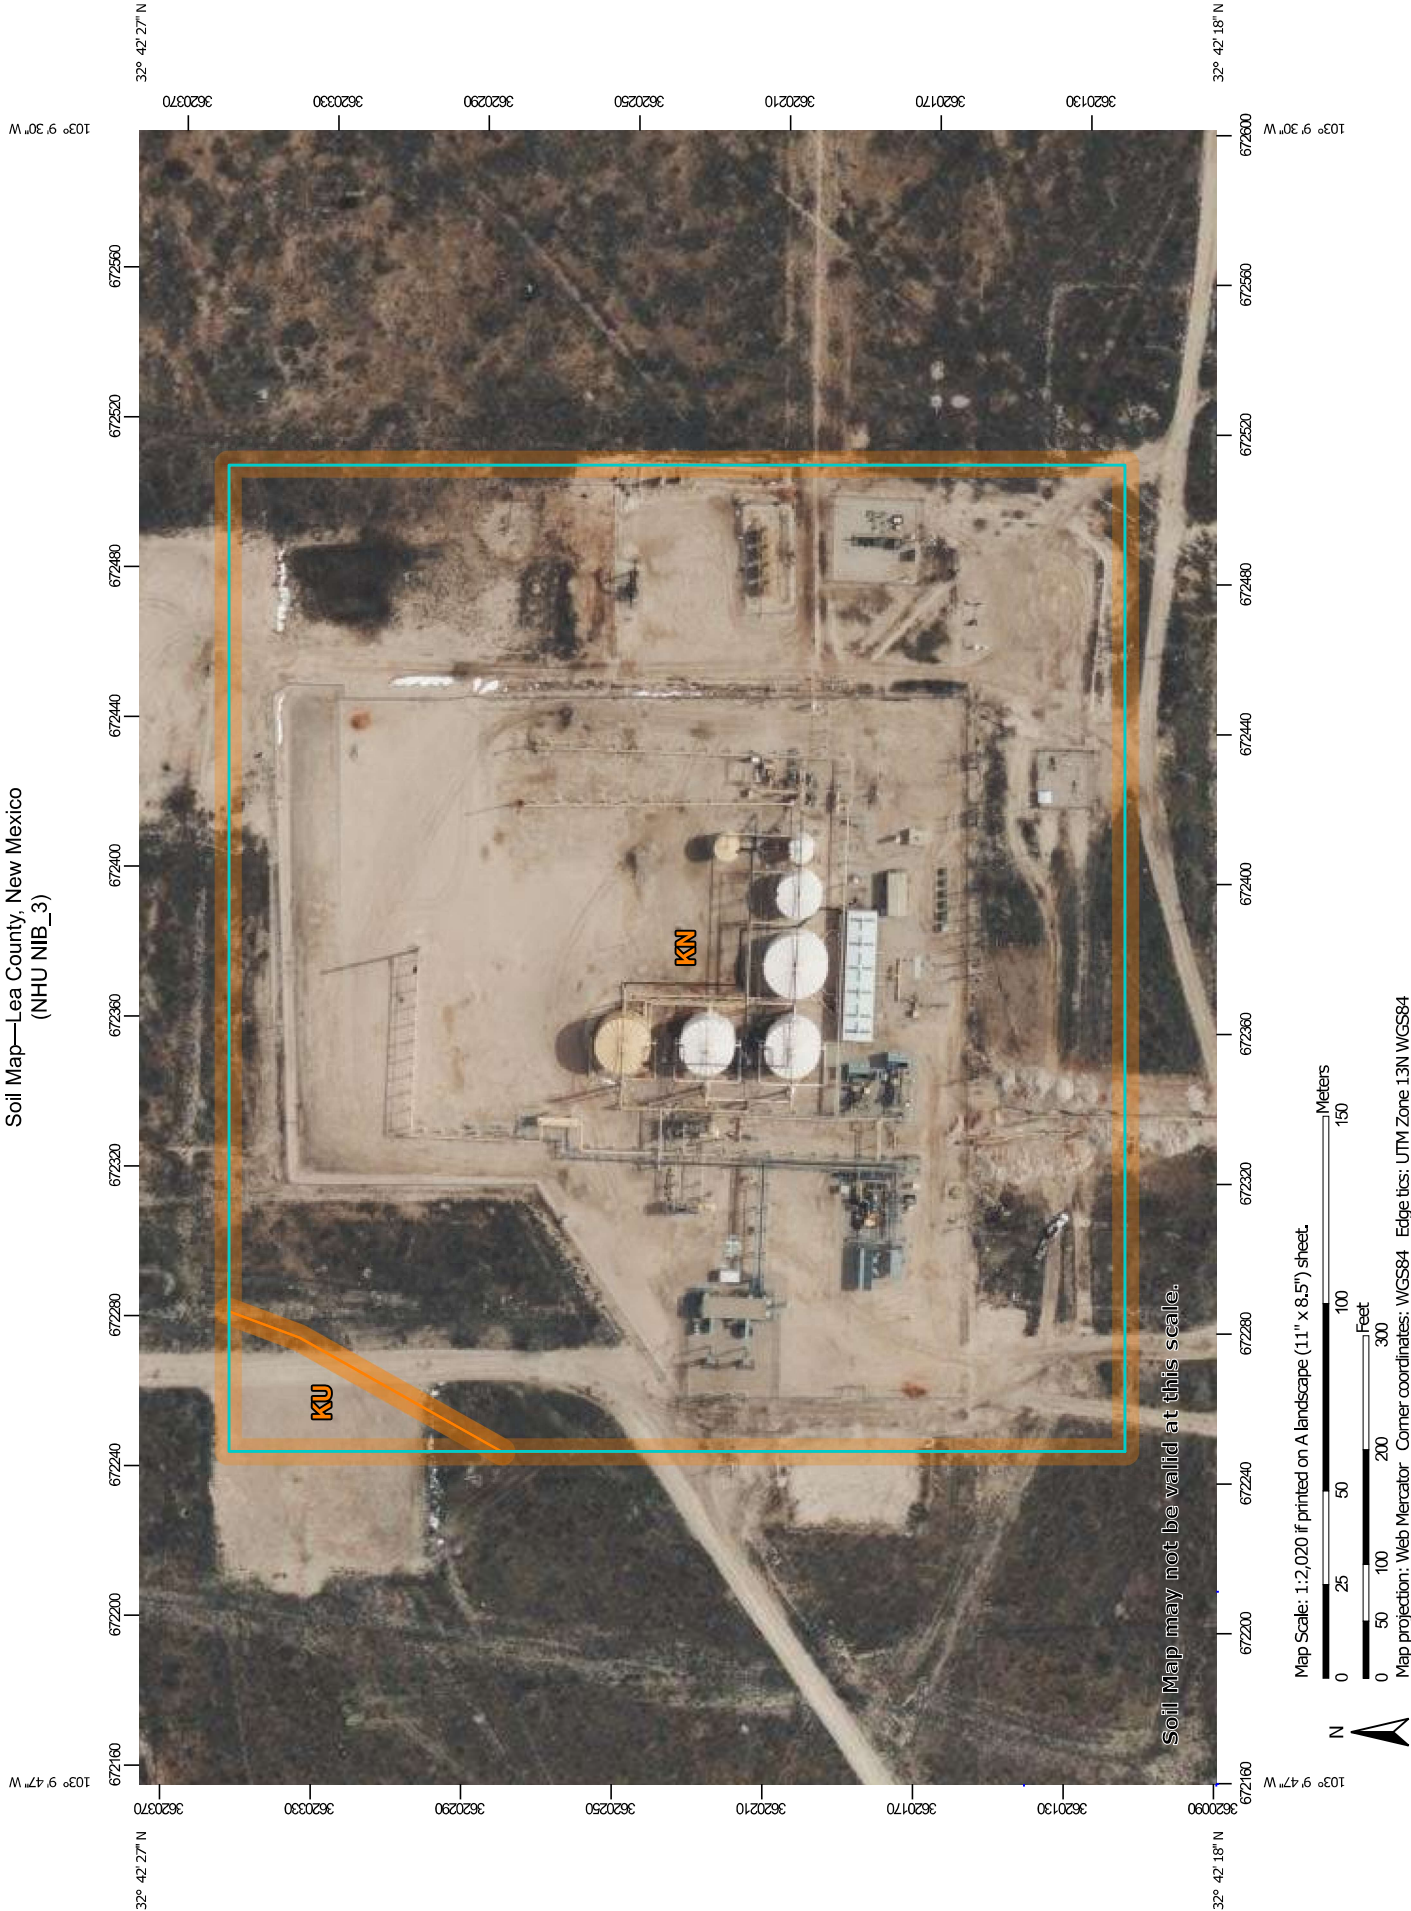
| Map Unit Symbol | Map Unit Name | Acres in AOI | Percent of AOI |
|---|---|---|---|
| KN | Kimbrough loam, 0 to 3 percent slopes | 15.2 | 97.7% |
| KU | Kimbrough-Lea complex, dry, 0 to 3 percent slopes | 0.4 | 2.3% |
