Re: Reclamation Report
Snapping 2 State 6H
Incident Number: nAB1712152502
Eddy County, New Mexico

Safety & Environmental Solutions (SESI), on behalf of Devon Energy Production Company, LP (Devon), has prepared this Reclamation Report for the Snapping 2 State 6H location. This report details the site's history and outlines the completed reclamation activities.

Devon Energy Production Company, L.P.
Snapping 2 State 6H

Reclamation Report
Incident Number: nAB1712152502

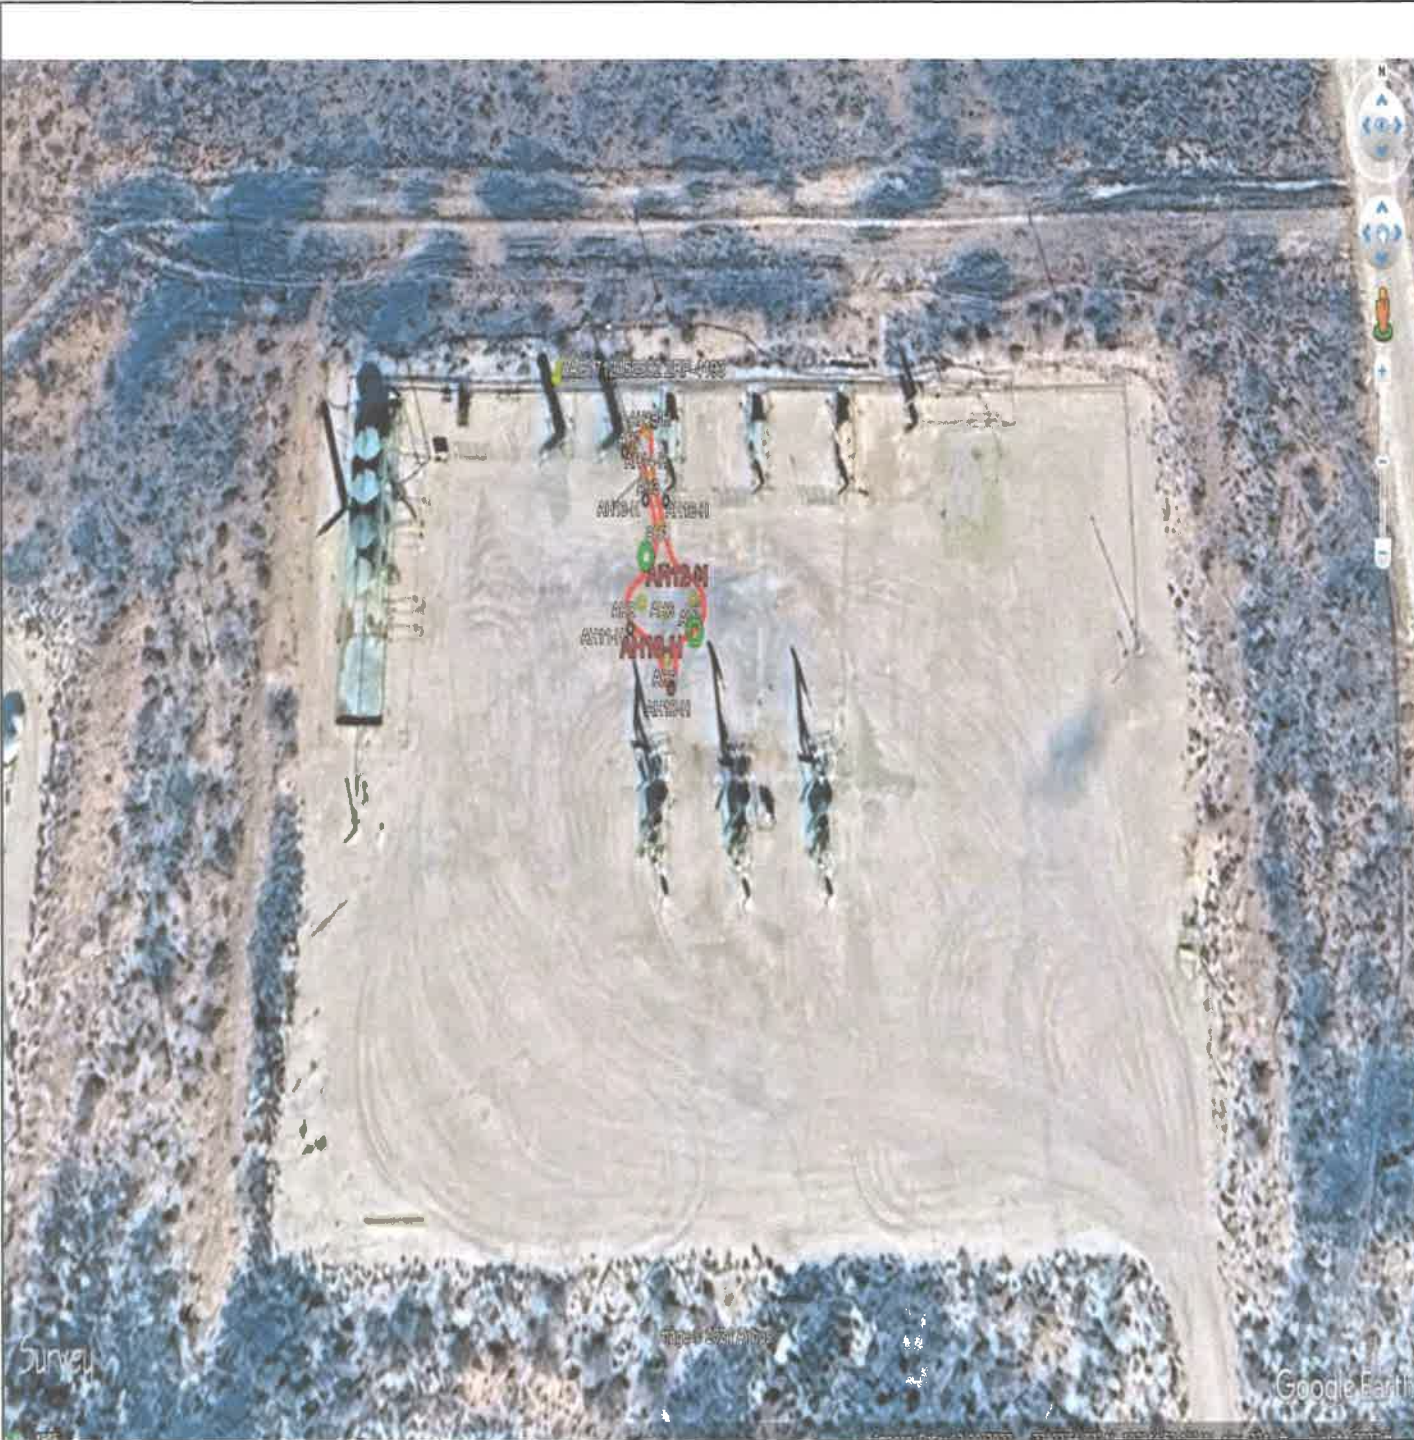
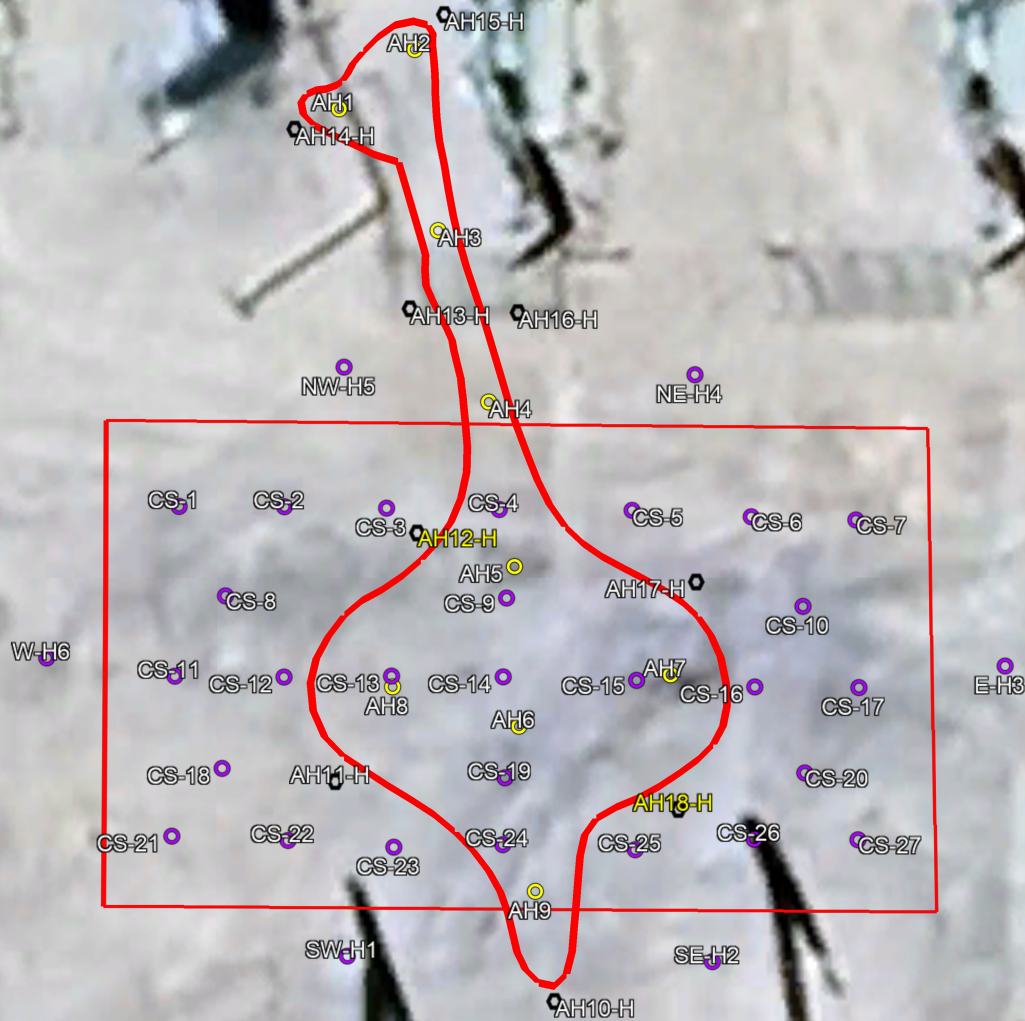
The remediation area at the Snapping 2 State 6H location encompassed approximately 5,700 square feet. Following the completion of excavation activities, a representative 5-point composite sample (BF-1) was collected from the caliche backfill material. The backfill soil sample was transported under strict chain-of-custody procedures to Cardinal Laboratories in Hobbs, New Mexico. The analysis focused on several constituents of concern (COCs): benzene, toluene, ethylbenzene, and total xylenes (BTEX) using EPA Method 8021B; total petroleum hydrocarbons (TPH) for gasoline range organics (GRO), diesel range organics (DRO), and oil range organics (ORO) using EPA Method 8015M/D; and chloride according to Standard Methods SM4500.

Upon receipt of the analytical results, the excavation area was backfilled with approximately 211 cubic yards of locally sourced caliche. The site was then graded contoured to blend with the surrounding landscape, providing erosion control, long-term stability, preventing water ponding, and preserving natural surface water flow patterns—ensuring the site is restored to its pre-disturbance condition.
