**New Mexico Oil Conservation Division**

**Re: Second Quarter 2025 – SVE System Update**

Sunray B 1B  
San Juan County, New Mexico  
Hilcorp Energy Company  
NMOCD Incident No: nAPP2212649502

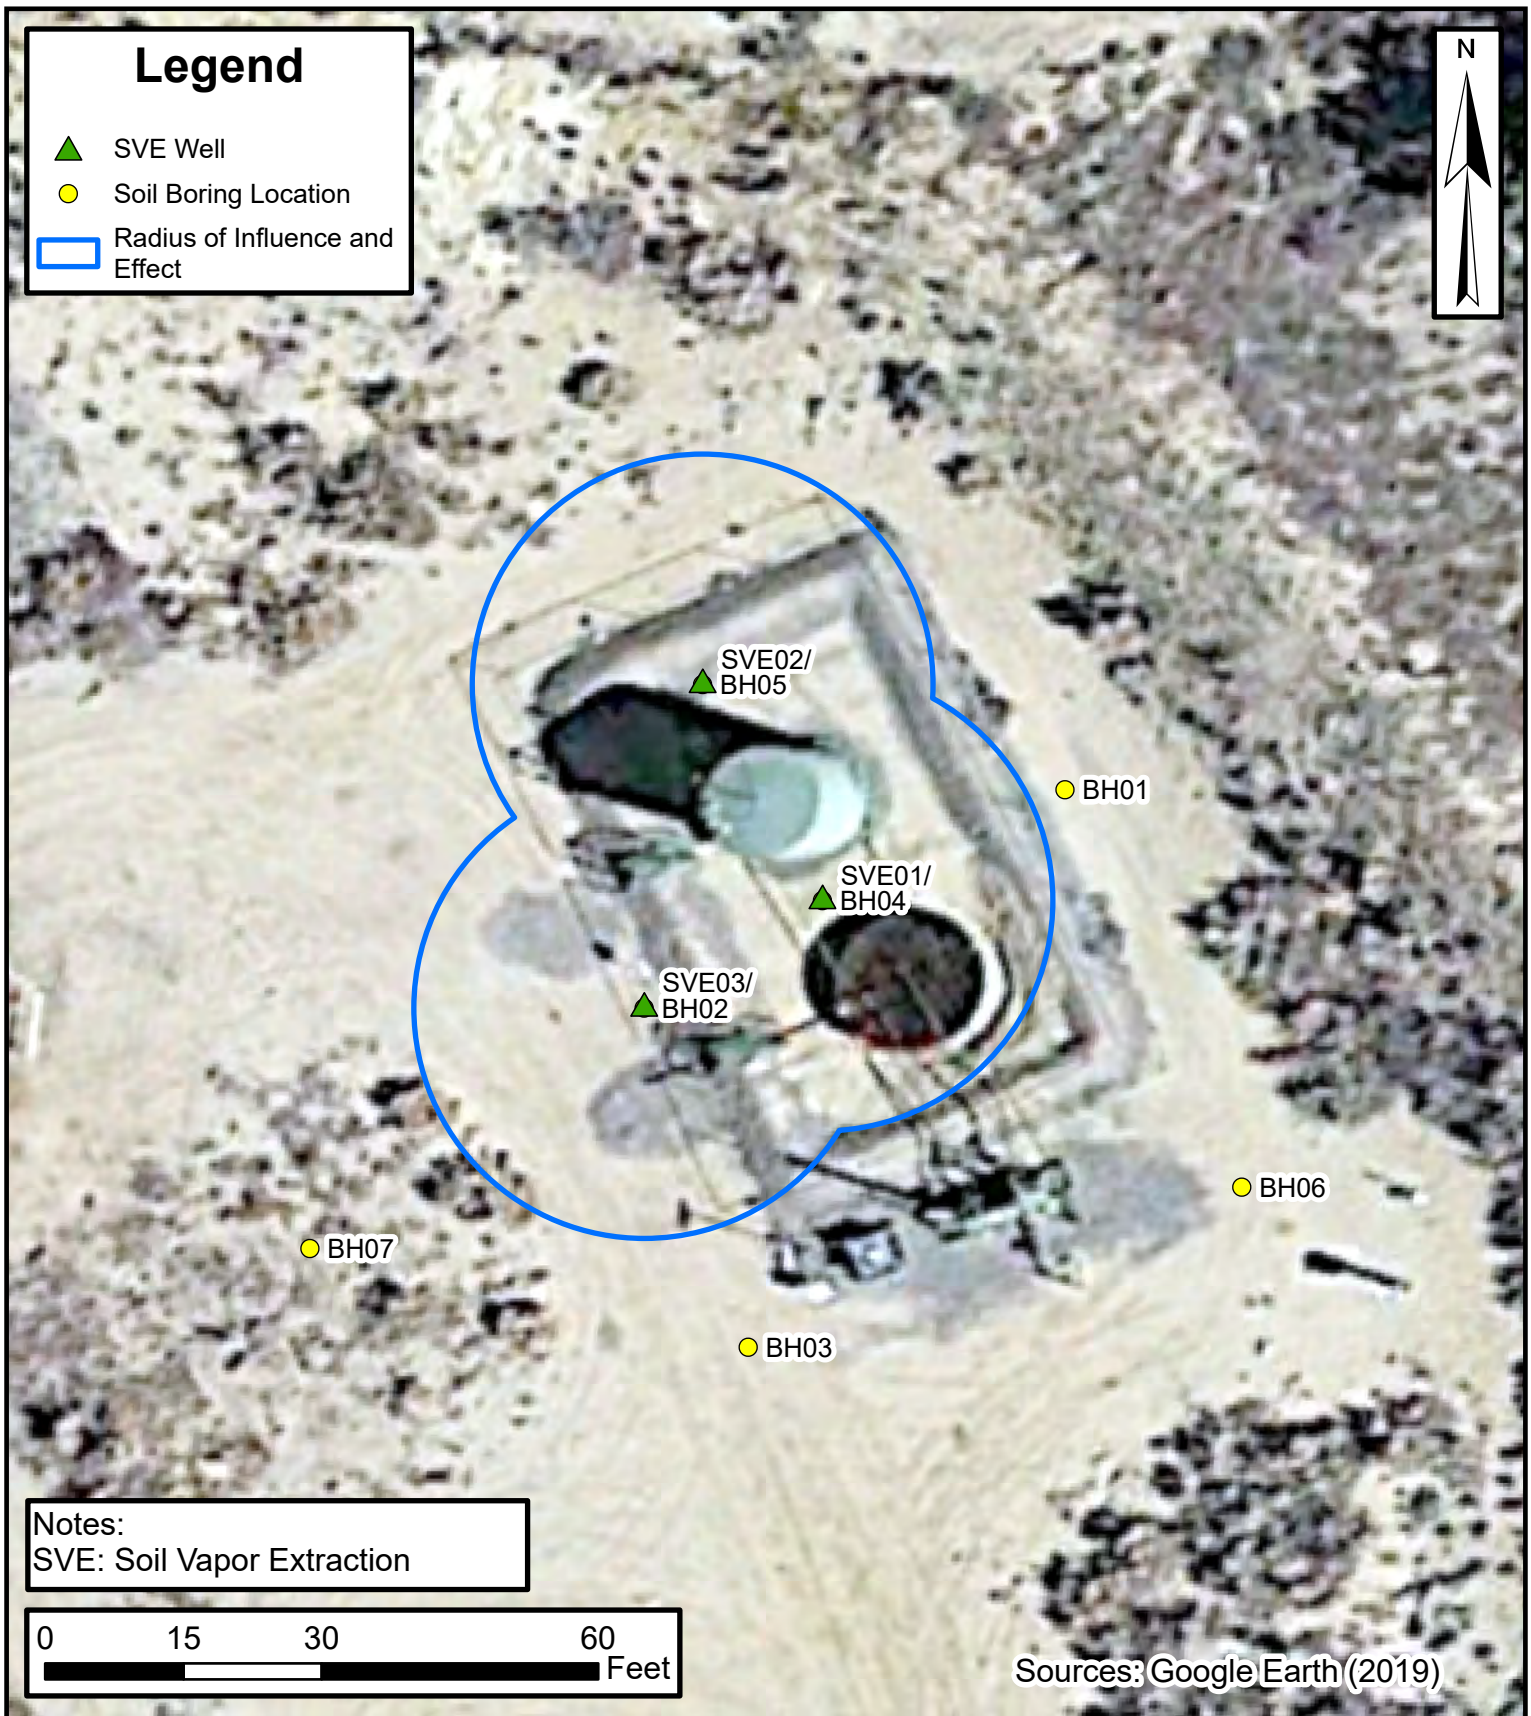
| Figure 2 | SVE System Radius of Influence and Radius of Effect |

The SVE system at the Site consists of a 3-phase, 5 horsepower Howden Roots 32 URAI rotary lobe blower capable of producing 112 cubic feet per minute (cfm) flow at 82 inches of water column (IWC) vacuum. The system is powered by a permanent power drop and is intended to run 24 hours per day. Three SVE wells were installed at the Site and are shown on Figure 2. SVE wells SVE01, SVE02, and SVE03 are screened at varying depths up to 25 feet below ground surface (bgs) to address residual soil impacts in the unsaturated zone.

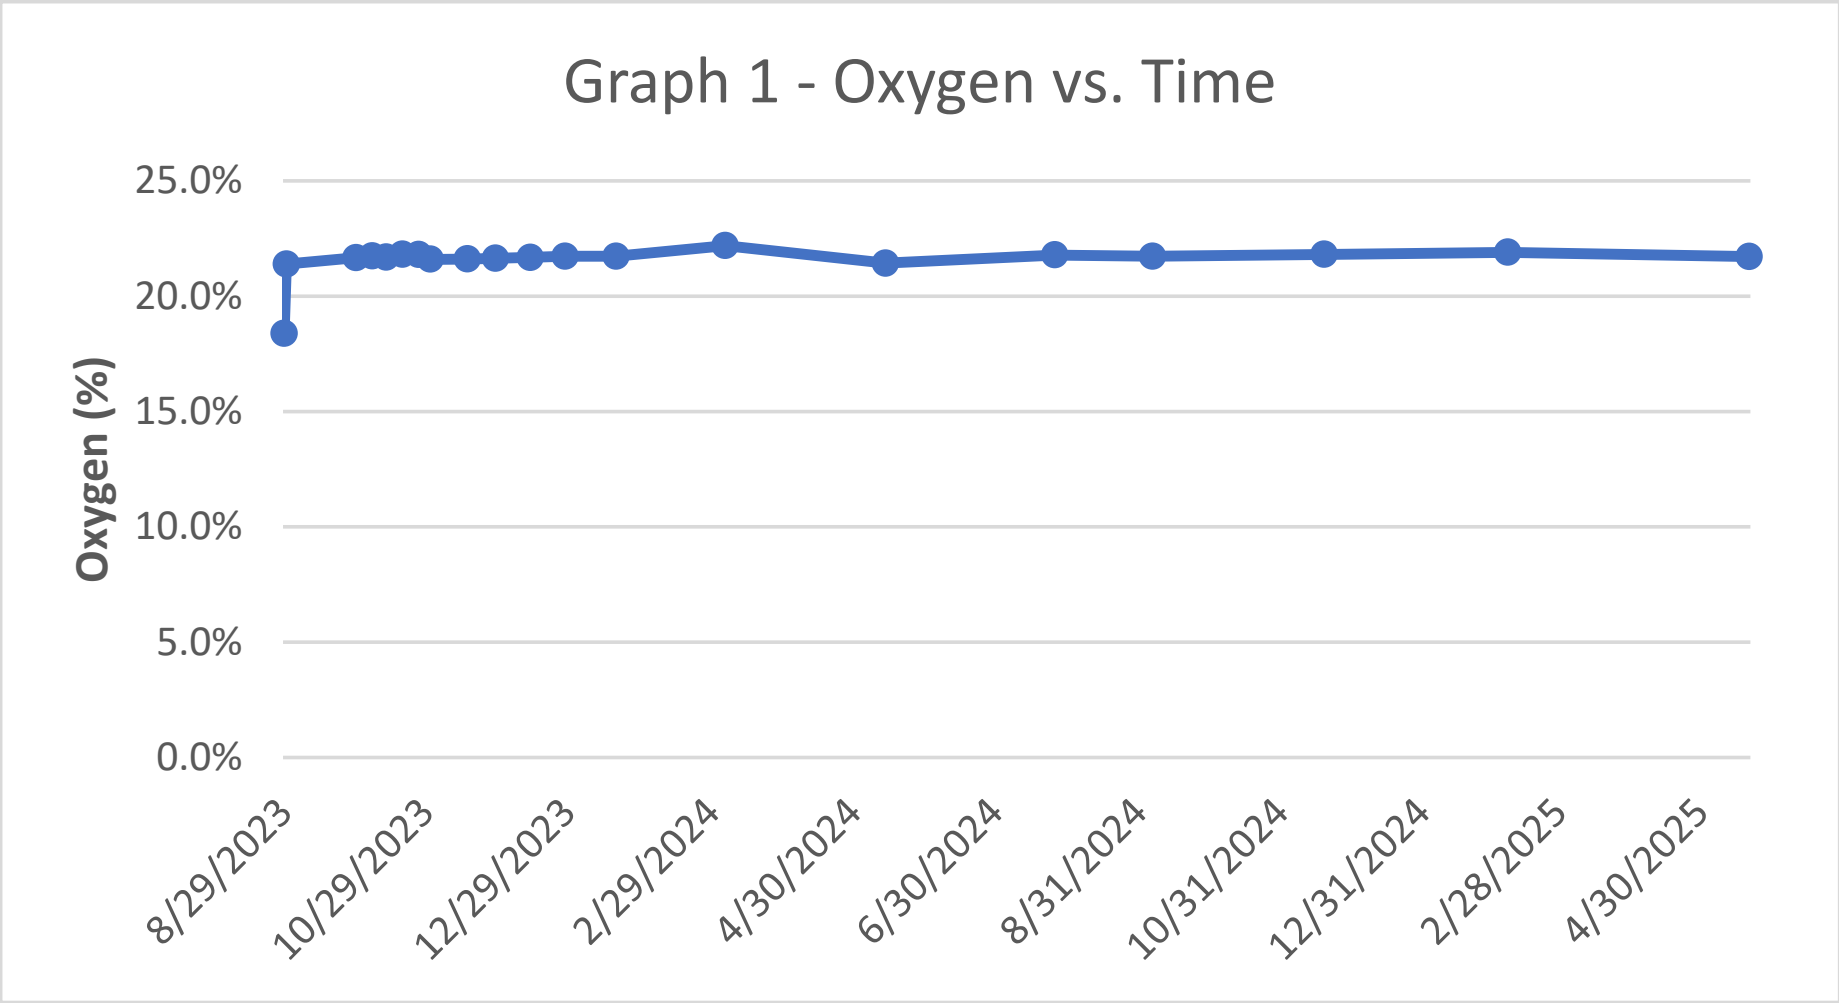
| Graph 1 | Oxygen vs Time |

Based on the February 2023 COAs, vapor samples are being collected quarterly following the first year of operation from a sample port located between the SVE piping manifold and the SVE blower using a high vacuum air sampler. A vapor sample was collected on May 21, 2025. Prior to collection, the vapor sample was field screened with a PID for organic vapor monitoring (OVM). The vapor sample was collected directly into two 1-Liter Tedlar® bags and submitted to Eurofins Environment Testing in Albuquerque, New Mexico for analysis of total volatile petroleum hydrocarbons (TVPH – also known as total petroleum hydrocarbons – gasoline range organics (TPH-GRO)) following United States Environmental Protection Agency (EPA) Method 8015D, VOCs following EPA Method 8260B, and fixed gas analysis of oxygen and carbon dioxide following Gas Processors Association (GPA) Method 2261. A summary of field measurements and analytical results are presented in Tables 2 and 3, respectively. The full laboratory analytical report is attached as Appendix C. Oxygen and carbon dioxide levels over time are presented in Graphs 1 and 2, respectively.

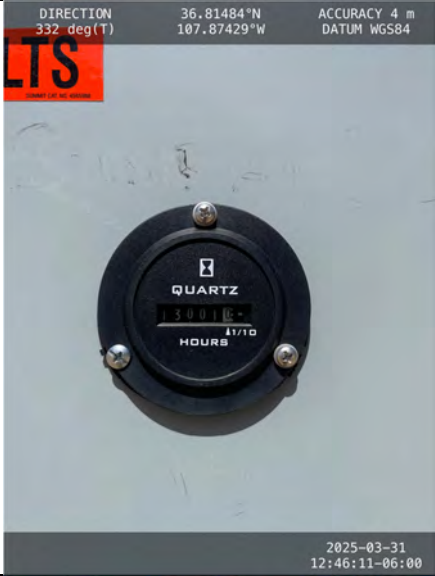
| <p><b>Photograph 1</b></p> <p>Runtime meter taken on March 31, 2025 at 12:46 PM<br/>Hours = 13,001.0</p> | |

The initial startup of the Site SVE system was performed on August 29 and 30, 2023. Based on the New Mexico Oil Conservation Division (NMOCD) Conditions of Approval (COAs), dated February 10, 2023, field data measurements were collected from the system and included the following parameters: total system flow, estimated flow rates from each SVE well, photoionization detector (PID) measurements of volatile organic compounds (VOCs) from each SVE well, vacuum measurements from each SVE well, and oxygen/carbon dioxide measurements via hand-held analyzers from each SVE well. Field visits were conducted bi-weekly throughout the second quarter of 2025. Field parameters noted above were collected during each visit. Field notes taken during operations and maintenance (O&M) visits are presented in Appendix A. Between March 31 and June 26, 2025, the SVE system operated for 2,074.6 hours for a runtime efficiency of 99.4 percent (%). Appendix B presents photographs of the runtime meter for calculating the second

quarter of 2025 runtime efficiency. Table 1 presents the SVE system operational hours and calculated percentage runtime.

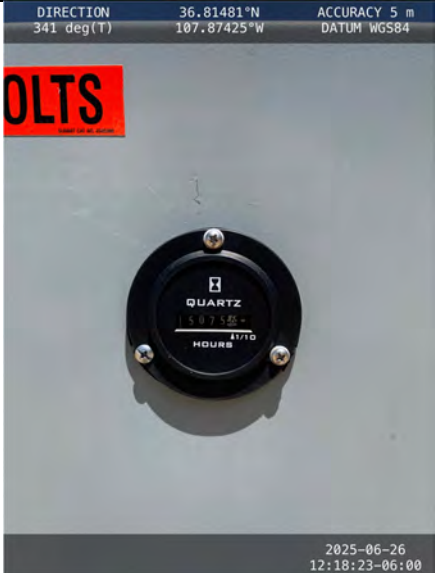
| <p><b>Photograph 2</b></p> <p>Runtime meter taken on June 26, 2025 at 12:18 PM<br/>Hours = 15,075.6</p> | |
