**Re: Closure Request  
PLU BS 03-25-31 USA Battery  
Incident Number nAPP2515346013  
Eddy County, New Mexico**

XTO Energy, Inc  
Closure Request  
PLU BS 03-25-31 USA Battery

**Photographic Log**

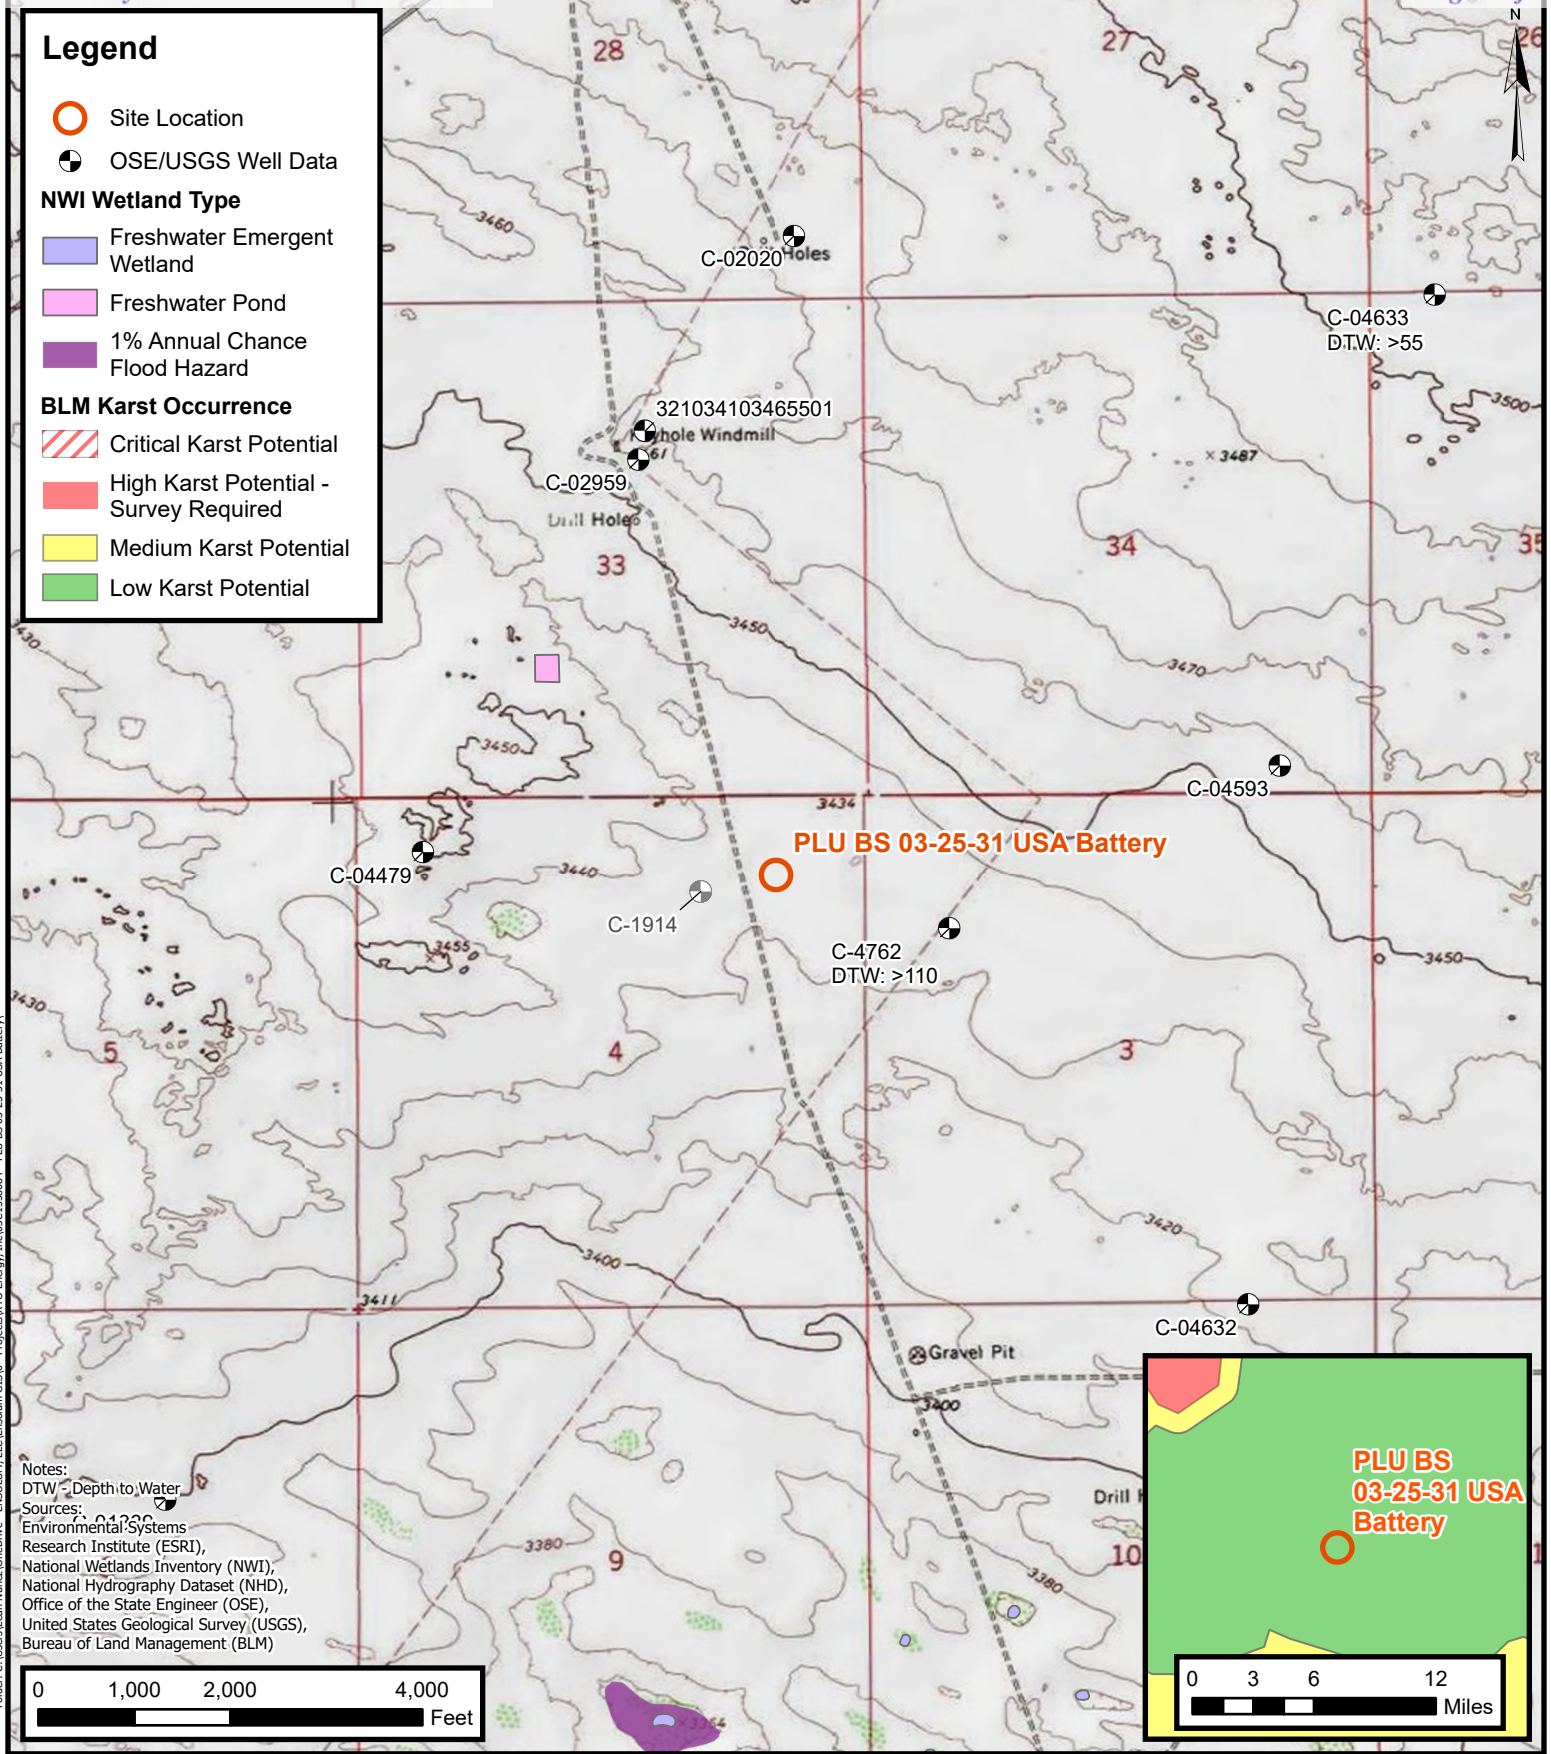
The Site was characterized to assess the applicability of Table I Closure Criteria for Soils Impacted by a Release, of Title 19, Chapter 15, Part 29 (19.15.29) of the New Mexico Administrative Code (NMAC). Results from the characterization desktop review are presented below and potential Site receptors are identified on Figure 1.

Depth to groundwater at the Site is estimated to be greater than 100 feet below ground surface (bgs) based on a recent soil boring drilled for determination of regional groundwater depth. On July 7, 2023, a soil boring permitted by New Mexico Office of the State Engineer (NMOSE), C-4762, was completed approximately 0.36 miles southeast of the Site utilizing air rotary drilling method. The soil boring was drilled to a total depth of 110 feet bgs, and no groundwater was encountered. All wells used for depth to groundwater determination are presented on Figure 1. The Well Record and Log is included in Appendix A.

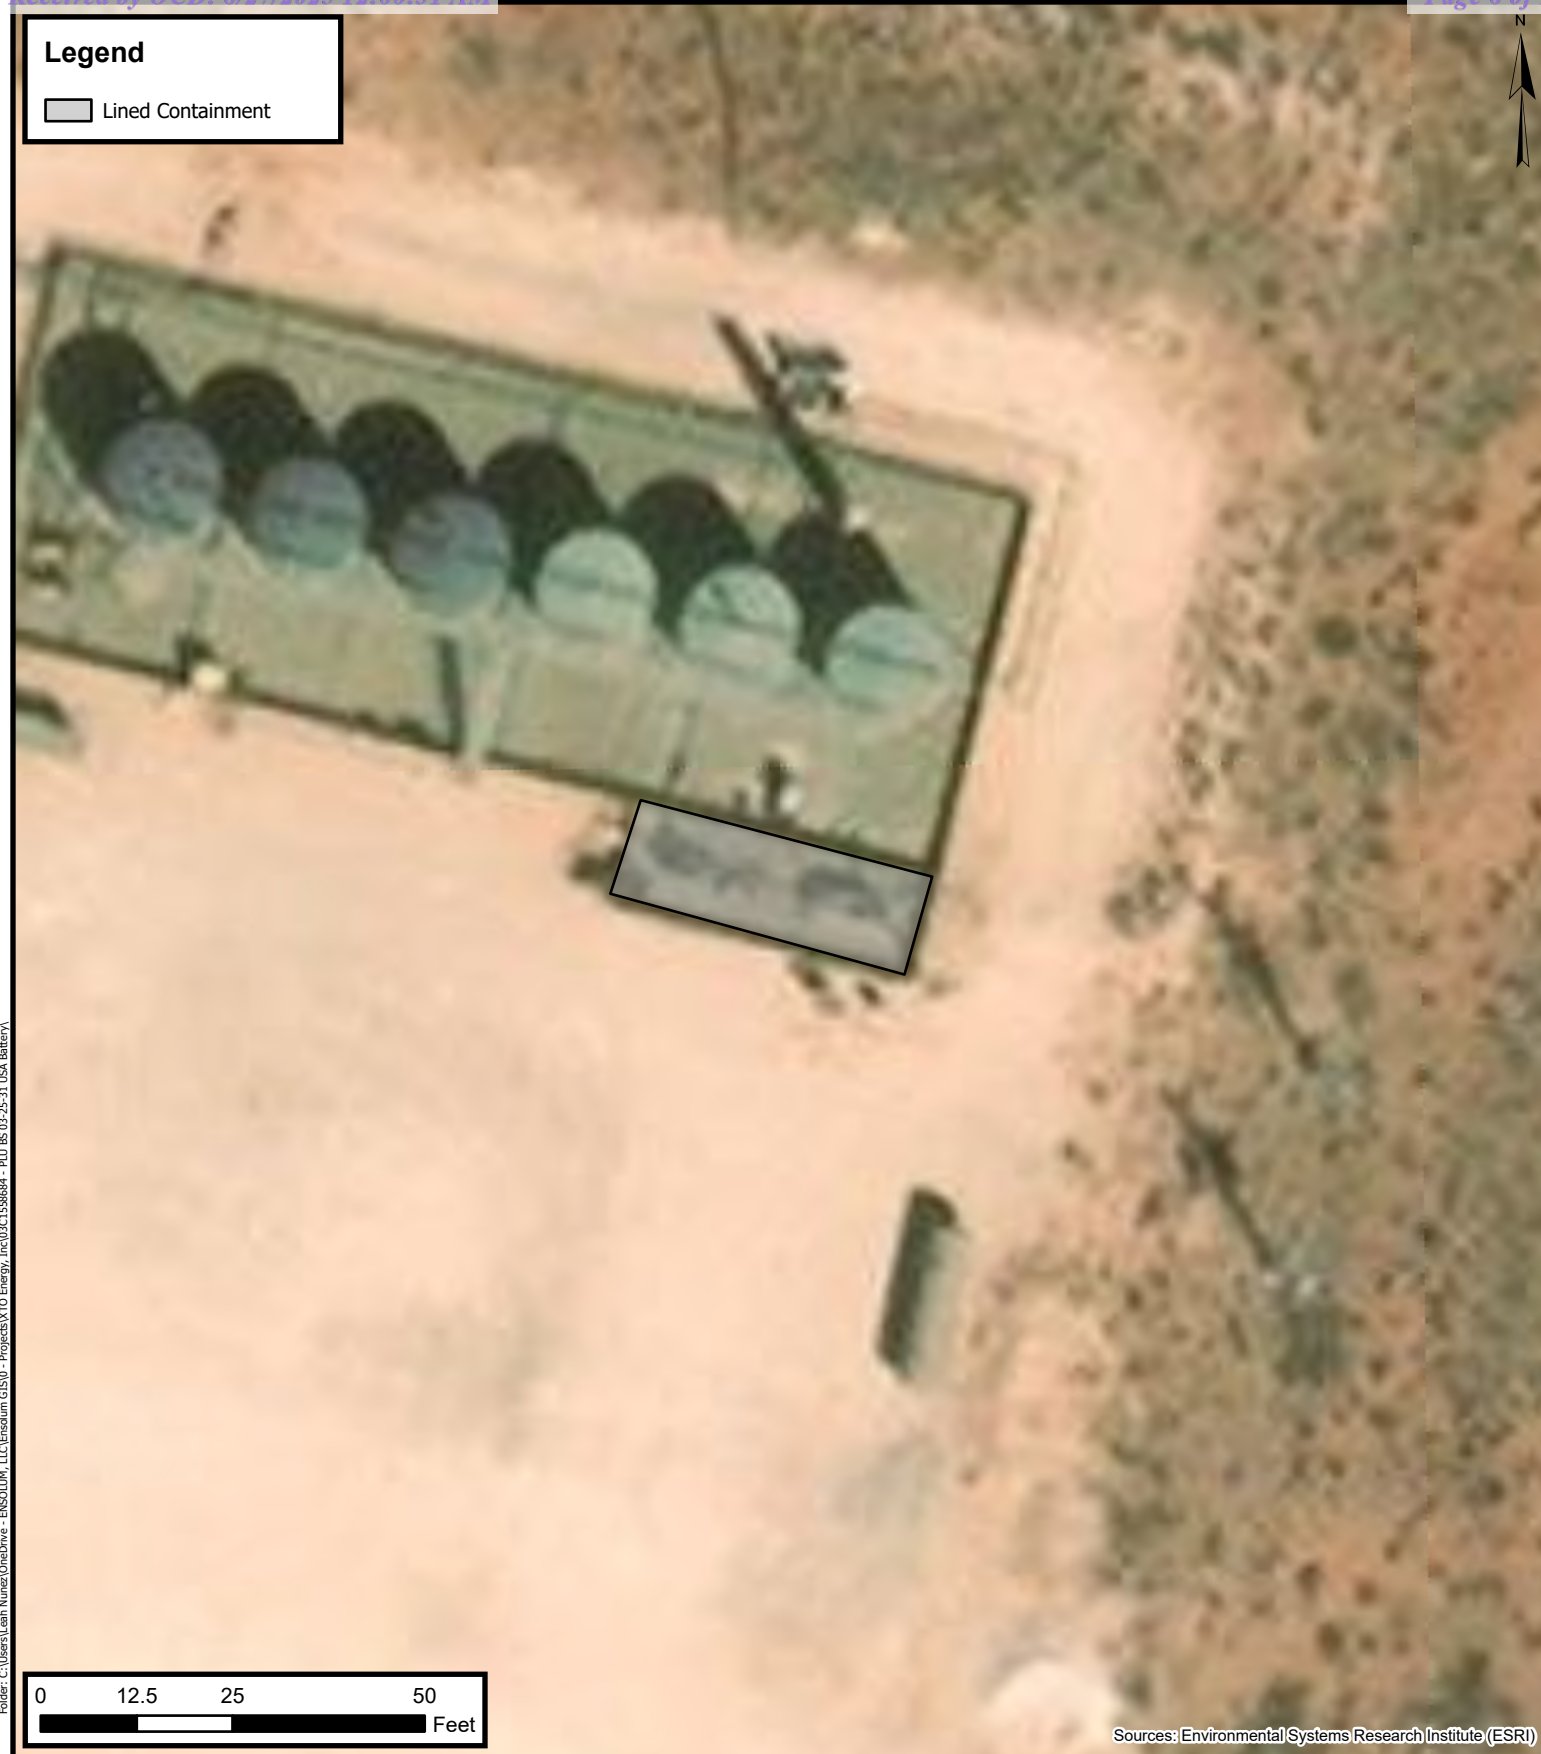
**FIGURE**  
**2**

**Site Map**  
XTO Energy, Inc  
PLU BS 03-25-31 USA Battery  
Incident Number: nAPP2515346013  
Unit A, Sec 4, T 25S, R 31E  
Eddy County, New Mexico

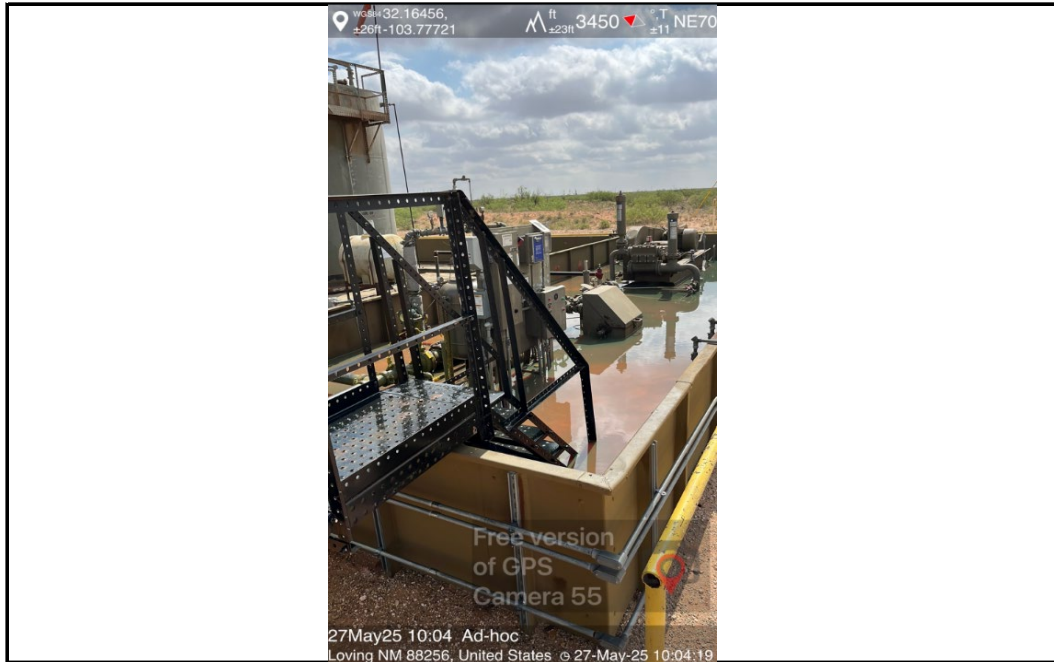
Photograph 1

Description: Initial release in lined containment; facing northeast

On May 27, 2025, equipment failure of a pump resulted in the release of approximately 70 barrels (bbls) of crude oil into a lined containment. A vacuum truck was dispatched to the Site to recover free-standing fluids and all fluids were recovered. The lined containment was power washed to remove any residual fluids. XTO reported the release to the New Mexico Oil Conservation Division (NMOCD) via a Notification of Release (NOR) and submitted an Initial C-141 Application (C-141) on June 2, 2025. The release was assigned Incident Number nAPP2515346013.

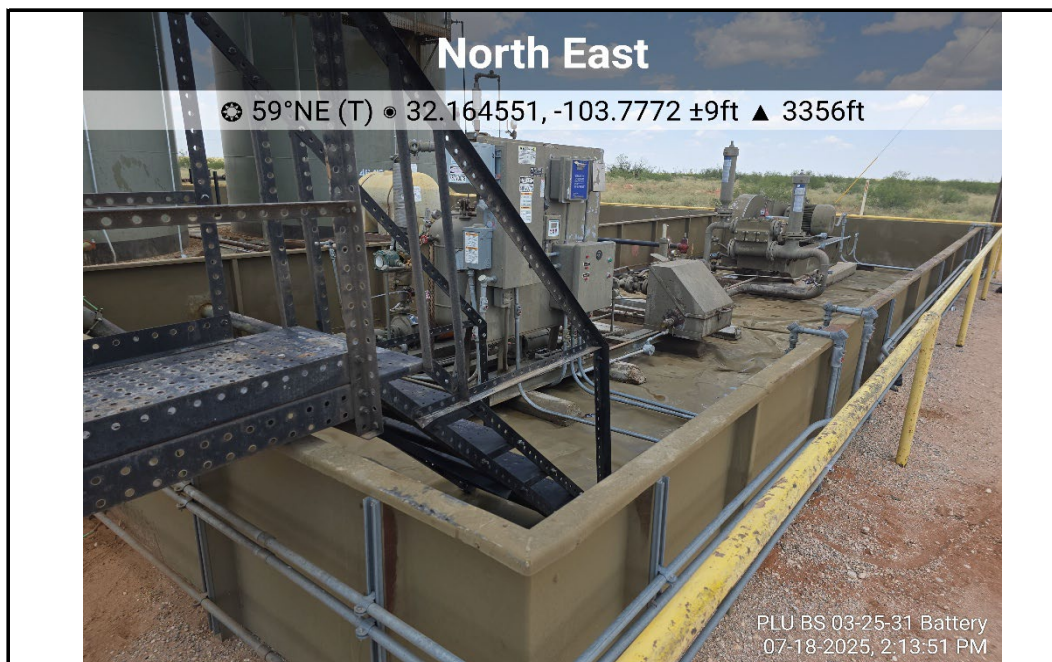
Photograph 3

Description: Liner inspection activities; view facing northeast

A 48-hour advanced notice of the liner inspection was submitted to the NMOCD on July 16, 2025. The lined containment was cleaned of all debris and power washed and a liner integrity inspection was conducted by Ensolum personnel on July 18, 2025. The lined containment was inspected, and it was determined that the liner was operating as designed. Upon inspection, no rips, tears, holes, or damage was observed. The liner was determined to be operating sufficiently, and all released fluids were recovered. Photographic documentation of the inspection is included in Appendix B.

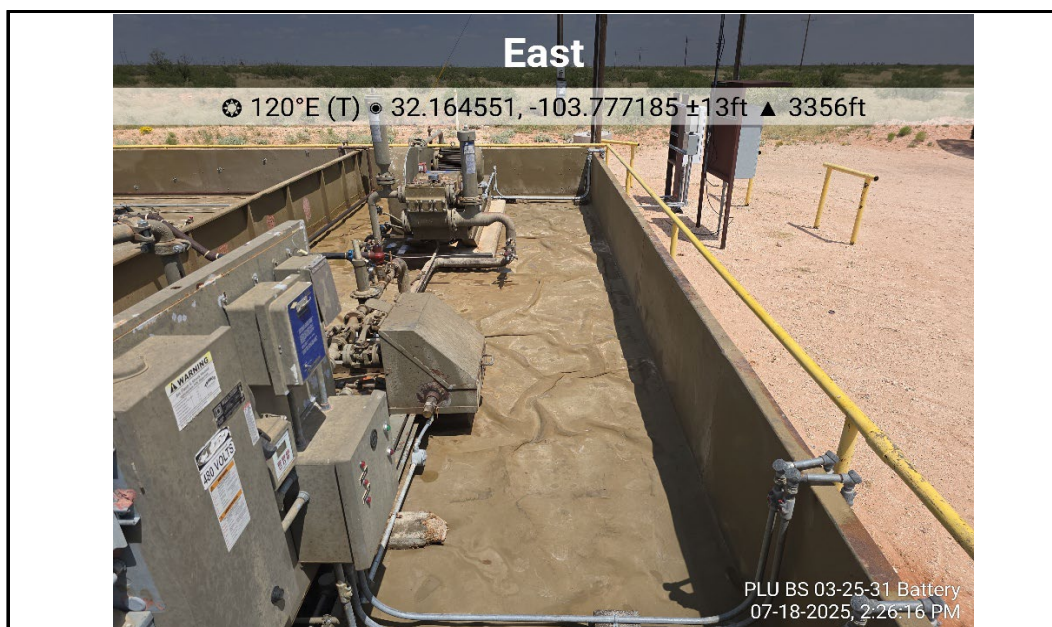
Photograph 4

Description: Liner inspection activities; view facing east

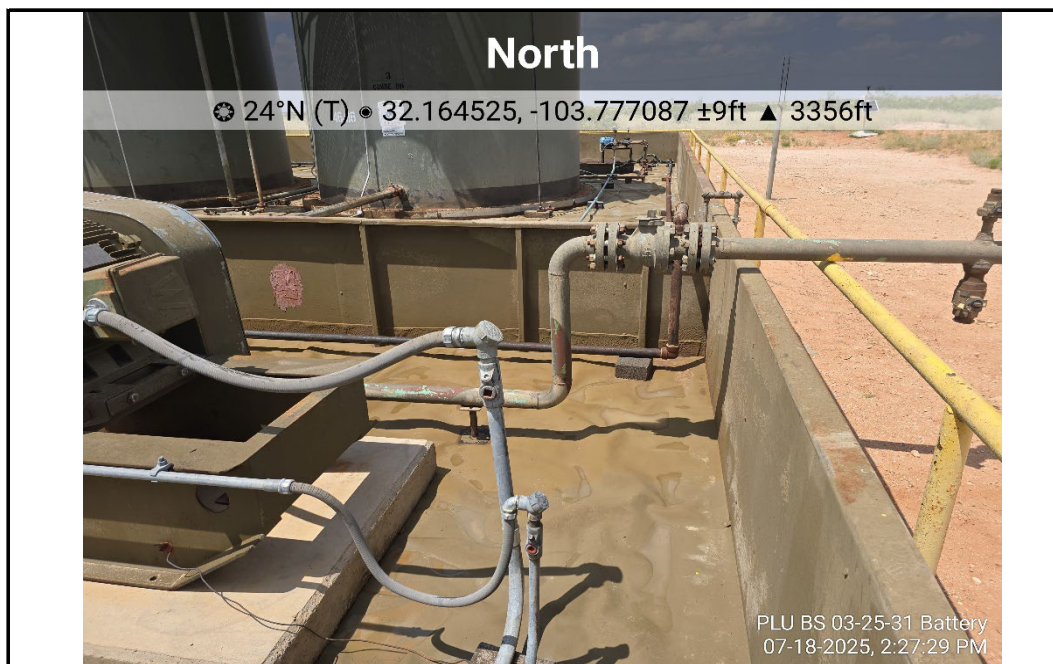
Photograph 5

Description: Liner inspection activities; view facing north

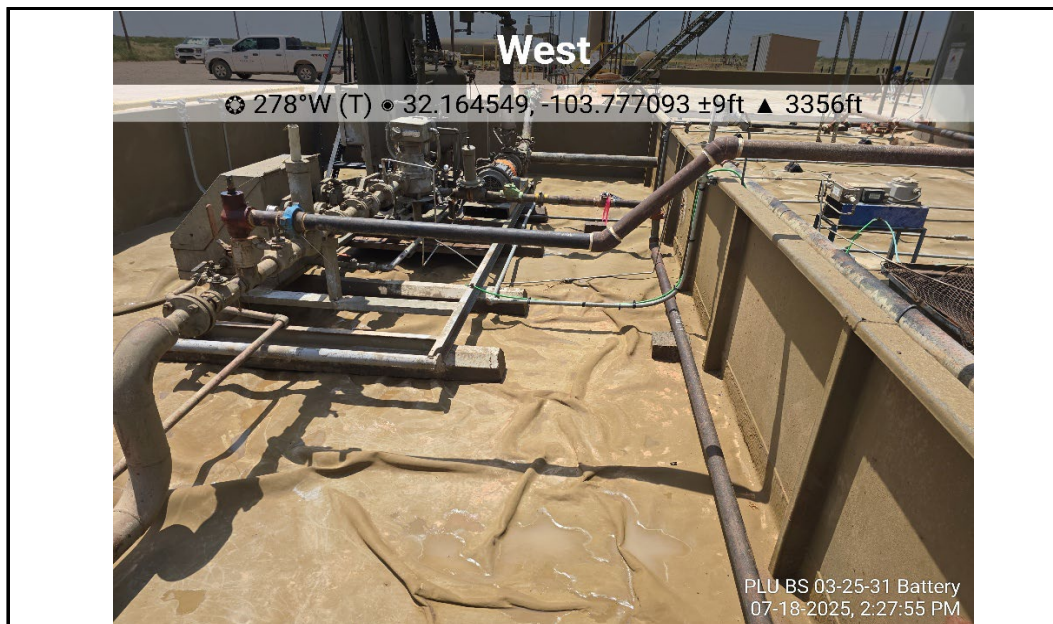
Photograph 6

Description: Liner inspection activities; view facing west
