**Closure Report**  
**July 16 State Com #1H**  
**Incident ID: nAPP2522652652**  
**Lea County, New Mexico**  
**Unit F Sec 16 T25S R34E**  
**32.13090°, -103.47630°**

**Produced Water Release**  
**Point of Release: Equipment Failure on Valve**  
**Release Date: 8/03/2025**  
**Volume Released: 30 Barrels of Produced Water**  
**Volume Recovered: 0 Barrels of Produced Water**

**Re: Closure Report**  
**July 16 State Com #1H**  
**EOG Resources Inc.**  
**API No. 30-025-39983**  
**NMOCD Incident ID: nAPP2522652652**  
**Site Location: Unit F, S16, T25S, R34E**  
**(Lat 32.13090°, Long -103.47630°)**  
**Lea County, New Mexico**

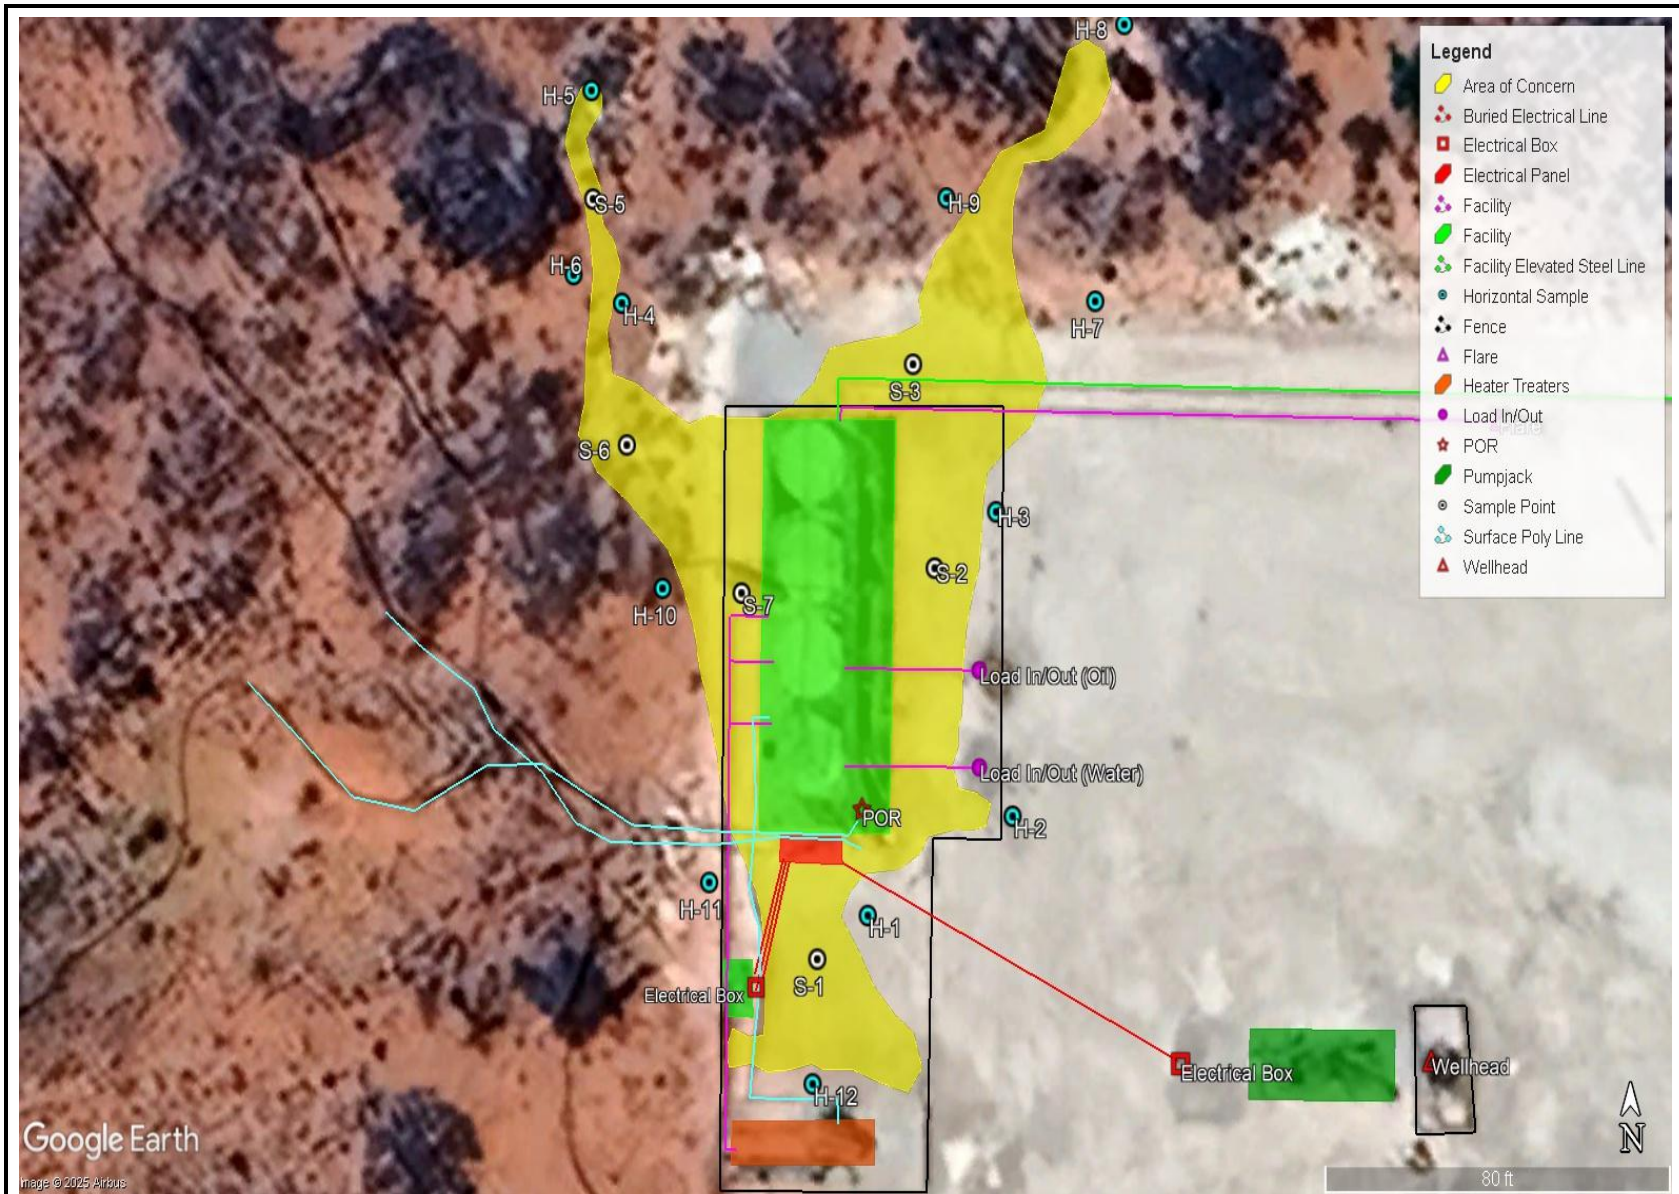
FIGURE 3

Based on the Notification of Release obtained from the New Mexico Oil Conservation Division (NMOCD), the release was discovered on August 3, 2025, due to equipment failure stemming from a valve. It resulted in the release of thirty (30) barrels of produced water and zero (0) barrels of produced water were recovered. The release occurred on the pad and into the pasture. Refer to Figure 3. The Notification of Release form is attached in Appendix C.

SAMPLE LOCATION MAP  
EOG RESOURCES  
JULY 16 STATE COM #1H  
LEA COUNTY, NEW MEXICO  
32.13090°, -103.47630°

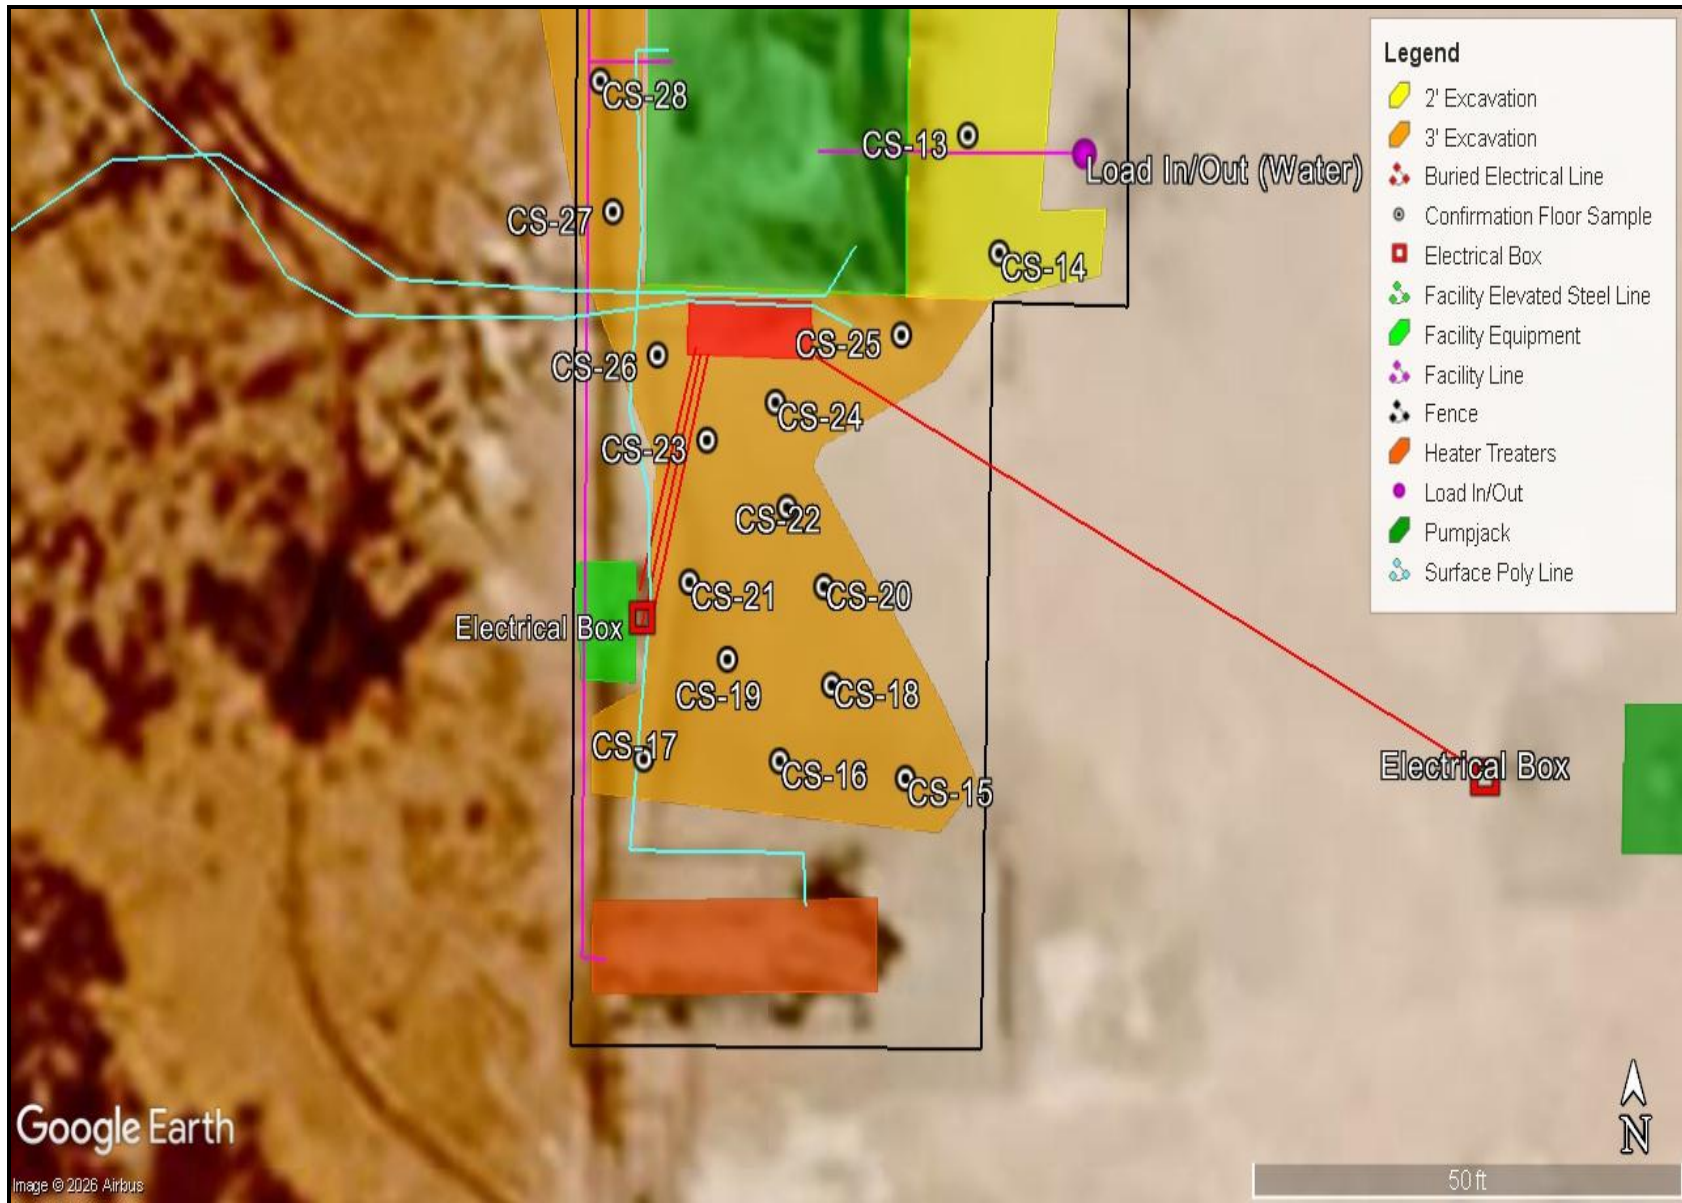
FIGURE 4C

EXCAVATION MAP  
EOG RESOURCES  
JULY 16 STATE COM #1H  
LEA COUNTY, NEW MEXICO  
32.13090°, -103.47630°

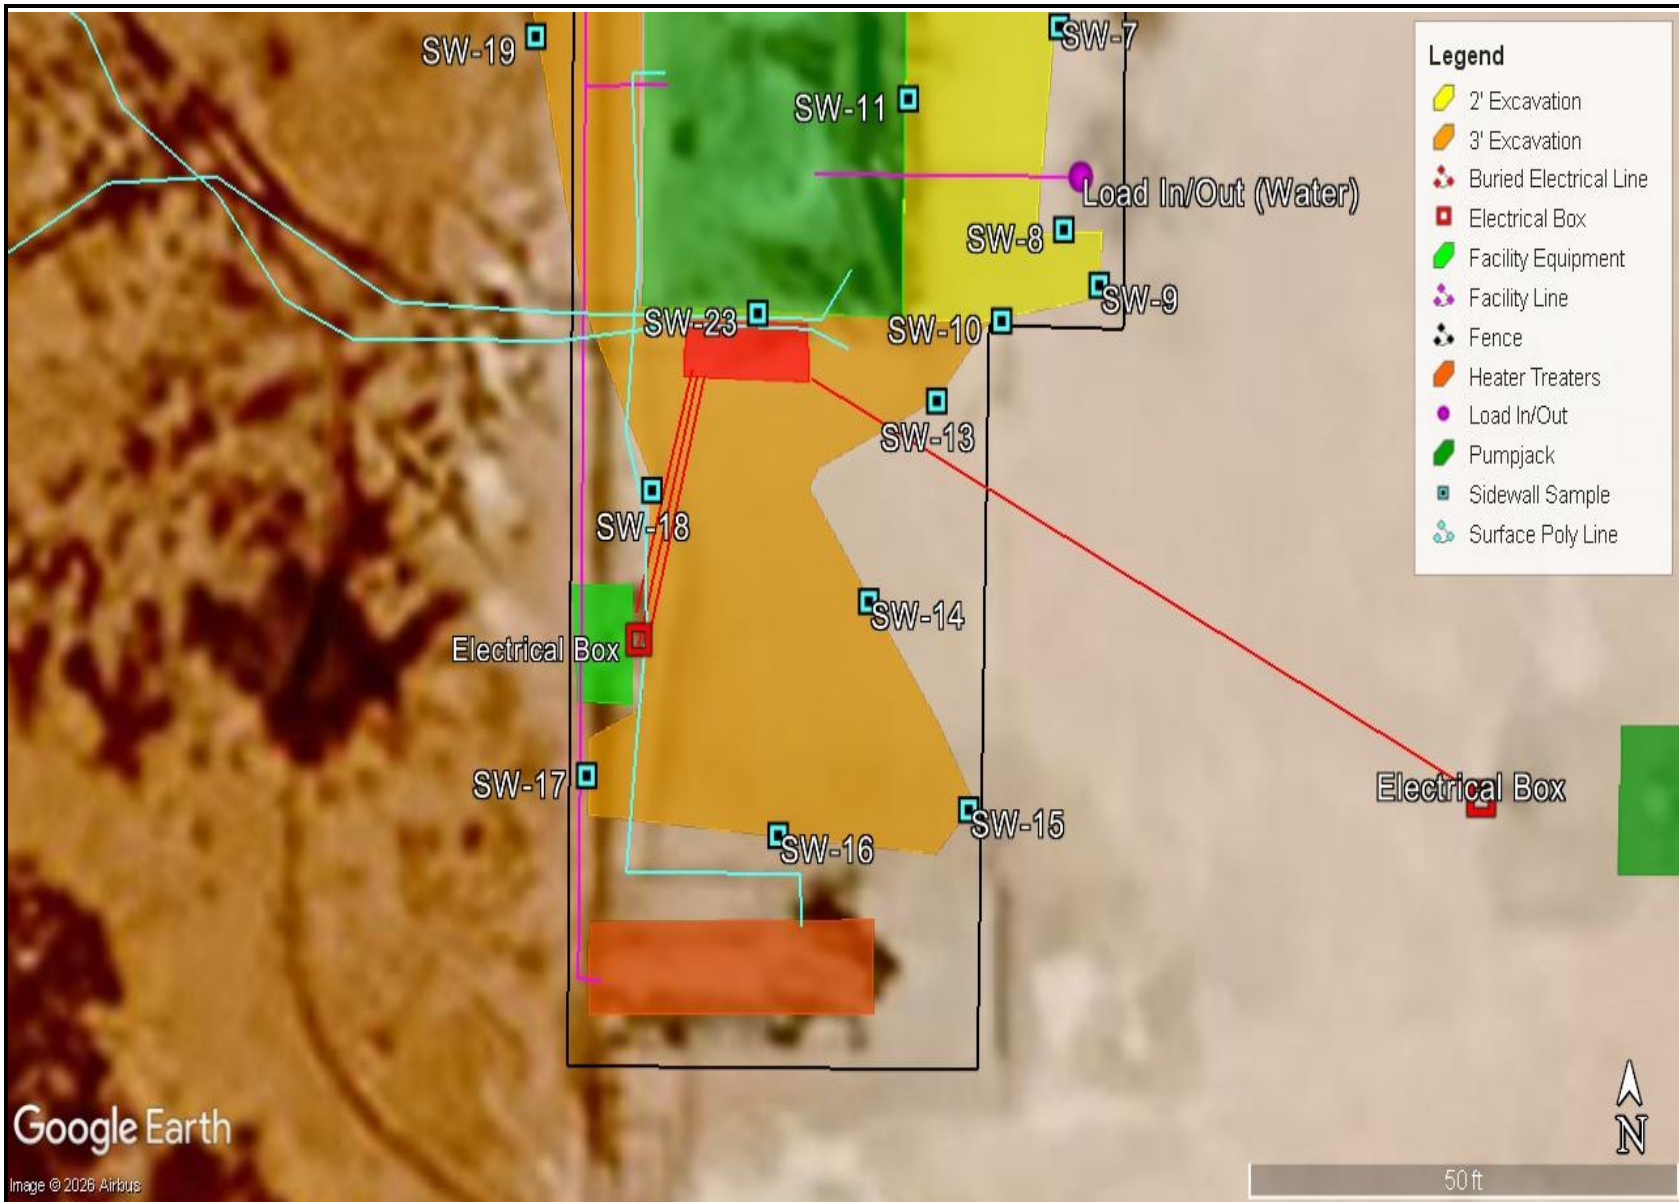
</p>	<p>FIGURE 4D</p>
---	--	------------------

<p>EXCAVATION MAP          EOG RESOURCES          JULY 16 STATE COM #1H          LEA COUNTY, NEW MEXICO          32.13090°, -103.47630°</p>	<p>CARMONA RESOURCES

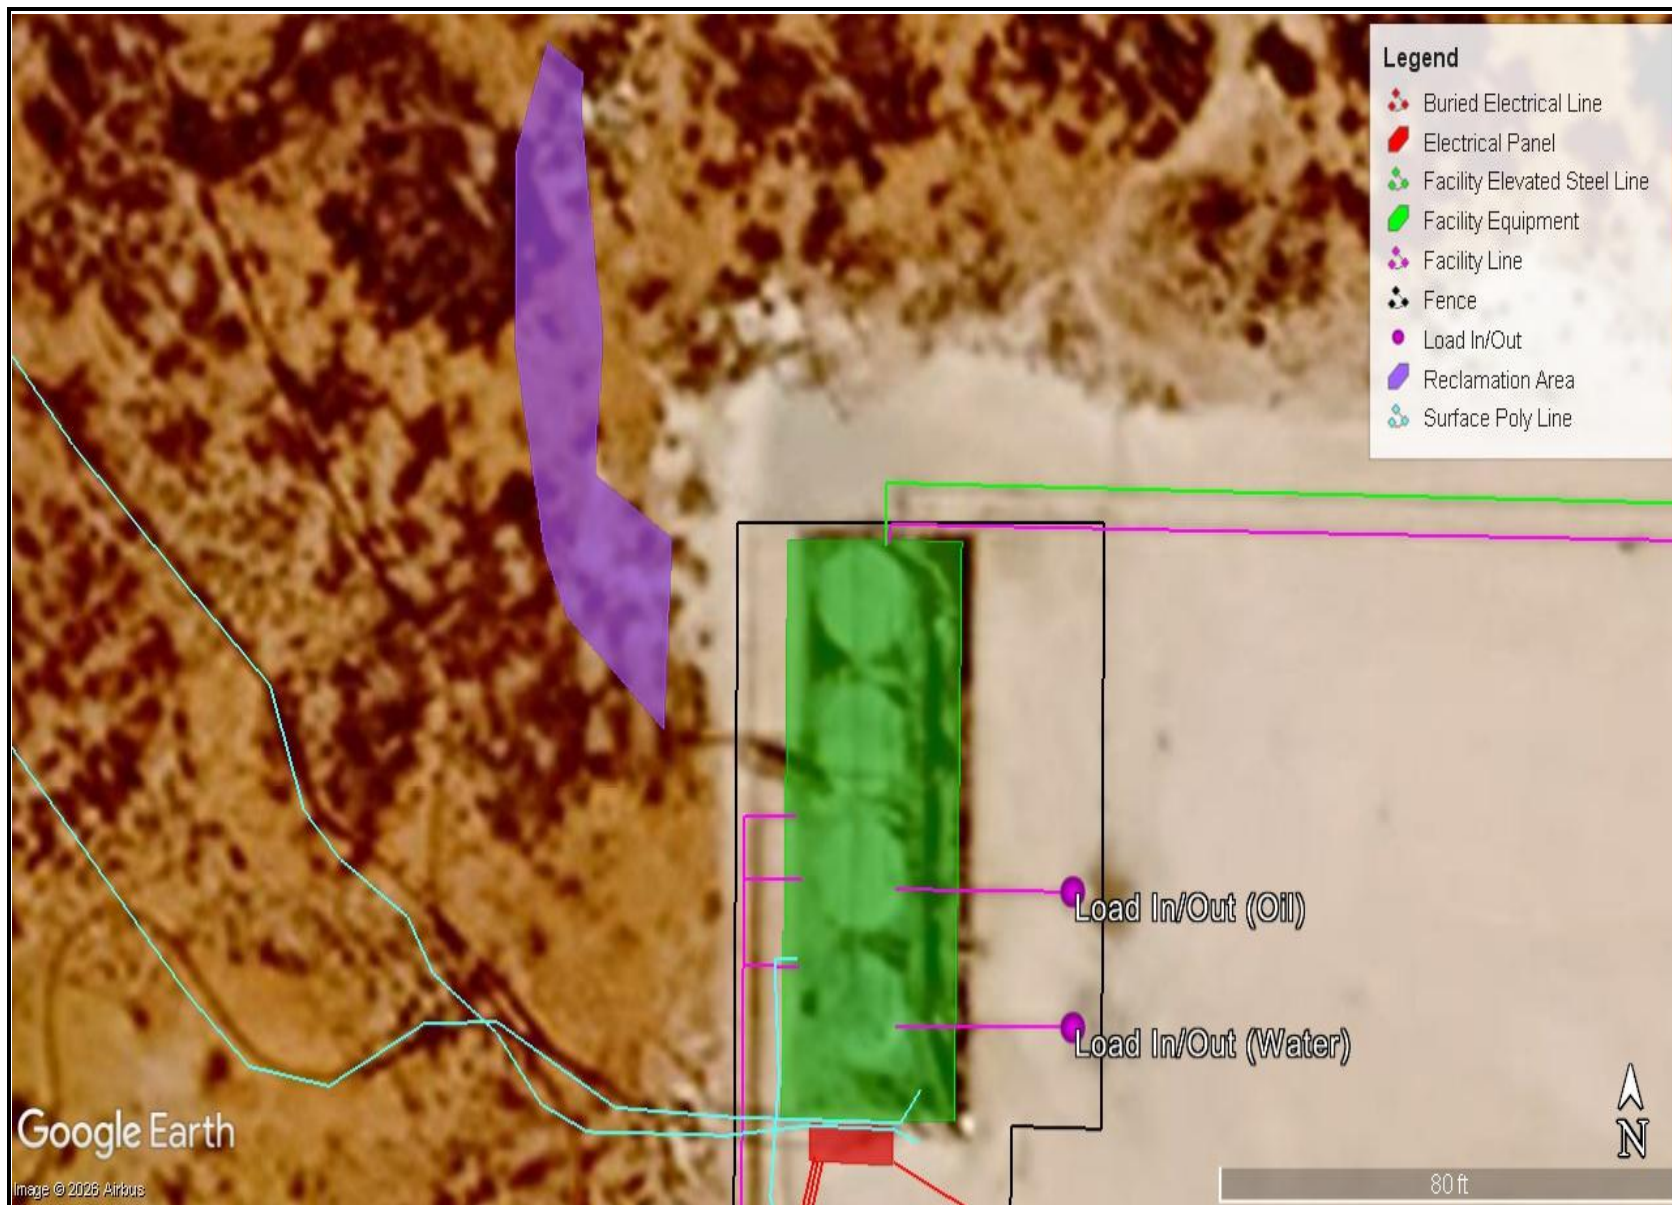
FIGURE 5

RECLAMATION MAP  
EOG RESOURCES  
JULY 16 STATE COM #1H  
LEA COUNTY, NEW MEXICO  
32.13090°, -103.47630°

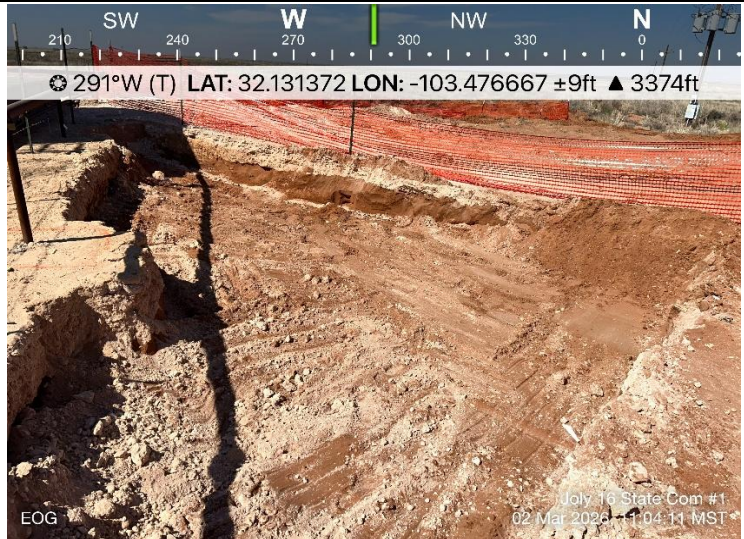
### Photograph No. 2

**Description:**  
View West, area of CS-1 through CS-6.

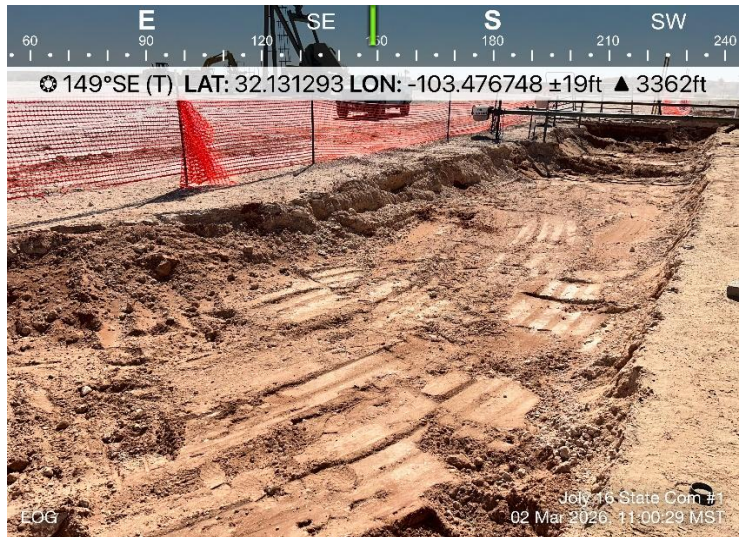
### Photograph No. 3

**Description:**  
View Southeast, area of CS-7 through CS-12.

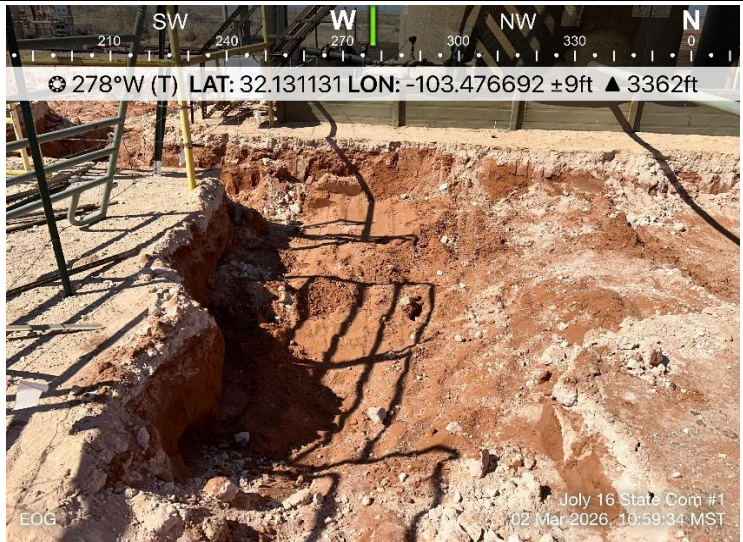
View West, area of CS-13 and CS-14.

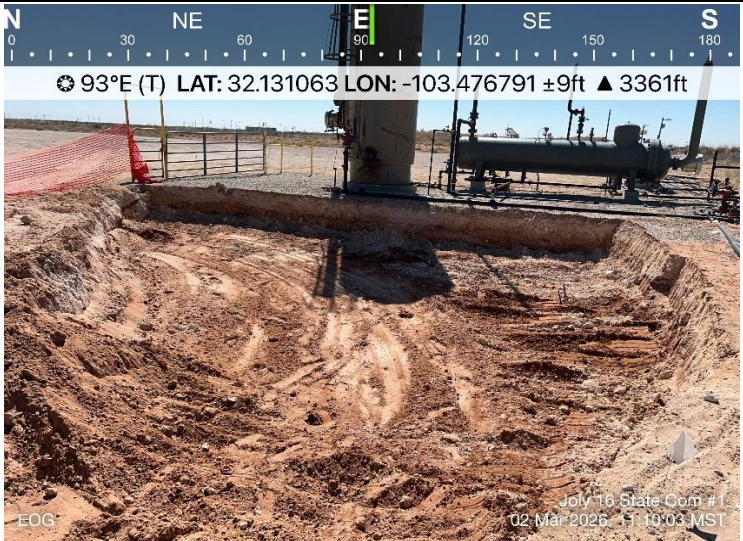
### Photograph No. 5

View East, area of CS-15 through CS-20.

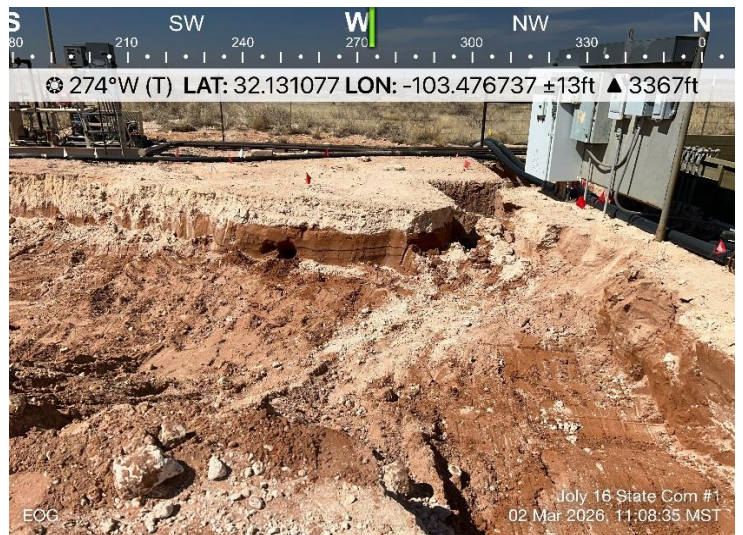
### Photograph No. 6

View West, area of CS-21 through CS-23.

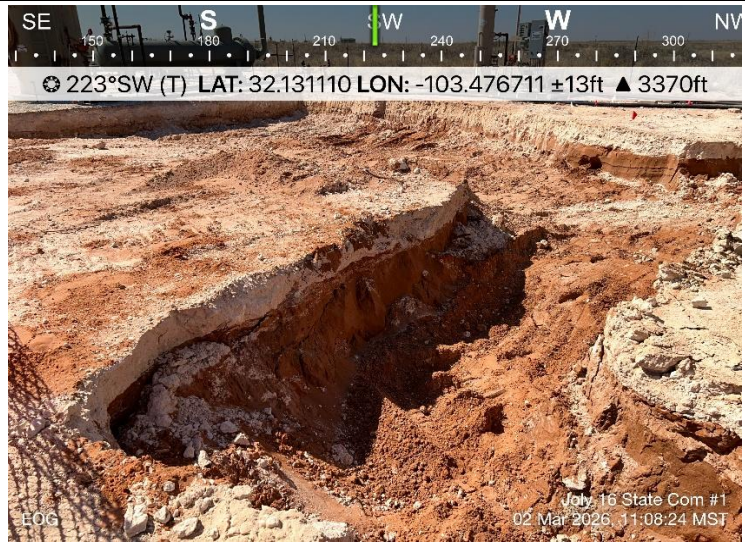
**Description:**  
View Southwest, area of CS-24 through CS-26.

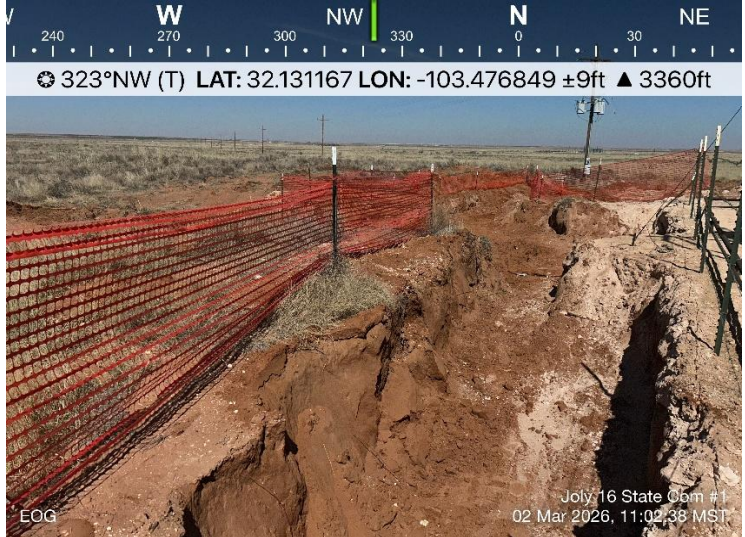
### Photograph No. 8

**Description:**  
View Northwest, area of CS-27 through CS-34.

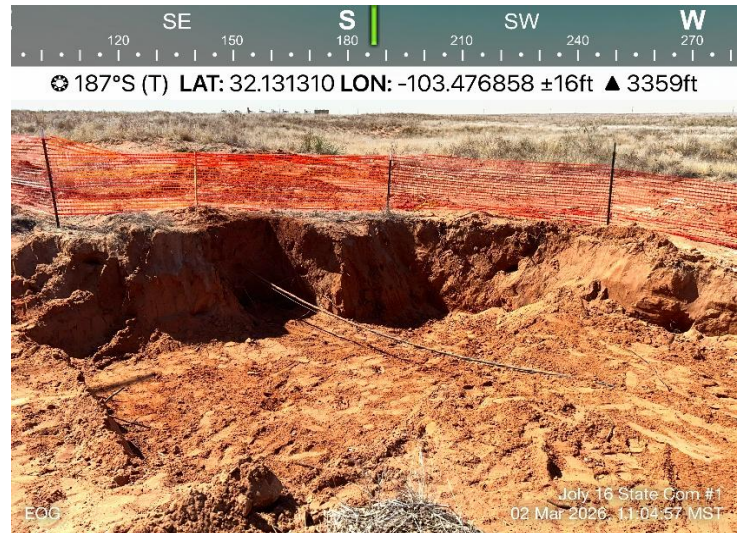
### Photograph No. 9

**Description:**  
View South, area of CS-35 through CS-38.

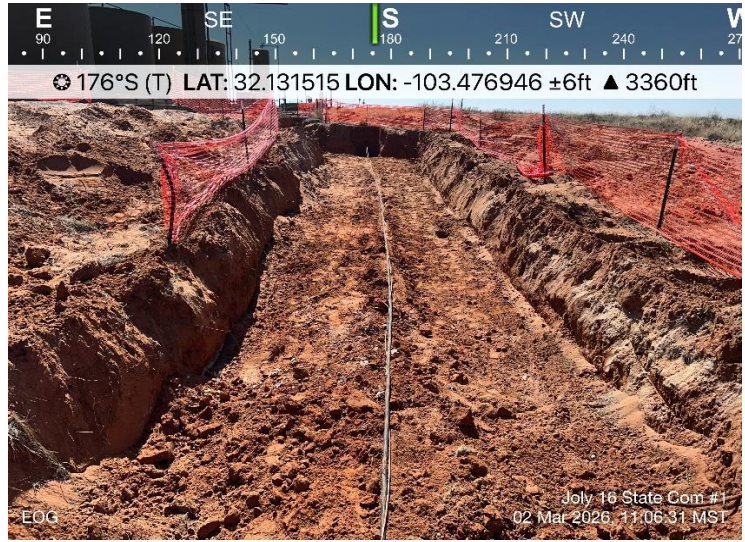
View South, area of CS-39 through CS-41 as well as SW-27 through SW-29. These walls horizontally bound the areas of H-4 through H-6.

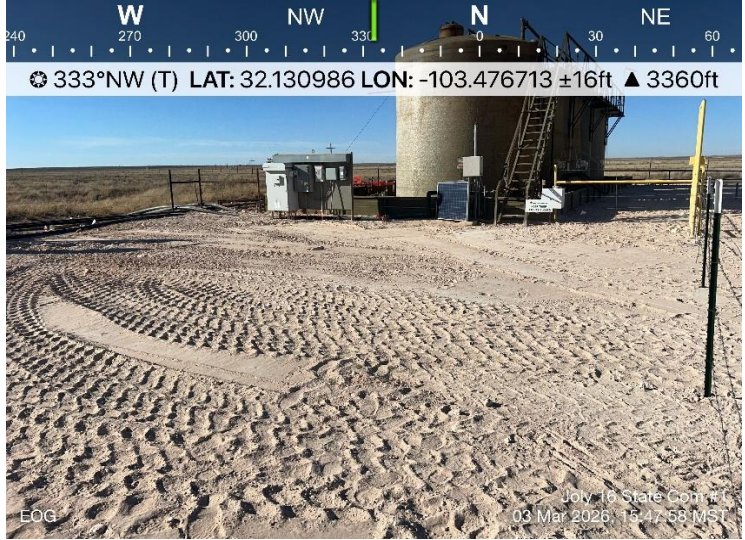
### Photograph No. 11

View Northwest of backfilled area.

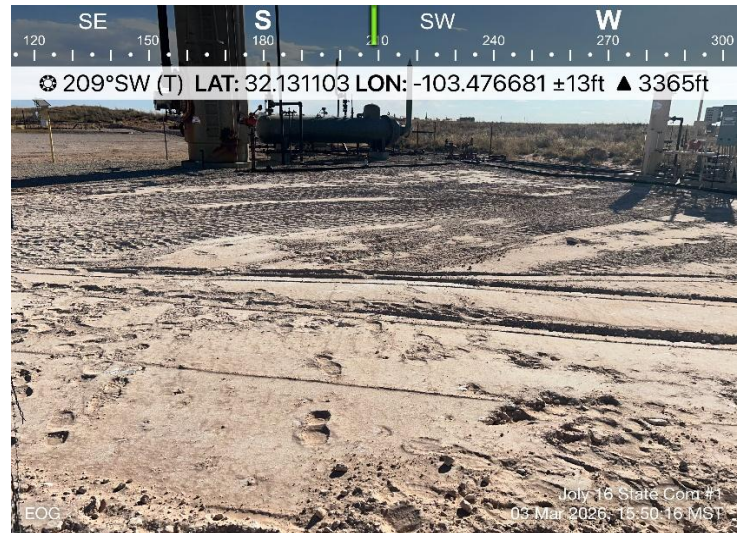
### Photograph No. 12

View Southwest of backfilled area.

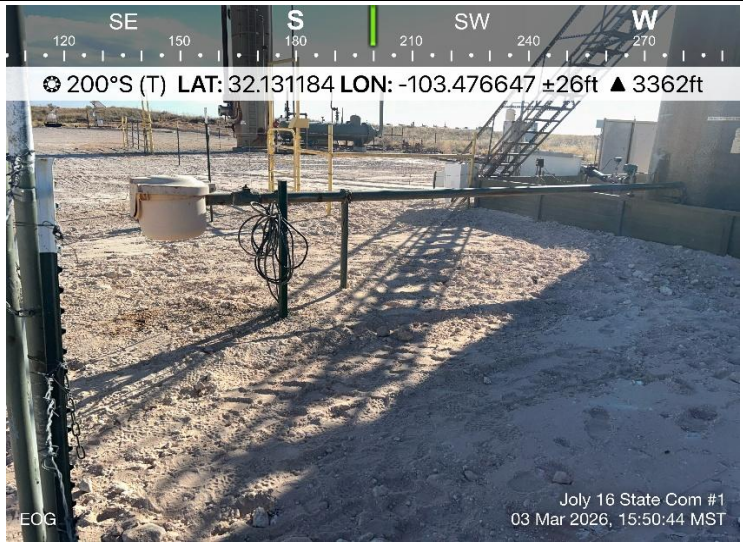
**Description:**  
View South of backfilled area.

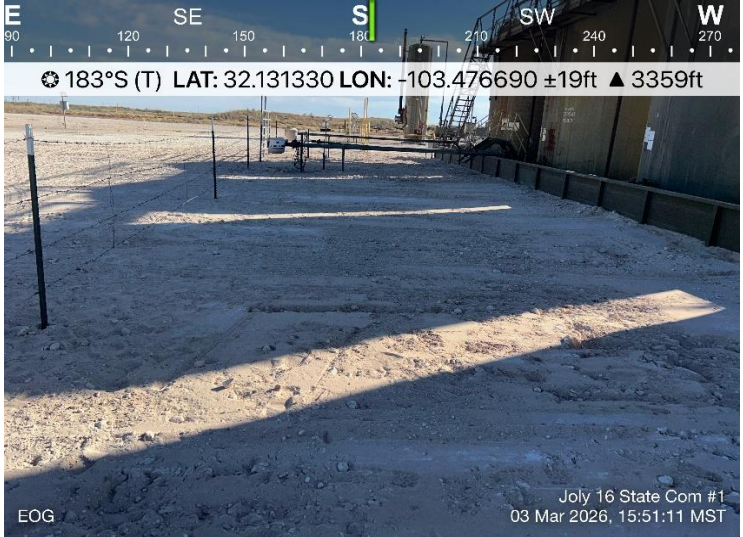
### Photograph No. 14

**Description:**  
View South of backfilled area.

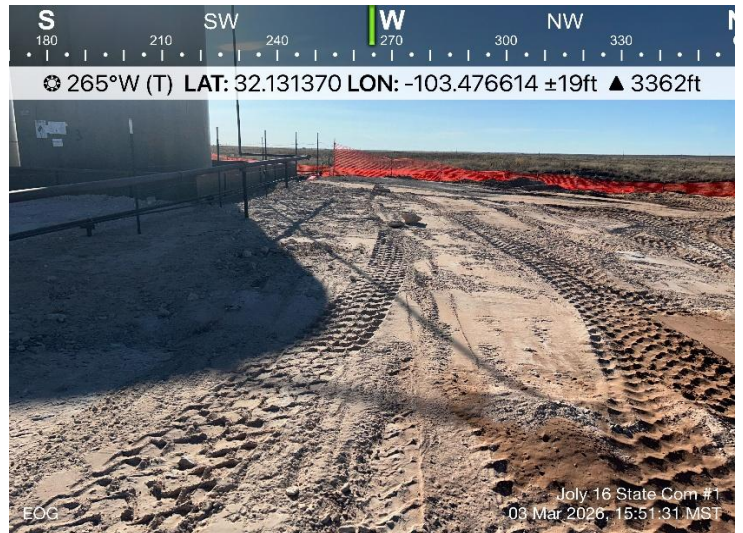
### Photograph No. 15

**Description:**  
View West of backfilled area.

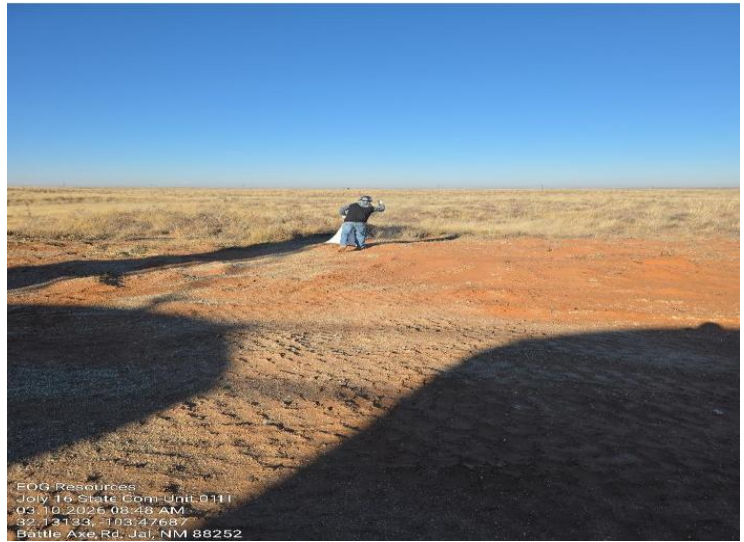
**Photograph No. 17**

**Description:**  
View of reseeding via hand broadcast.

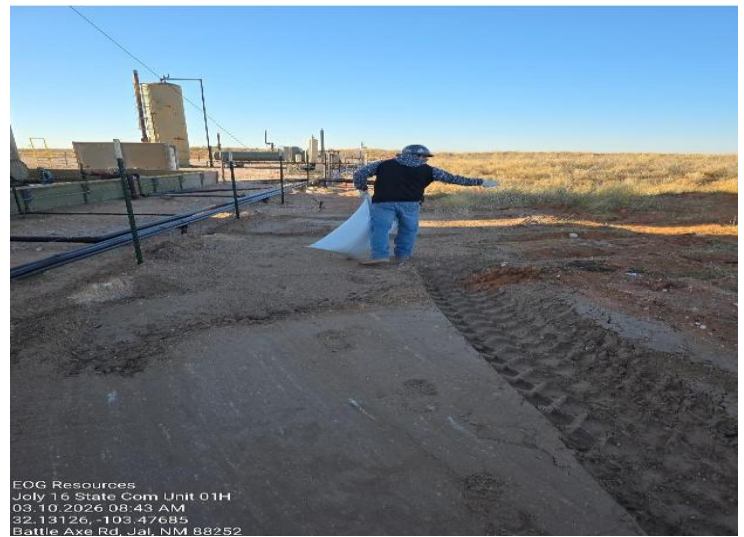
**Photograph No. 18**

**Description:**  
View of reseeding via hand broadcast.

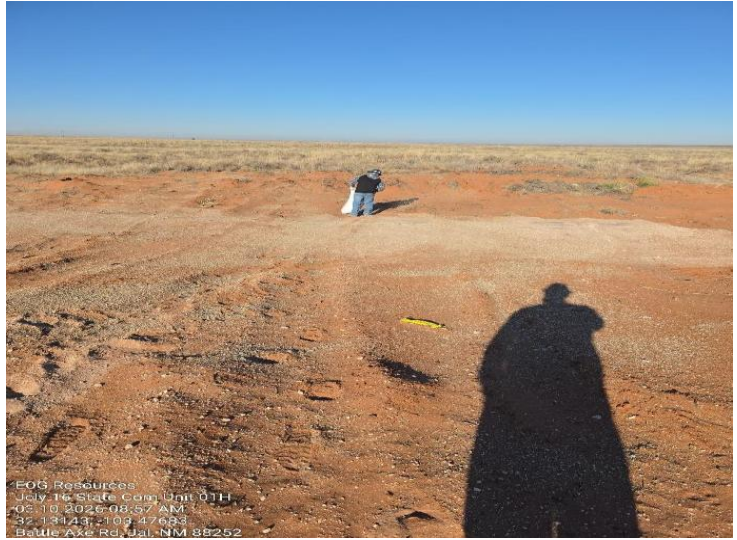
**Description:**  
View of reseeding via hand broadcast.
