CLOSURE REPORT

Trunk K #2
Unit Letter B, S 08, T 26 N R 7 W
Rio Arriba County, New Mexico

New Mexico EMNRD OCD Incident ID No. NAPP2601447138

Ensolum Project No. 05A1226398

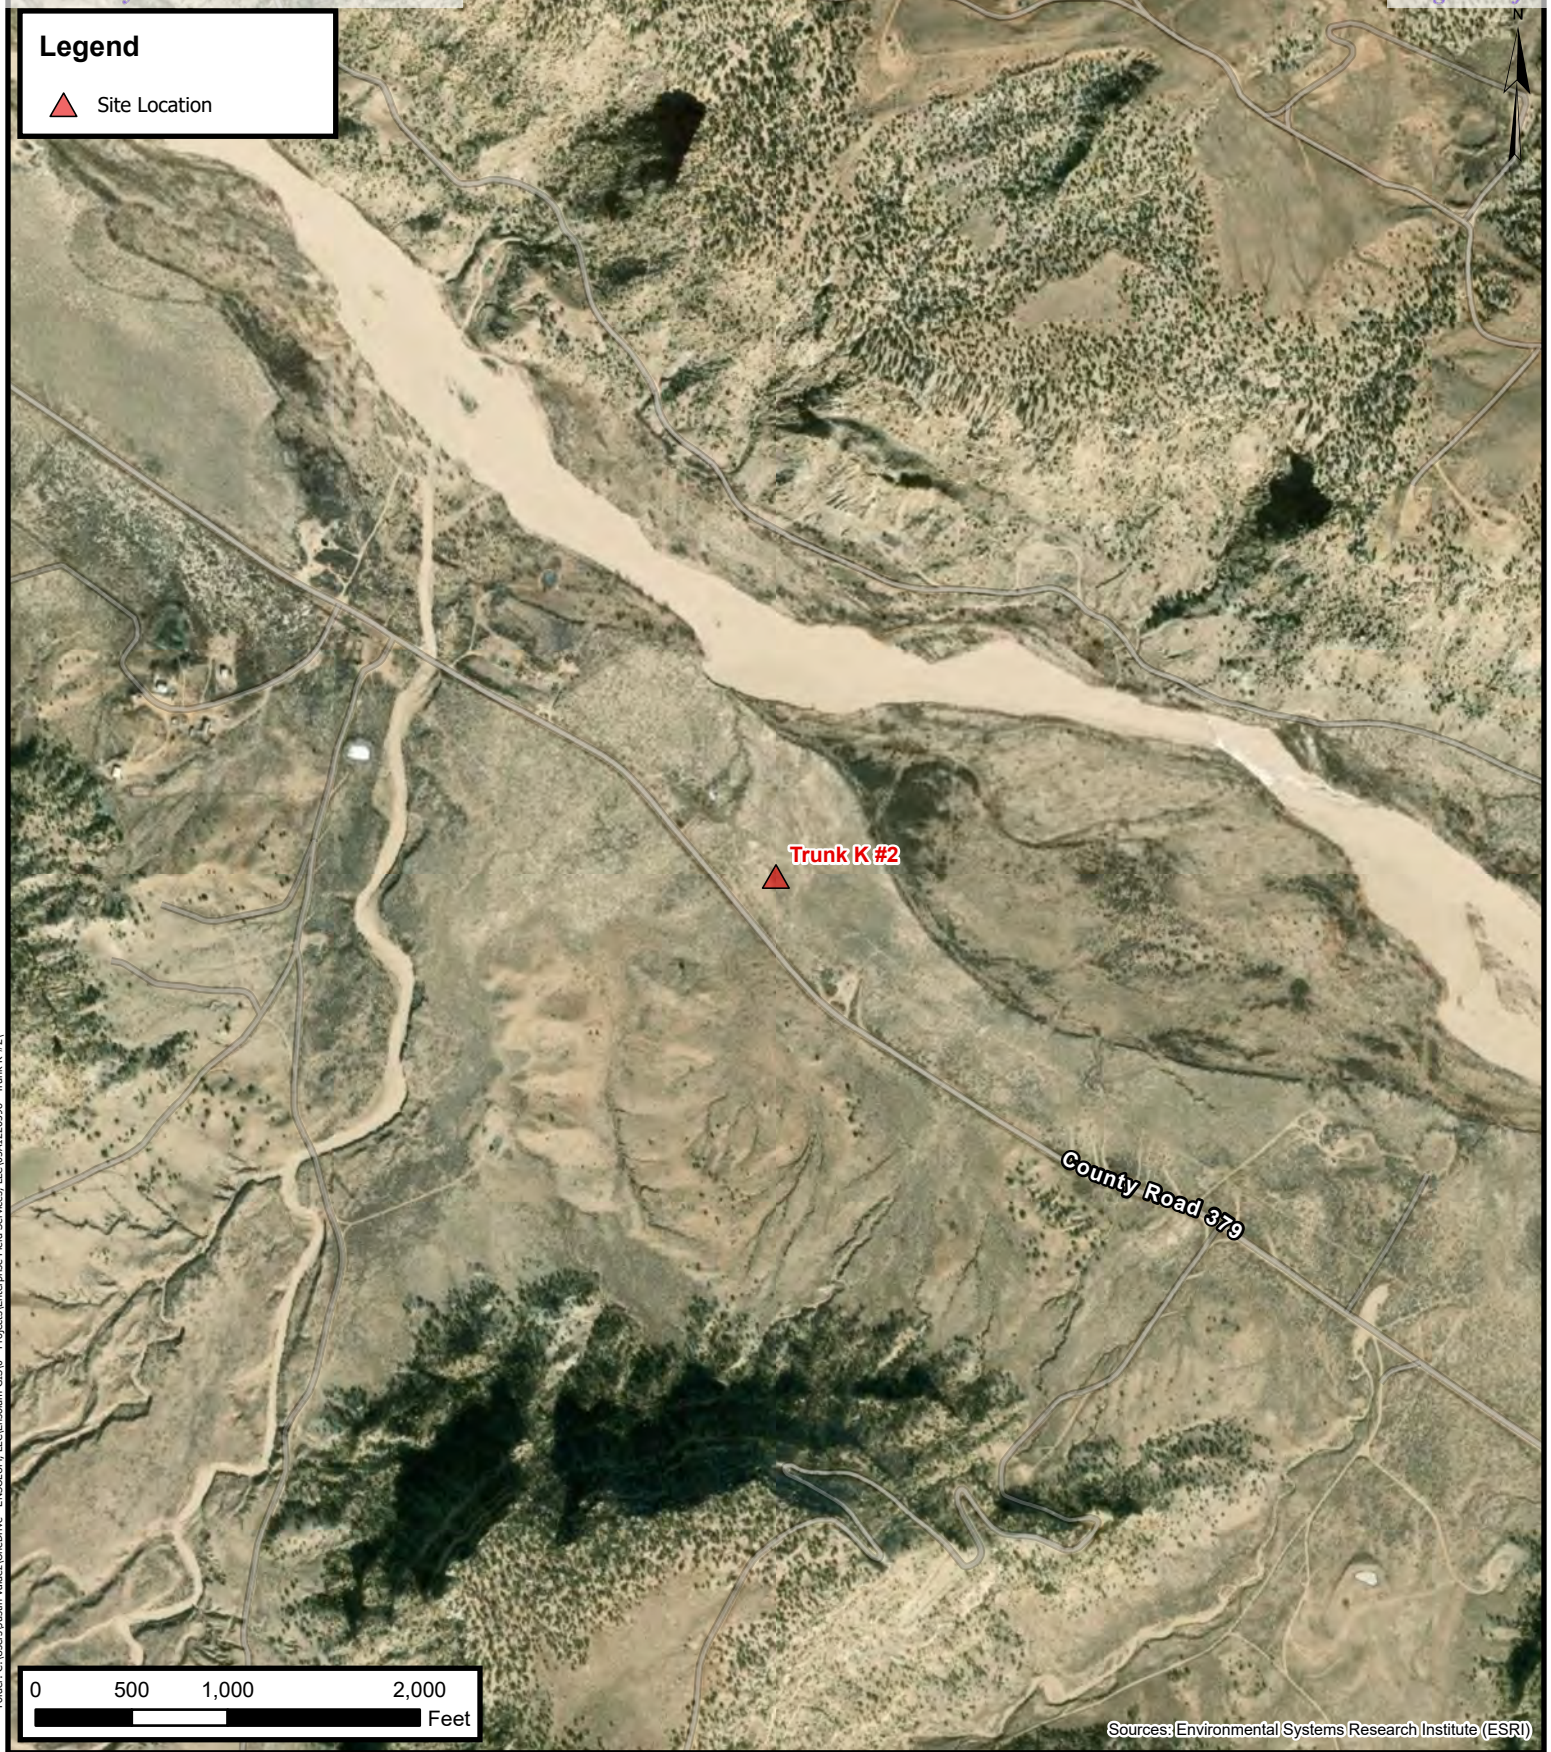
2

A **Topographic Map** depicting the location of the Site is included as **Figure 1**, and a **Site Vicinity Map** is included as **Figure 2** in **Appendix A**.

Site Vicinity Map

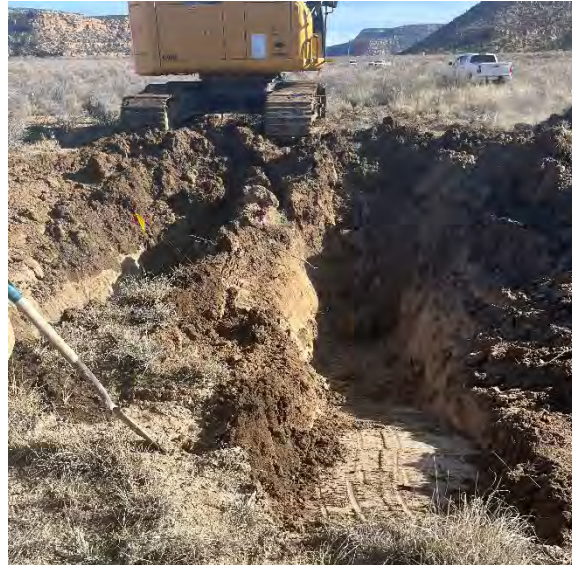
Photograph 5
Photograph Description: View of the final excavation.

The excavation measured approximately 30 feet long and 15 feet wide at the maximum extents. The calculated surface footprint is approximately 450 ft². The maximum depth of the excavation measured approximately 6 feet bgs. The lithology encountered during the completion of remediation activities consisted primarily of silty clay and silty sand.
