CLOSURE REPORT

Trunk K #6
Unit Letter B, S 08, T 26N, R 07W
Rio Arriba County, New Mexico

New Mexico EMNRD OCD Incident ID No. NAPP2601541117

Ensolum Project No. 05A1226403

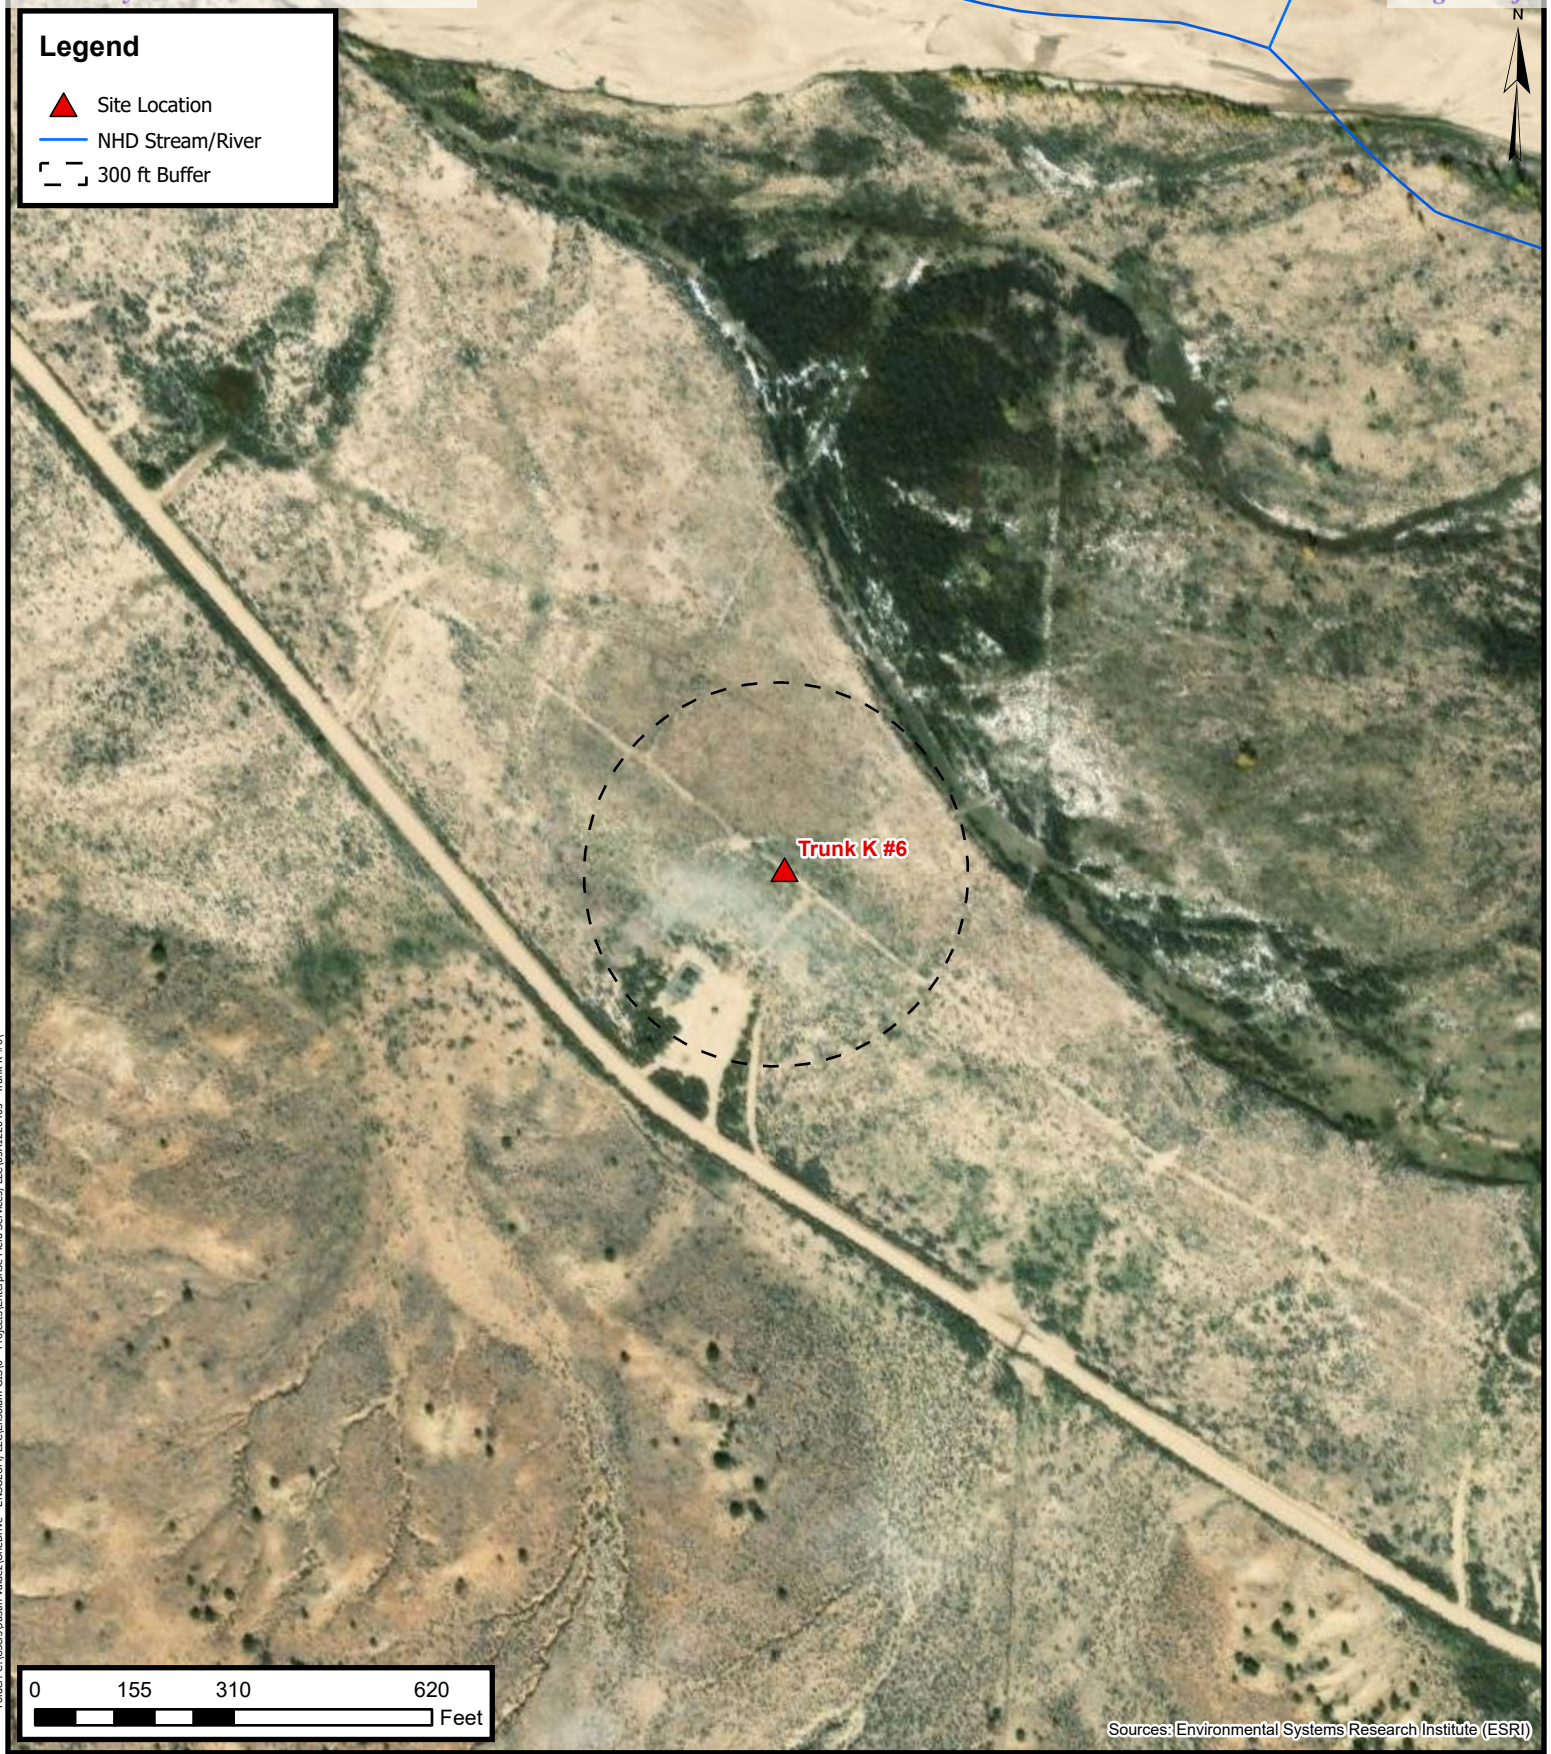
**FIGURE
D**

**300 Foot Radius Occupied
Structure Identification**
Enterprise Field Services, LLC
Trunk K #6
Project Number: 05A1226403
Unit B, Section 08, T 26N, R 07W, Rio Arriba County, New Mexico
36.506411, -107.594771

- The Site is not located within 200 feet of a lakebed, sinkhole, or playa lake.
- The Site is not located within 300 feet of a permanent residence, school, hospital, institution, or church (**Figure D, Appendix B**).

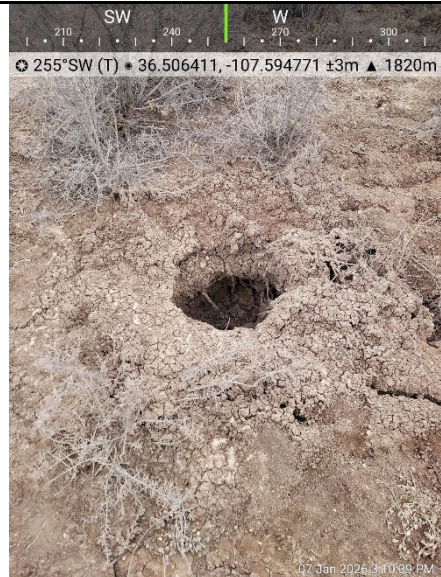
Photograph 1

Photograph Description: View of release point.

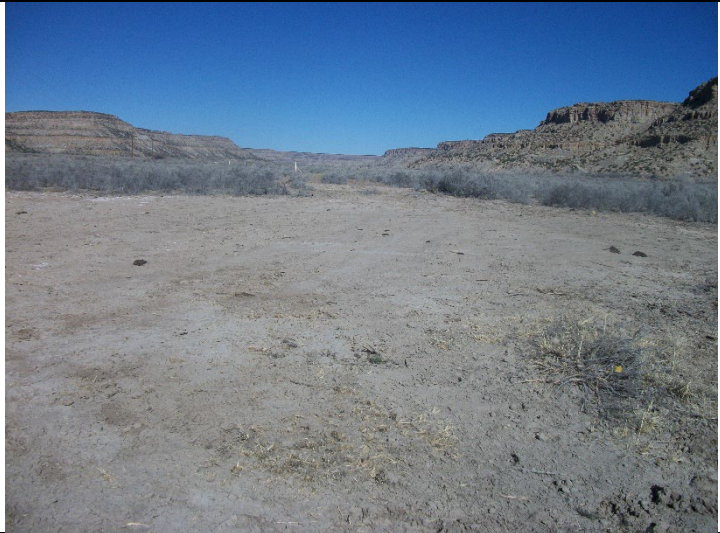
Photograph 2

Photograph Description: View of the final excavation after initial restoration.

The excavation was backfilled with imported fill and then contoured to the surrounding grade. The backfill and the upper four feet of the excavation have been analytically verified to be below the Tier I soil standards of 50 mg/kg BTEX, 10 mg/kg benzene, 100 mg/kg total combined TPH, and 600 mg/kg Chloride. See **Appendix D** and **Appendix F** for further documentation.
