From: Hansen, Edward J., EMNRD
Sent: Tuesday, May 08, 2012 4:28 PM
To: Hack Conder (hconder@riceswd.com)
Cc: Leking, Geoffrey R, EMNRD; Katie Jones <kjones@riceswd.com> (kjones@riceswd.com);
Laura Pena (lpena@riceswd.com); Scott Curtis (scurtis@riceswd.com)
Subject: Remediation Plan (1R425-18) Termination - ROC Vacuum Jct G-33 Site

RE: Termination Request
Vacuum Jct. G-33 (1R425-18): UL/G, Sec. 33, T17S, R35E
RICE Operating Company – Vacuum SWD System

**RICE OPERATING COMPANY
JUNCTION BOX FINAL REPORT**

Vacuum jct. G-33

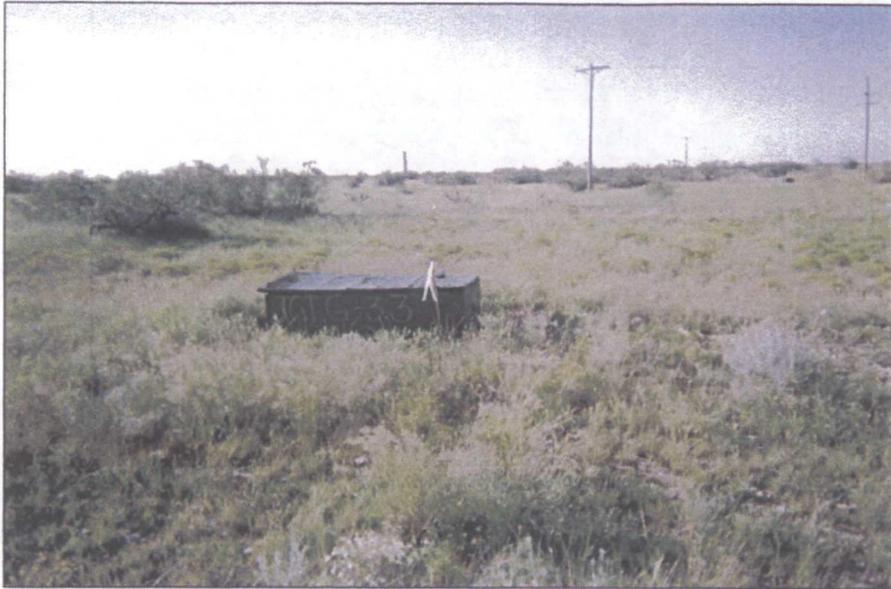
undisturbed junction box (facing south) 9/13/2005

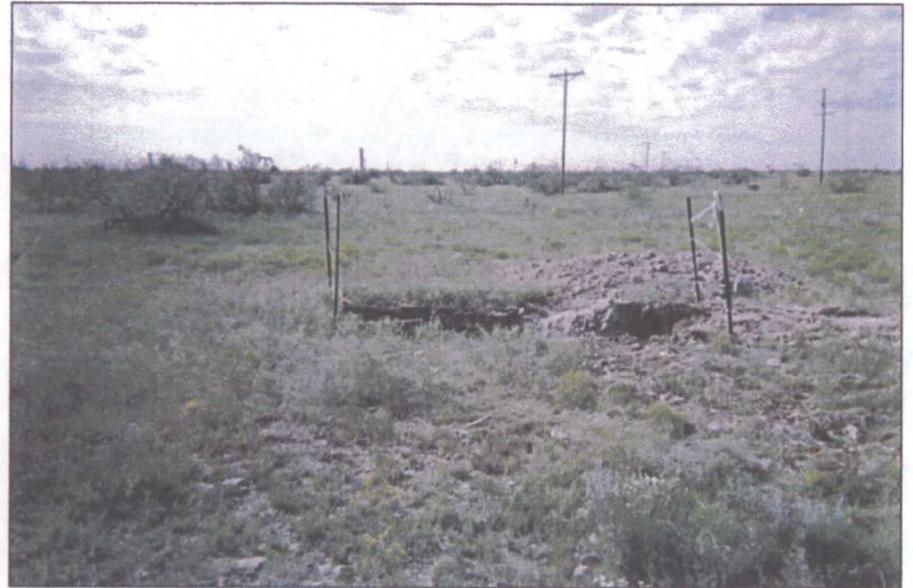
box removed; prior to excavation (facing south) 9/13/2005

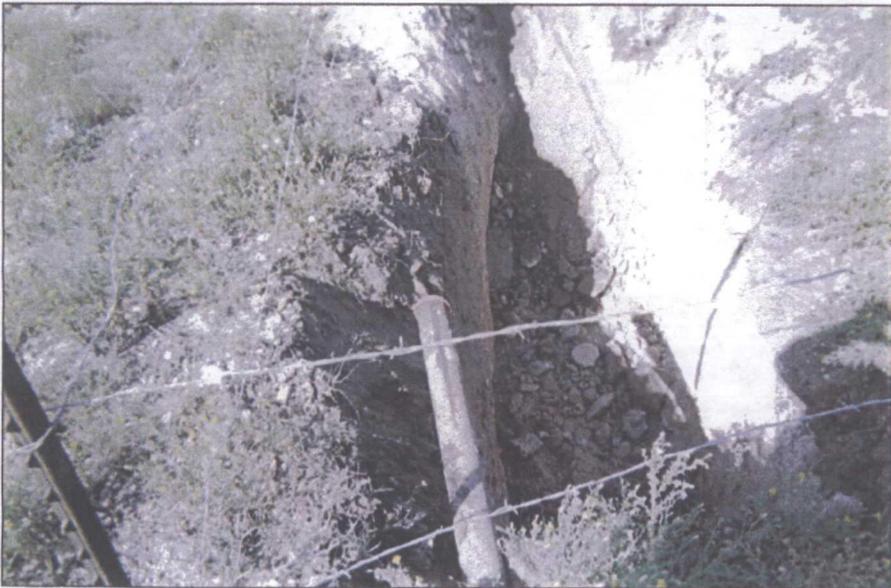
delineation trench at former junction box site 9/13/2005

part of the Vacuum SWD System abandonment. A delineation trench was made at the junction to 6 ft BGS using a backhoe. Soil samples were collected every vertical ft of depth from 2 to 6 ft. Chloride field tests were conducted on these samples and yielded a conclusive trend of decline with depth, indicative of non-saturated vadose conditions. The laboratory analysis of the 6 ft sample confirmed the low concentration of 67.1 ppm, similar to background level. PID screenings performed on the soil samples were all 0.0 ppm and there were no indications of hydrocarbon impact. TPH was not present in detectable concentrations (<10.0 ppm), meeting NMOCD guidelines. The excavated soil was blended on site and then backfilled into the trench. The disturbed surface was seeded with a blend of native vegetation and is expected to return to productive capacity at a normal rate. Because the SWD System is no longer active, a new junction box is not required.

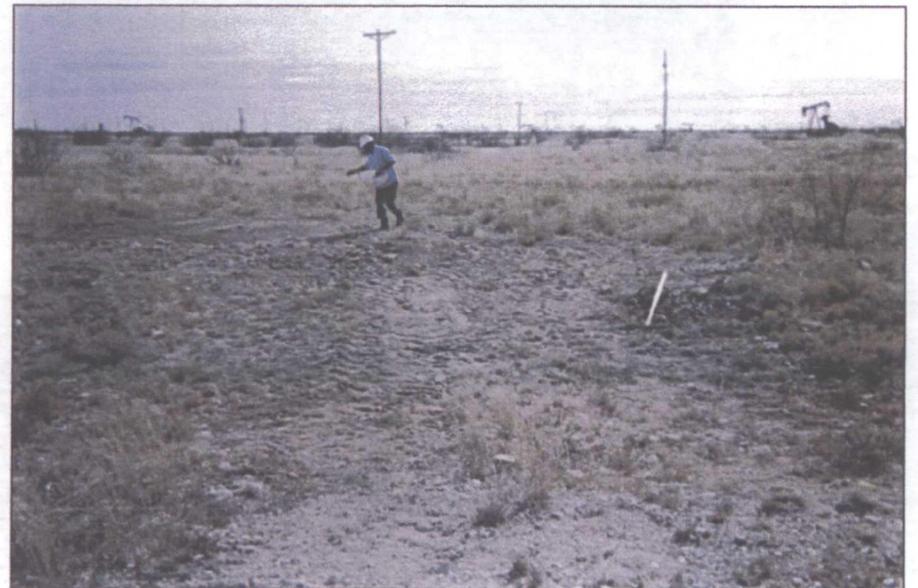
seeding disturbed surface after backfill 11/23/2005
