RE: Soil Closure Request
EME G-11 (1R427-03): UL/G, Sec. 11, T20S, R36E
RICE Operating Company – EME SWD System

EME G-11 (1R427-03)

Unit G, Section 11, T20S, R36E

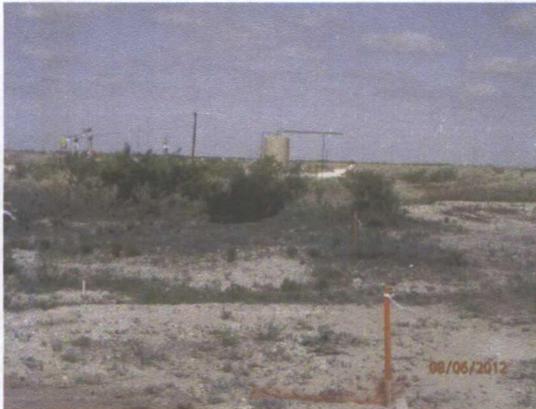
Site prior to excavation, facing west 6/8/2012

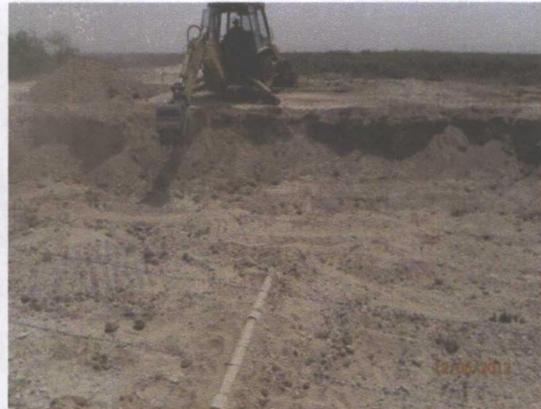
Excavating site, facing east 6/12/2012

Beginning June 8, 2012, the site was excavated to dimensions of 50x50x5 ft deep. Soil was imported and a six inch pad was placed in the bottom of the excavation. A 20-mil, reinforced liner was then properly seated in the bottom of the excavation and padded with an additional 6 inches of blow sand. The excavation was then backfilled with imported soil and contoured to the surrounding area. Field sampling of the backfilled surface area yielded a chloride concentration of 169 mg/kg and a PID reading below 100 ppm. Approximately 456 yards³ of soil were imported to the site, and approximately 832 yards³ of excavated soil were properly disposed of at a NMOCD approved facility. The site was seeded with a blend of native vegetation and a silt net fence was placed around the area to maintain seed integrity.

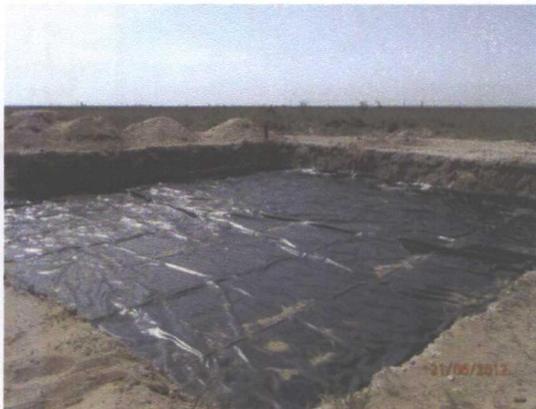
Liner installed, facing southeast 6/21/2012

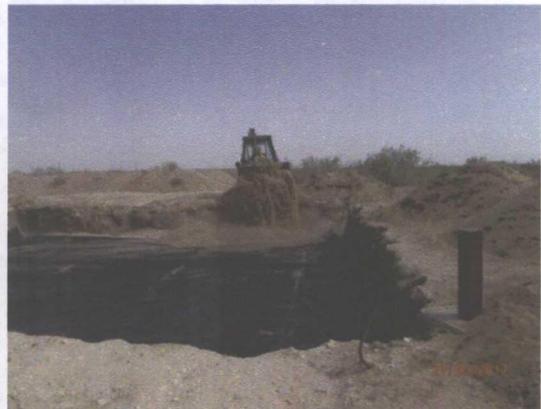
Backfilling site 6/21/2012

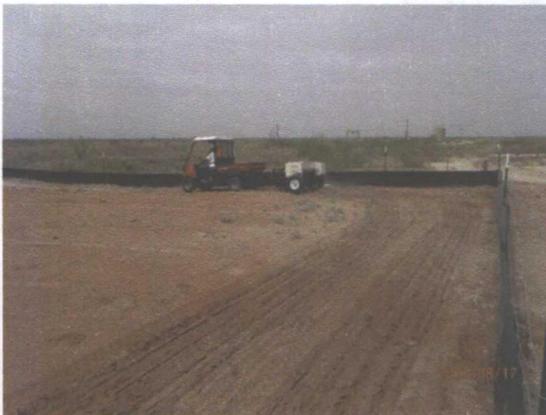
Tilling and seeding site, facing west 8/17/2012

Custom seed mix <input checked="" type="checkbox"/>	Prescribed mix <input type="checkbox"/>	Seed mix name: 4 lbs. Blue Grama and 4 lbs. Side Oats Grama	Seeding date: 8/17/2012
Broadcast <input checked="" type="checkbox"/>			
Method: Mechanical spreader/tiller			
Soil conditions during seeding: Dry <input checked="" type="checkbox"/> Damp <input type="checkbox"/> Wet <input type="checkbox"/>			
Photos attached <input type="checkbox"/>	Observations: Seed was tilled into soil.		
Number of photos:

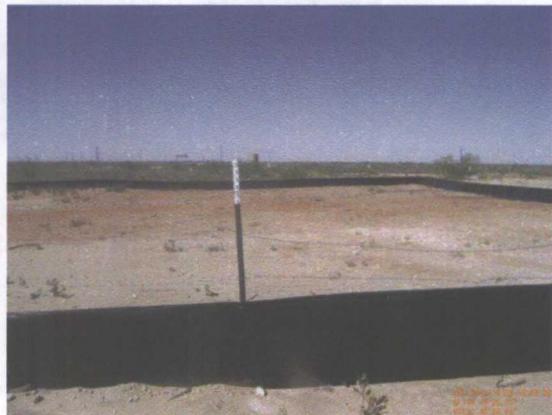
Site complete, facing west 10/3/2012
