Release Notification and Corrective Action

Federal Silver #4

CLOSURE REPORT

RP-3196

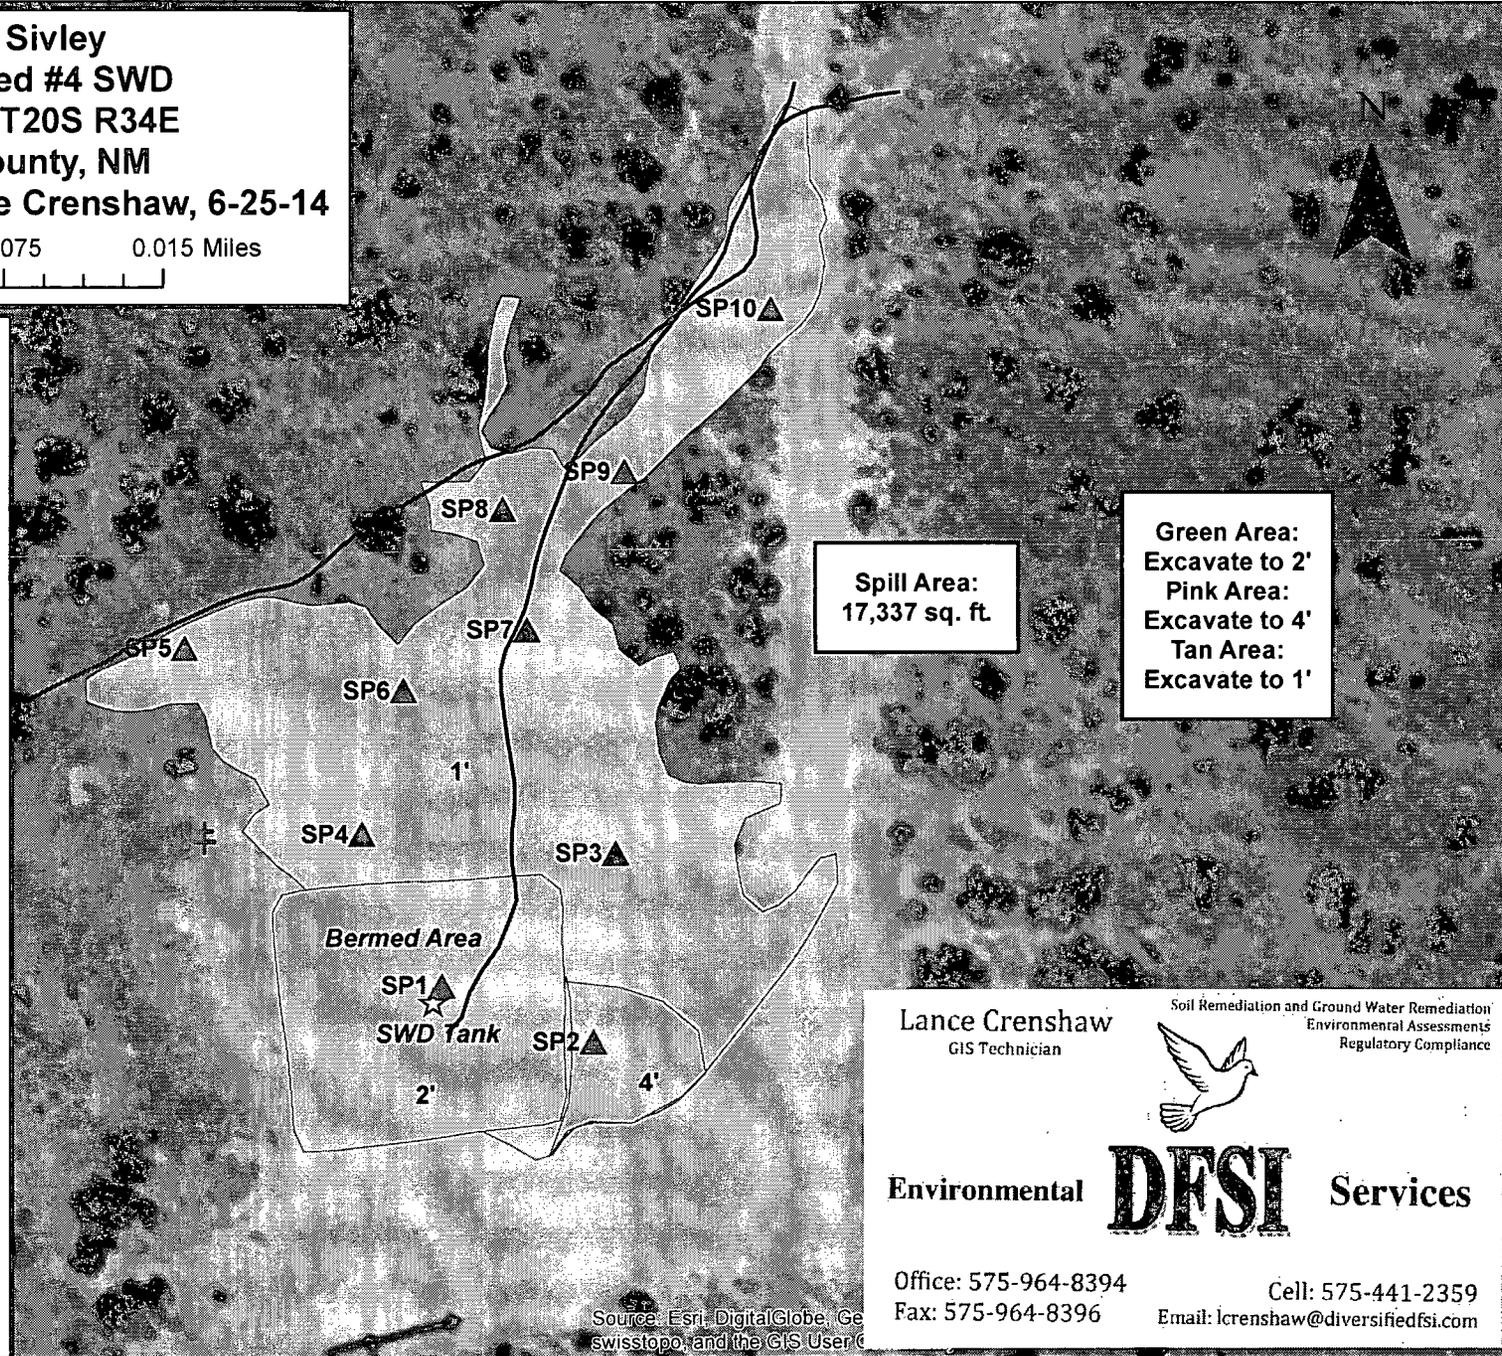
Site Diagram

Spill Area:
17,337 sq. ft.

Green Area:
 Excavate to 2'
Pink Area:
 Excavate to 4'
Tan Area:
 Excavate to 1'

SP1 located inside the bermed area was to be excavated to 2ft. bgs. This area was then lined and backfilled with caliche, battery area and berm were reconstructed. SP2 was excavated to 4 ft. bgs., and lined with a 20 mil. liner. The liner was layered with top soil to prevent impairment, penetration and topped with fresh caliche. All remaining sample points were excavated to 1ft. bgs., and backfilled with fresh topsoil. Likewise with SP3 thru SP10 however, these sample points were located in pasture area, therefore in addition to backfilling was re re-seeded in accordance with BLM guidelines.

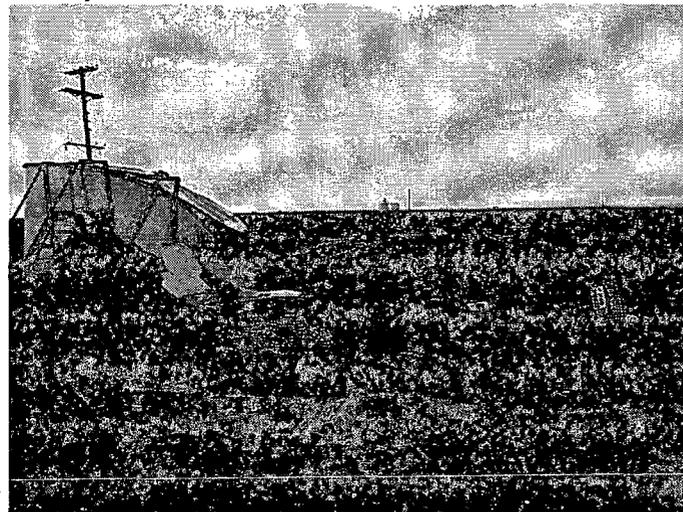
Tank inside bermed area 06/25/14

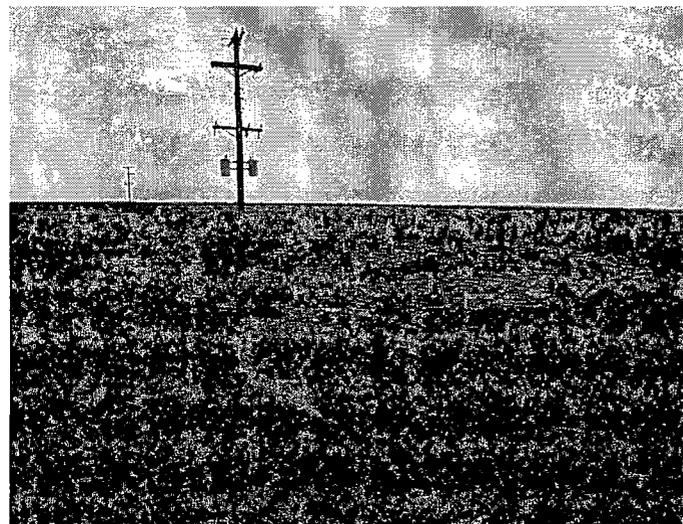
Impacted area NW outside berm 06/25/14

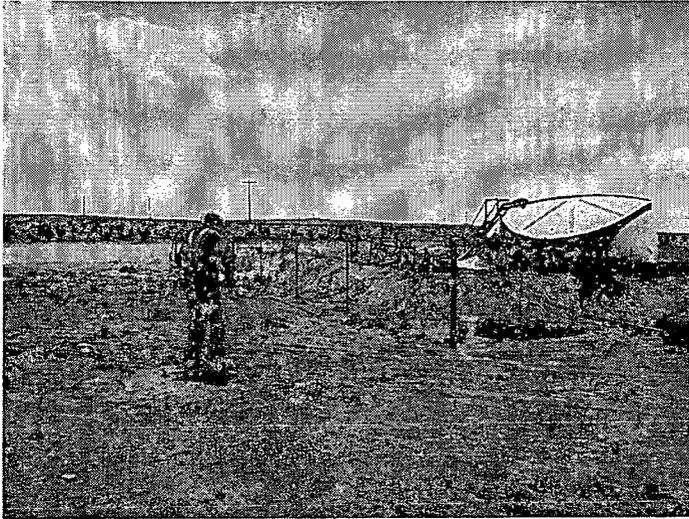
Hand auger- sampling 06/25/14

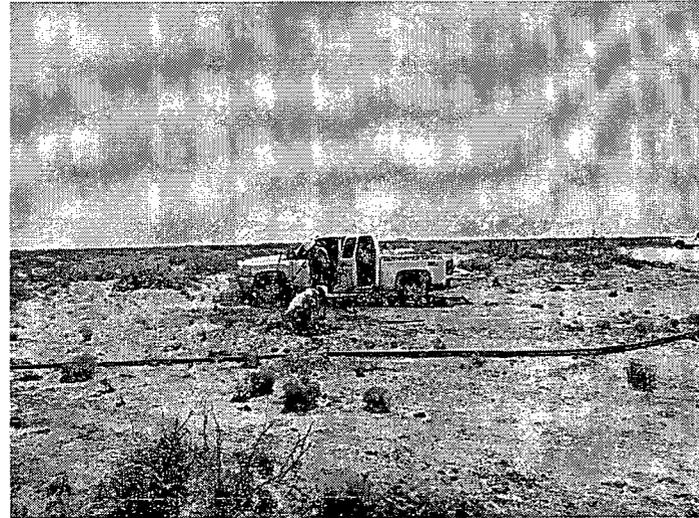
Hand excavation 06/30/14

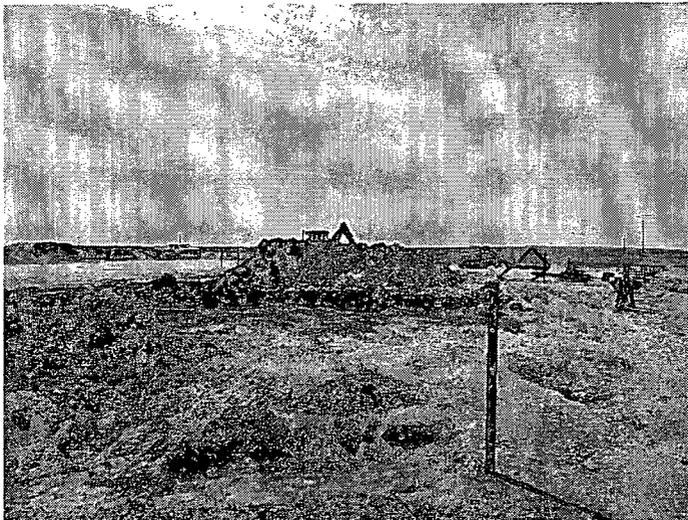
Excavation of impacted area 07/2/14

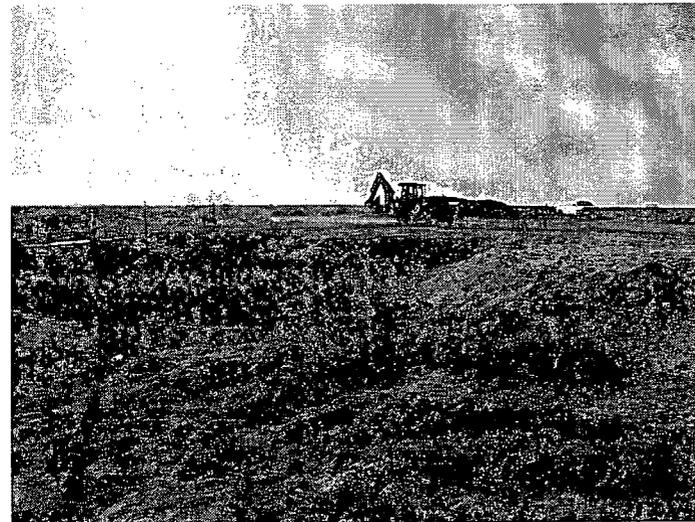
Construction of pad 07/07/14

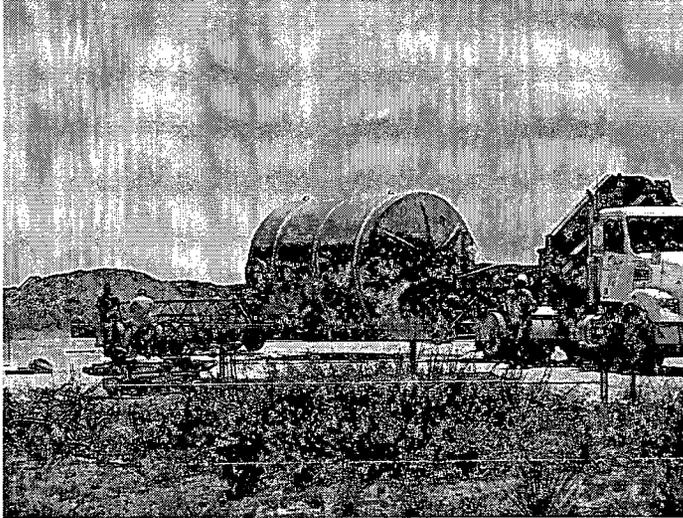
Setting of new tank 07/07/14

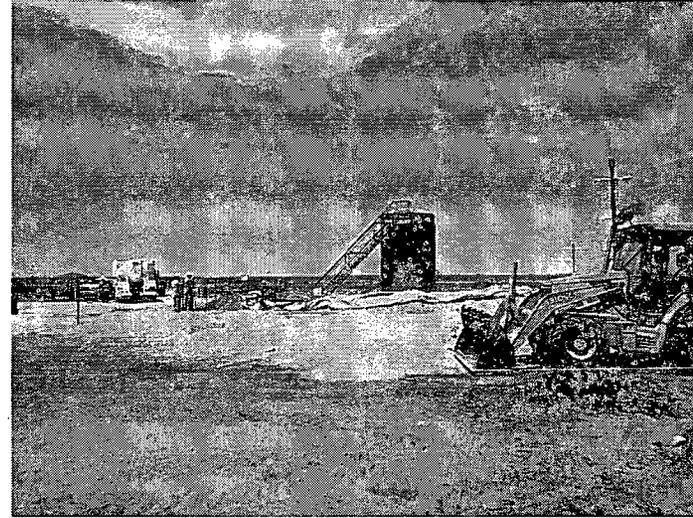
Liner Install – Firewall construction 07/10/14

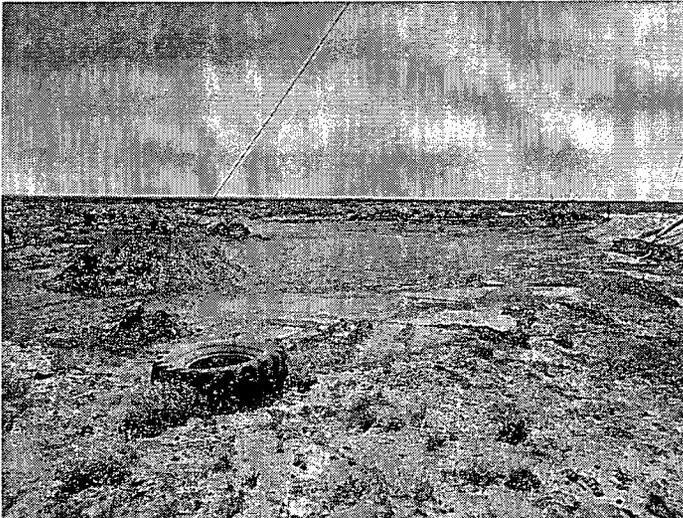
Backfill of pasture 07/10/14

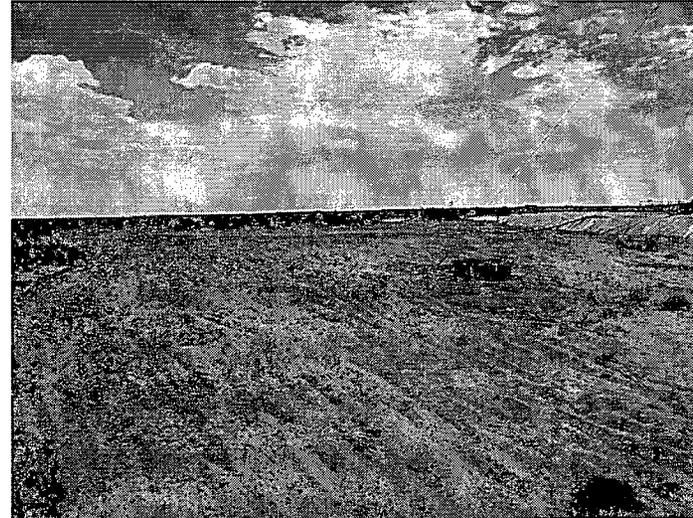
Pasture area at completion of seeding 07/16/14

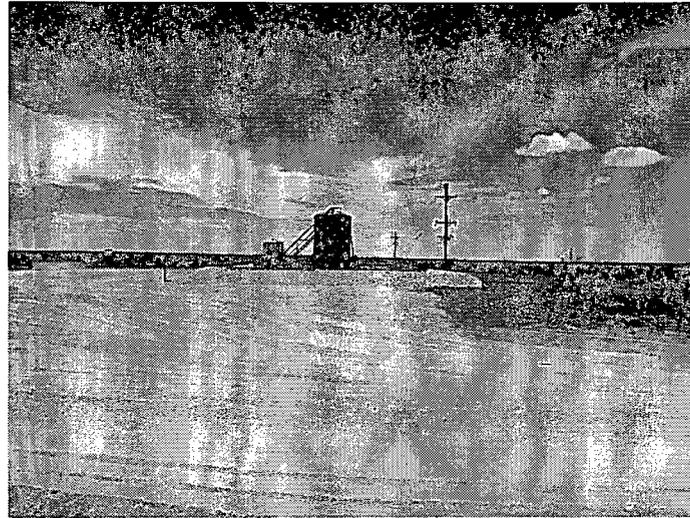
Silver Federal #4 at completion 07/16/14

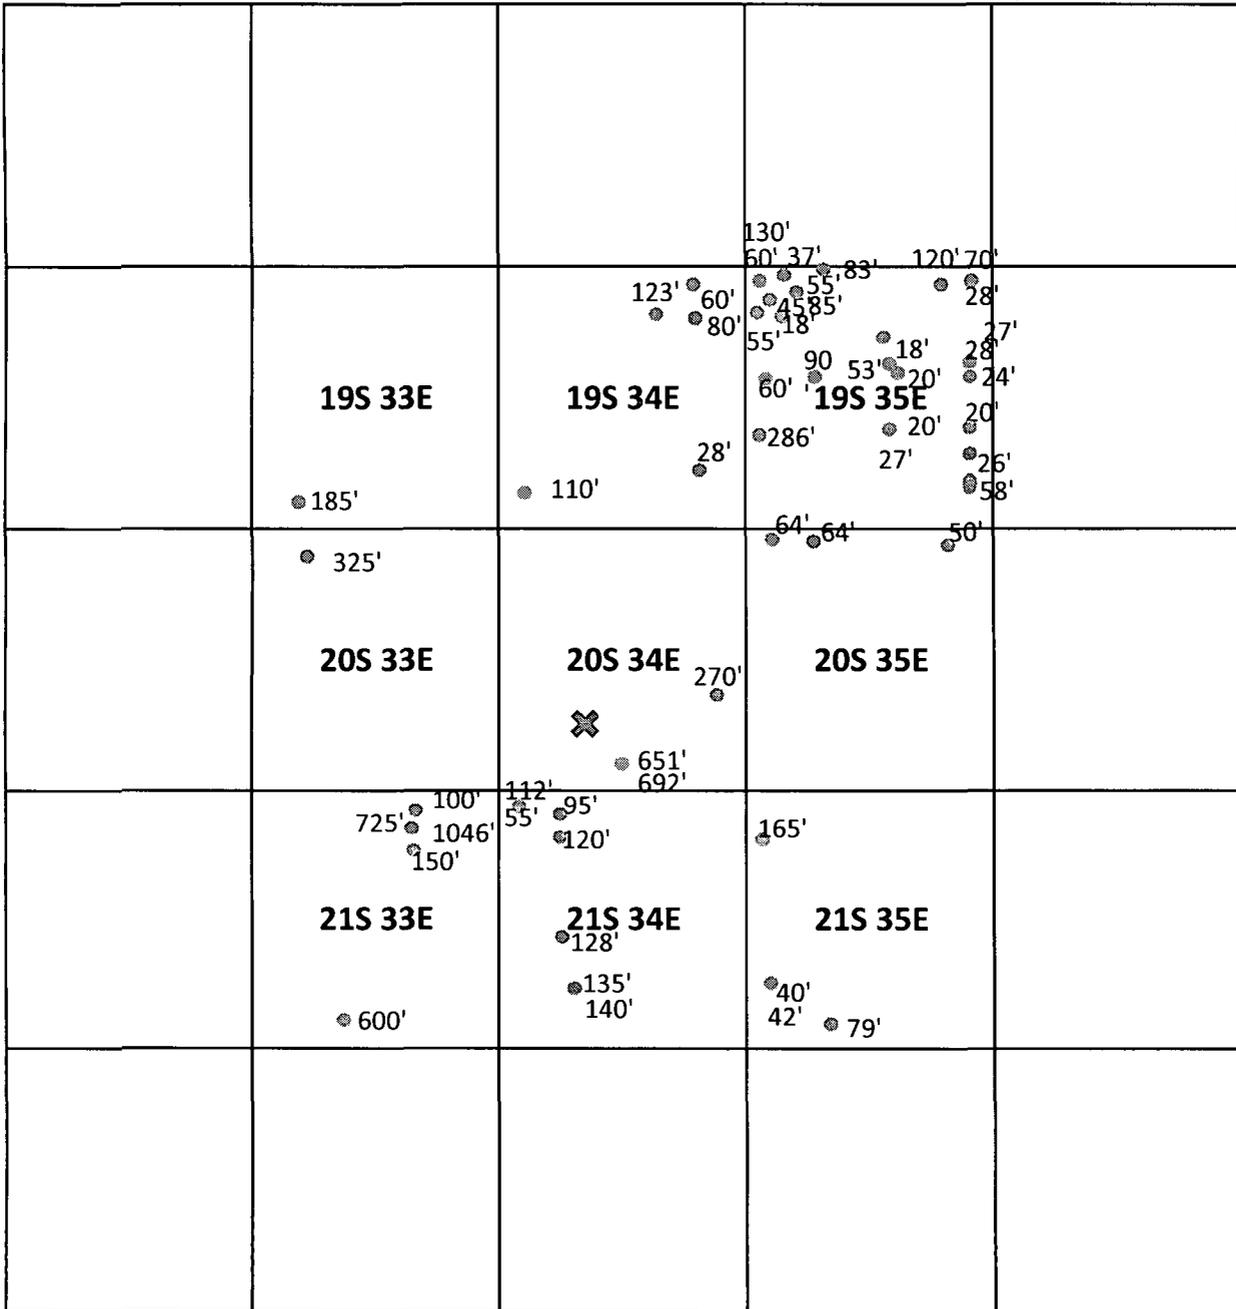
GROUND WATER SEARCH

Groundwater Depth: 537 ft.
