**Release Notification and Corrective Action**

Name of Company: BOPCO, L.P. <i>260737</i>	Contact: Tony Savoie
Address: 522 W. Mermod, Suite 704 Carlsbad, N.M. 88220	Telephone No. 575-887-7329
Facility Name: South Loop 10" SWD Mainline. The spill location was 1,608 ft. east of the PLU-CVX-JV-BS #021H	Facility Type: Exploration and Production

South Loop 10" 9-6-14

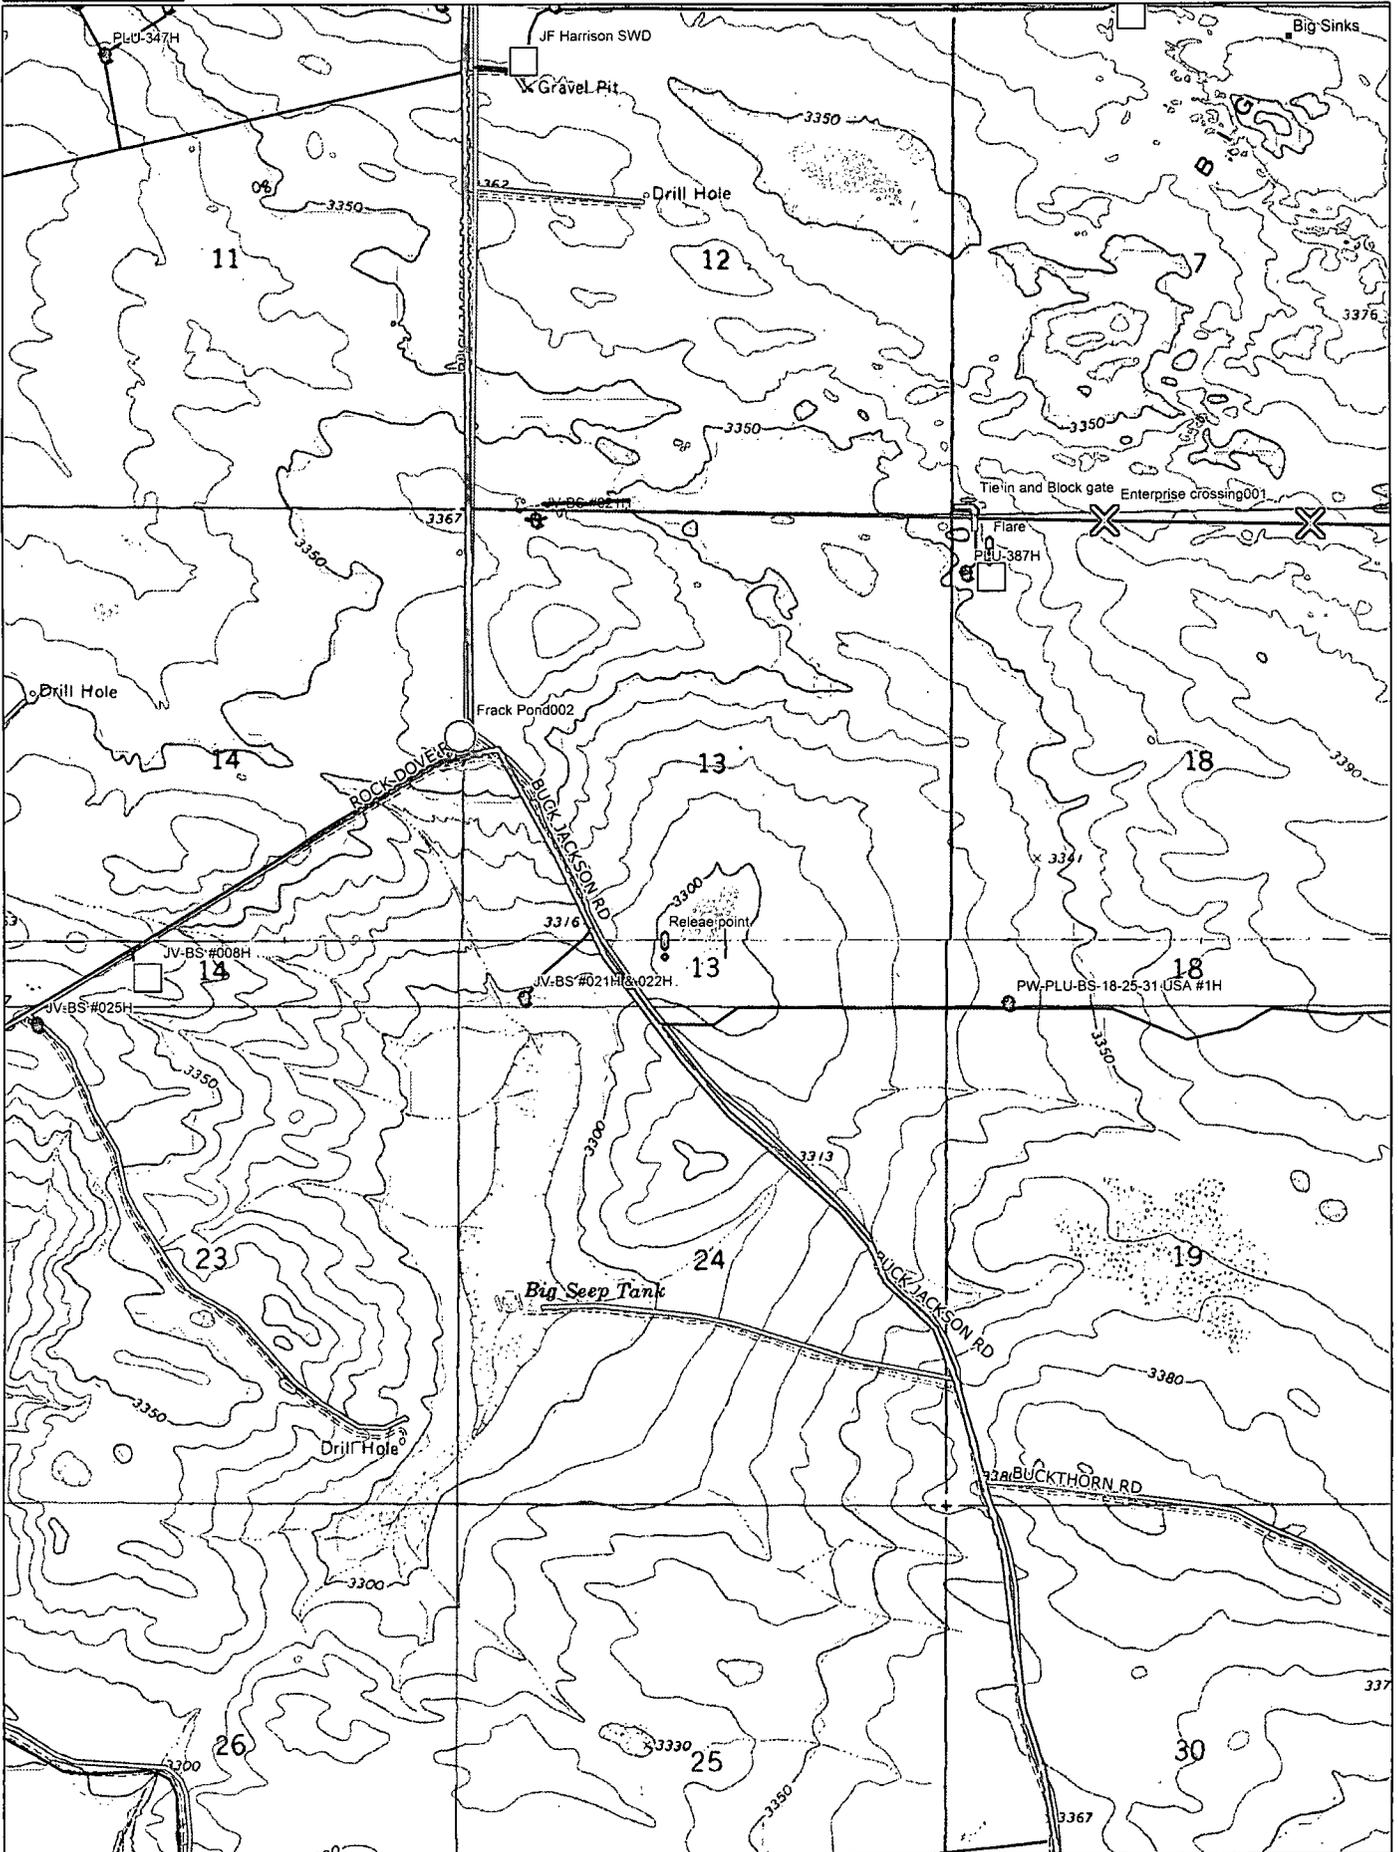
North Block valve

B.S. 008 tie in

South Block valve
