From: Tavarez, Ike [Ike.Tavarez@tetrattech.com]
Sent: Monday, September 13, 2010 2:46 PM
To: Bratcher, Mike, EMNRD; Terry Gregston (terry_gregston@nm.blm.gov)
Cc: Pat Ellis; Joshua Russo
Subject: COG - Sampling Notifications - Schley Federal #11 TB and Electra North TB

COG Operating LLC

Schley Federal #11 (flowline)
Section 23, T17S, R29E
Eddy County, New Mexico

From: Terry_Gregston@blm.gov
Sent: Thursday, September 16, 2010 4:52 PM
To: Joshua Russo
Cc: Tavarez, Ike; james_amos@nm.blm.gov; Bratcher, Mike, EMNRD; Pat Ellis
Subject: Re: C-141 - Schley Federal #11 Flowline
Attachments: Schley Federal 11 flowline spill map-082810.jpg

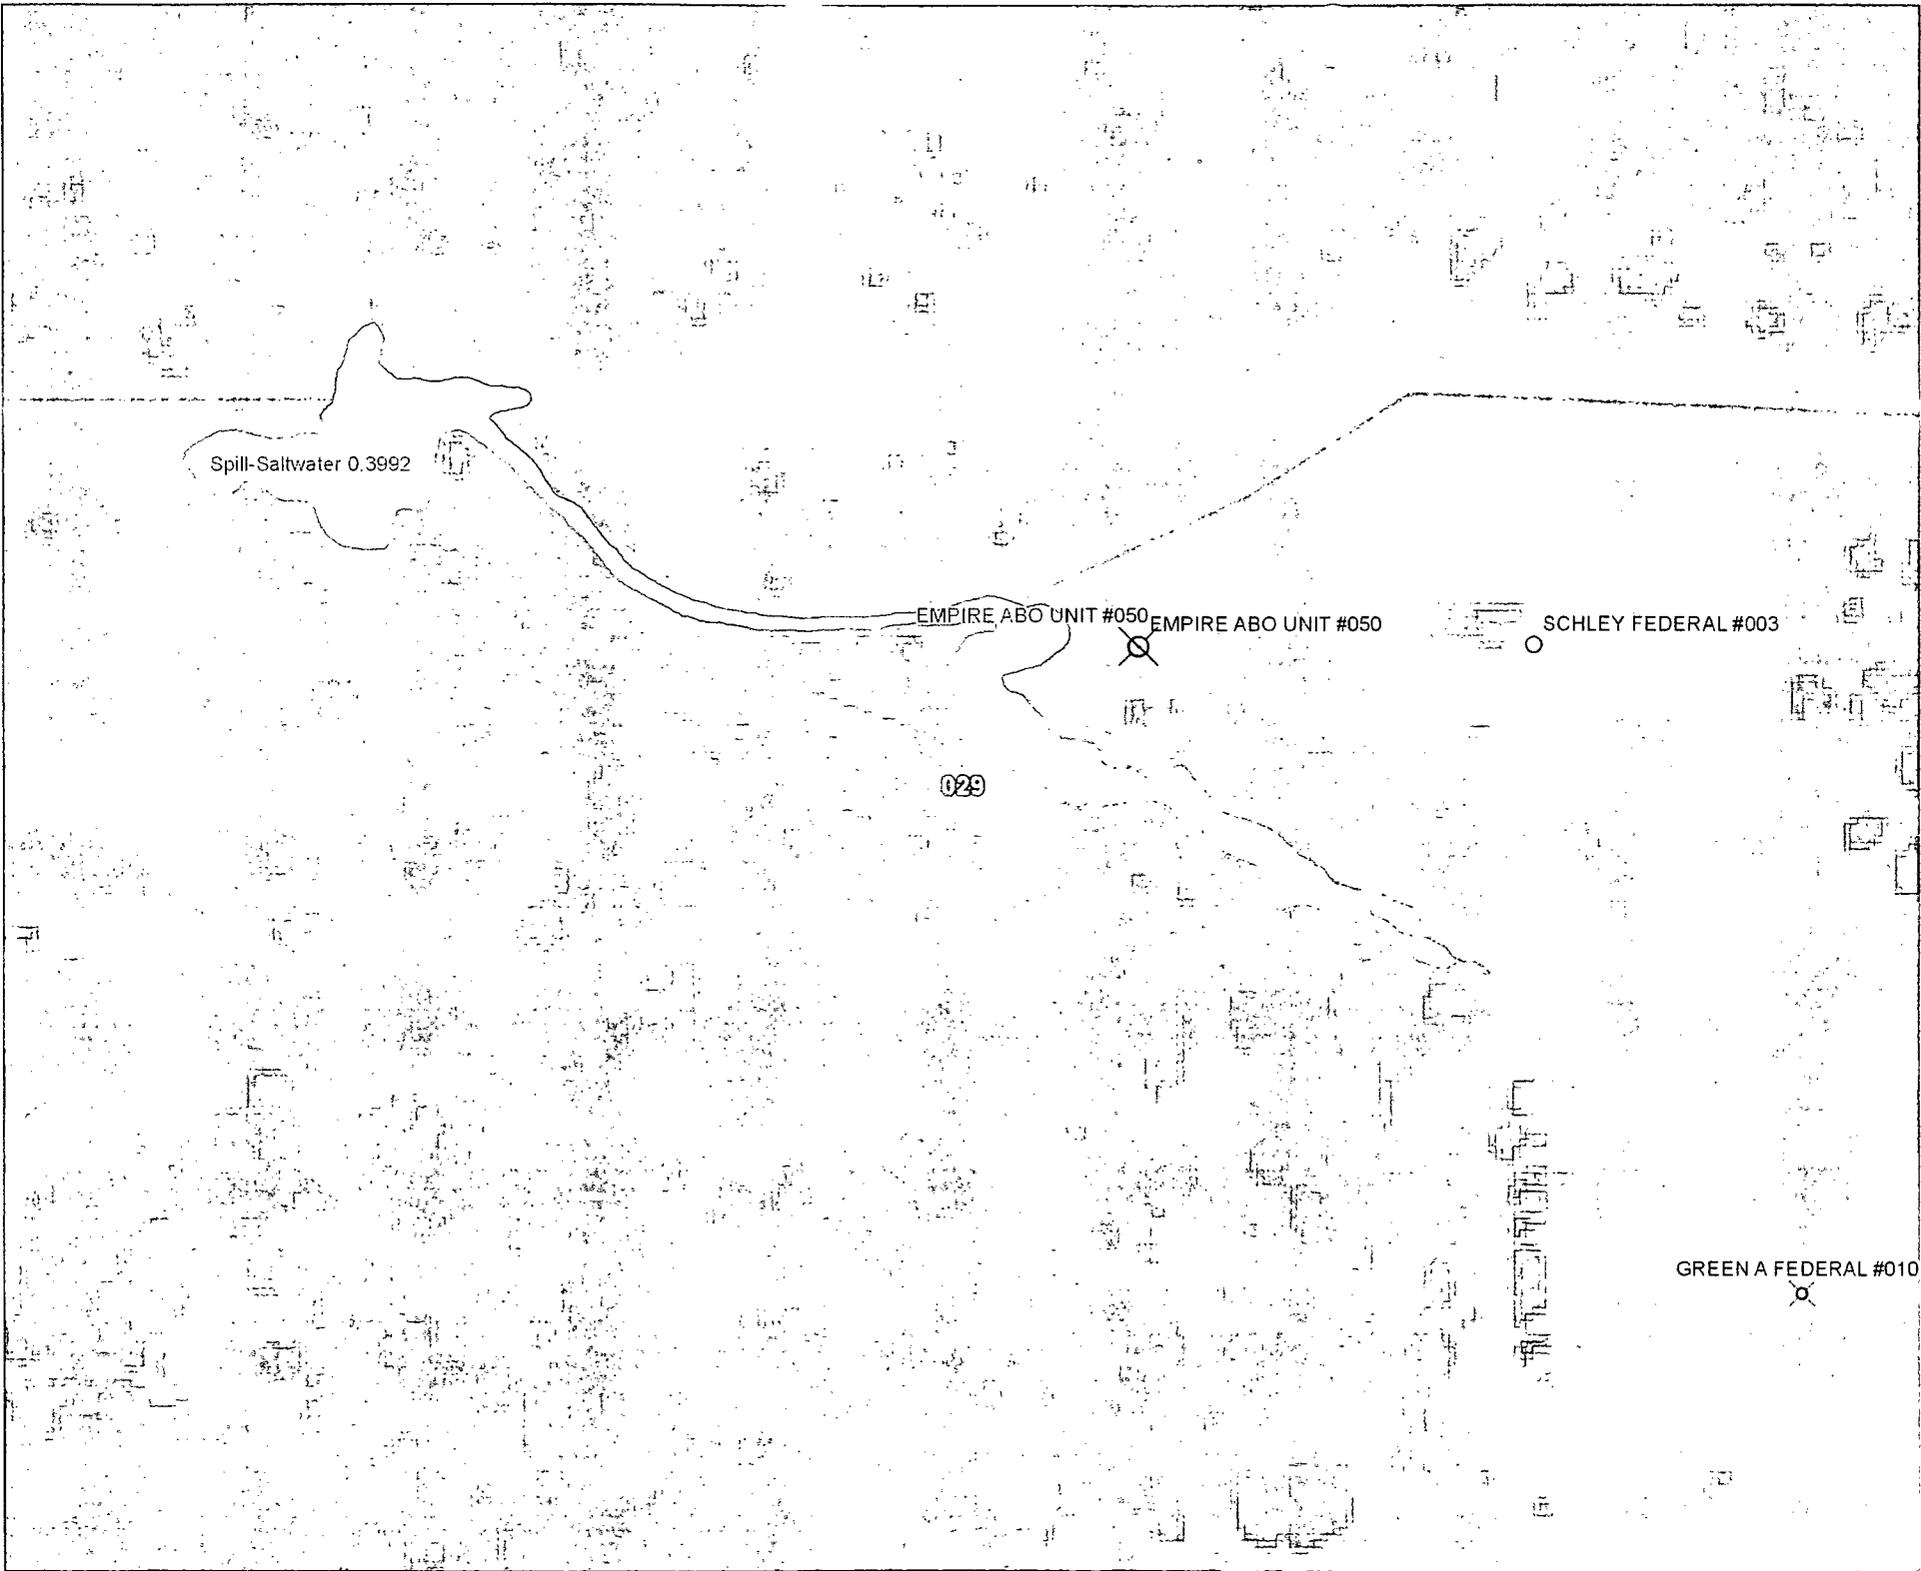
I inspected the Schley Federal 11 flowline spill yesterday and mapped the visible salts from the spill point downslope. The spill is larger than indicated on your spill report. Fluids ran down the road to the Empire Abo Unit 50, then followed drainage off the western edge of that pad to the south, then southeast. I tracked the spill/salts down to an older spill in the flowline corridor about 200 feet northwest of the Green A Federal 10 SWD unit. At this point, it appeared that your spill overran and/or comingled with an older spill. I do not know whose flowline the older spill belongs to.

I am attaching a spill map of the spill as I GPS'd it yesterday.

Spill-Saltwater 0.3992

All of the spill path area is covered by pre-existing archeological surveys, so it is okay to proceed with cleanup. However, the older spill complicates things somewhat.
