# Americo Energy LLC

## Site Remediation Summary

East Shugart # 75

Eddy County New Mexico

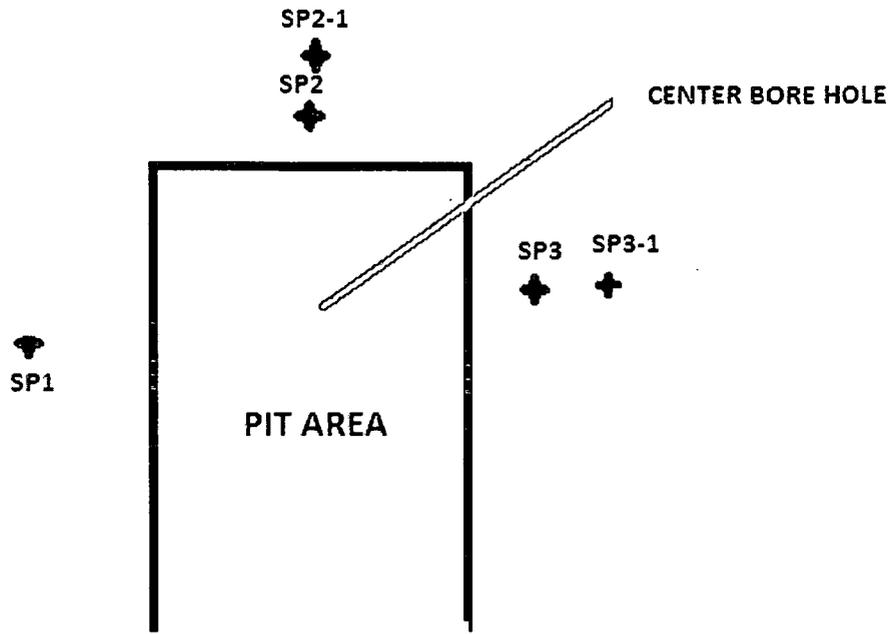
EAST SHUGART #75

This report addresses the remediation of the East Shugart # 75. This site is a work over pit (20' X 60' X 8') which had been left open at some point in the past. As a result, the release from the injection well ran off and settled in the bottom of this existing pit.

The location was delineated and a work plan submitted/approved by OCD and BLM (land owners). The site had all visual contaminants removed down to a level of 11 feet. The sides were then widened and excavated down four feet and outward 15 feet. This was done to assure the removal of all chlorides from the top soil before returning soil to the location. The pit was then lined with a 20 mil poly liner with the edges key locked for security. Soil was then replaced up to a level of four feet. Then top soil was used to finish off the top four feet. The site was then contoured and seeded with BLM approved seed.
