**PERMIT
/
REGISTRATION**

**WPX Section 30 Recycling
Facility and Containment
Date: 2015**

C-147 Registration Package for Section 30 Recycling Containment Section 30, T31N, R5W, Rio Arriba County

Siting Criteria (19.15.17.10 NMAC) WPX - Section 30 Recycling Containment

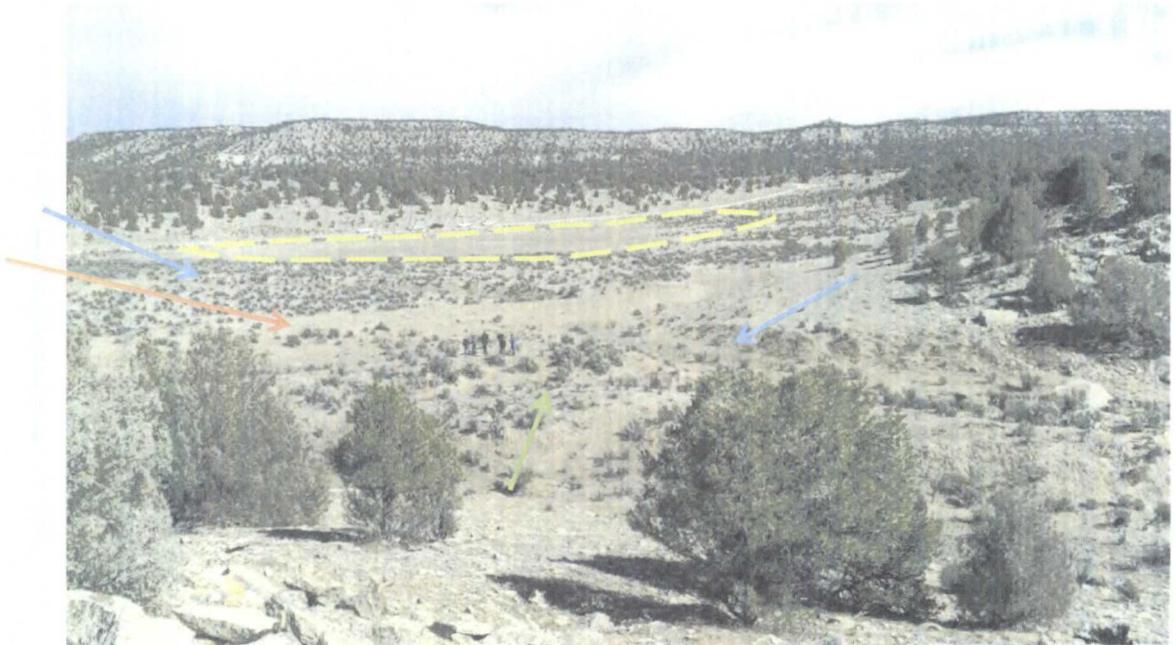
View northeast of proposed site showing people standing in abandoned stock tank/pond, the abandoned dam (red arrow) and abandoned stream channel (blue arrows, the active arroyo)(green arrow) and general location of proposed produced water recycling containment (yellow dashed area)

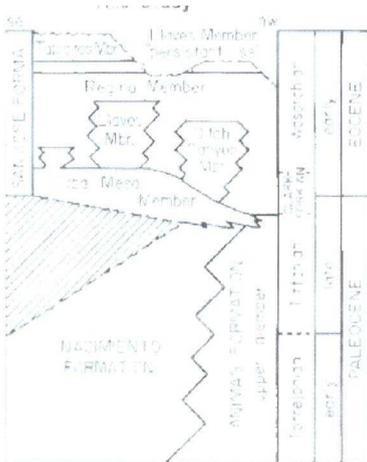
intertongue with the Regina Member of the San Jose Formation. A laterally-persistent sheet sandstone characterizes the upper portion of the Llaves Member and we believe the exposed sandstone of the hills around the containment area is this same unit. The Tapicitos Member is composed of red mudrock and pink sandstone and overlies the Llaves and/or Regina

Members as shown in the schematic cross-section from this same publication. Thus, in the area of the containment, the Tapicitos Member has been removed by erosion, as suggested in the NW side of schematic cross section.

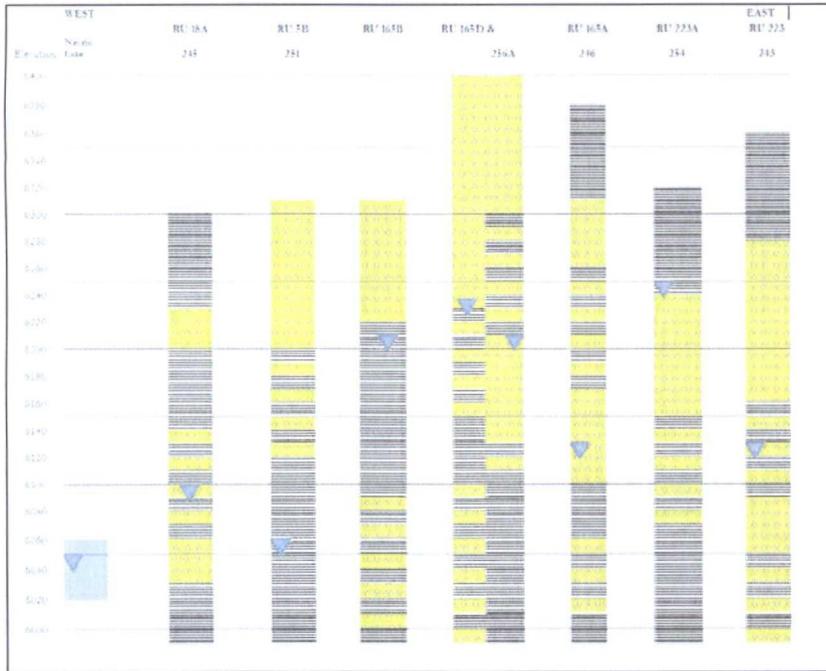
Explanation of Figure

The Rosa Unit well names and the corresponding Miscellaneous well names on Figure 1 are presented at the top of the figure.

Miscellaneous wells 243 and 254 are depicted on the cross section above. We conclude that the shallowest groundwater encountered by the driller in Misc-254 is a localized groundwater zone that is perched above a regional water table. Perhaps the uppermost sandstone observed in Misc-246 (elevation 6260-6310) is hydraulically connected to the uppermost sandstone in well Misc-254 (top sandstone elevation 6250). It is possible that this sandstone hydro-stratigraphic unit receives some recharge from the drainage system that lies between Misc-246 and Misc-254 at an elevation of 6310 or from Laguna Seca Draw to the north. This recharge could be sufficient to cause the driller to observe groundwater in this cathodic protection well at the elevation of 6242. This groundwater zone is not observed in Misc-243 or Misc-247, but is observed in Misc-256. As shown in the table below, the first groundwater is encountered more than 100 feet below land surface in 18 of 21 cathodic protection wells.

While one or more localized and relatively shallow groundwater zones are observed in the area at depths of 60-80 feet from ground surface, the preponderance of data allow a conclusion that the distance between the uppermost groundwater zone and the bottom of the proposed containment will be greater than 100 feet.

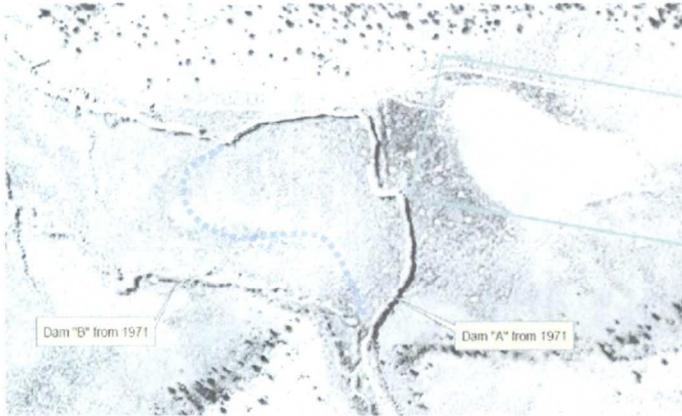
4. Figure 3e is a 1950 aerial photograph showing the nature of the drainage prior to construction of Dam A and Dam B. This photograph, an enlargement of which is presented below, shows the following features:

- The “blue line” arroyo is the active arroyo and the “straight line” flow path with a right-angle bend of this arroyo is dissimilar to the other nearby, more sinuous arroyos
- The presence of the current “active” arroyo that flows west-north west from the mouth of the

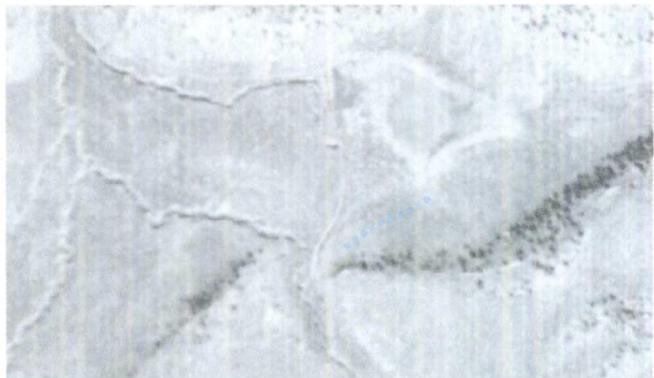
- a) What appears to be a water feature within the footprint of the Containment
- b) The channel that is active today is clearly present and well developed
- c) The “blue line arroyo” feature is relatively straight and cannot be traced north of an east-west shadow, which is a small excavation or earth pile. No evidence of a watercourse exists north of this east-west shadow.
- d) Two north-south scars (excavation tracks?) exist north of the east-west shadow

- e) A spillway appears to exist between the blue line arroyo and this water feature (north of blue dashed line)
 - f) The white/reflective “rind” that creates a border of the water feature is truncated by dark earth in the northwest quadrant of the water feature
 - g) Downhill from this dark earth truncation of the white rind of the water feature, the blue line arroyo is obvious
6. WPX (and BLM) proposes to stockpile the clean earth material excavated from the Containment over the blue-line “arroyo” from adjacent to the existing road uphill to the abandoned stock pond/dam area (see Appendix B). This stockpile will not lie within 100 feet of the active “significant watercourse”.

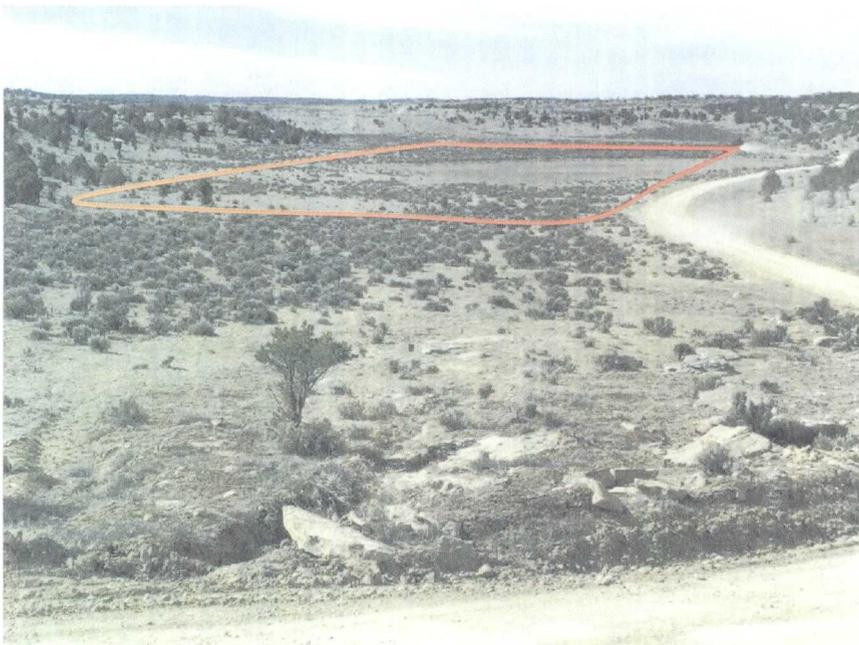
Figure 1 – Looking west to proposed location of Section 30 MWFM pit. Area of proposed pit is roughly outlined in red.

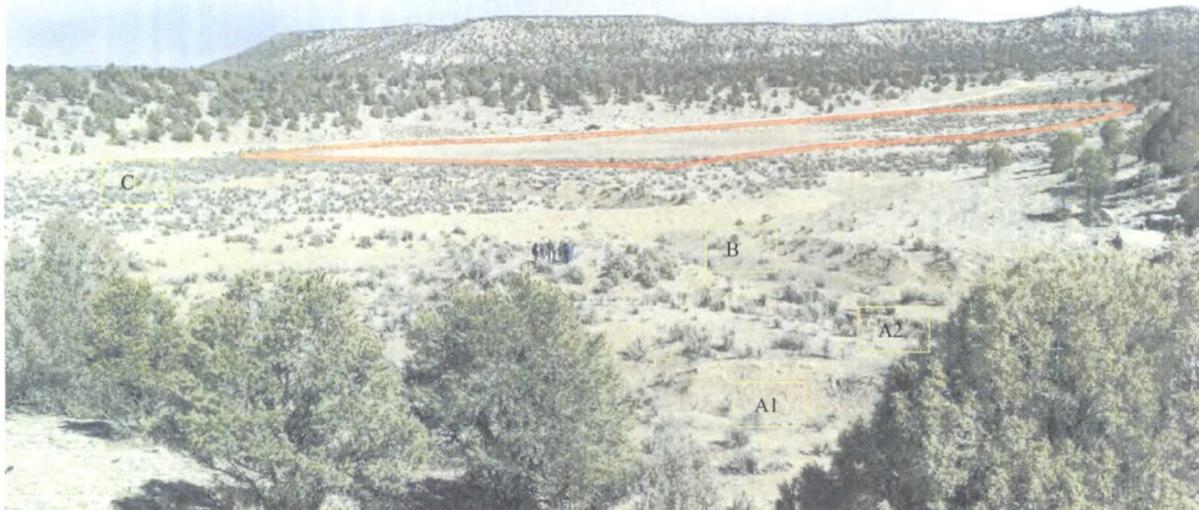
Figure 2 – View to northeast of Section 30 MWFM Pit location (roughly outlined in red). Note the following features: two incised channels of arroyo flowing north into frame (A1 and A2), abandoned stock tank dam and water holding area (B), abandoned incised arroyo downhill from dam and west of proposed pit (C)

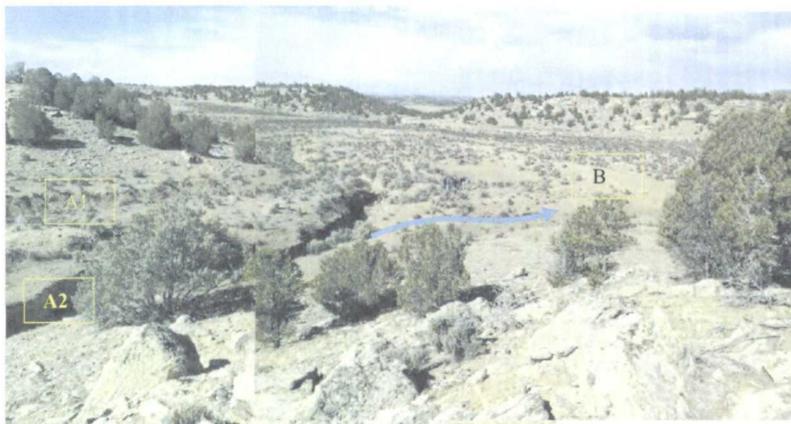
Figure 3 – Photo-mosaic looking northwest showing: two incised channels of active arroyo (A1 and A2), abandoned stock tank dam (B), abandoned arroyo channel upstream from stock tank and dam (arrow). Section 30 MWFM Pit is northwest of photograph, outside of frame to the right.

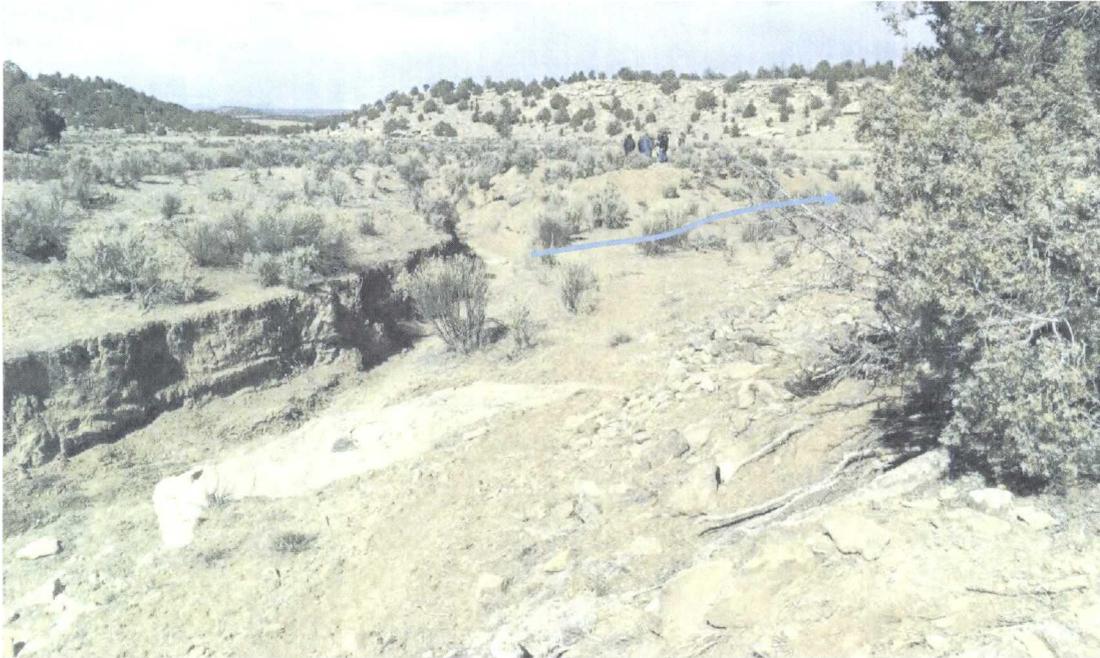
Figure 4: View to northwest showing eastern channel of active incised arroyo, in-place sandstone bedrock and abandoned channel to former stock tank and dam (arrow)

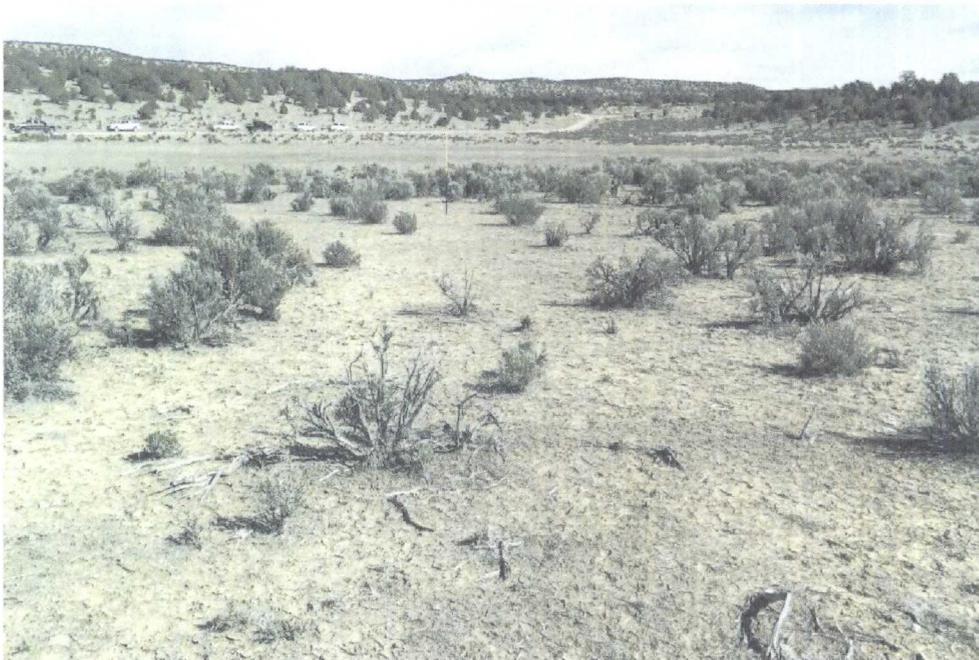
Figure 5 – View northeast showing staked location of southwest extent of proposed Section 30 MWFM Pit. Photo is taken near edge of abandoned incised arroyo.

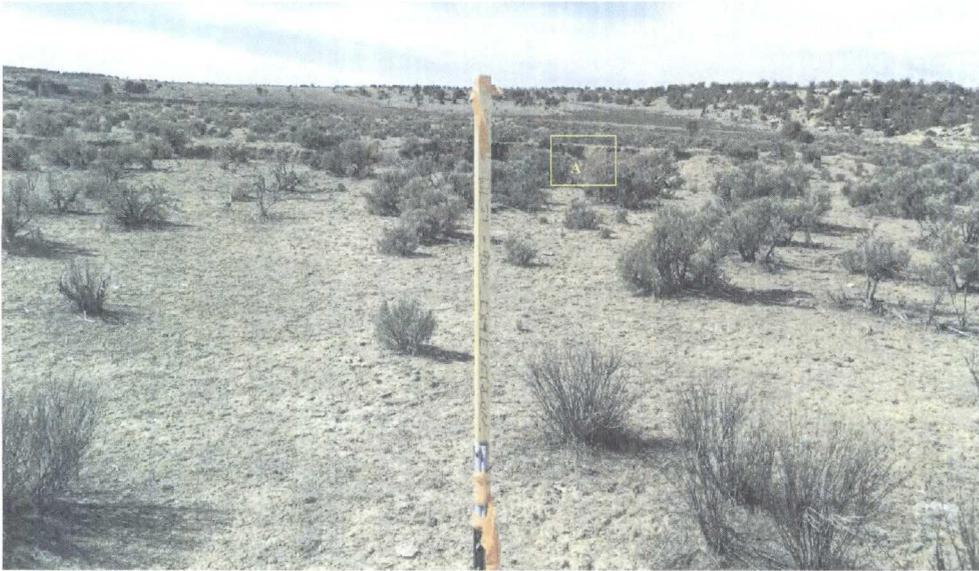
Figure 6 – View from stake of southwest extent of Section 30 MWFM pit location with abandoned incised arroyo in background (A)

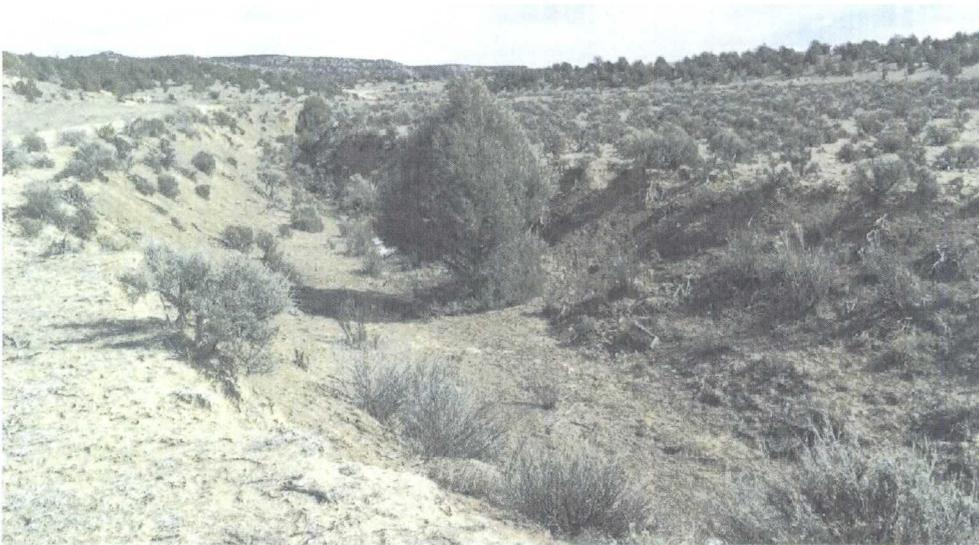
Figure 7 – View east showing nature of abandoned incised channel downhill from Section 30 MWFM pit location. Note the lack of a defined bed and bank in this former drainage with no evidence of recent water flow.

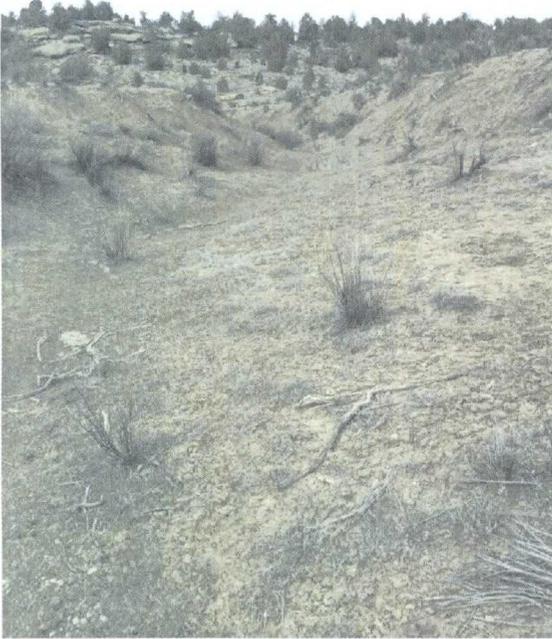
Figure 8 – View south from within blue-line arroyo showing no evidence of bed, bank or visible evidence of occasional water flow.

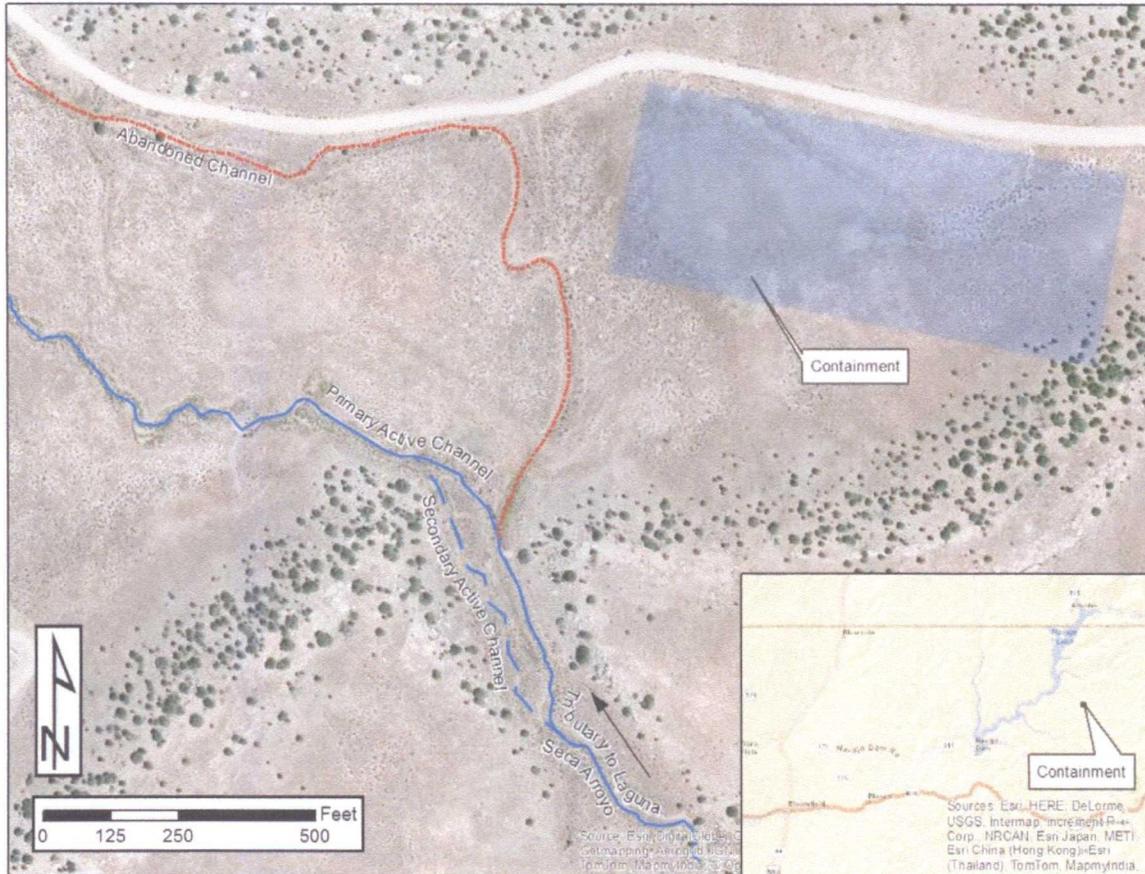
Figure 1

I have investigated the on-going construction at the site, as well as completing a pedestrian survey (August 4, 2015) of the tributary arroyo to Laguna Seca Draw. This tributary arroyo runs generally southeast to northwest across the northern half of section 30, and is at its closest, 400 feet southwest of the Containment site. A portion of the tributary arroyo is paralleled by a secondary active channel to the west for approximately 530 feet. An abandoned channel, now filled in, is north of the primary active channel; these features all as shown on Figure 1.

During the site visit on August 4th, I directed the acquisition of detailed survey data for the tributary arroyo. This survey data included profiles of the primary and secondary active channels, and cross sections through both channels adjacent to the WPX Containment site. Cross sections were extended over to the Containment site for four cross sections. This detailed survey supplements the USGS topography I used to evaluate the contributing watershed.

Given the relatively small contributing watershed, and the existing rangeland conditions, it is my professional opinion that the capacity of the existing primary active channel well exceeds the peak flowrates in the tributary arroyo resulting from the 100-year 6 hour (2.26 inches) and 100-year 24 hour (2.86 inches) precipitation events in the tributary arroyo watershed. Flooding potential of the Containment site from overtopping the primary active channel and secondary active channel is not a risk associated with the 100-year event. Furthermore, even if the primary active channel did overtop to the north, the flow would be spread out over the entire valley floor, resulting in very low depth and velocity. The dominate down-valley slope to the west would direct these sheet flows away from the Containment site.

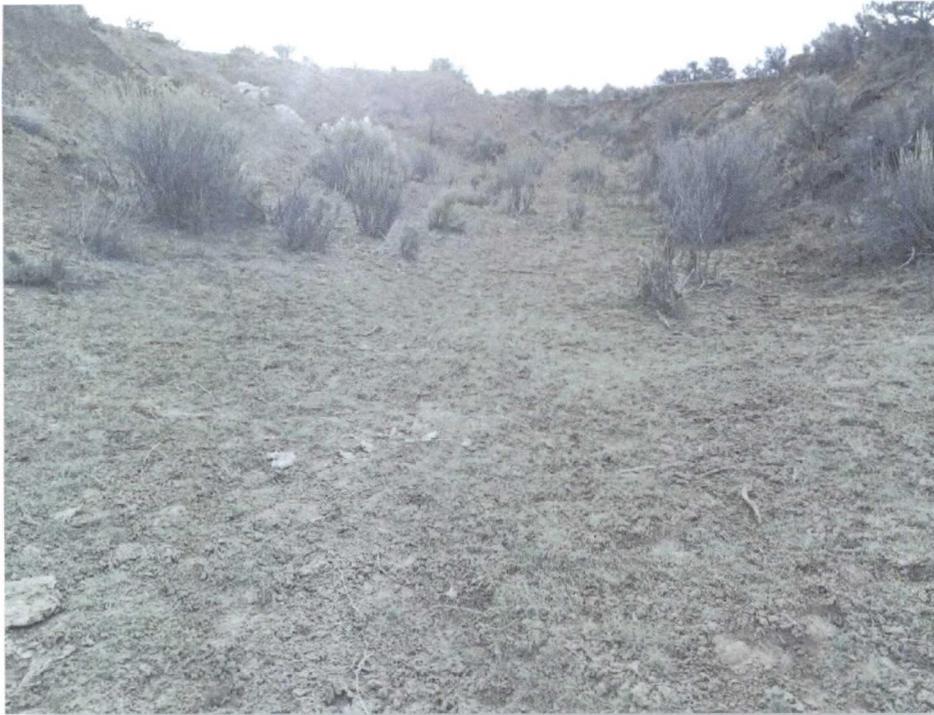
Figure 9. Photo taken from Point A, looking up-gradient towards the abandoned drainage showing no OHWM

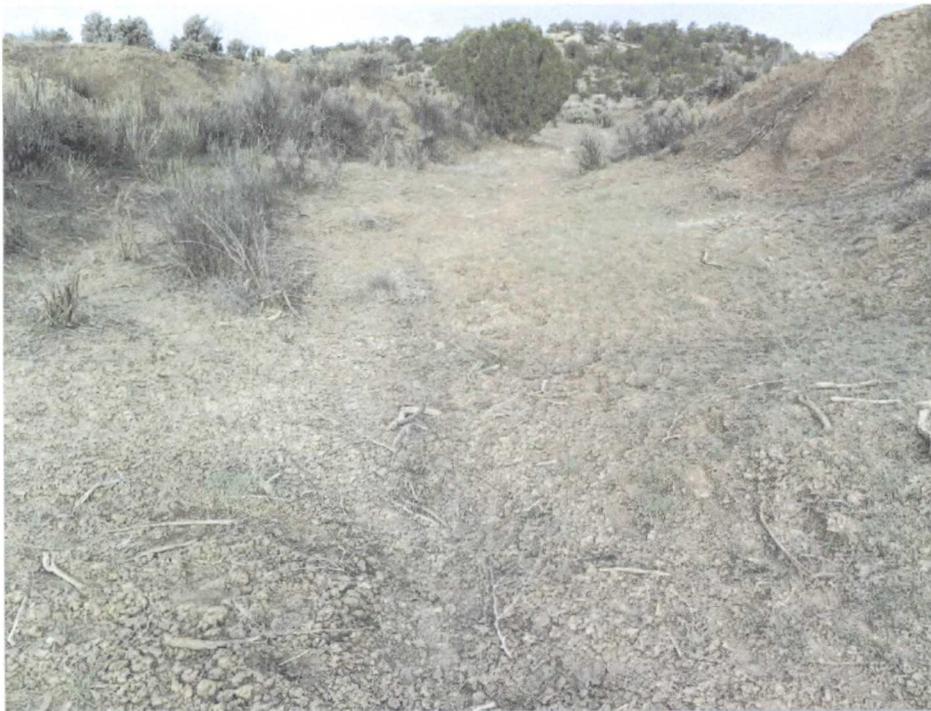
Figure 10. Photo taken from Point A, looking down-gradient towards area exhibiting indicators of ponding and an OHWM

- Figures 10, 11, & 12 illustrate the indicators of an OHWM from water backing up and ponding in the abandoned drainage.
- Indicators of OHWM down-gradient of Point A include: dessication/mud cracks, reduction in presence of vegetation compared to areas up-gradient of Point A, and presence of debris collected during ponding.

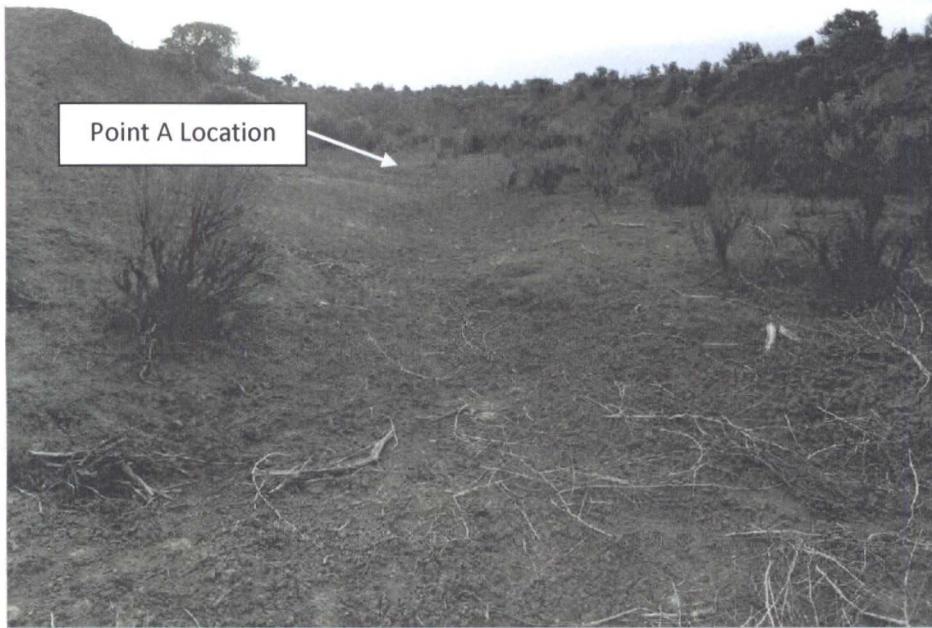
Figure 11. Photo taken down-gradient of Point A, looking towards Point A

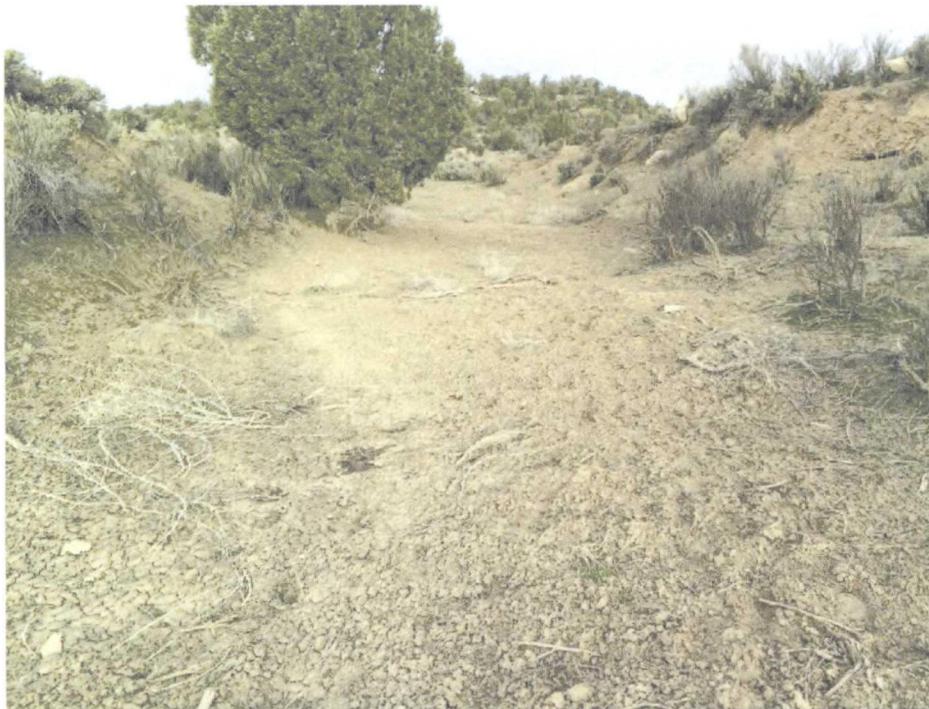
Figure 12. Pondered area down-gradient of Point A, looking towards connection point with active drainage

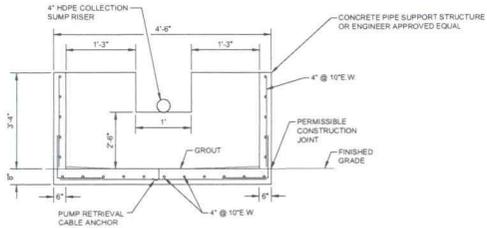
LEAK DETECTION SYSTEM PUMP ACCESS STRUCTURE SECTION
Scale: N.T.S. **A**

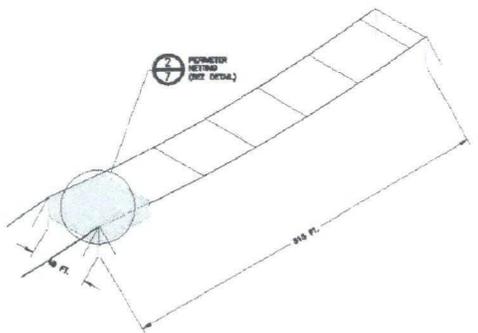
1 WOOD POLE LOCATION AND NETTING PLACEMENT PARTIAL VIEW
N.T.A.

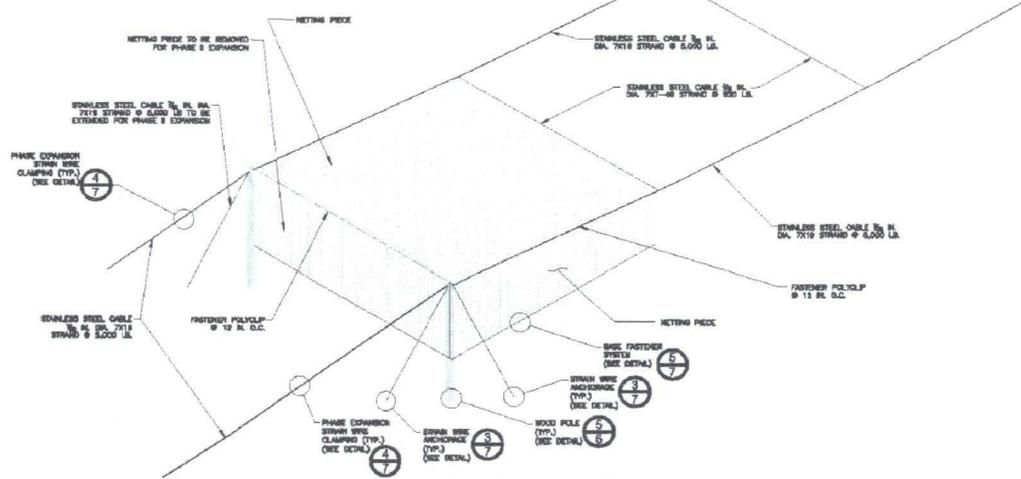
2 PERIMETER NETTING PLACEMENT DETAIL
N.T.A.

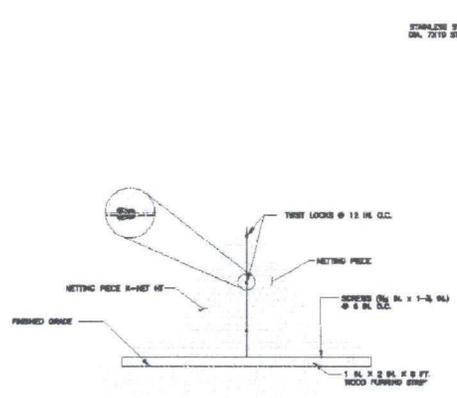
4 STRAIN WIRE CLAMPING DETAIL FOR PHASE II EXPANSION
N.T.A.
