Flood AFN Federal #1  
 Section 30, T19S-R32E  
 Lea County, NM

SITE SAMPLE DIAGRAM  
 (Not to Scale)  
 Prepared by Robert Asher  
 Environmental Regulatory Agent  
 September 5, 2008

# **Analytical Report 311386**

**Flood AFN Federal # 1**

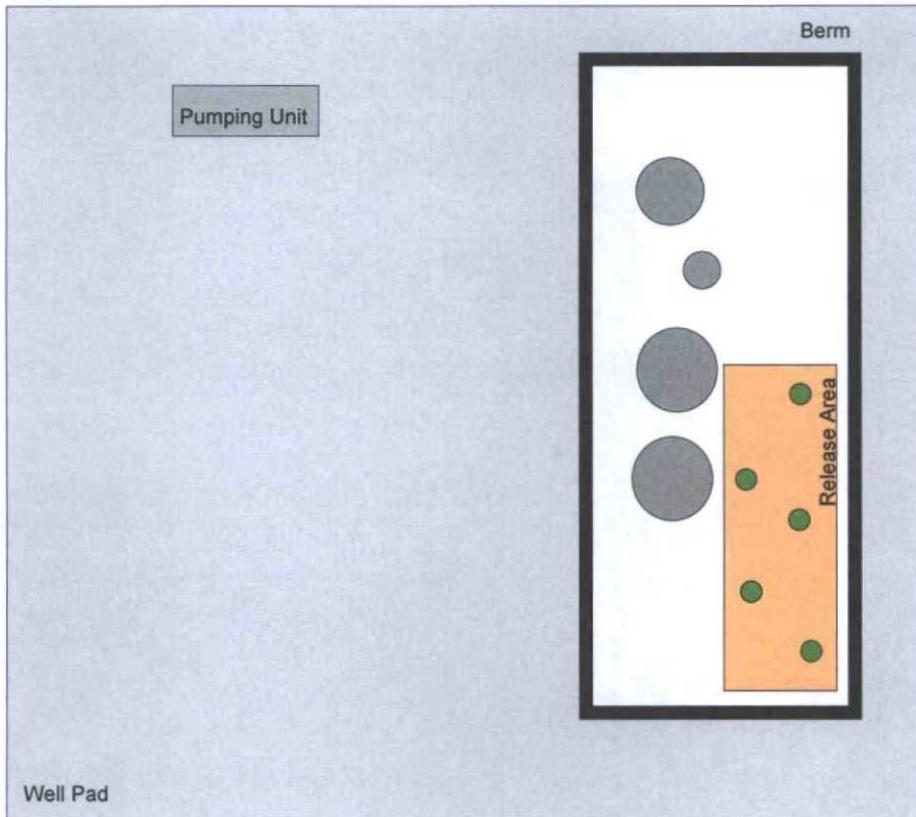
Sample ID	Sample Date	Sample Type	Depth	BTEX	GRO	DRO	TPH TOTAL
GS/Comp-001	8/25/2008	Grab/Auger	1'	0.4689	ND	128.0	128.0
GS/Comp-002	8/25/2008	Grab/Auger	2'	1.069	31.2	405.0	436.2
GS/Comp-003	8/25/2008	Grab/Auger	3'	0.0191	ND	50.7	50.7

Site Ranking is Zero (0). Depth to Ground Water >100' (approx. 345'). All results are ppm.
