RE: Letter of Violation for Range Operating New Mexico, Inc. Inspection
#iCLB0534948599, South Culebra Bluff (SCB) 23 No. 004

Chronology

Site Photographs
SCB 23-4
3-29-2006

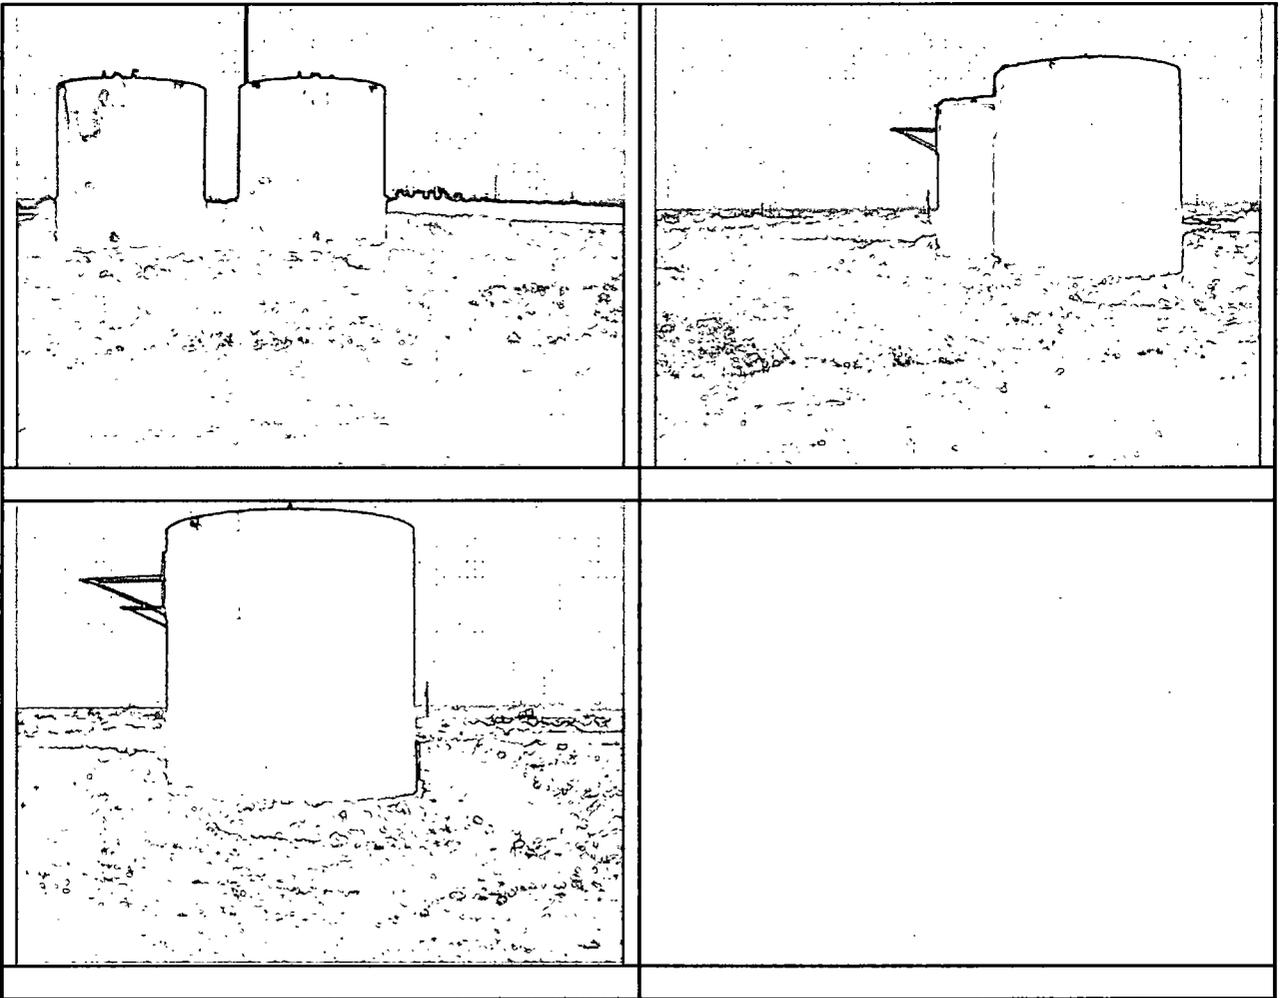
On March 29, 2006 after receiving notice from Tony Tucker, Range Resources Production Foreman Loving New Mexico Area., of completion of excavation and remediation; Ronnie Taylor of White Buffalo Environmental Services Inc arrived on site to perform final sampling. Samples were collected from the floor area, South wall, and West wall of the spill site. These samples were immediately placed on ice for transportation and shipment to ASK Laboratories in Amarillo, Texas. The samples were analyzed for BTEX, TPH (NM 8015N), and Chloride content.

On April 10, 2006 the sample results were received from the laboratory. The results revealed that the BTEX, and TPH concentrations were above remediation limits. Further excavation will be performed and a future sampling date will be coordinated with you.
