Pit or Below-Grade Tank Registration or Closure

Re: Drilling Pit Closure of Bold Energy – Bell Lake #25
UL 'L' Sec. 5 T24S R34E Lea County, NM
API # 30-025-38175

Bold Energy
Bell Lake #25

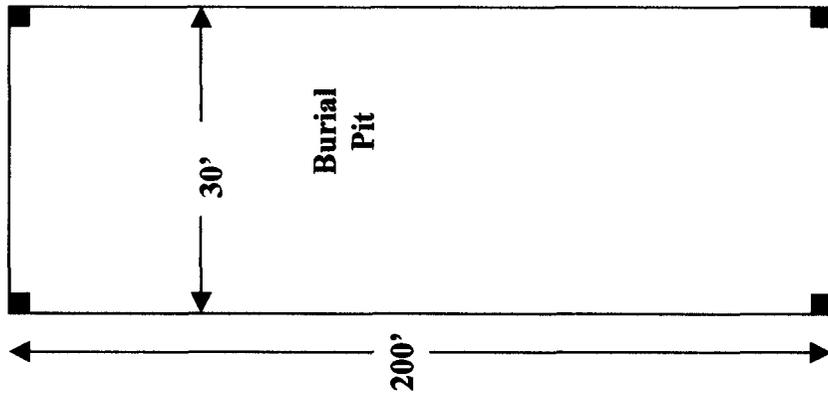
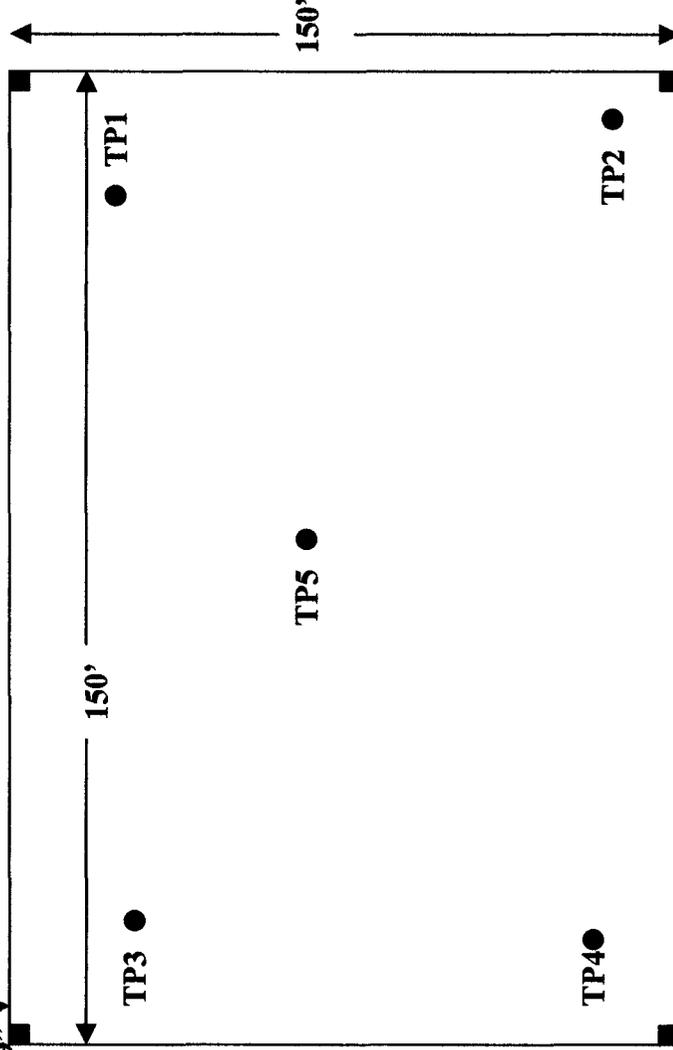
Plat Map

Wellhead

32° 24' 35.0"
104° 16' 38.9"

50'
32° 14' 62.3"
103° 29' 83.9"

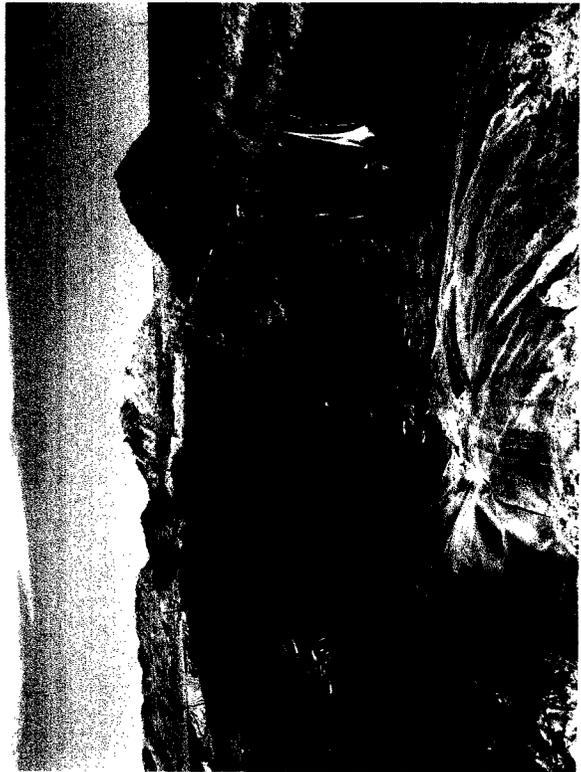
Burial pit lined with a 12 mil impervious liner.

Additional Comments: A burial was excavated to 14' deep then lined with a 12 mil impervious liner. The drilling pit contents were mixed with dry soil to stiffen the mud and placed in the burial pit. The burial pit was then capped with a 20 mil impervious liner 3' below ground surface and overlapping 3' in all directions. 3' of clean native soil was backfilled and doomed to prevent pooling. 5 bottom sample points were analyzed on the bottom of the drilling pit after all contents were removed with NMOCD standards being achieved with the deepest point at 21' below ground surface. As per the approved risk based closure the drilling pit was backfilled to 4' the capped 20 mil impervious liner then backfilled to the contour of the area.
