Release Notification and Corrective Action

Name of Company: Targa Midstream Services L P	Contact: James Lingnau 505.394.2534, Chuck Tolsma 505.631.6026
Address: PO Box 1909 Eunice, NM 88231	Telephone No. (505) 394-2534
Facility Name: Eunice Gathering System	Facility Type Gas Processing Plant

Type of Release: Gas and Produced Liquids	Volume of Release: Gas and spray of liquid.	Volume Recovered: None
Source of Release: 20" Gas Gathering Pipeline leak	Date and Hour of Occurrence: 1PM April 23, 2007	Date and Hour of Discovery: 2PM April 23, 2007
Was Immediate Notice Given? <input checked="" type="checkbox"/> Yes <input type="checkbox"/> No <input type="checkbox"/> Not Required	If YES, To Whom? Pat Caperton OCD	
By Whom? Rebecca Woodell	Date and Hour 1:40 PM April 24, 2007	
Was a Watercourse Reached? <input type="checkbox"/> Yes <input checked="" type="checkbox"/> No	If YES, Volume Impacting the Watercourse.

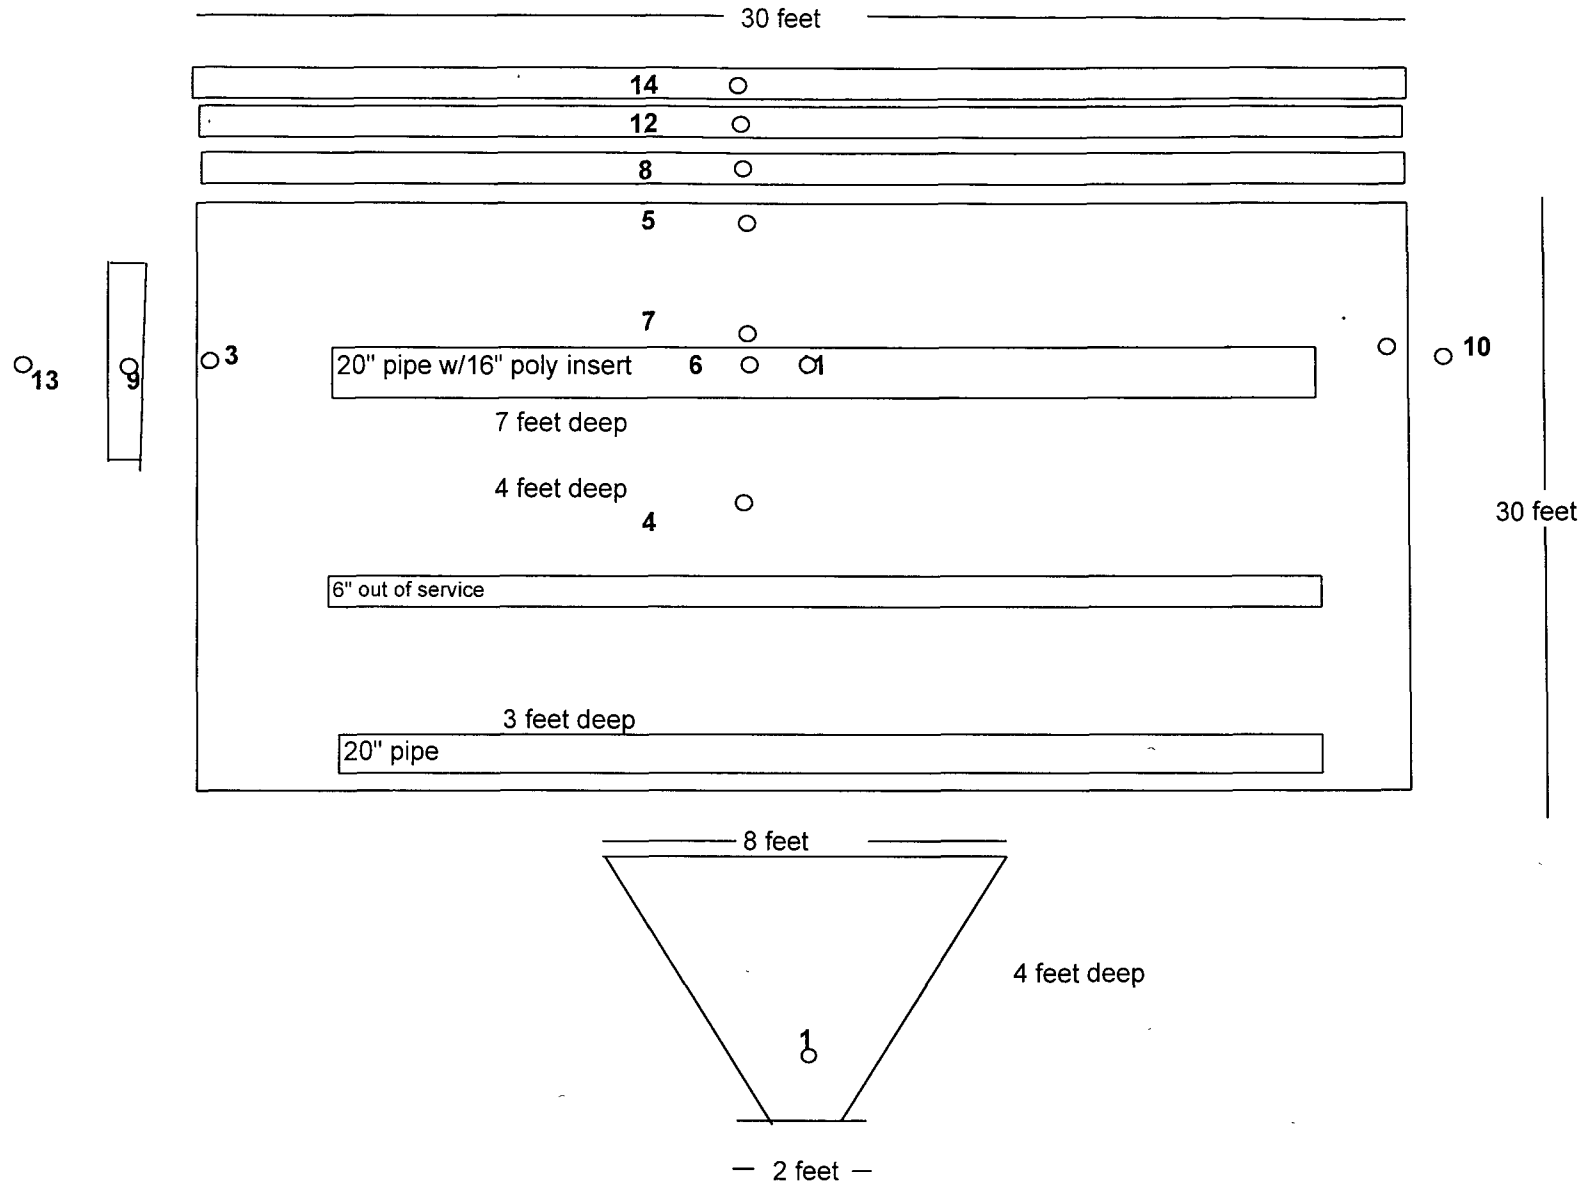
EDWIN JOHNSON

SAMPLE DATE	SAMPLE I.D.	SOIL STATUS	TPH GRO	TPH DRO	CHLORIDE
8/30/2007	#1	In Situ	<10	16.3	<16
8/30/2007	#2(North Wall)	Excavated	<10	860	<16
8/30/2007	#3(South Wall)	Excavated	<10	86	144
8/30/2007	#4	In Situ	<10	29.3	<16
8/30/2007	#5	Excavated	<10	<10	1410
8/30/2007	#6(Bottom 6 feet)	Excavated	<10	1230	3620
8/30/2007	#7(Bottom 3 feet)	Excavated	98.6	8930	2900
9/25/2007	#8(West Wall)	Excavated	<10	<10	511
9/25/2007	#9(South Wall)	Excavated	<10	<10	1220
9/25/2007	#10(North Wall)	In Situ	<10	<10	<16
9/25/2007	#11(Bottom 9 feet)	In Situ	<10	<10	<16
11/6/2007	#12(West Wall)	Excavated			1040
11/6/2007	#13(South Wall)	In Situ			64
11/20/2007	#14(West Wall)	In Situ			<16
