CLOSURE

RICE OPERATING COMPANY
JUNCTION BOX FINAL REPORT

BD Hugh EOL

Unit C, Section 14, T22S, R37E

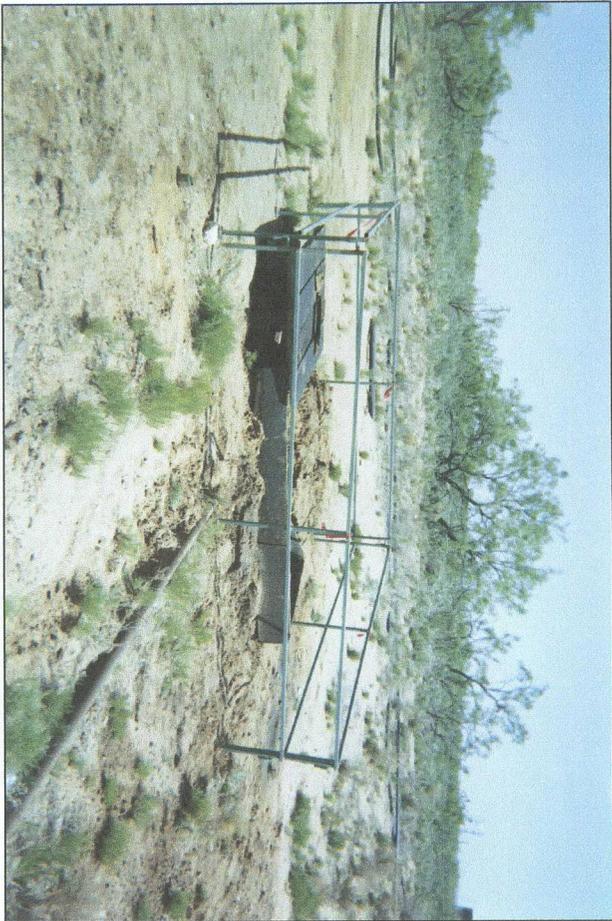
5/3/2006

former junction box

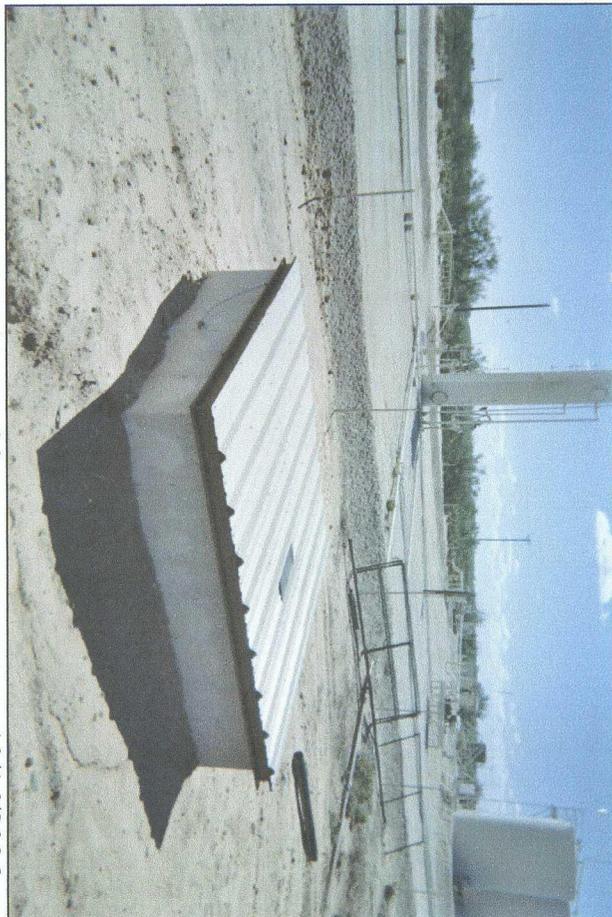
10/16/2006

new junction box 30 ft east of former

This junction was replaced 30 ft east with the pipeline replacement/upgrade program.

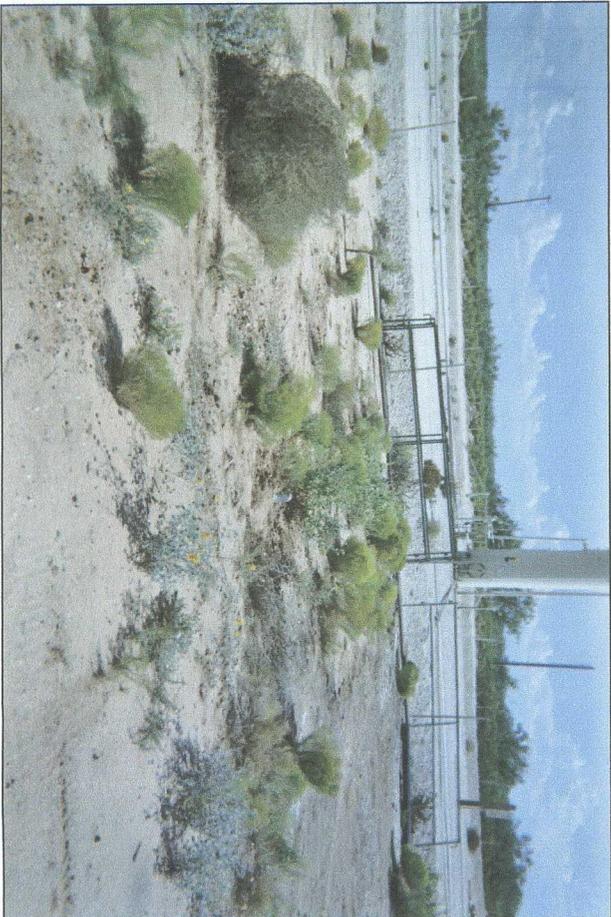
8/7/2007

former junction site; box removed

After the box lumber was removed from the old site, the site was investigated using a hand auger to collect samples to 6 ft of depth. The soils at and surrounding the site were a red sand and did not exhibit any signs of adverse impact resulting from the junction. Chloride field tests were conducted on these samples and yielded very low concentrations. Organic vapors were also measured using a PID and the soil samples exhibited very low concentrations as well. The deepest sample (6 ft) was collected for confirmation analysis at a commercial laboratory. Constituents were not present within the laboratory's detection limits. Approx. 3 cubic yards of clean, imported soil was used to backfill the shallow hole where the former box was located. The backfilled surface was seeded with a blend of native vegetation on 9/21/2007 and is expected to return to productive capacity at a normal rate. A new concrete junction box has been built 30 ft east of this subject site.

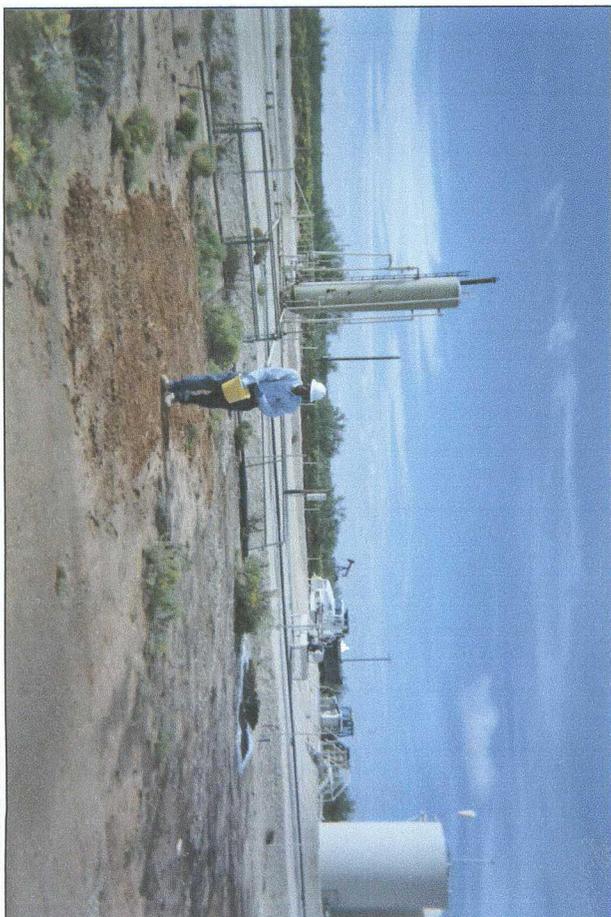
9/21/2007

seeding imported soil over former junction site
