**Release Notification and Corrective Action**

Name of Company <b>Rice Operating</b>	Contact <b>Tony Grieco</b>
Address <b>122 W. Taylor St., Hobbs, NM 88240</b>	Telephone No. <b>(575) 393-9174</b>
Facility Name <b>JUSTIS</b>	Facility Type: <b>Salt Water Gathering System</b>

## JUSTIS N-2 LEAK

## BD J-15 LEAK

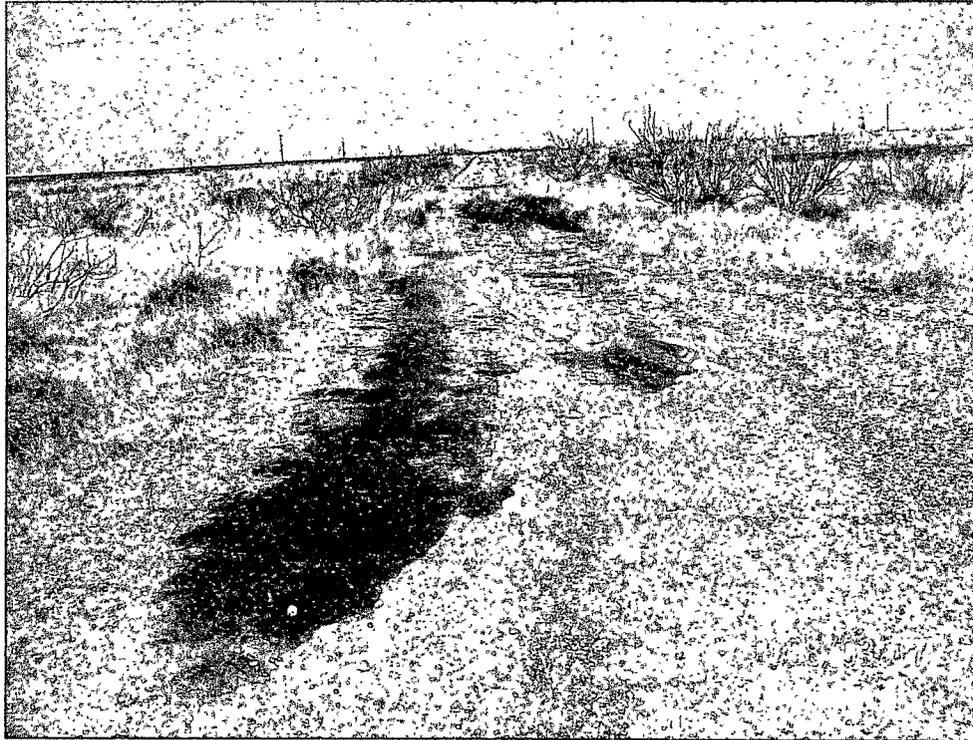
FACING EAST, LEAK AREA ALONG CALICHE ROAD. SOURCE IS TO THE IMMEDIATE RIGHT OF THE ROAD AT THE DIRT RIDGE.

Describe Cause of Problem and Remedial Action Taken.\*  
**A 2 in pipeline cracked. Pipeline was clamped as a permanent repair.**

Describe Area Affected and Cleanup Action Taken.\*  
**A total of 4445 sq ft were affected, of which 1830 sq ft were lease road and 2615 sq ft were pasture. A vacuum truck was dispatched to remove and dispose standing water. On 3/17/08, the roadway was scraped to a depth of 2 to 3 inches and 12 yds of impacted caliche were hauled to Sundance disposal facility. The pasture area was scraped to a depth of 6 in, with the impacted soil stockpiled on site. This soil (60 yds total) was hauled to Sundance on 3/18/08. 12 yds of caliche were imported and spread on the road 3/18/08.**

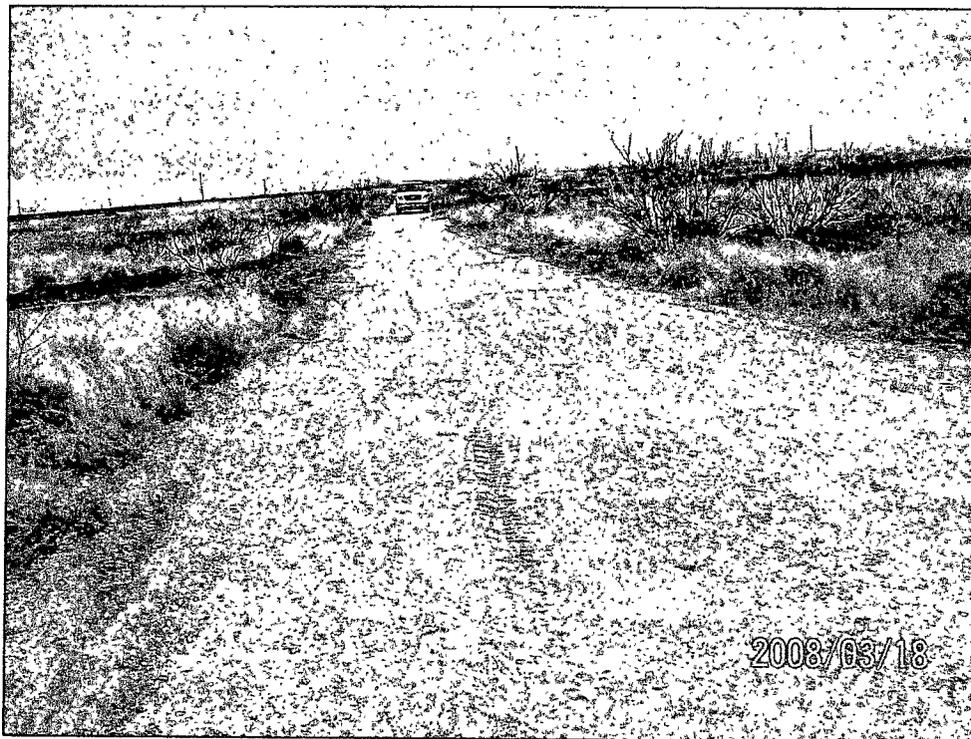
AFTER SCRAPING AND IMPORTING CLEAN CALICHE

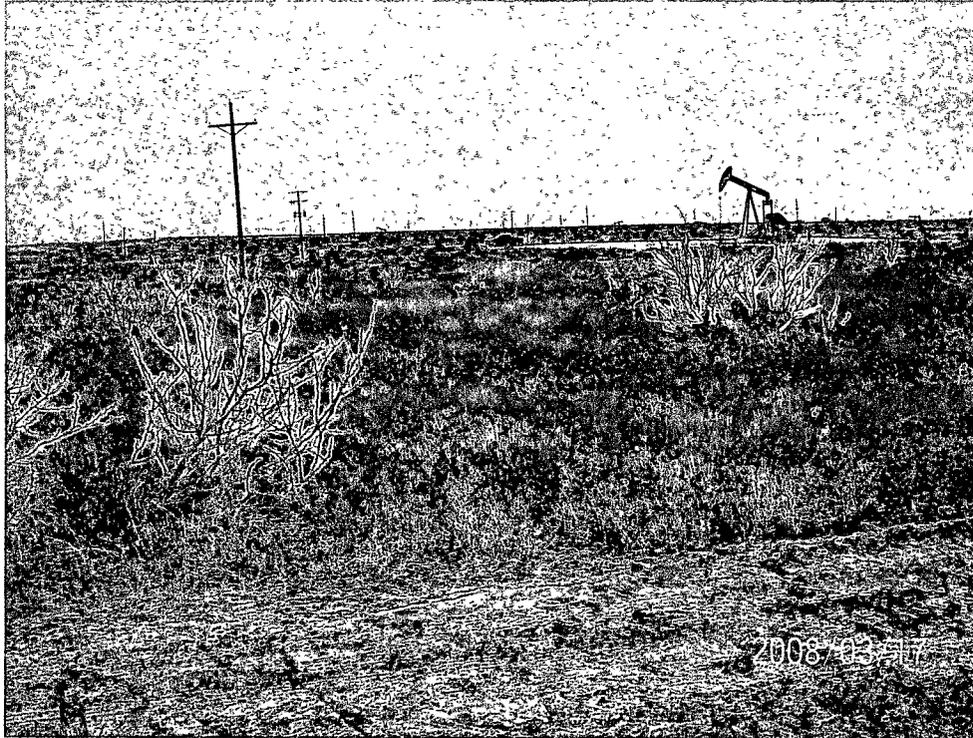
## JUSTIS N-2 LEAK

FACING SOUTH, SPILL AREA IN PASTURE. EDGE OF SPILL AREA IS MARKED BY FLAGS.

**Delineation was conducted with a hand auger and backhoe on 3/17/08. On 3/20/08 the pasture area was further scraped to a depth where either hard rock or dry sand was encountered, between 6 inches and 18 inches depth, a total of 72 yds were hauled to Sundance. On 3/24/08 a total of 132 yds of clean soil were imported from a nearby pit; this soil was installed and contoured. The site was seeded on 4/7/08.**

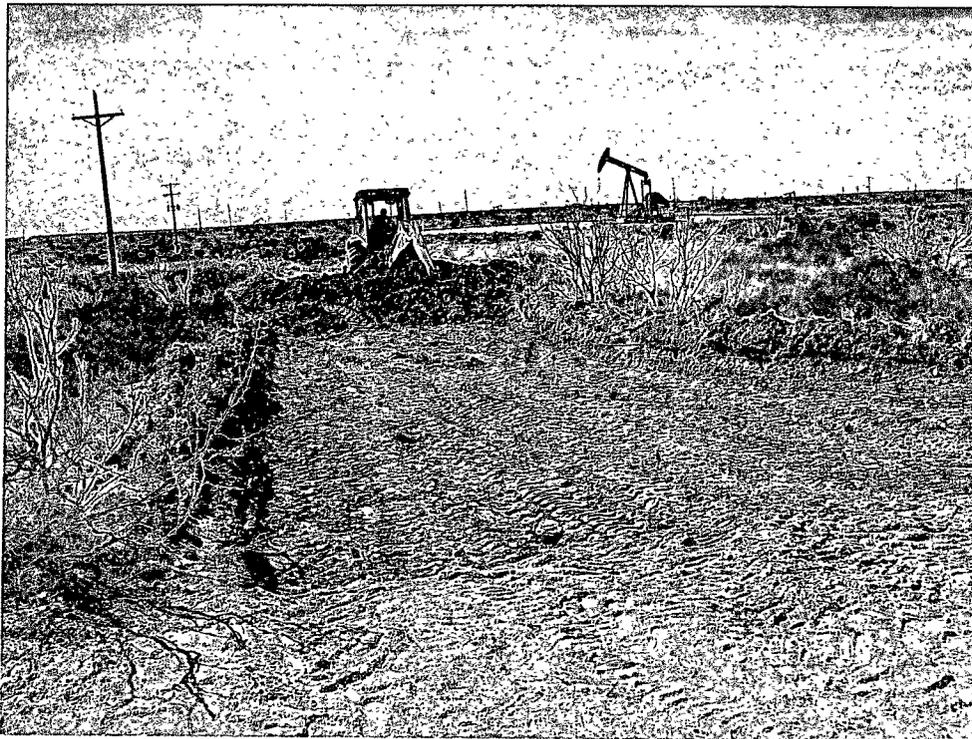
AREA BEING EXCAVATED

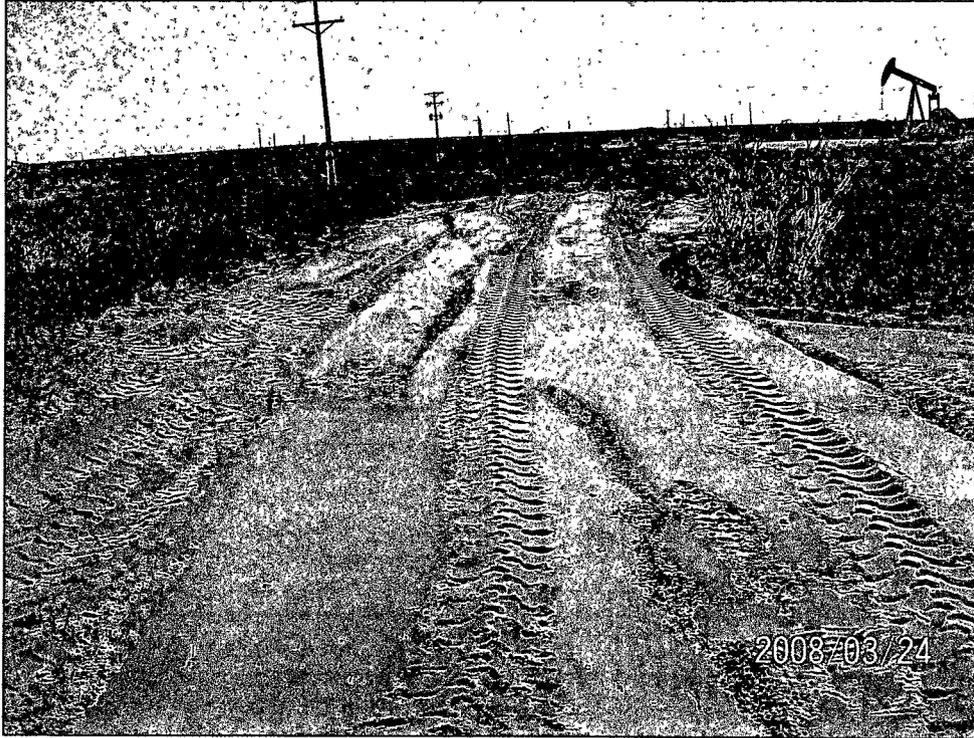
# JUSTIS N-2 LEAK

EXCAVATED AREA AFTER BACKFILL

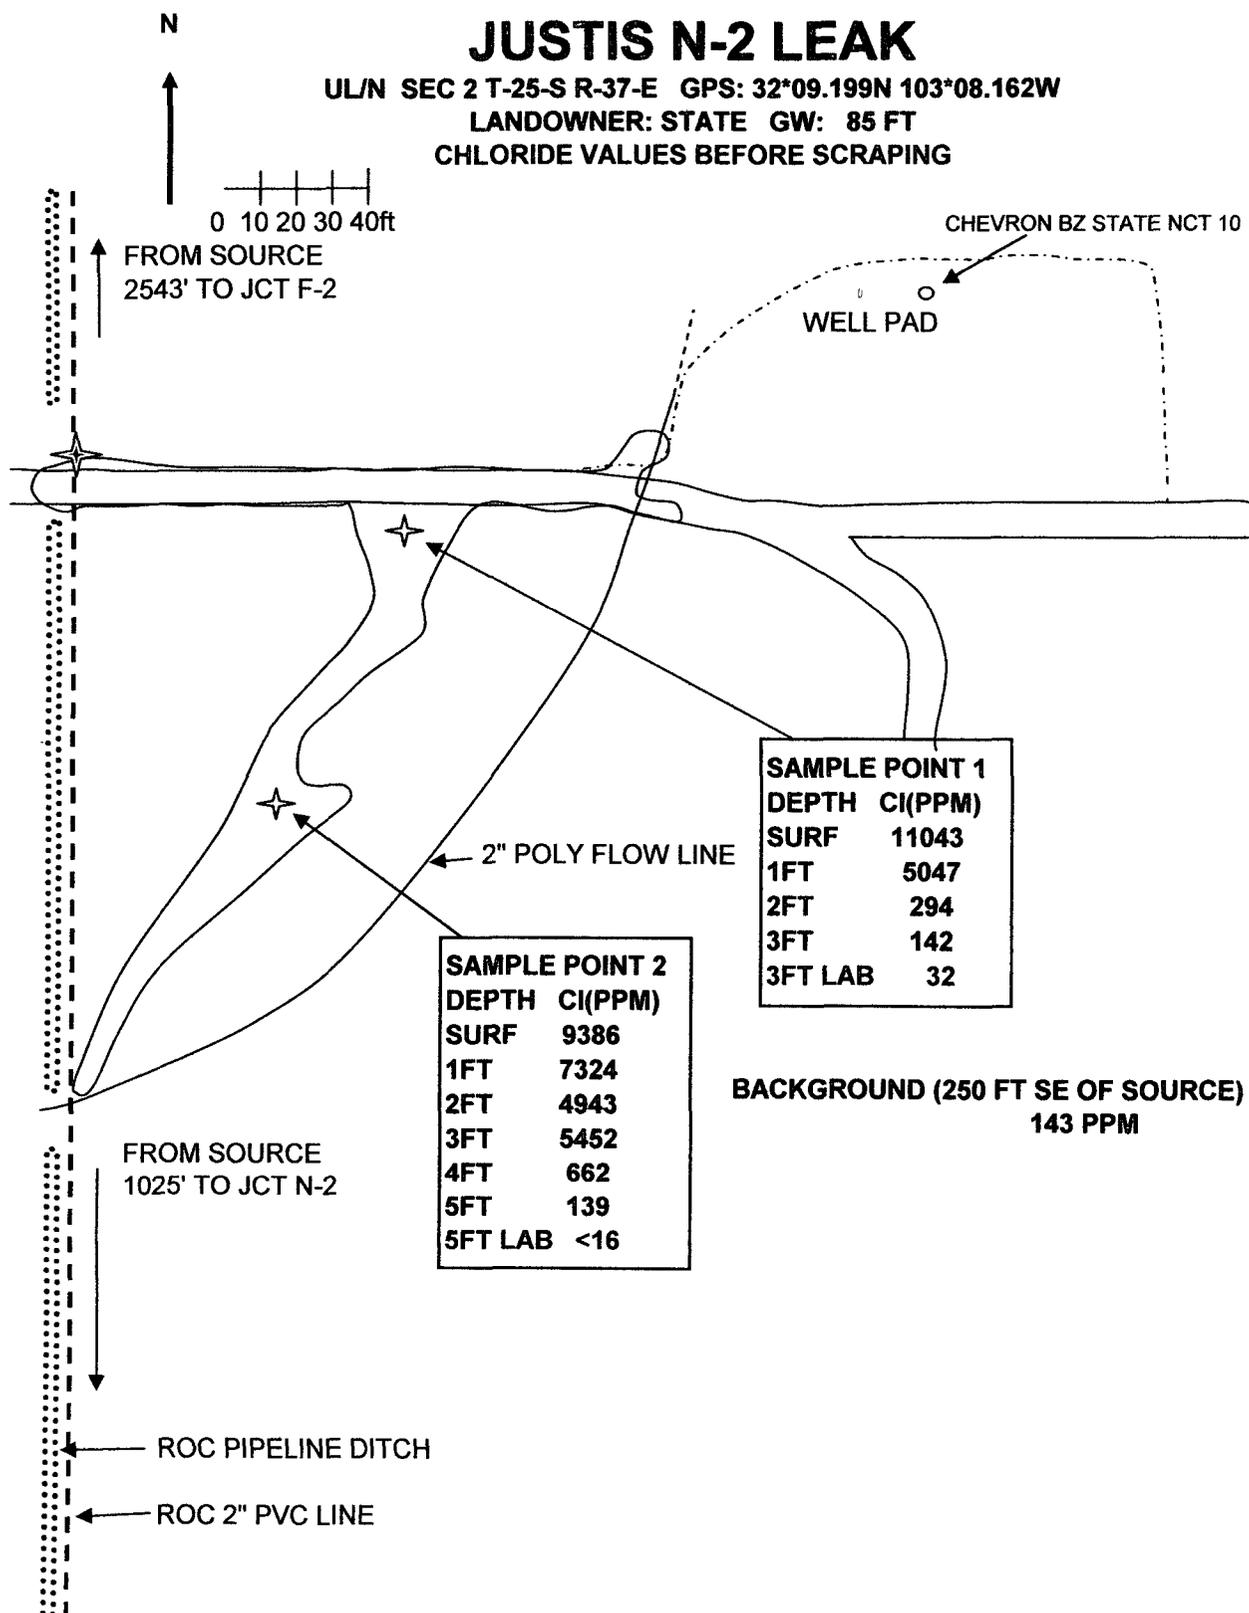
# JUSTIS N-2 LEAK

UL/N SEC 2 T-25-S R-37-E GPS: 32°09.199N 103°08.162W

LANDOWNER: STATE GW: 85 FT

CHLORIDE VALUES BEFORE SCRAPING

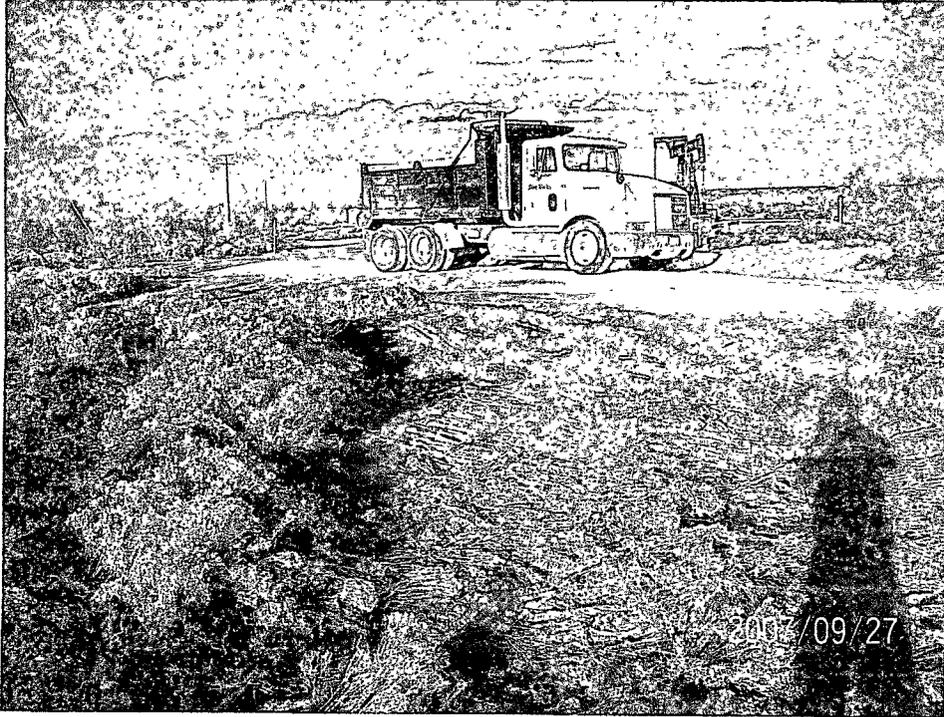
# BD J-15 LEAK

**IMPACTED PASTURE AREA BEING SCRAPED**

Describe Area Affected and Cleanup Action Taken.\*  
5,633 sq ft were affected, of which 150 sq ft were pasture and 5,483 sq ft were 2-track roadway. A backhoe was used to scrape the entire roadway area to a depth of 3-6 in, the small pasture area was scraped to a depth of approximately 6-12 in. 24 yds of impacted soil were removed to Sundance disposal facility. 24 yds of clean soil were imported and used to fill in the pasture area.

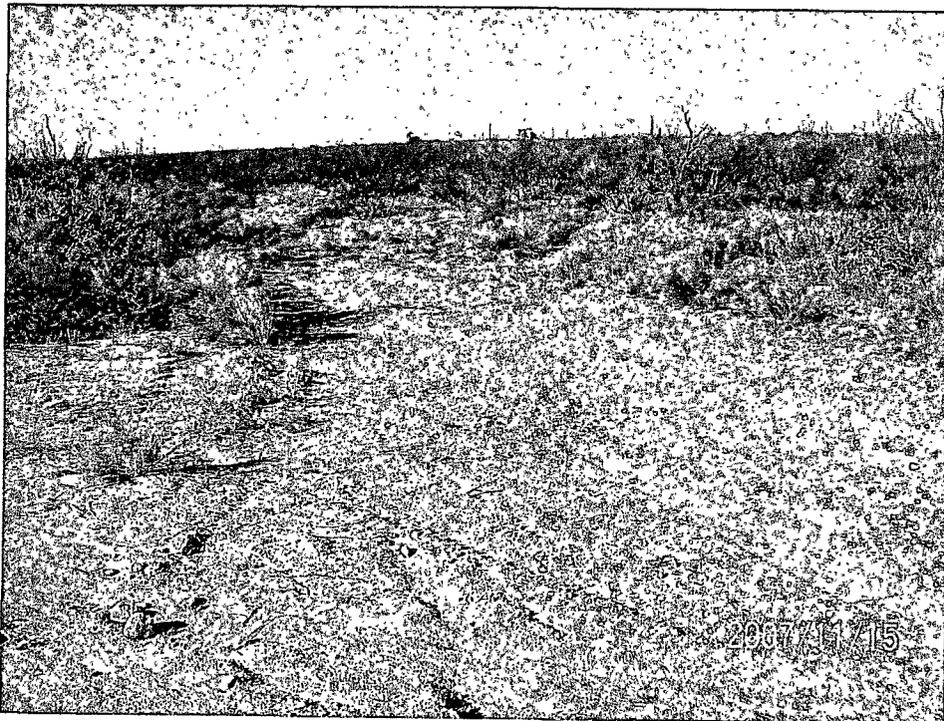
**IMPACTED PASTURE AREA AFTER IMPORTATION OF CLEAN SOIL**

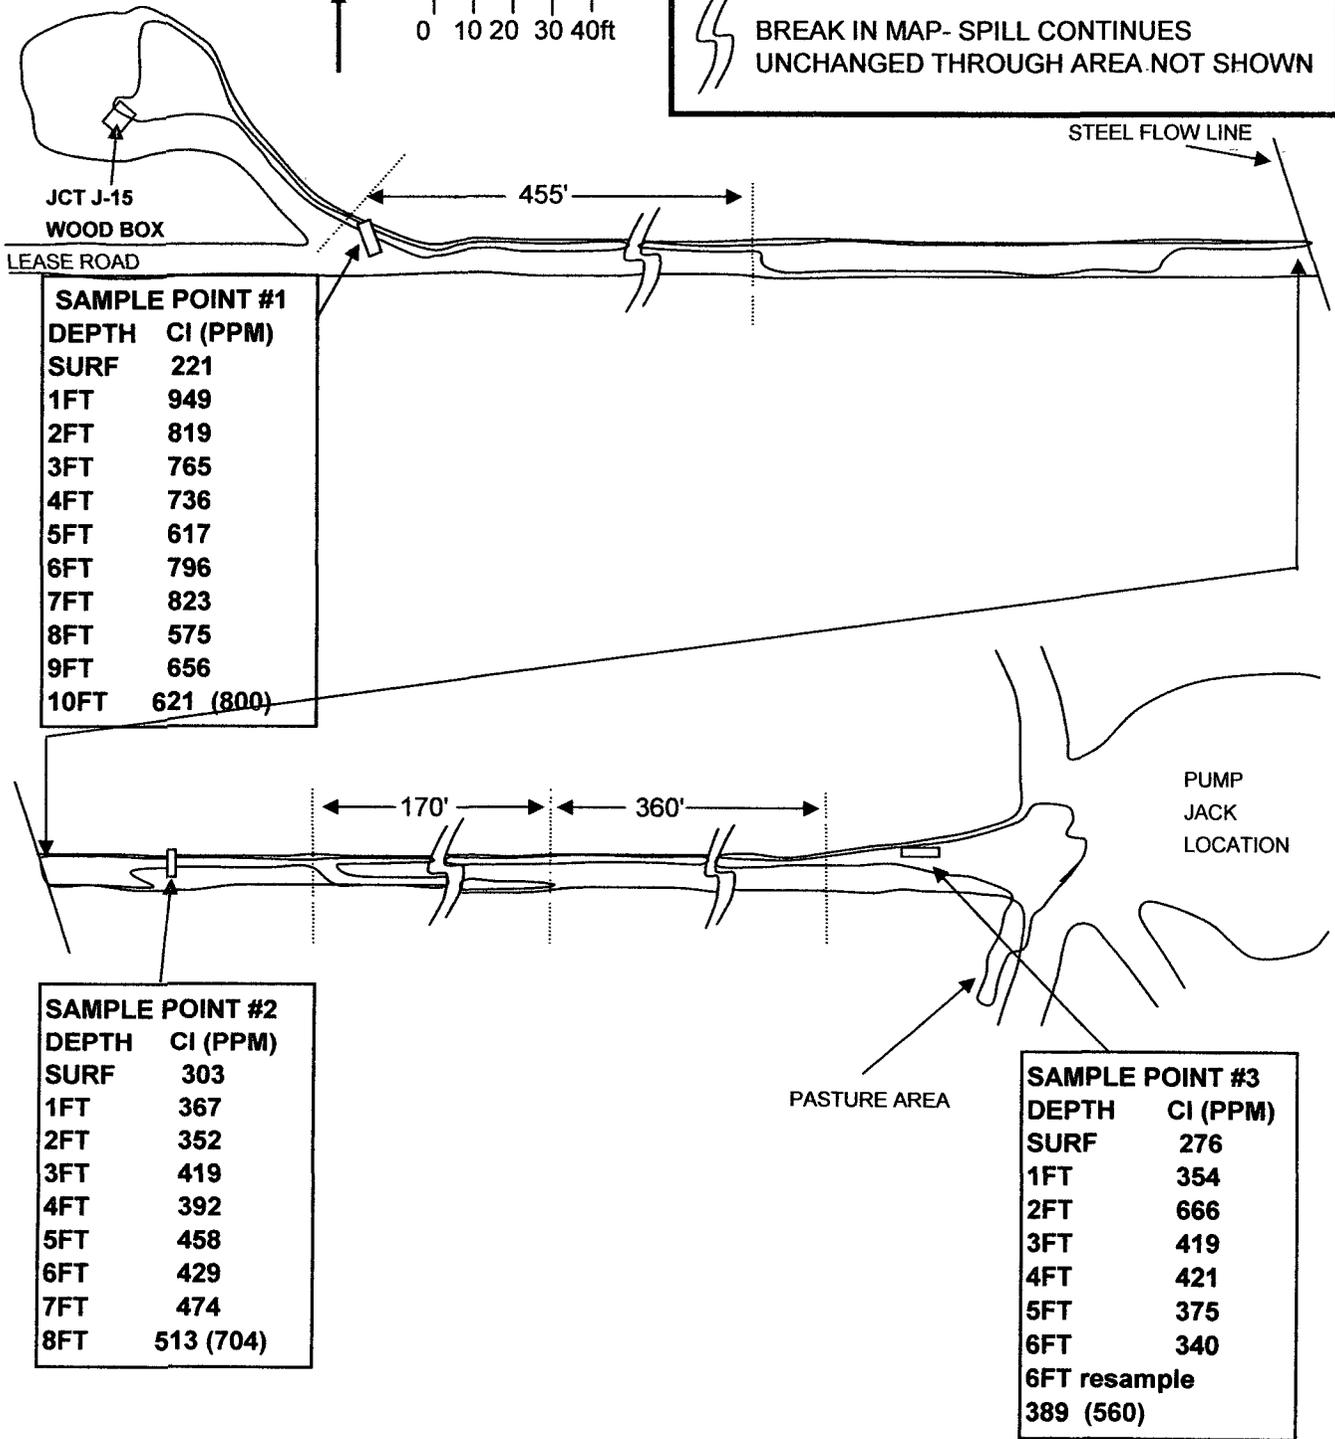
# BD J-15 LEAK

RED NUMBERS: FIELD CHLORIDES

BLUE NUMBERS: LAB CHLORIDES

SPILL AREA

BREAK IN MAP- SPILL CONTINUES UNCHANGED THROUGH AREA NOT SHOWN

**SAMPLE POINT #1**

DEPTH	CI (PPM)
SURF	221
1FT	949
2FT	819
3FT	765
4FT	736
5FT	617
6FT	796
7FT	823
8FT	575
9FT	656
10FT	621 (800)

**SAMPLE POINT #2**

DEPTH	CI (PPM)
SURF	303
1FT	367
2FT	352
3FT	419
4FT	392
5FT	458
6FT	429
7FT	474
8FT	513 (704)

**SAMPLE POINT #3**

DEPTH	CI (PPM)
SURF	276
1FT	354
2FT	666
3FT	419
4FT	421
5FT	375
6FT	340
6FT resample	389 (560)

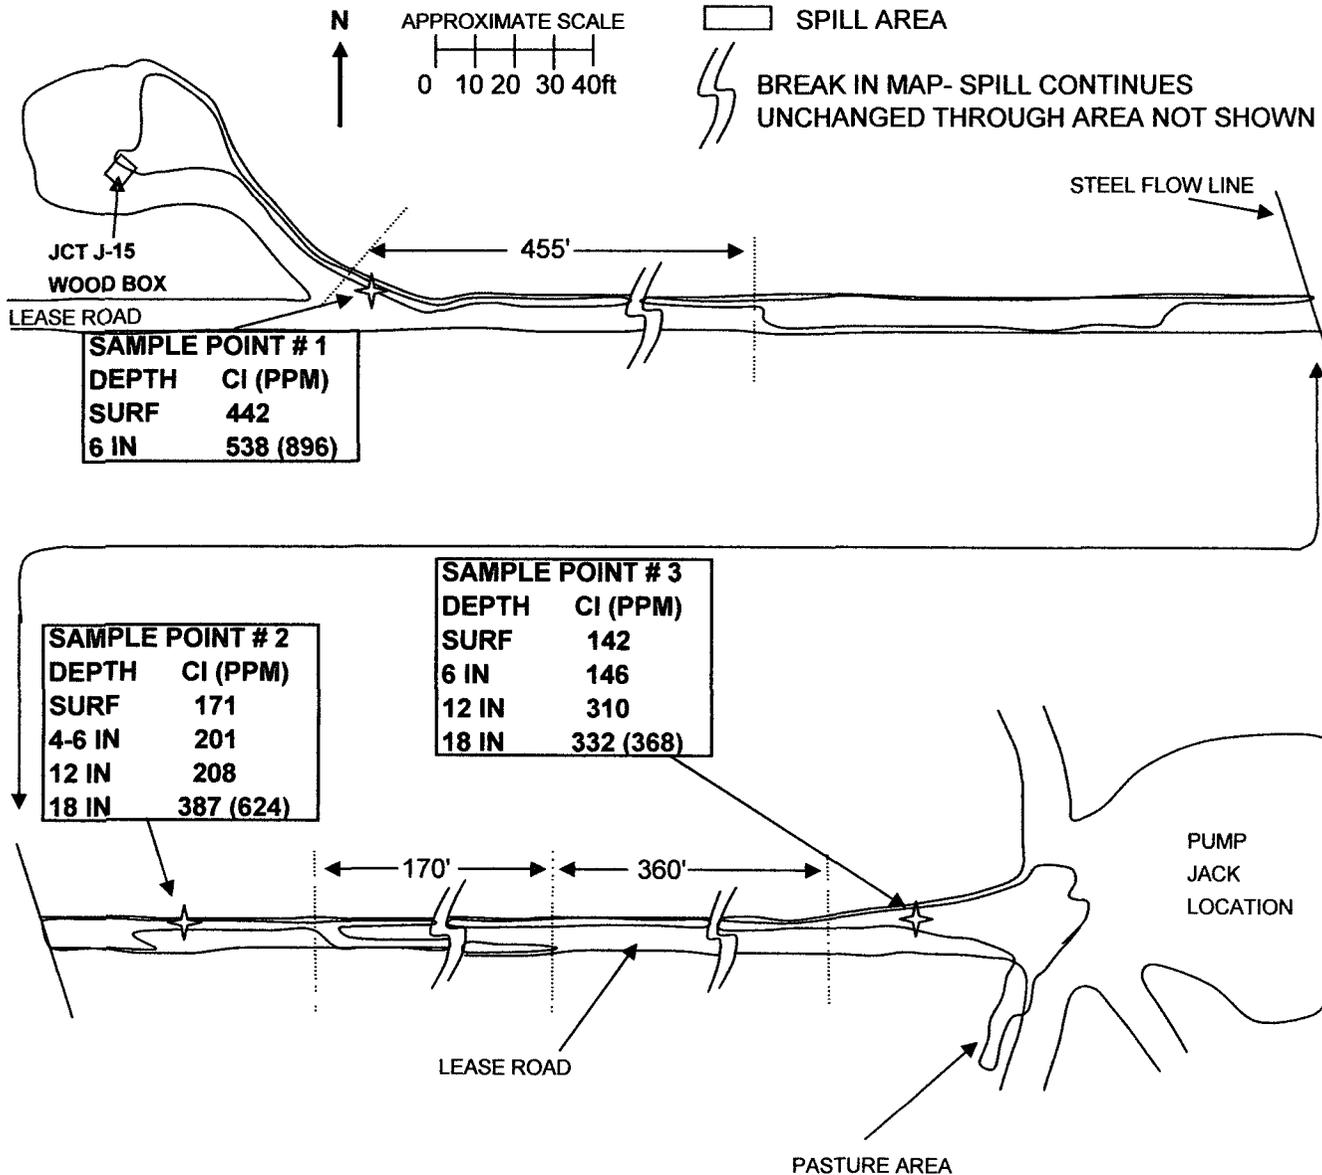
# BD J-15 LEAK

FIELD CHLORIDE VALUES IN RED  
 LAB CHLORIDE VALUES IN BLUE

BACKGROUND CHLORIDES 200ft NORTH OF SOURCE: 116 PPM
