Vacuum Jct B-5-2

CLOSURE

**RICE OPERATING COMPANY
JUNCTION BOX FINAL REPORT**

SWD SYSTEM	JUNCTION	UNIT	SECTION	TOWNSHIP	RANGE	COUNTY	BOX DIMENSIONS - FEET		
							Length	Width	Depth
Vacuum	Jct. B-5-2	B	5	18S	35E	Lea	no box; system abandonment

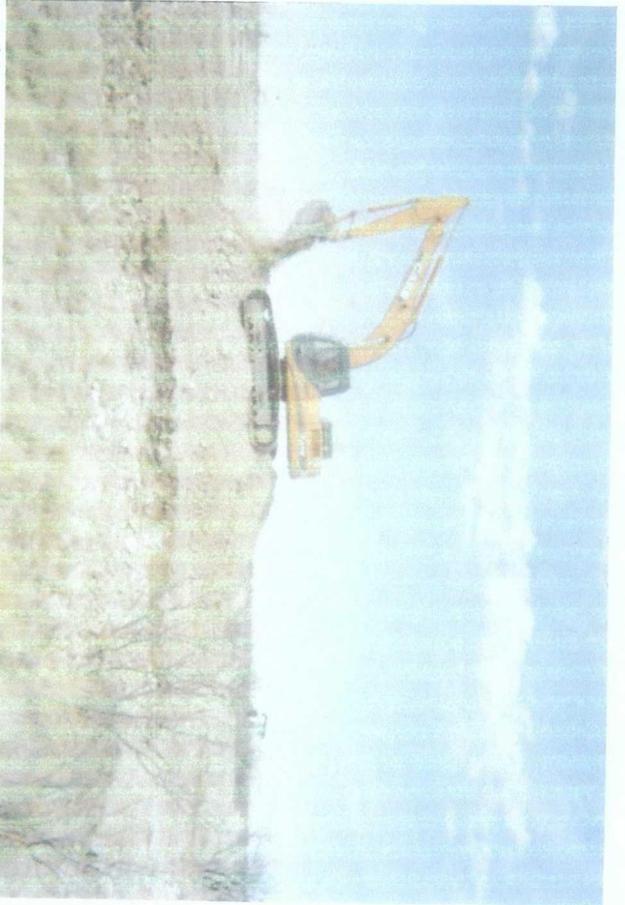
3/15/2006

trackhoe delineation

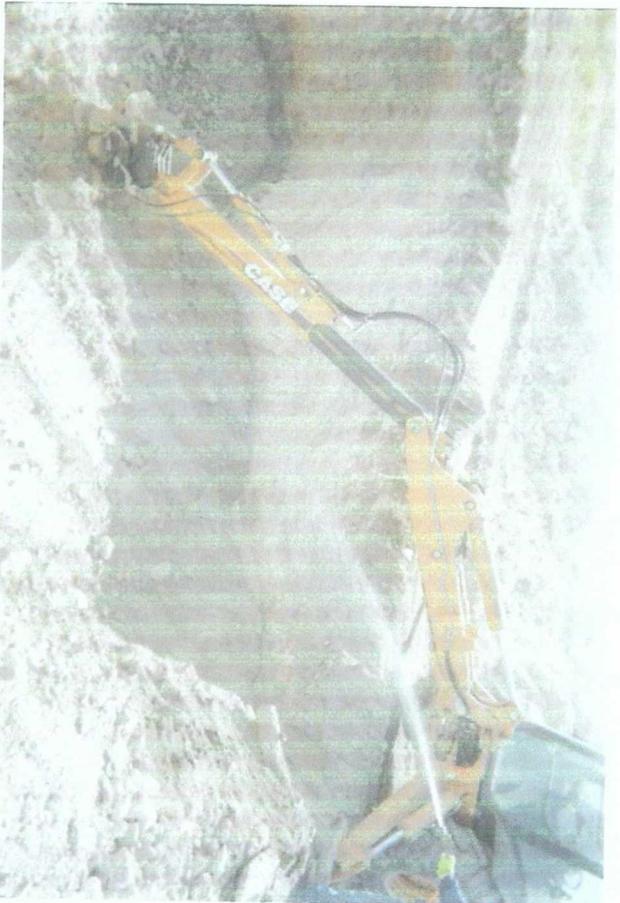
3/30/2006

backfilling excavation site, facing north

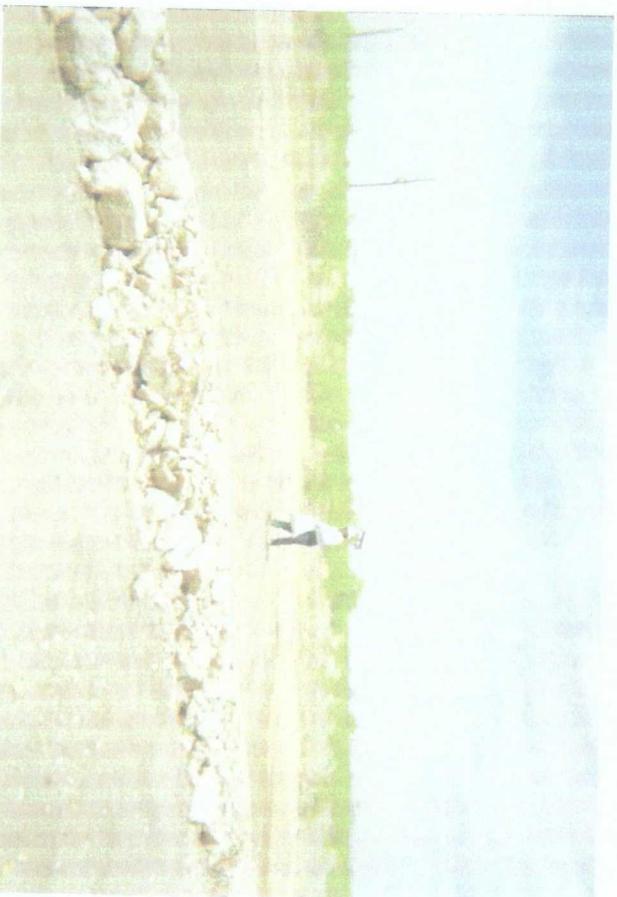
4/25/2006

seeding backfilled site

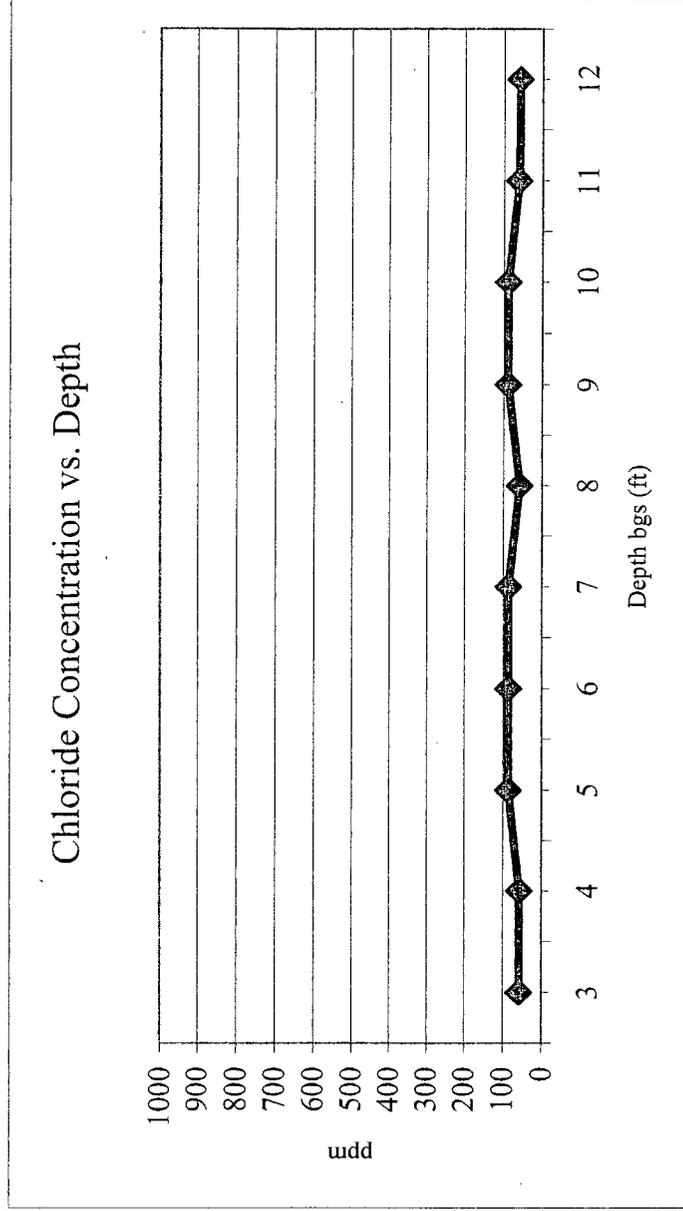
CHLORIDE CONCENTRATION CURVE

Backhoe samples at 15 ft south of junction (source)

Depth bgs (ft)	[Cl] ppm
1	59
2	58
3	86
4	86
5	86
6	59
7	88
8	88
9	61
10	59
11	90
12	59

Groundwater = 70 ft

LOCATION	DEPTH	mg/kg
bottom comp.	12'	239
vertical delineation trench 15 ft south of junction (source)	1'	59
	2'	58
	3'	86
	4'	86
	5'	86
	6'	59
	7'	88
	8'	88
	9'	61
	10'	59
	11'	90
12'	59
