BD Jct I-18-1

**RICE OPERATING COMPANY
JUNCTION BOX FINAL REPORT**

BD Jct. I-18-1

Unit I, Section 18, T22S, R37E

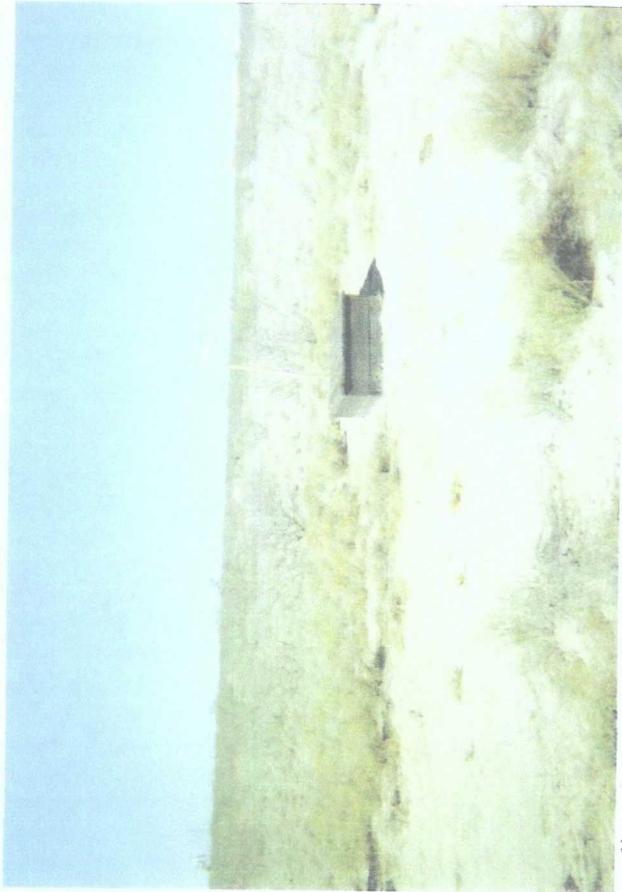
2/15/2006

undisturbed junction box, facing north

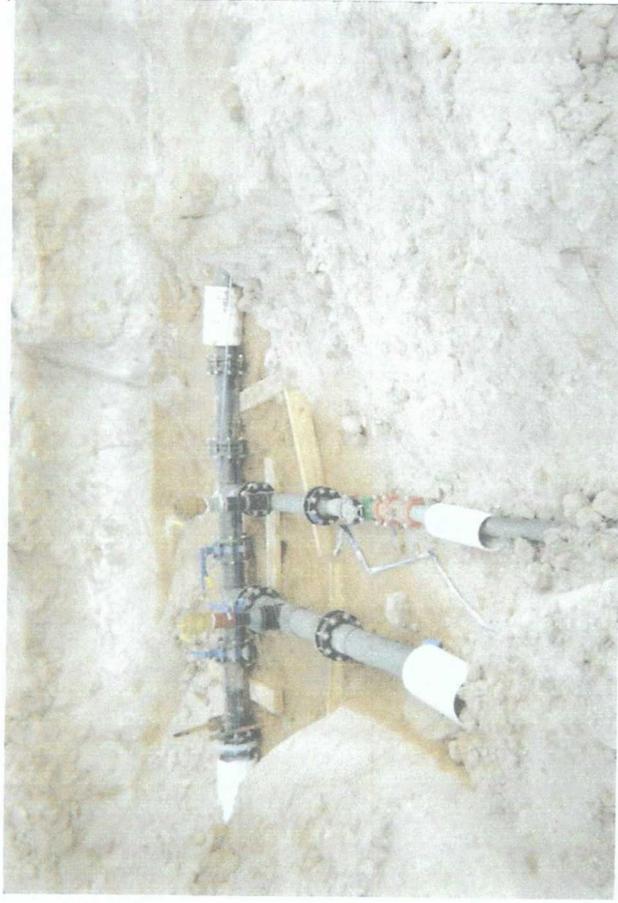
3/6/2006

new junction

General Description of Remedial Action: This junction was addressed under the pipeline replacement/upgrade program. A new, watertight junction box was built in place of the former. After the former box was removed, an investigation was conducted using a backhoe to collect soil samples at regular intervals producing a 5x3x12-ft-deep hole. Chloride field tests were performed on each sample. Organic vapors were also measured using a PID, which yielded low concentrations. The deepest sample, 12 ft BGS, was sent to a commercial laboratory for analysis. On 7/25/2007, the site was seeded with a blend of native vegetation and is expected to return to a productive capacity at normal rate. To further investigate depth of chloride presence, a soil boring was initiated on 6/5/2008 at 10 ft north of the former junction. The boring was advanced to 40 ft BGS while soil samples were collected every 5 ft and tested for chloride concentrations. The 15 and 40 ft samples were analyzed by a commercial laboratory for chloride, which yielded low concentrations.

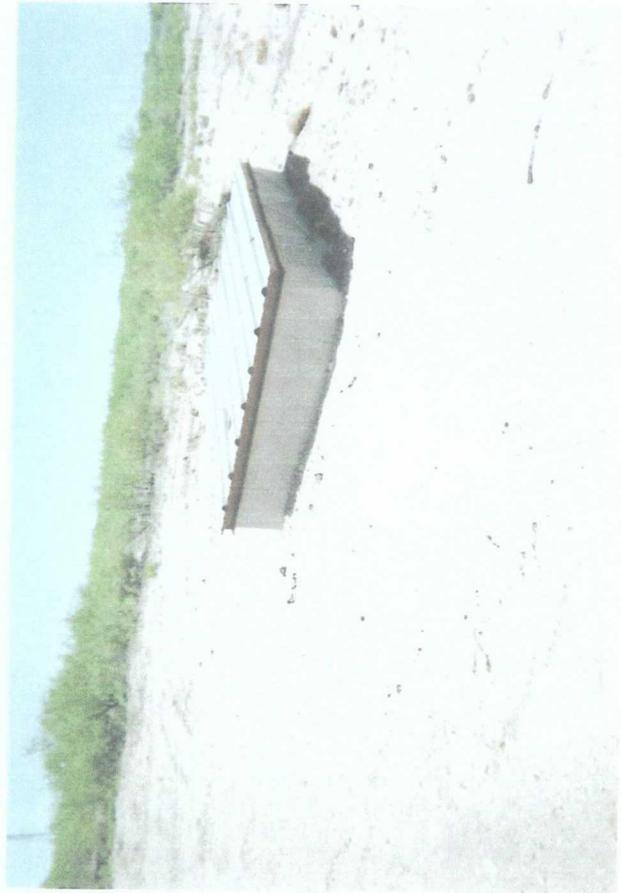
7/17/2006

new, watertight junction box

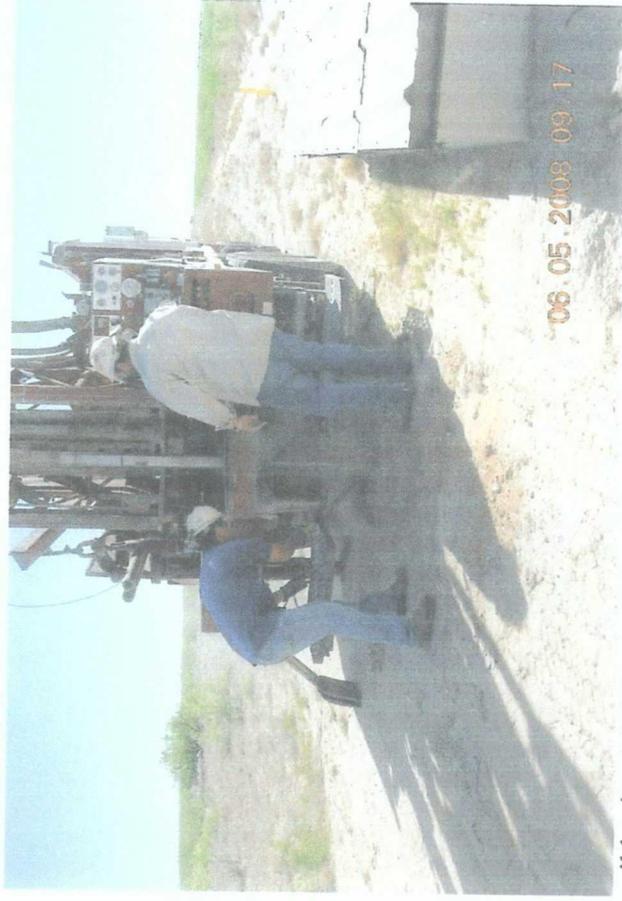
6/5/2008

soil boring 10 ft north of the junction

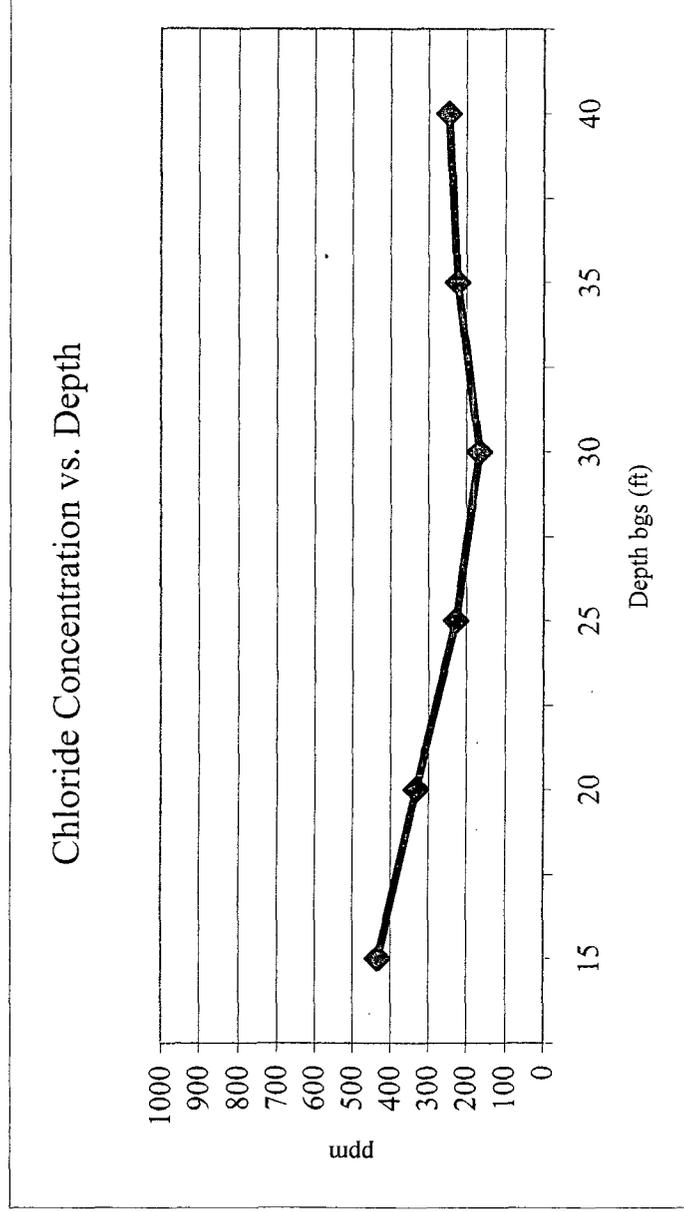
CHLORIDE CONCENTRATION CURVE

Backhoe samples at 10 ft north of junction (source)

Groundwater = 125 ft
