RE: **Hobbs SWD System F-24-3 Vent Site: T-18-S, R-37-E, Section 24, Unit F,
Initial Characterization Report and Corrective Action Plan
NMOCD CASE #: 1R428-46**

On behalf of Rice Operating Company (ROC), R.T. Hicks Consultants, Ltd. is submitting this Initial Characterization Report (ICR) and Corrective Action Plan (CAP) for the Hobbs F-24-3 Vent Site regulatory file. The investigation conducted demonstrates that neither chloride nor hydrocarbons are present in the vadose zone in quantities that represent a threat to ground water quality.

Figure 2
Characterization Results
Rice Operating Company
Hobbs F-24-3 Vent
T-18-S R-37-E Sec. 24 (F)
Lea County, New Mexico

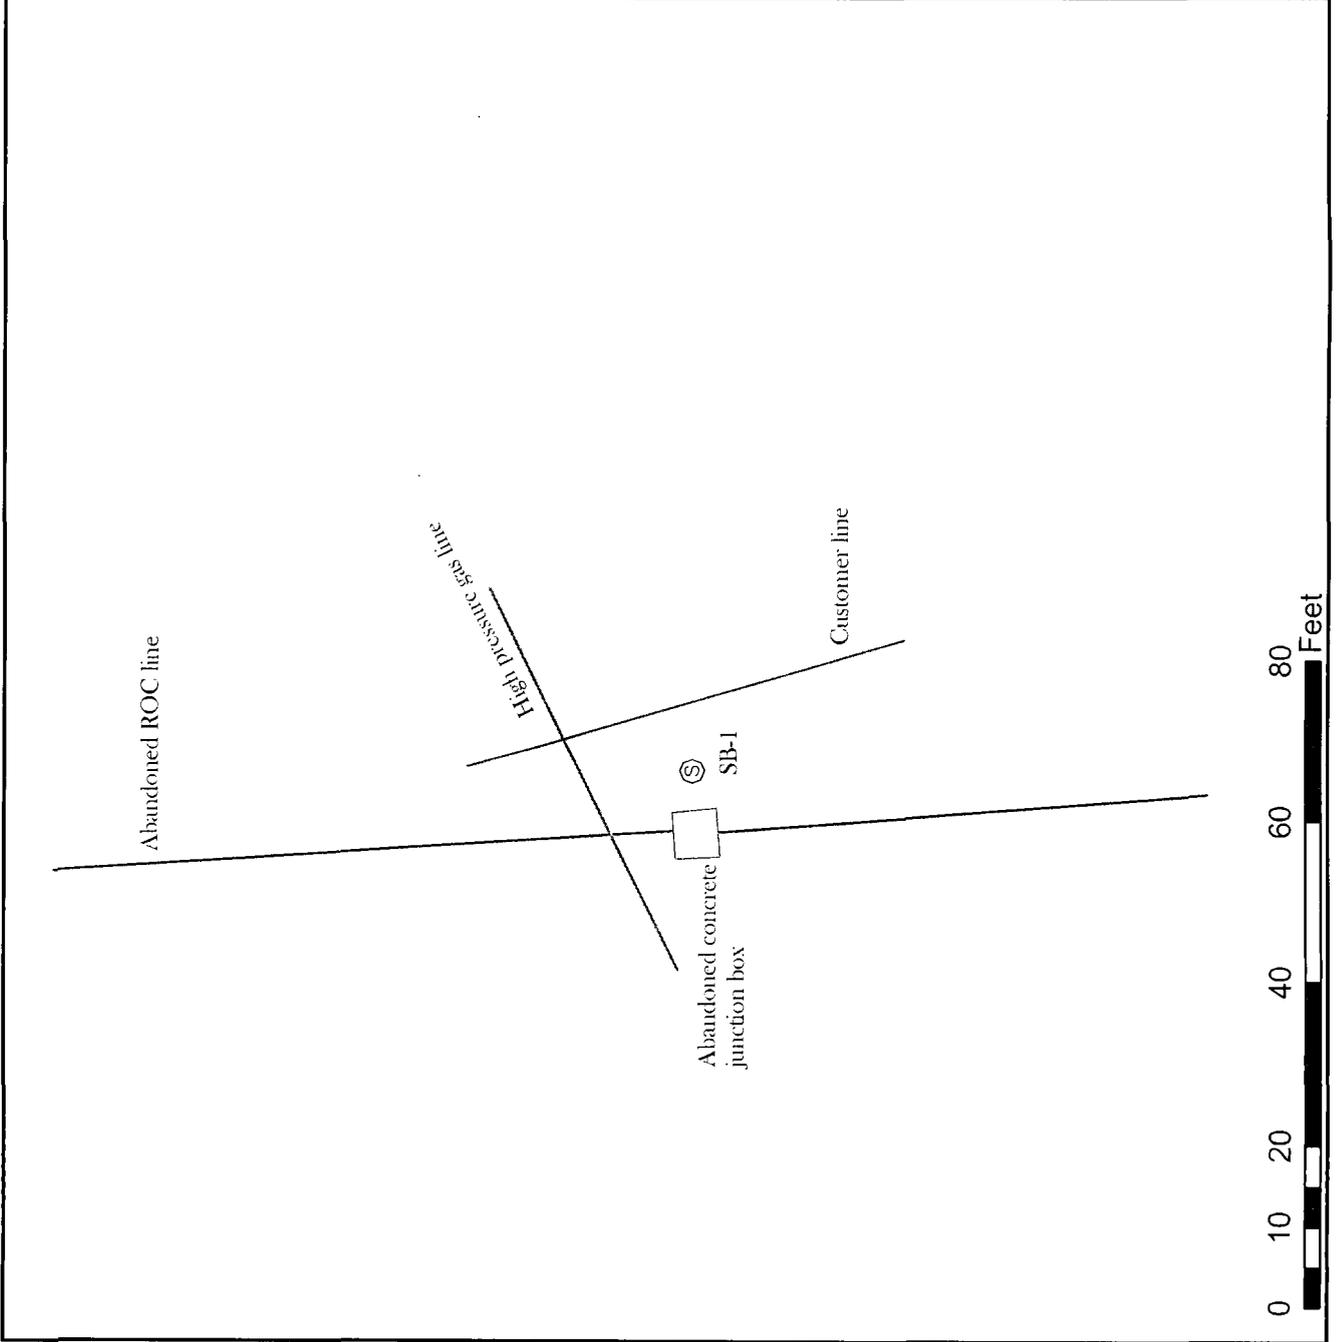
Hicks Consultants supervised a deep soil sampling program to characterize possible hydrocarbon and chloride impact due to past activities. On September 23, 2009, soil boring No. 1 (SB-1) was drilled adjacent to the east side of the concrete junction box to evaluate the deep soil directly below the former ROC equipment. Figure 1 is a map that demonstrates the original junction box and SB-1 locations as determined using a Trimble model GEO-XH GPS that is accurate to within 0.5 ft.

Soil Bore Location

SB-1
32°44'6.846"N
103°12'25.644"W

Abandoned
Concrete
Junction Box

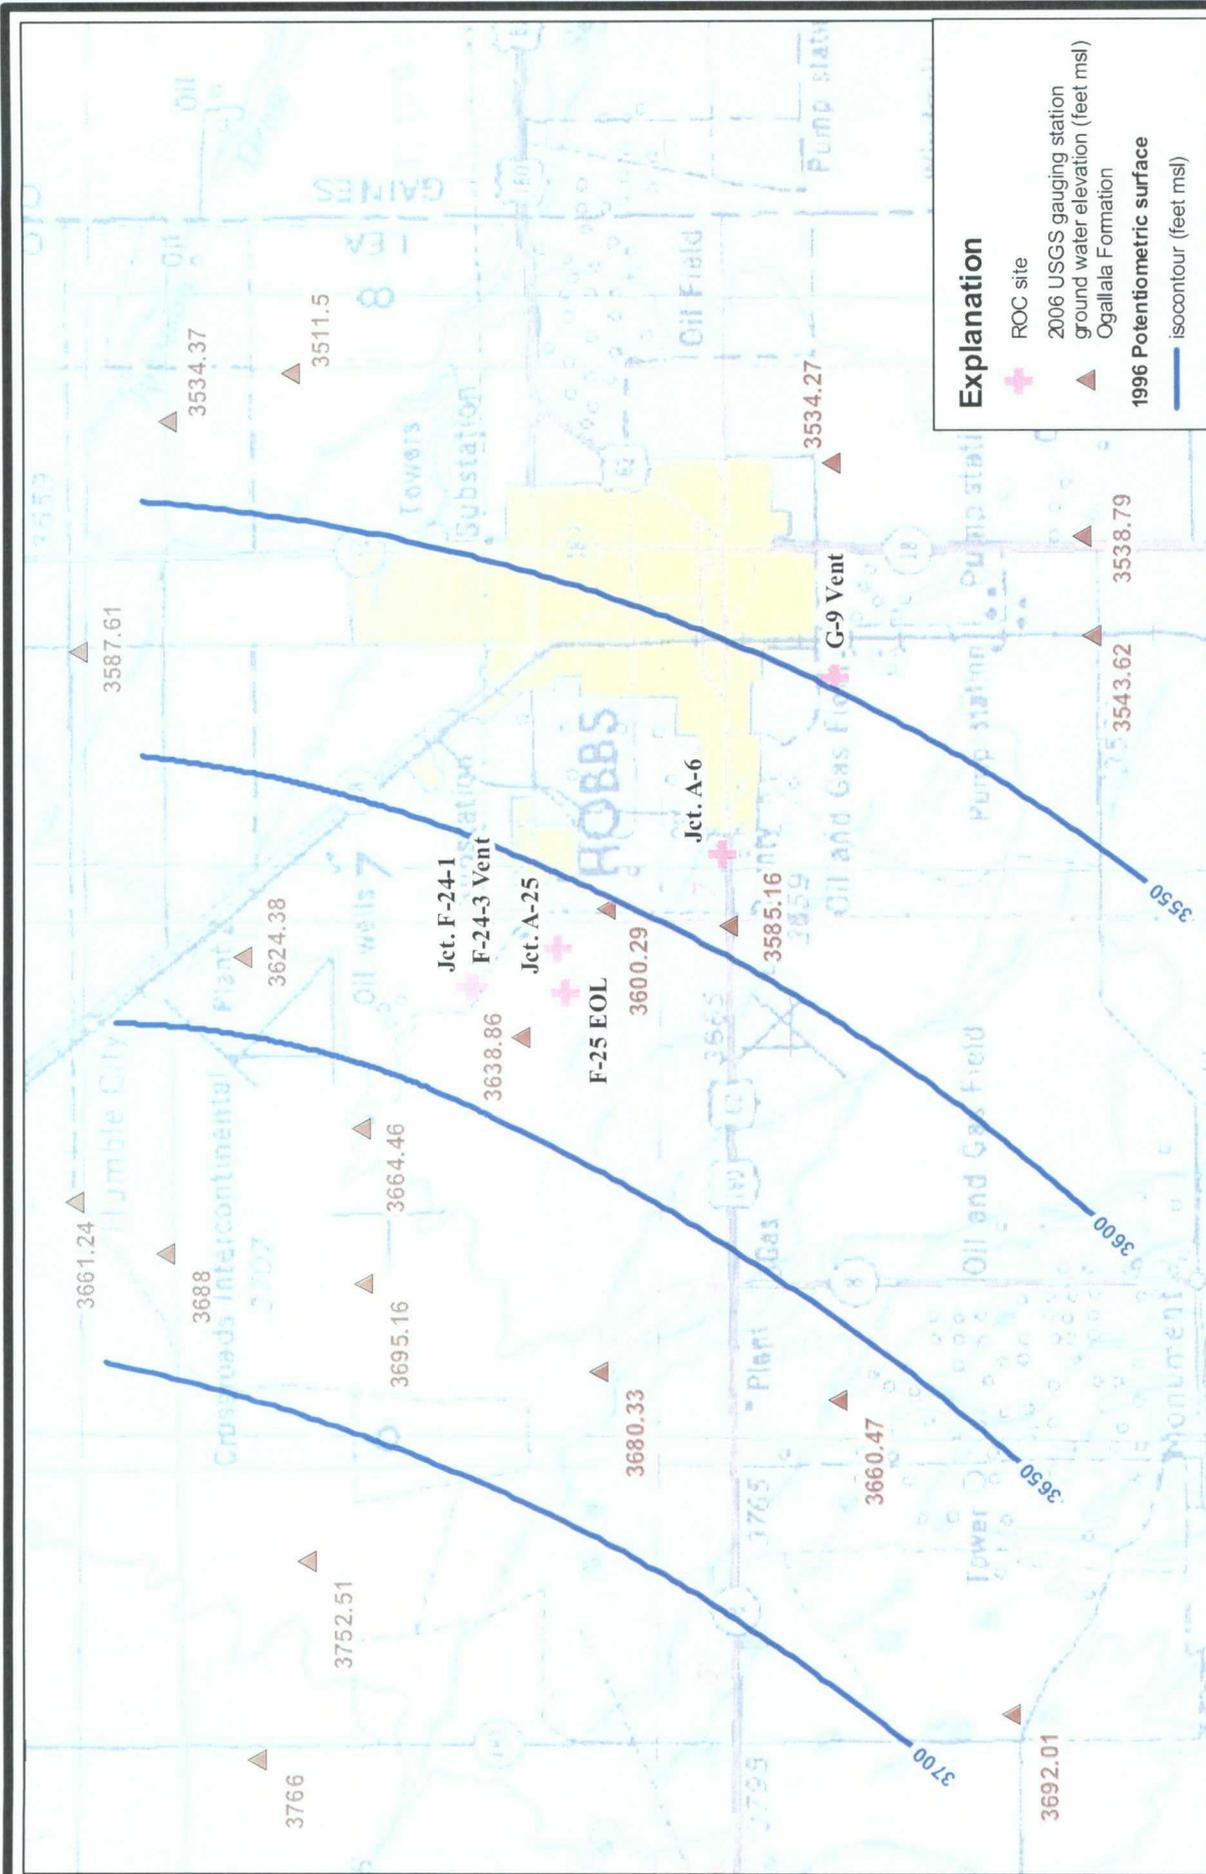
On behalf of Rice Operating Company (ROC), R.T. Hicks Consultants, Ltd. is pleased to submit this Investigation & Characterization Plan (ICP) for the six (6) junction box and vent sites within the Hobbs Salt Water Disposal System referenced above. Plate 1 is a map showing the sites relative to major roads in the area. Plate 2 shows the sites, nearby USGS monitoring wells, and a regional potentiometric surface map.

2006 Potentiometric Surface Map
 Jct. A-6, Jct. A-25, Jct. F-24-1, Jct. F-24-3 Vent, G-9 Vent

8. If the boring penetrates the capillary fringe, a monitoring well will be completed with a 2 or 4" diameter casing 25 feet down gradient from confirmed impact for use during possible corrective actions. Plate 2 presents a potentiometric surface map for the site area.
9. If field analysis of hydrocarbon vapors and observations of staining show that hydrocarbon impact is unlikely at the site or below 20-feet, collection of samples from cuttings may be substituted for split spoon sampling (chloride only).

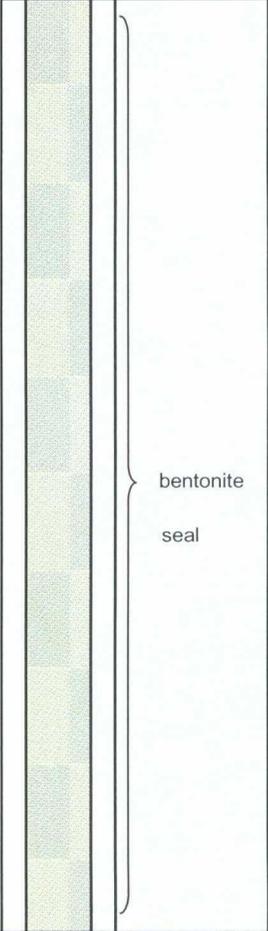
Driller:	Harrison & Cooper, Inc. Drilling	
Consultant:	R.T. Hicks, Consultants	
Drilling Method:	Air rotary	
Start Date:	9/23/2009	
End Date:	9/23/2009	
Comments:	All samples from cuttings; the soil was too rocky to split spoon. Drafted by: Lara Weinheimer TD = 25 ft GW = 45 ft	
Project Name:		Well ID:
Hobbs F-24-3 vent		SB #1
Location:		UL/F sec. 24 T18S R37E
Lat: N32°44'6.866"		County: Lea
Long: W103°12'25.644"		State: NM

Depth (feet)	chloride field tests	LAB	PID	Description	Lithology	Well Construction
				0 - 5 ft

SILT AND CALICHE		
5	151		1.2	dark brown to light gray, hydrocarbon odor		
				5 - 15 ft

SILT AND CALICHE		
10	149		4.5	dark grayish brown, hydrocarbon odor		
				15 - 20 ft

SILT AND CALICHE		
15	152		2.1	dark brown, pinkish brown caliche		
				20 - 25 ft

SAND, SILT AND CALICHE		
20	119		1.2	pinkish brown sand, brown silt, no odor		
				20 - 25 ft		
				SAND, SILT AND CALICHE		
25	150		0.2	pinkish brown sand, brown silt, no odor
