From: Terry_Gregston@blm.gov
Sent: Friday, July 23, 2010 7:11 PM
To: Pat Ellis
Cc: Ike Tavaréz (ike.tavaréz@tetrattech.com); Joshua Russo; Bratcher, Mike, EMNRD
Subject: Re: Spruce Federal Tank Battery - Immediate Notification
Attachments: Spruce Federal 1-second spill-072010-spill map.jpg

SPRUCE FEDERAL #001

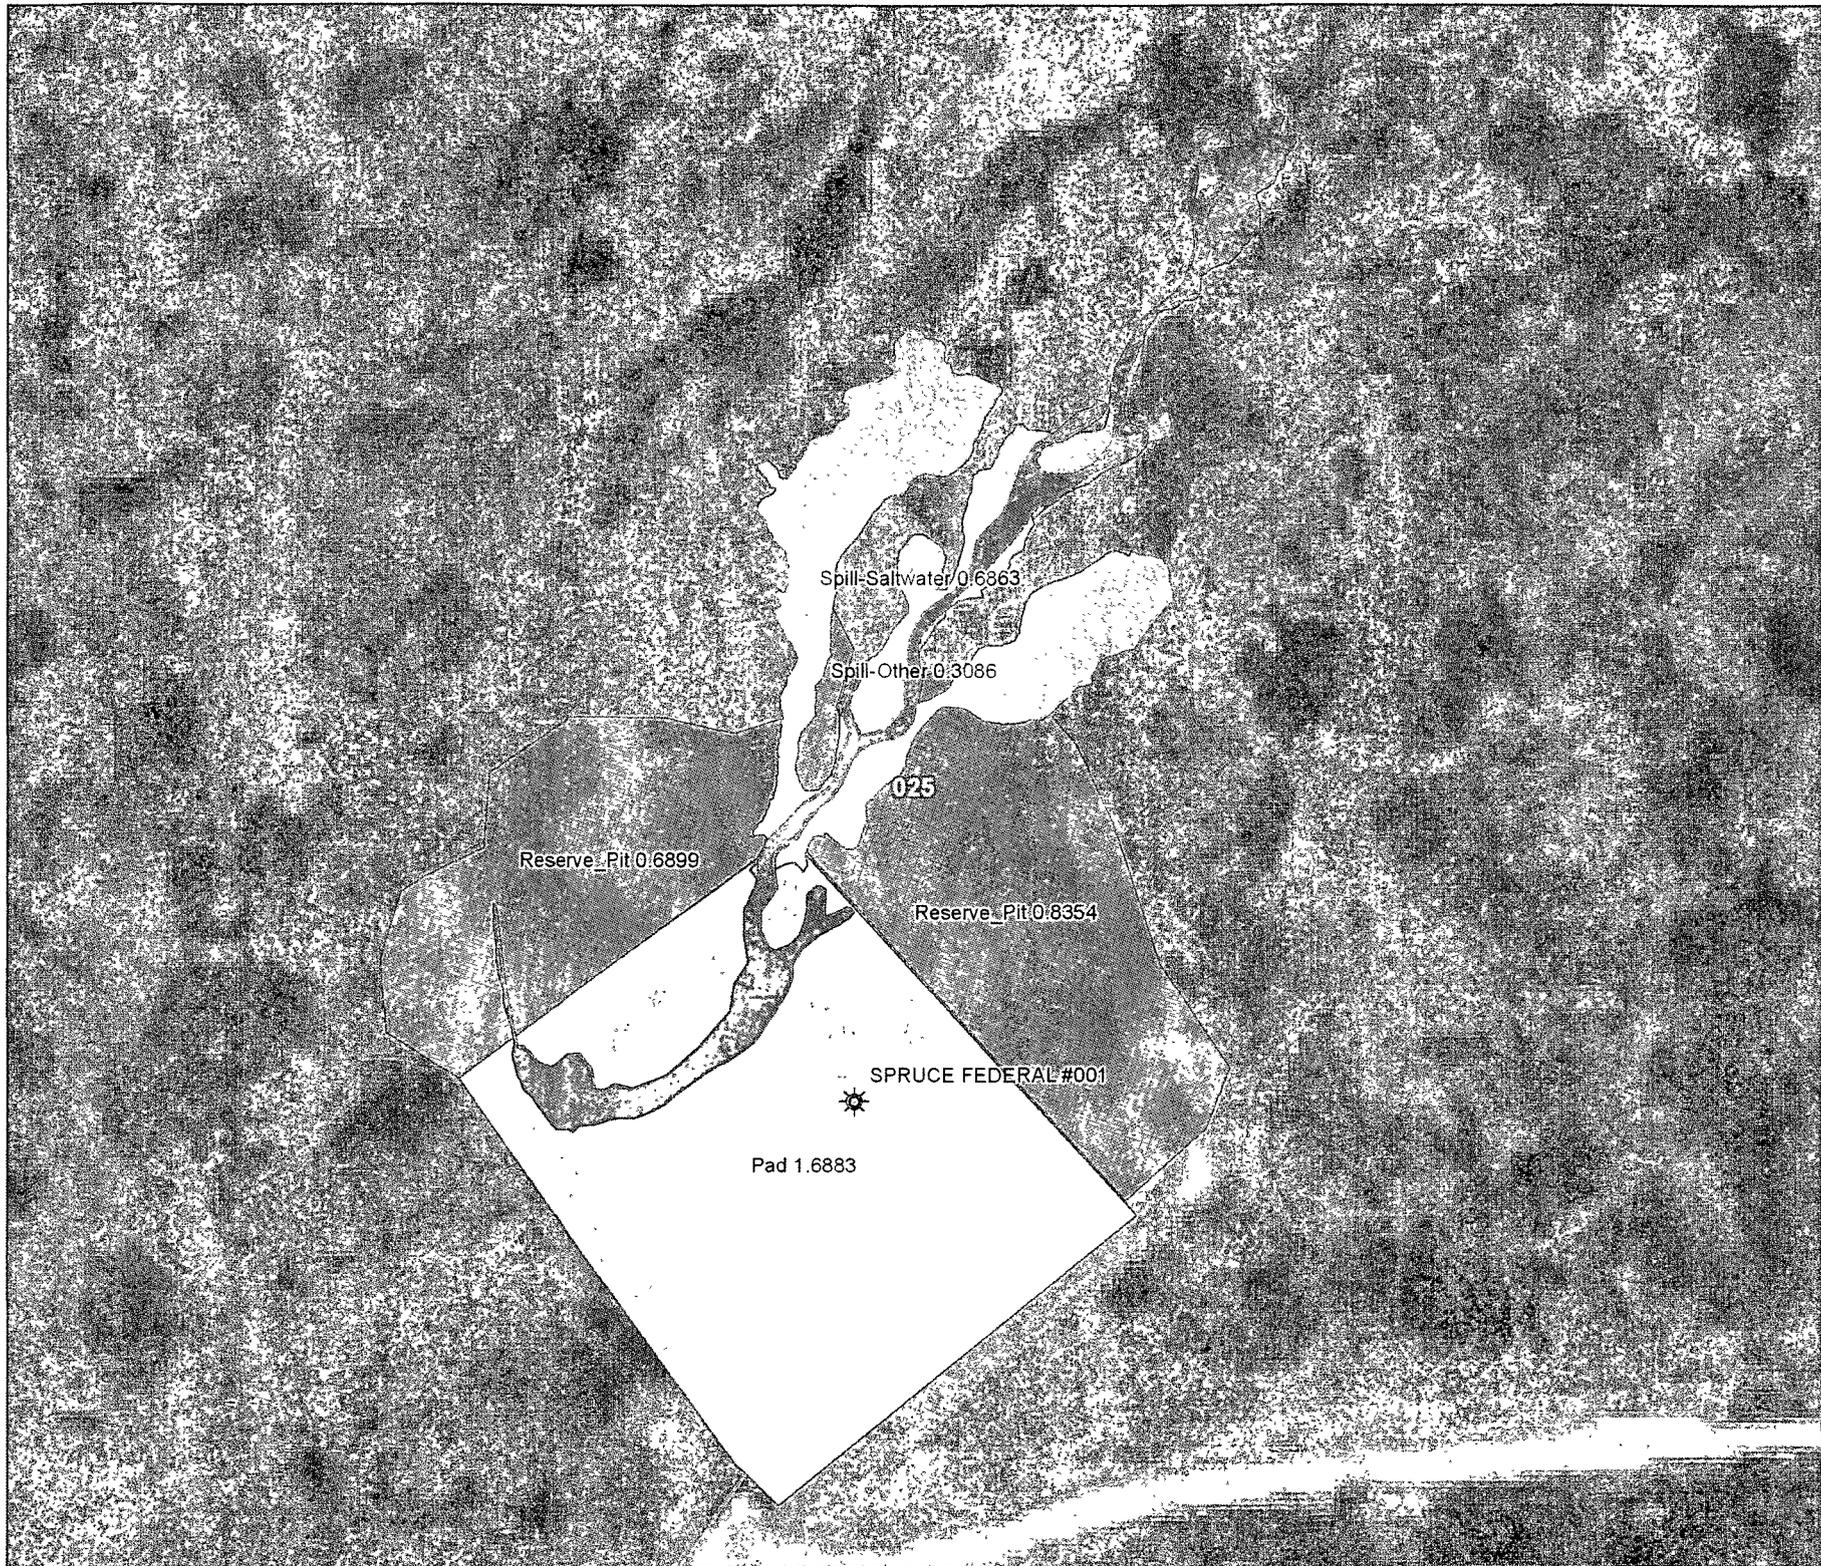
I went out and pulled an onsite on the Spruce on Thursday and GPS'd the second spill. The second spill does pretty much follow the track of the first one, but it was narrower and went farther down slope than the first spill, and it also originated farther upslope than the first spill. Also, a portion of the release from the tank ran out into the water diversion ditch that goes across the old pit. The second spill is the one in pink on the attached spill map.

Spill-Saltwater 0.6363

Spill-Other 0.3086

Reserve_Pit 0.6899

Reserve_Pit 0.8354

Pad 1.6883

Again, this area was previously cleared for archeology with the first spill, so you are free to proceed with cleanup as soon as possible. I hope you had the opportunity to pick up the worst part of the spill on the surface prior to the weekend. Due to the slope and other drainage issues, I would advise COG to proceed with cleanup on both spills as soon as possible.
