Release Notification and Corrective Action

Name of Company	COG OPERATING LLC 229137	Contact	Pat Ellis
Address	550 W. Texas, Suite 100, Midland, TX 79701	Telephone No.	432-230-0077
Facility Name	Northwest Central Tank Battery	Facility Type	Tank Battery

From: Joshua Russo [jrusso@conchoresources.com]
Sent: Tuesday, November 16, 2010 9:43 AM
To: Bratcher, Mike, EMNRD; terry_gregston@nm.blm.gov
Cc: Pat Ellis; james_amos@nm.blm.gov; Tarez, Ike; Dorey, Kim; tom.k.franklin@tetrattech.com
Subject: C-141 Initial Report - Northwest Central Tank Battery
Attachments: NORTHWEST CETRAL TANK BATTERY (MCINTYRE DK FEDERAL #6) -- DATE OF RELEASE -- 11-04-2010.PDF

From: Terry_Gregston@blm.gov
Sent: Tuesday, November 16, 2010 11:32 AM
To: Joshua Russo
Cc: james_amos@nm.blm.gov; Bratcher, Mike, EMNRD; Tavarez, Ike
Subject: Re: C-141 Initial Report - Northwest Central Tank Battery
Attachments: Northwest Central Tank Btty-McIntyre DK Federal 6-spill map-110410.jpg

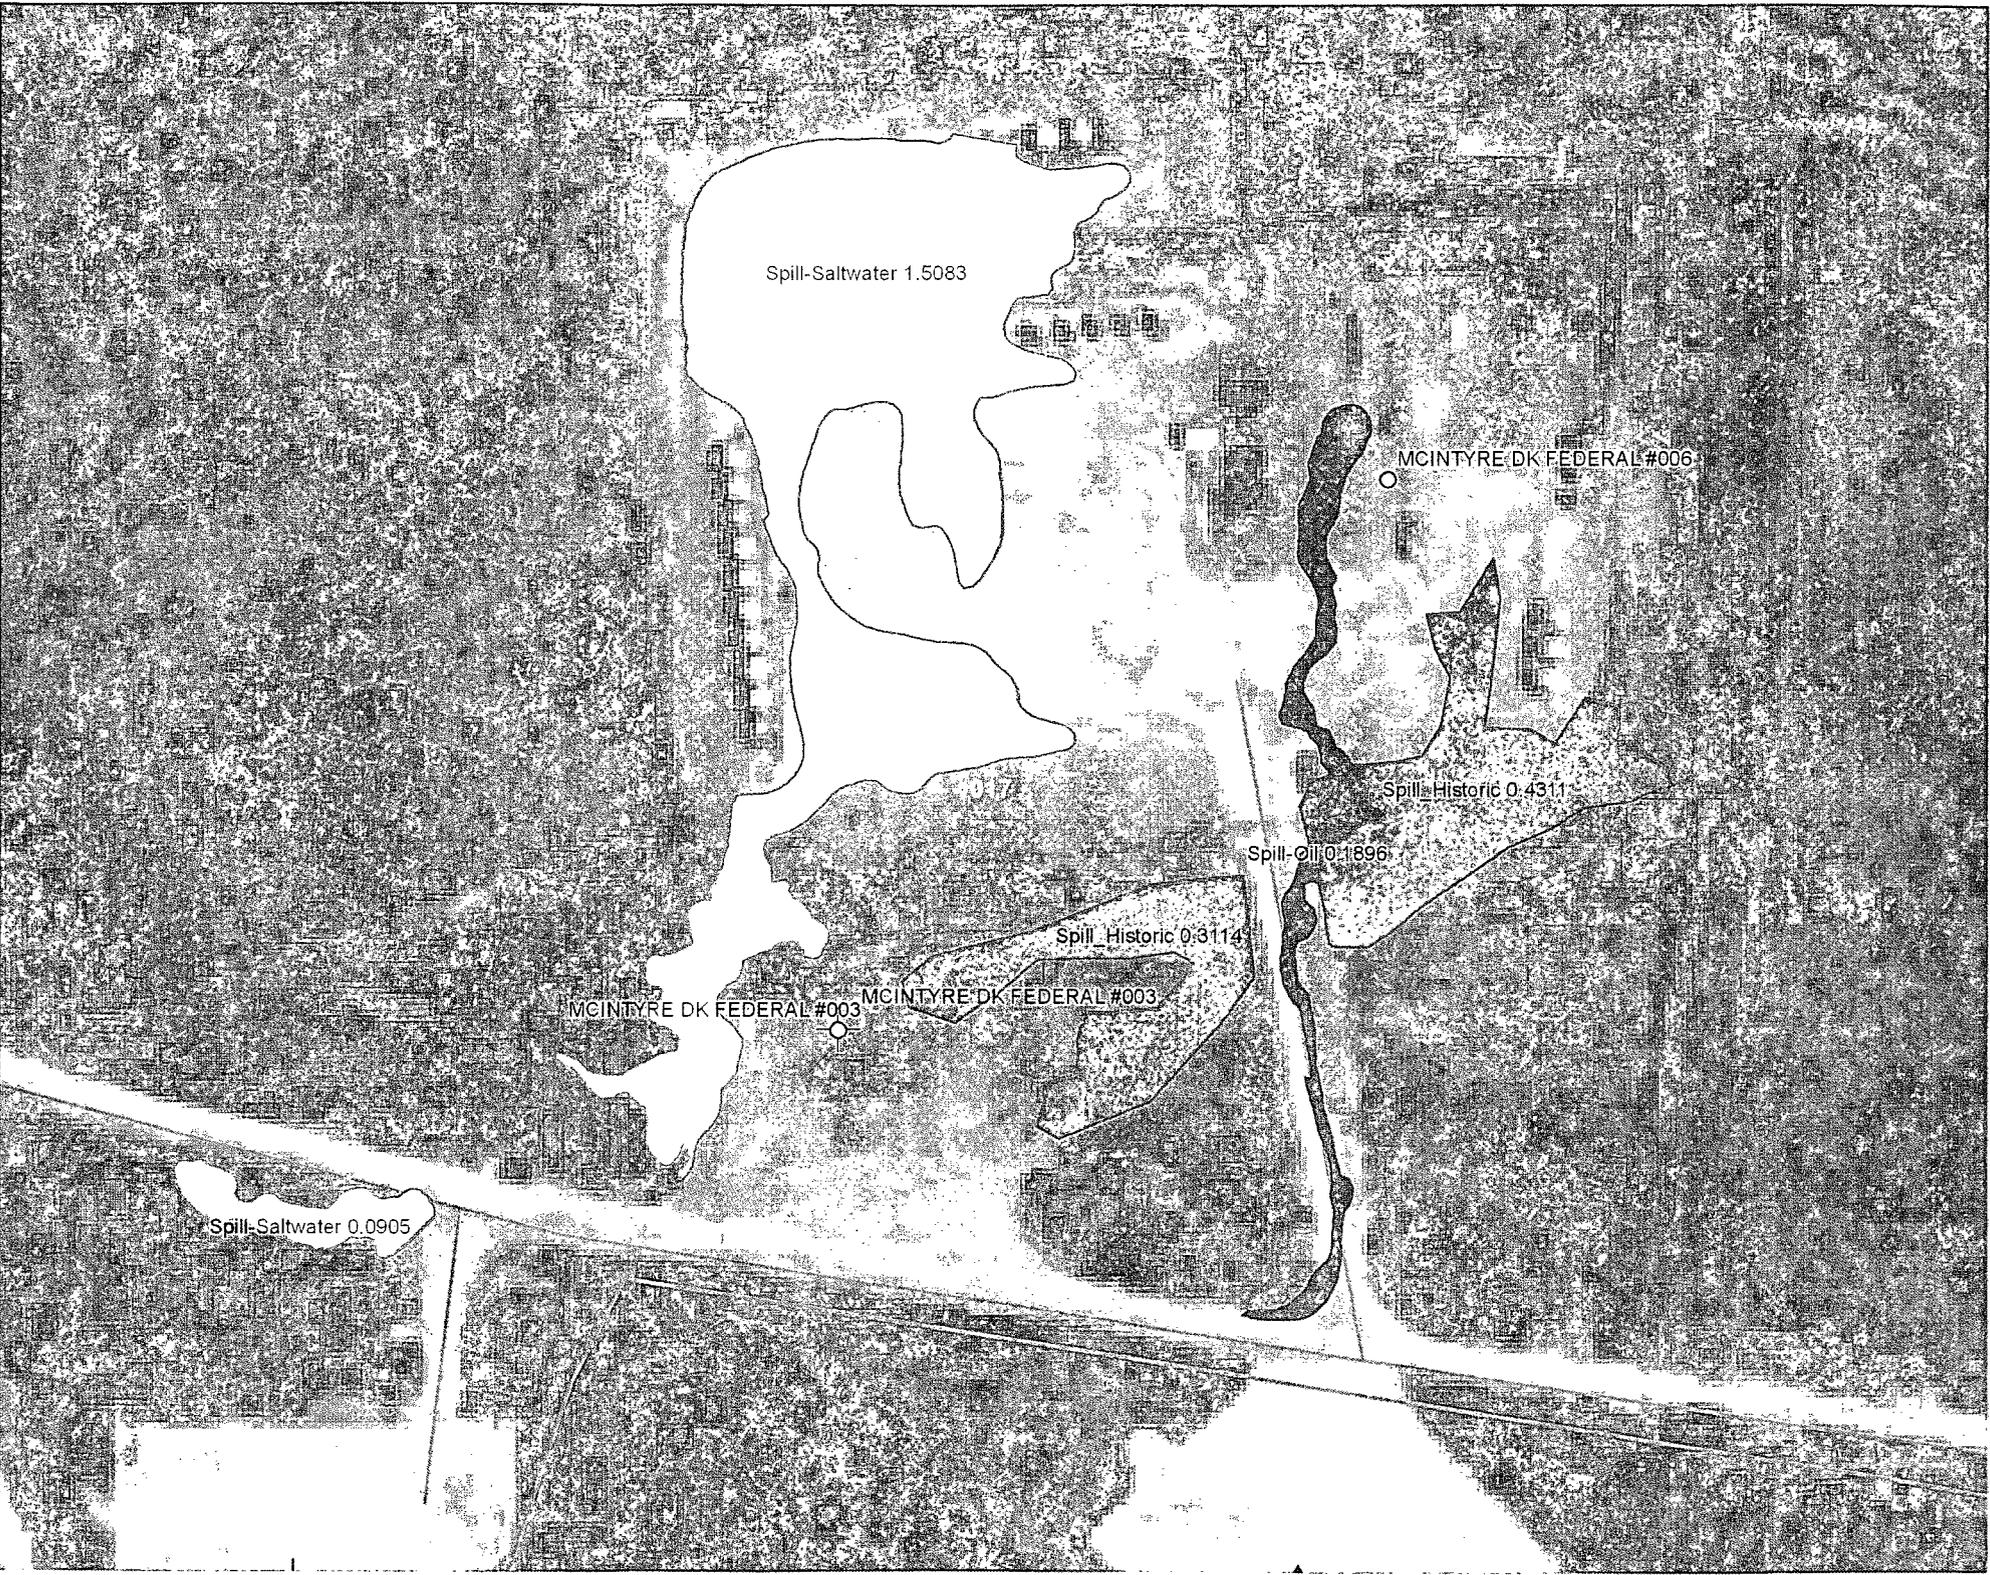
I have received your C141. Attached is the spill map of the site collected on 11/05/10. In order to differentiate the newer oil spill from the McIntyre 6 from the older oil spill that it crossed, the older spill is labelled as "historic". It is not a historic spill, it is just an older spill than the one on top of it. The map shows all the current spills on the Northwest Tank battery. The small spill to the lower left has been cleaned up, reclaimed, and reseeded as of last month. It would be good to address the older spill under the McIntyre 6 spill at the same time that this newest spill is addressed. In order to prevent more spills from leaving the pad once all the current spills are addressed, COG should consider berming the southern half of the pad and installing low areas to catch the overflows. These would need to be vacuuumed up in heavy rains and/or spill events to keep the water off, but it could save a great deal in reclamation costs for spills that leave the pad ---and protect the cleanup work that will be performed when all the spills on this tank battery are addressed.

Spill-Saltwater 1.5083

Spill_Historic 0.4311

Spill_Oil 0.1896

Spill_Historic 0.3114

Spill-Saltwater 0.0905
