NAVAJO REFINING COMPANY  
ARTESIA REFINERY, EDDY COUNTY, NEW MEXICO  
**FIRST SEMIANNUAL EVENT 2010 (MAR-APR)**

## VALLEY FILL AQUIFER POTENTIOMETRIC SURFACE MAP

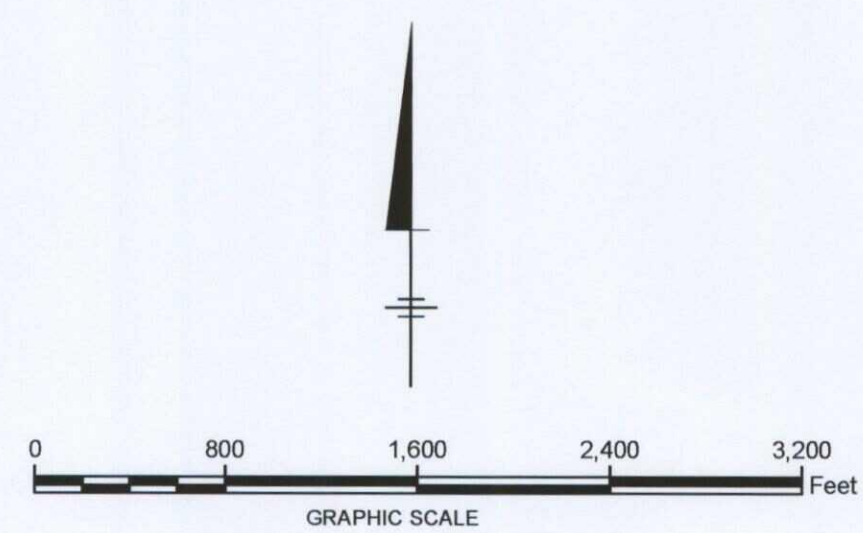
**FIGURE**  
**4**

- ◆ MONITORING WELL  
 ○ RECOVERY WELL  
 ■ IRRIGATION WELL  
 ● ABANDONED WELL  
 — VALLEY FILL AQUIFER POTENTIOMETRIC SURFACE CONTOURS
