From: Cheryl Winkler [cmwink@me.com]
Sent: Tuesday, January 25, 2011 11:34 AM
To: Bratcher, Mike, EMNRD
Cc: tbrandt@mar-win.com; gherrera@mar-win.com
Subject: Dublin 23 Federal No. 1 Lab Results Today

Project Name: Dublin 23 Fed. No. 1 Discharge
Project Number: Unauthorized Discharge

From: Cheryl Winkler [cmwink@me.com]
Sent: Monday, January 24, 2011 5:19 PM
To: Bratcher, Mike, EMNRD; jim_amos@nm.blm.gov
Cc: tbrandt@mar-win.com; gherrera@mar-win.com
Subject: Dublin 23 Federal No. 1 Further Excavation Consideration

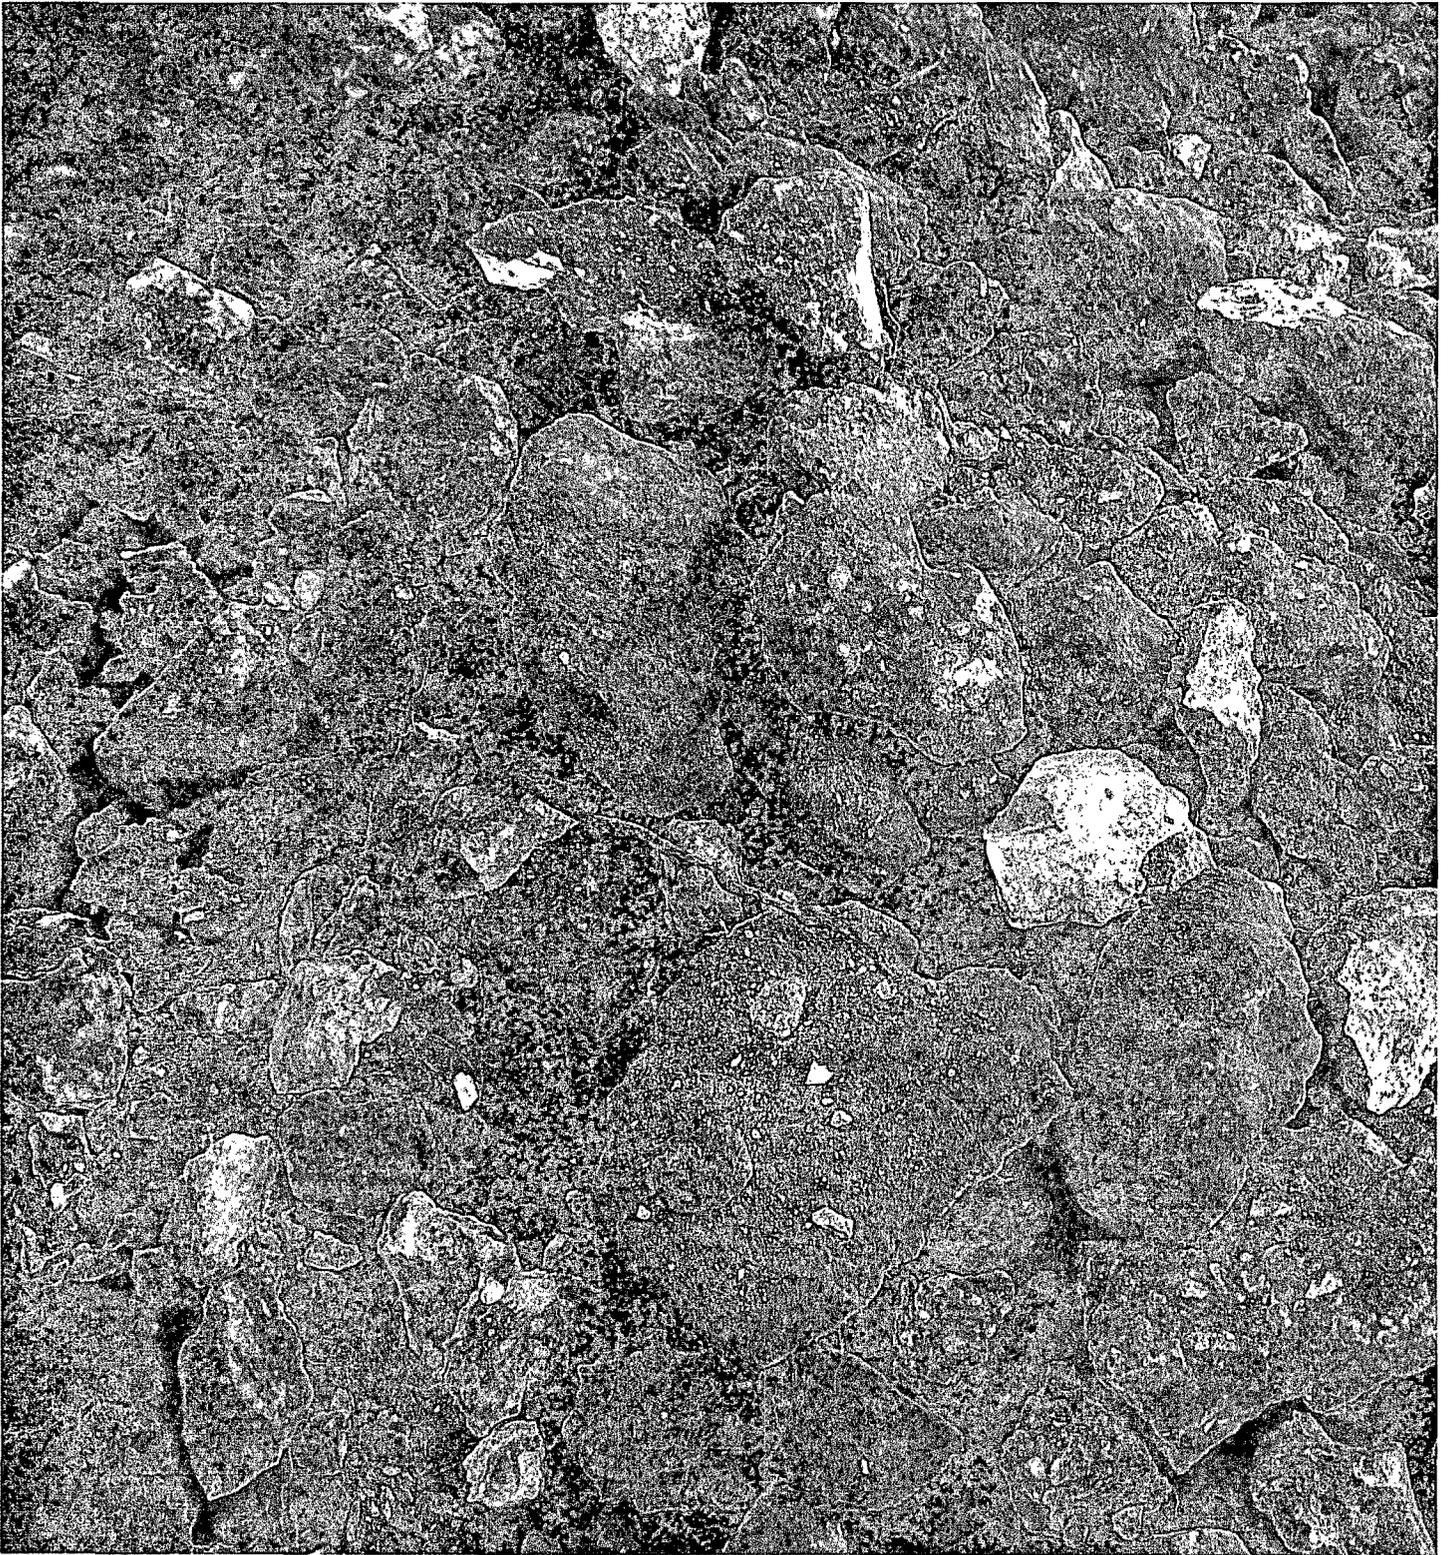
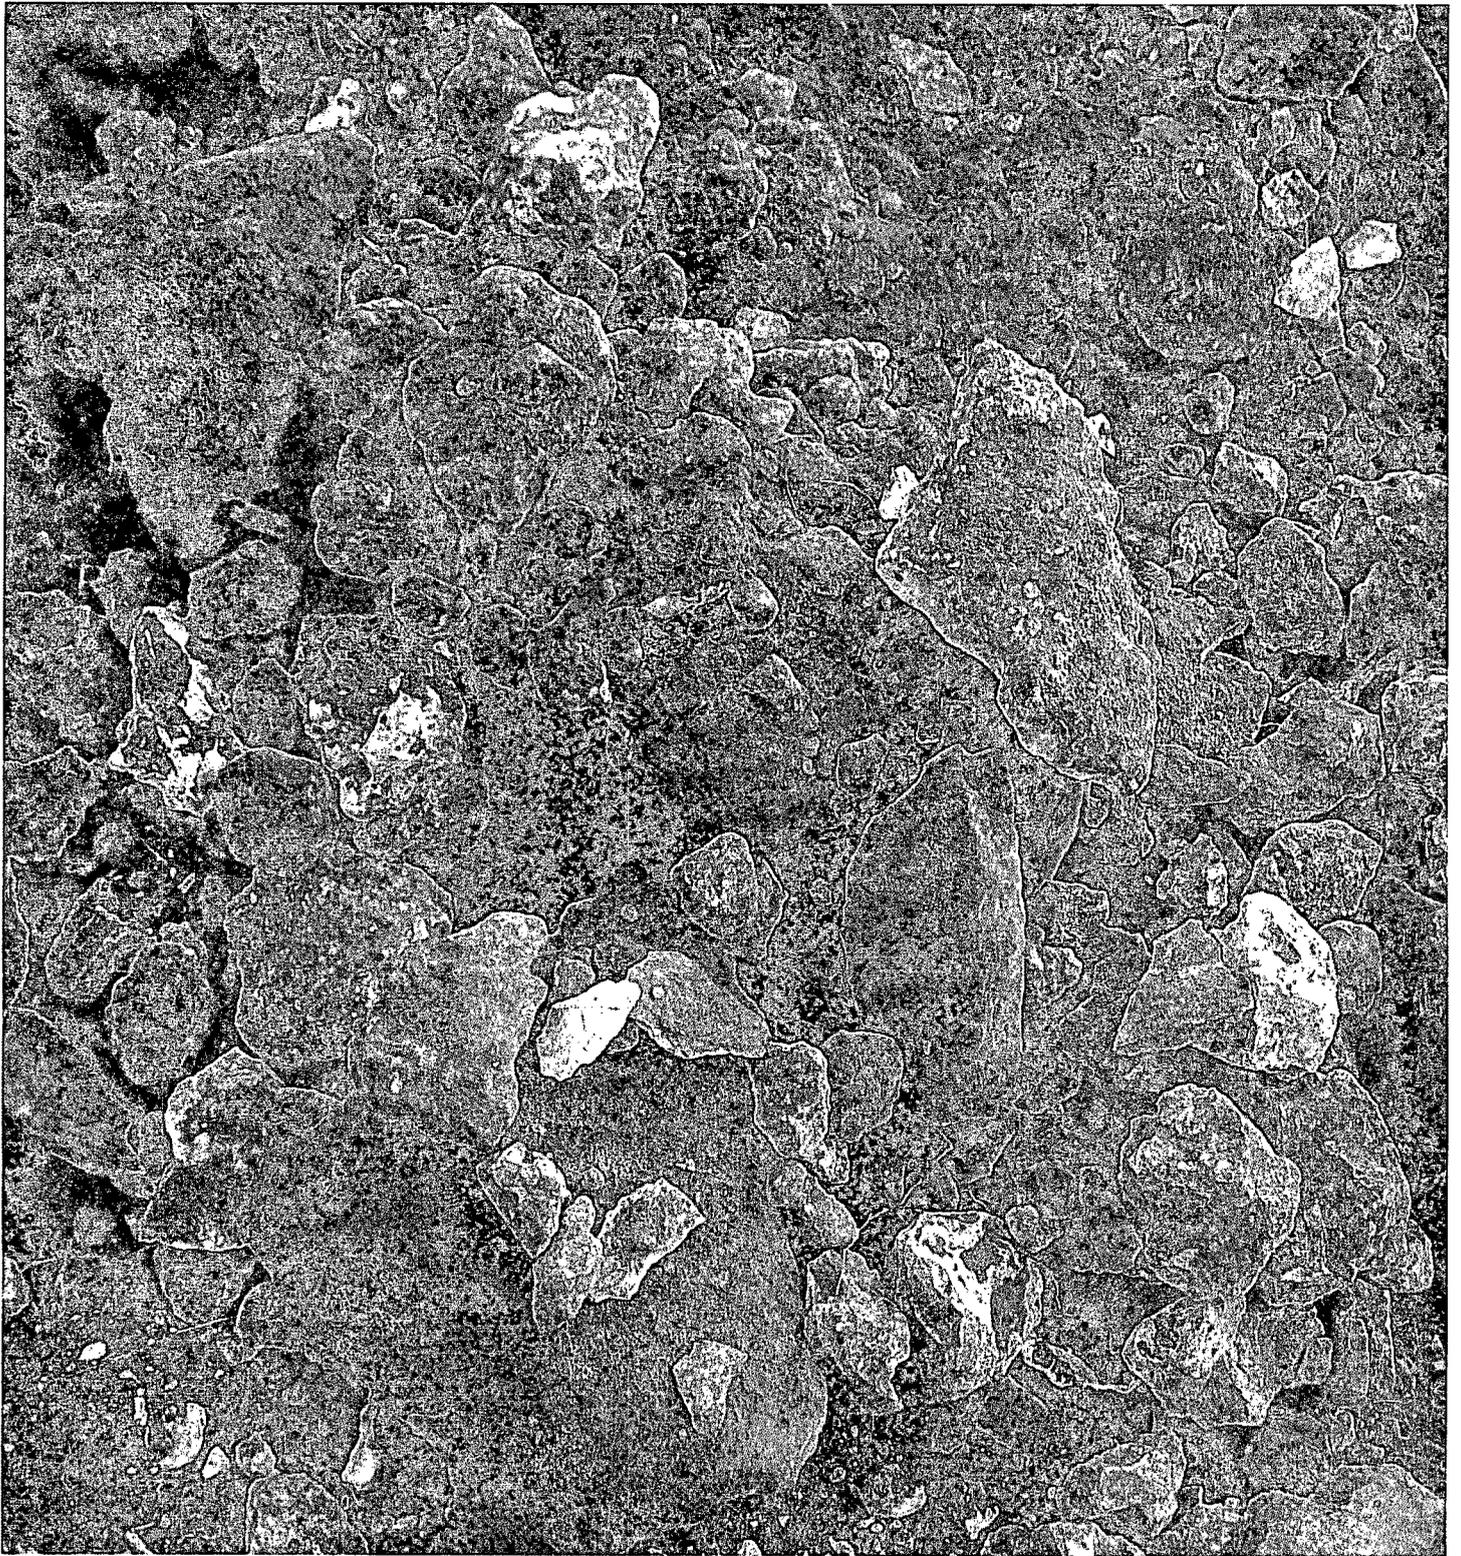
The attached 4 photos were taken during the latest excavation of the contaminated soil resulting from the unauthorized discharge of produced water by the trucking company hauling for Marshall & Winston. As you can tell from the laboratory analyticals which I have forwarded to you, the sodium chloride levels are currently averaging around 5,000 mg/K in the impacted soils. Since this report was issued, we have subsequently removed another 4" of material in an attempt to reach NMOCD regulatory standards but I would suggest it is not bearing further environmental benefit for the simple reason that the impact is not a "fit" for the normal situation. We have been excavating mostly rock with very little accompanying soil because it just isn't present in this ecosystem. Currently, we are on top of the cap in this area whose groundwater lies somewhere around 400 feet beneath it.

The latest soil chloride samples will be ready by early tomorrow but the dilemma still remains. We are on solid rock (See jpeg No. 5967) and literally cannot excavate more unless we penetrate the rock lens with something like a rock hammer. Then, we will only pollute the subterranean environment. *This is a very small area as well.*

Further, such an aggressive/radical action forebears any common sense application of environmental assuredness. Remember to, we began with 80,000 mg/K on the surface which for all practical and measurable options has been removed. What does make sense is to replace the excavated material with good soil, fertilize and seed it pursuant to BLM seed mixes for this area. Thus, restoring the natural habitat of the area. No contamination will pass through the rock cap and penetration of the cap is definitely not prudent.
