Vacuum M-31 EOL

CLOSURE

Unit M, Section 31, T17S, R35E

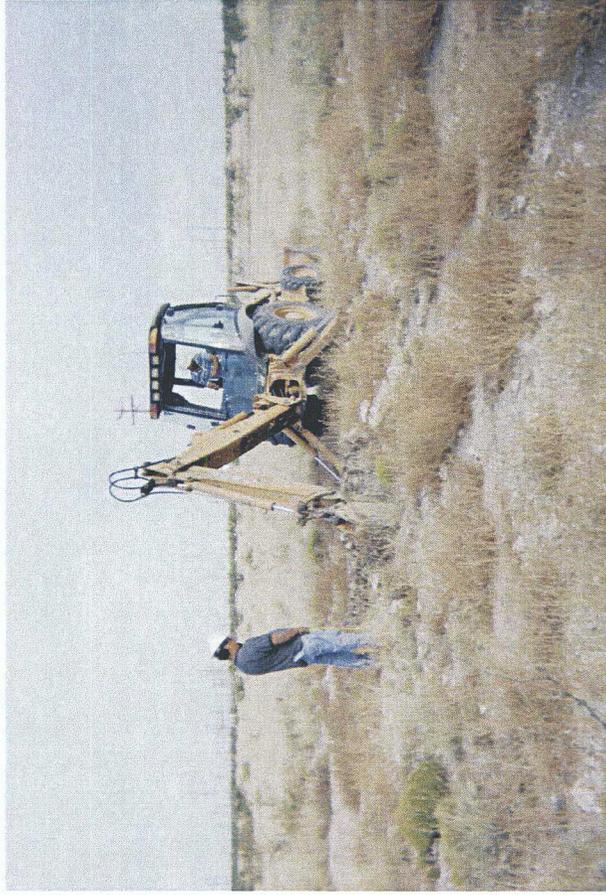
10/18/2010

Digging initial vertical delineation trench

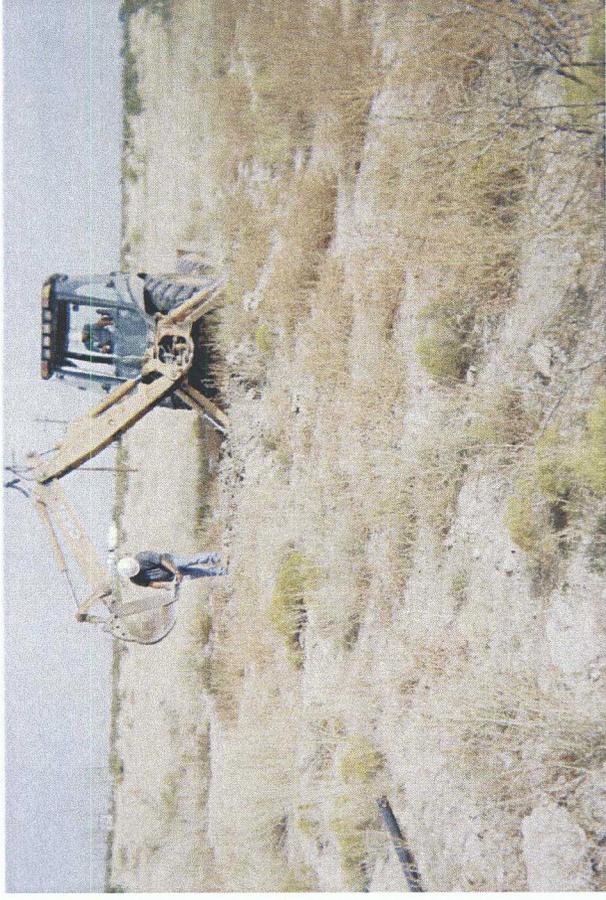
10/18/2010

Collecting Sample

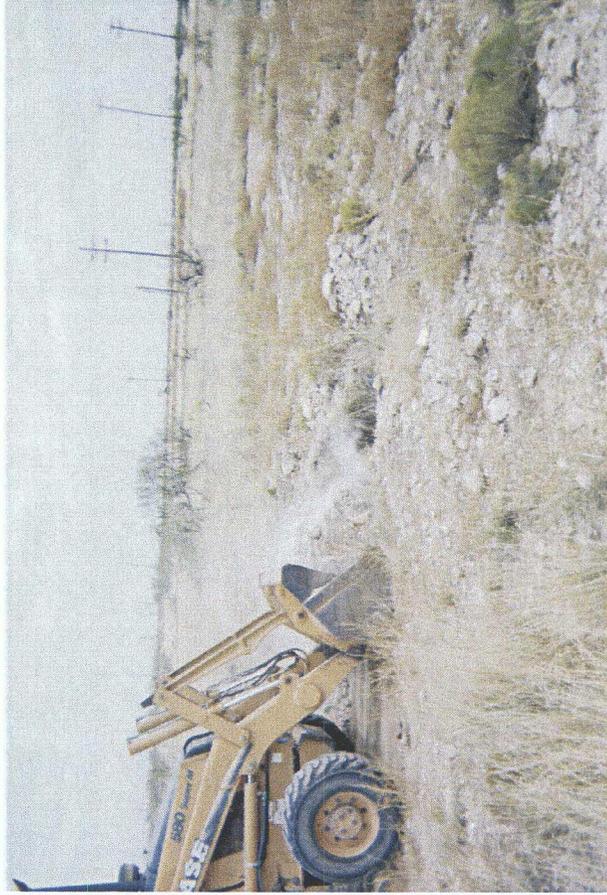
10/25/2010

Backfilling site

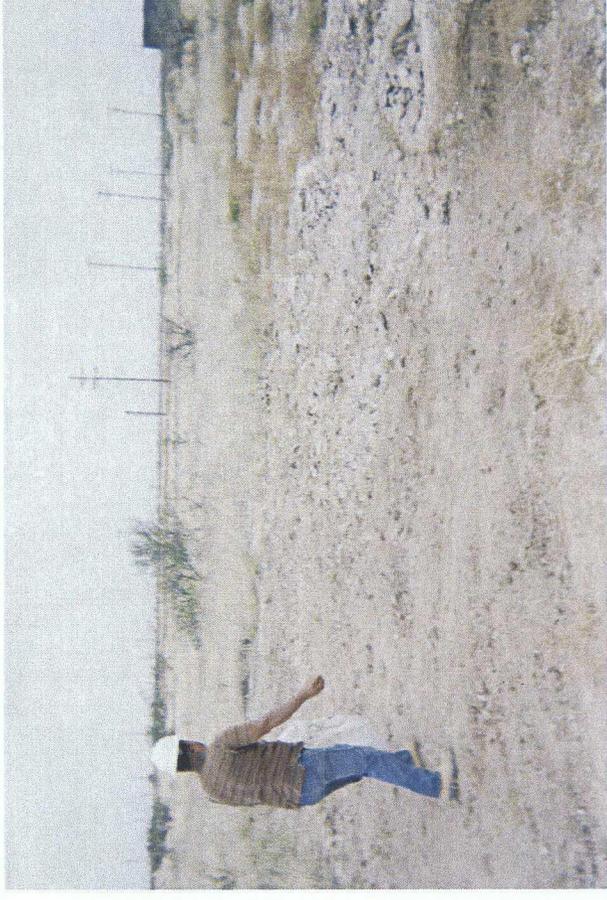
10/25/2010

Seeding site

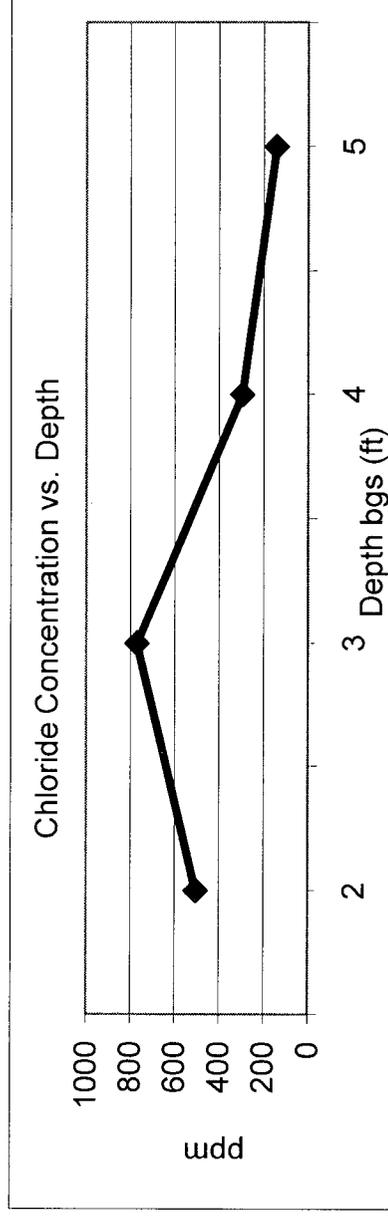
Backhoe samples at the junction (source)

Depth bgs (ft)	[Cl] ppm
2	505
3	770
4	295
5	142

Groundwater = 95 ft
