DELINEATION WORKPLAN

OXY – BRAVO DOME LEG 7 (Leak Date: 10/10/16)

RP # 4RP-11

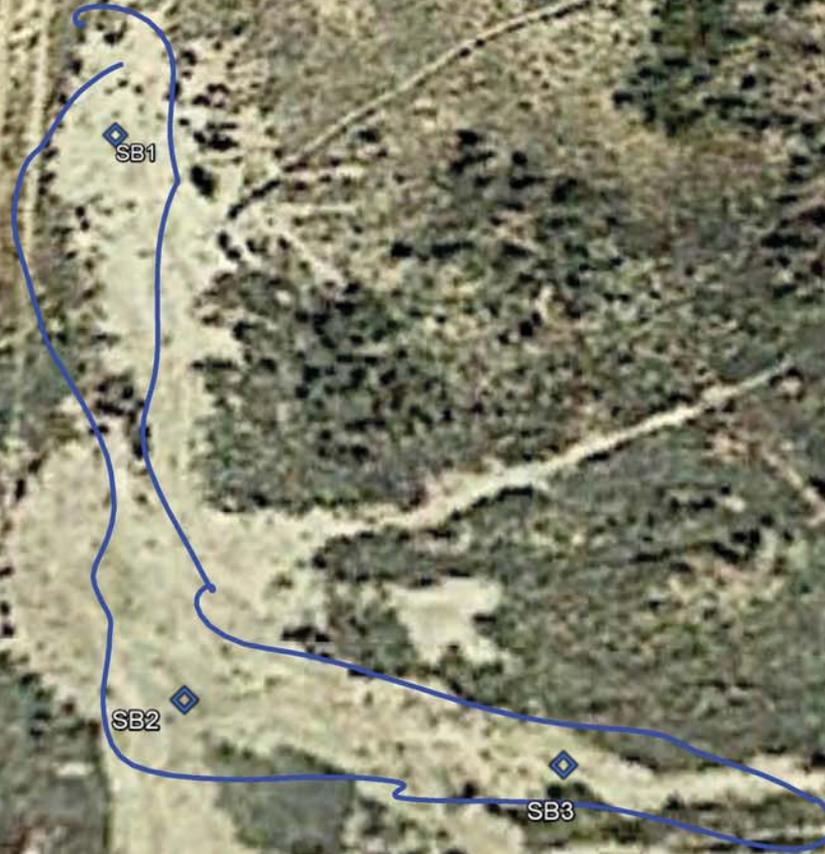
The entire site will be revegetated (if warranted) to the standards of the appropriate regulatory agency or private surface owner.

Oxy, Bravo Dome Leg 7

Legend

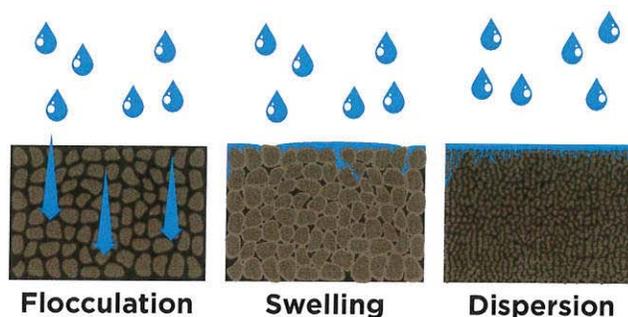
Halophytes are able to grow and reproduce in soils with EC values of 20 dS/m or more. In comparison, EC values above 2 dS/m negatively affect the growth of many row crops and small grains. Halophyte plants are able to survive due to adaptations that allow them to regulate, transport or store salts safely in special compartments of the plants' tissues.

For most soils in the region, when the SAR from a saturated paste extract (assume that at values of less than 50, the SAR \approx exchangeable sodium percentage \approx % sodium) is 5 or more and the EC of the saturated paste is 2 dS/m or less, soils will swell and/or disperse (Figure 3). Thus, remediation strategies should focus on reducing the concentration of sodium (a known dispersant), increasing the concentration of calcium (a known flocculant), and maintaining EC levels above the threshold at which swelling and dispersion will occur.

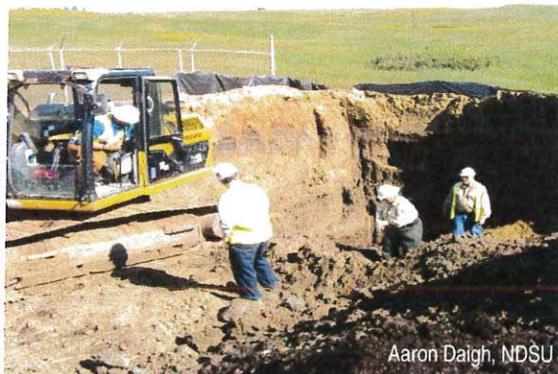
The success of *in situ* remediation can be enhanced through the establishment of halophytic vegetation. Halophytes take up salts and store them in plant parts. Harvesting the above-ground biomass and removing it from the site can reduce salts in the soil.

Ex Situ Remediation

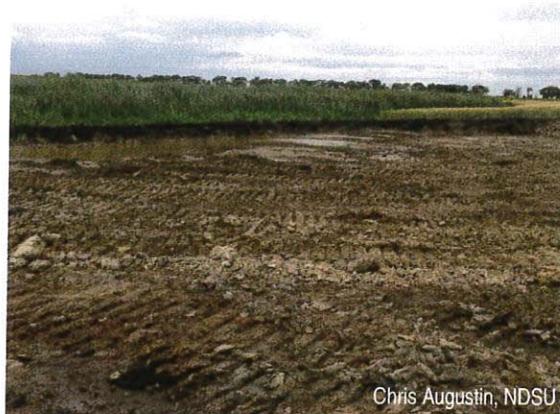
Aaron Daigh, NDSU

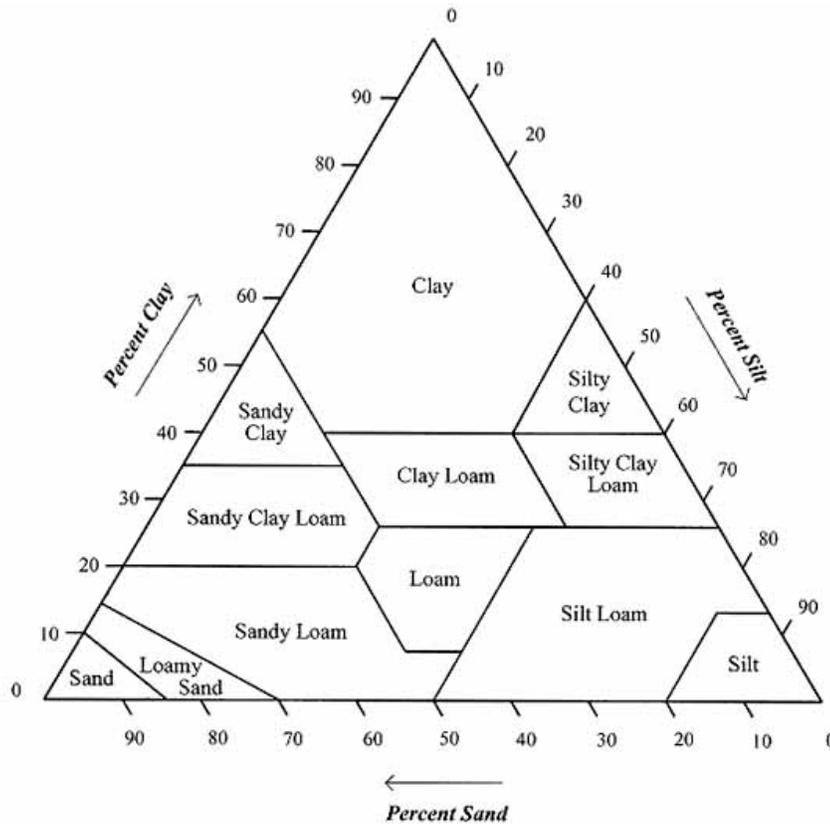
A wide variety of clay particles with very different characteristics are found in the soil. The differences in clay type will affect the characteristics of the soil quality.

Figure 4 - Textural triangle illustrating the twelve USDA soil classifications.

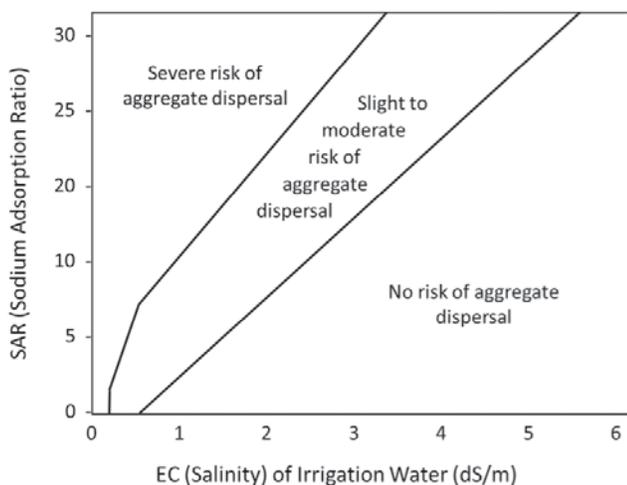
In addition to the relative proportions of flocculating cations, it is also important to know the total concentration of soluble salts in the soil. Cations are always accompanied by negatively charged ions (anions), and together they are called salts. Salts dissolved in water conduct electricity, so we can measure the electrical conductivity or EC of a soil-water mixture to determine the amount of salt.

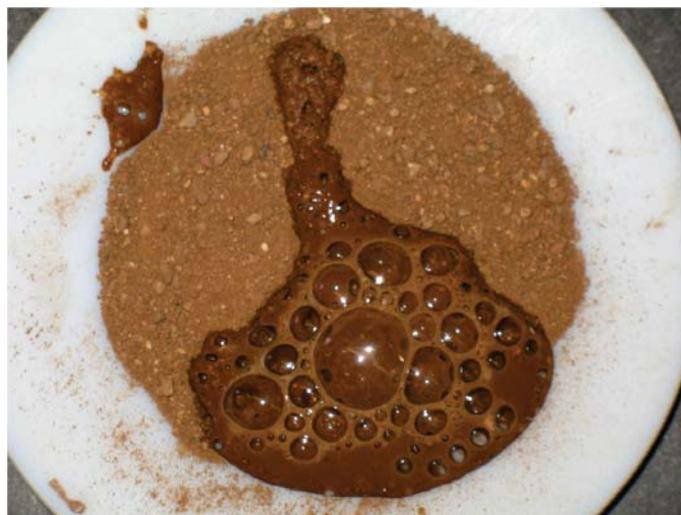
Figure 2. Calcareous soil effervescing when acid is applied.
