**Revised RCRA Facility Investigation
Phase II Report
North Colony Landfarm
Navajo Refinery, Artesia, New Mexico**

**Navajo Refining Company
501 East Main Street
P. O. Drawer 159
Artesia, New Mexico 88210**

November 1997

COVENANT TECHNICAL ASSOCIATES, INC.

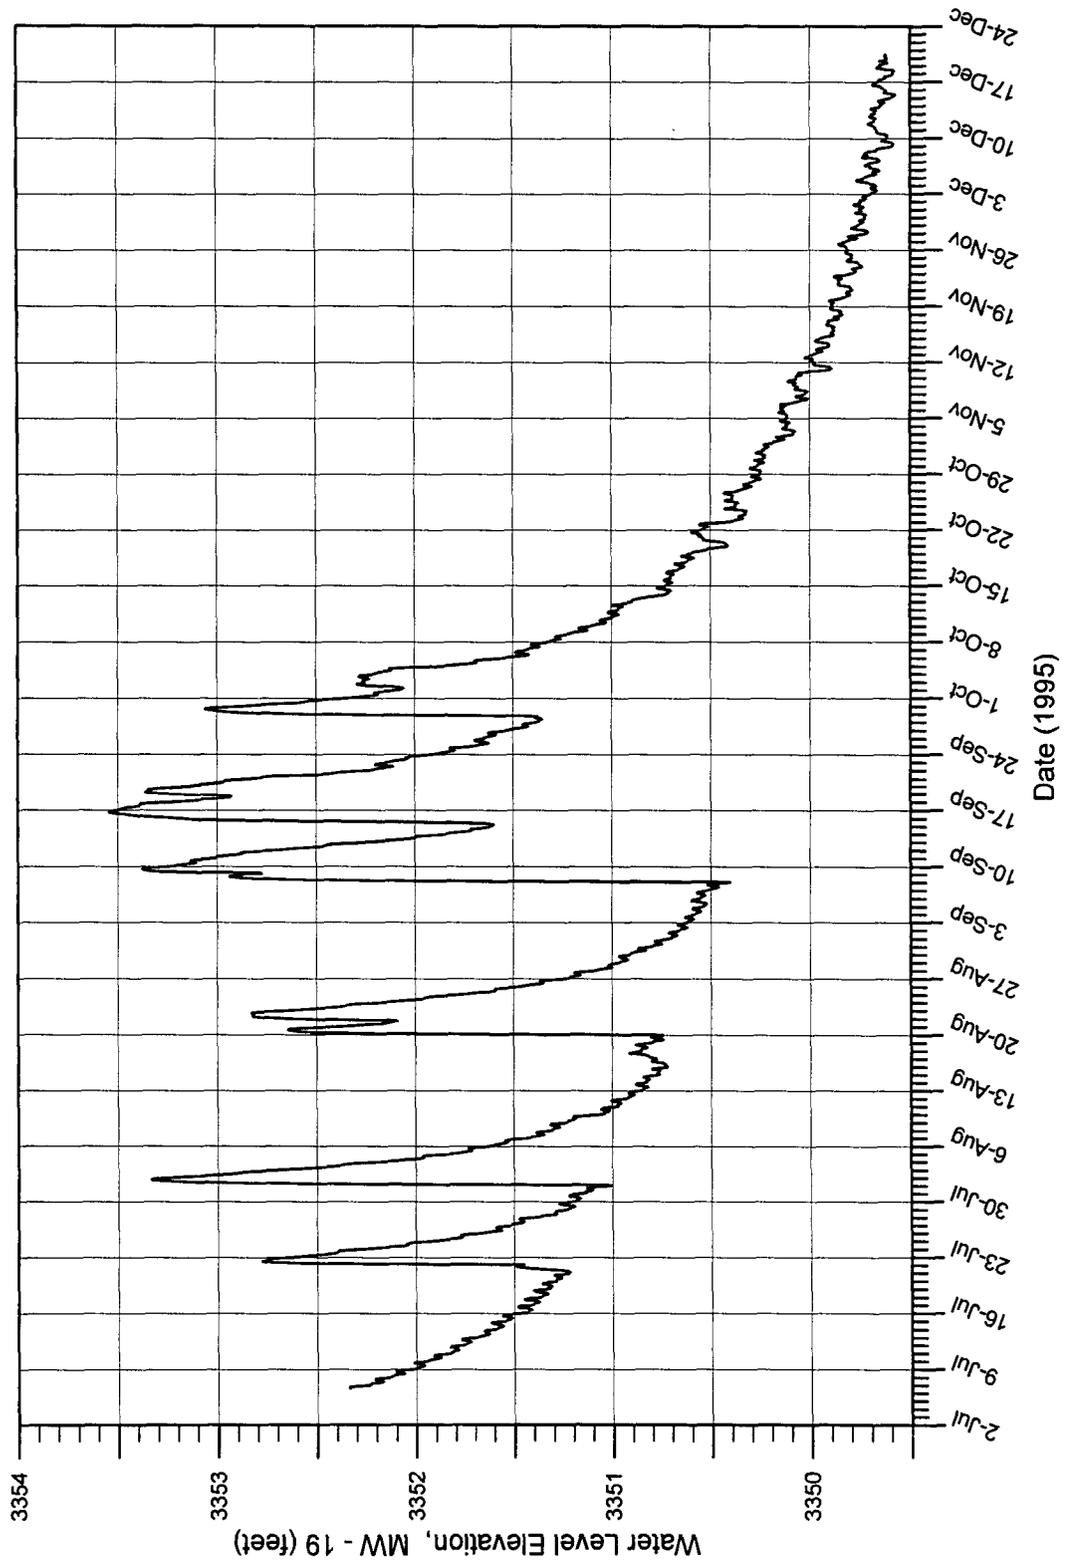
Figure 6-7. Six-Month Water Level Elevations, North Colony Landfarm, MW-19, July - December, 1995

Although monitoring of groundwater elevations on a periodic basis provides an accurate snapshot of the hydrologic system at fixed point in time, the detection of rapid potentiometric fluctuations, such as might be caused by precipitation, irrigation, pumping, etc., is more appropriately assessed by means of continuous groundwater elevation monitoring. Therefore, in early July 1995, a data logger as described in Section 5.2.2.4 was installed adjacent to the NCL in unused MW-19. Data from the recorder was downloaded and copied into a PC-driven graphical plotting program. The resultant graph is presented in Figure 6-7.

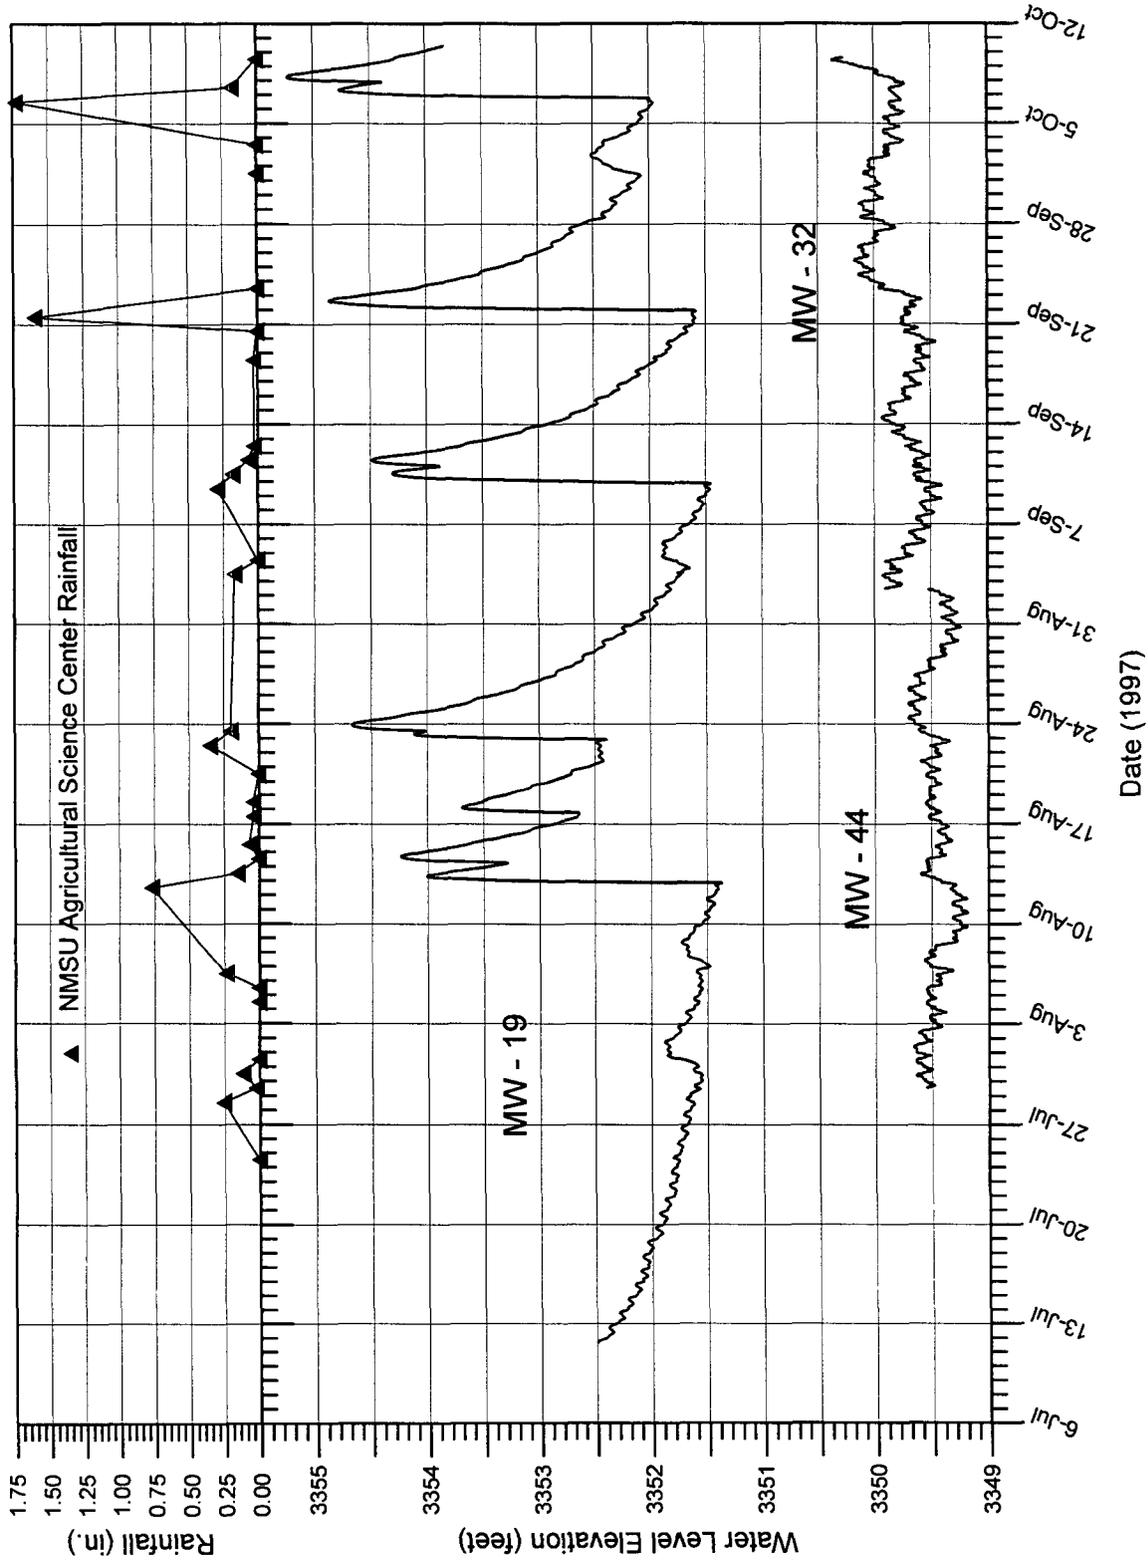
Figure 6-9. Water Level-Rainfall Relationship, North Colony Landfarm, MW-19, -32, and -44, July - October, 1997

The exercise was repeated in 1997 for collection of data at multiple NCL observation wells simultaneously. Two water level data recorders were installed. The first was reinstalled in MW-19 on July 11 and remained in that well until October 10. The second data recorder was installed in NCL-44 on July 29, removed on September 2, and placed in NCL-32 that same day. It remained in that well until retrieval on October 9. These two wells are located on the north-central and northeast side of the landfarm and are generally downgradient from MW-19. Daily precipitation data was only available from the NMSU Agricultural Science Center and is combined with the water level data for presentation on Figure 6-9.

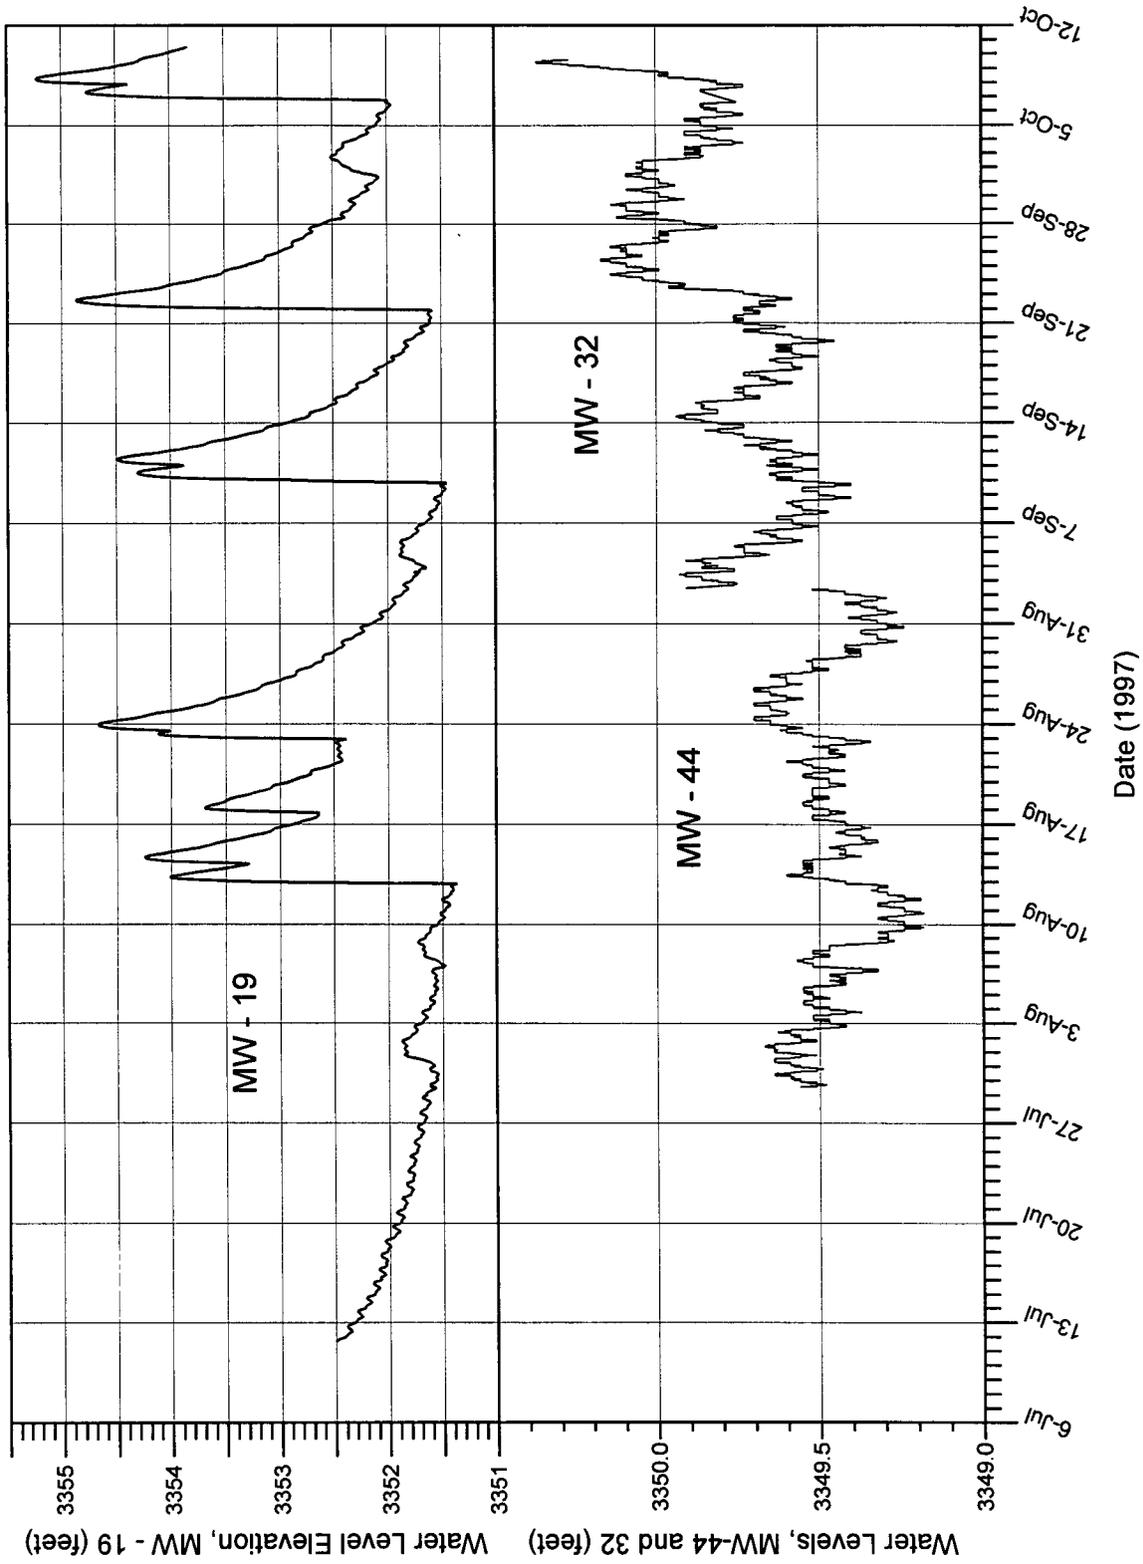
Figure 6-10. Hydrograph Comparison, North Colony Landfarm, MW-19, -32, and -44, July - October, 1997

The exact location of the source of water that recharges MW-19 is unknown. The City of Artesia is directly upgradient from the NCL and no obvious nearby infiltration source, such as a retention basin or city park pond was identified. A shallow unlined city stormwater drainage ditch is located adjacent to NCL. Limited trenching performed along the ditch during the NCL Phase I investigation and reported in Section 6.1.1.2 found that clay overburden present in the ditch location was similar to that observed directly under the landfarm. However, since the ditch is concreted in the city and concentrates rainfall runoff, it is possible that a relatively small permeable recharge area may exist at the juncture of the lined and unlined portion of the ditch. This is given some credence by the fact that both highway and railroad structures occur at the same location and the ditch was no doubt excavated at that locale to remove the overlying clay and provide foundation structural stability. This, combined with stormwater scouring at the exit point of the concreted ditch, may provide a permeable temporary storage site and serve as a source of subsurface infiltration. If this location is not the source of the water, the next possible upgradient source is Eagle Draw in an area in the city where it has been modified from an incised channel into a broad swale that serves as a park planted with grass, landscaped, and irrigated with wastewater effluent. If the recharge is from Eagle Draw and the direction of flow remains constant, the closest upgradient location for such infiltration to occur is at distance of about 4,000 feet in the vicinity of the 10th Street crossing of Eagle Draw.

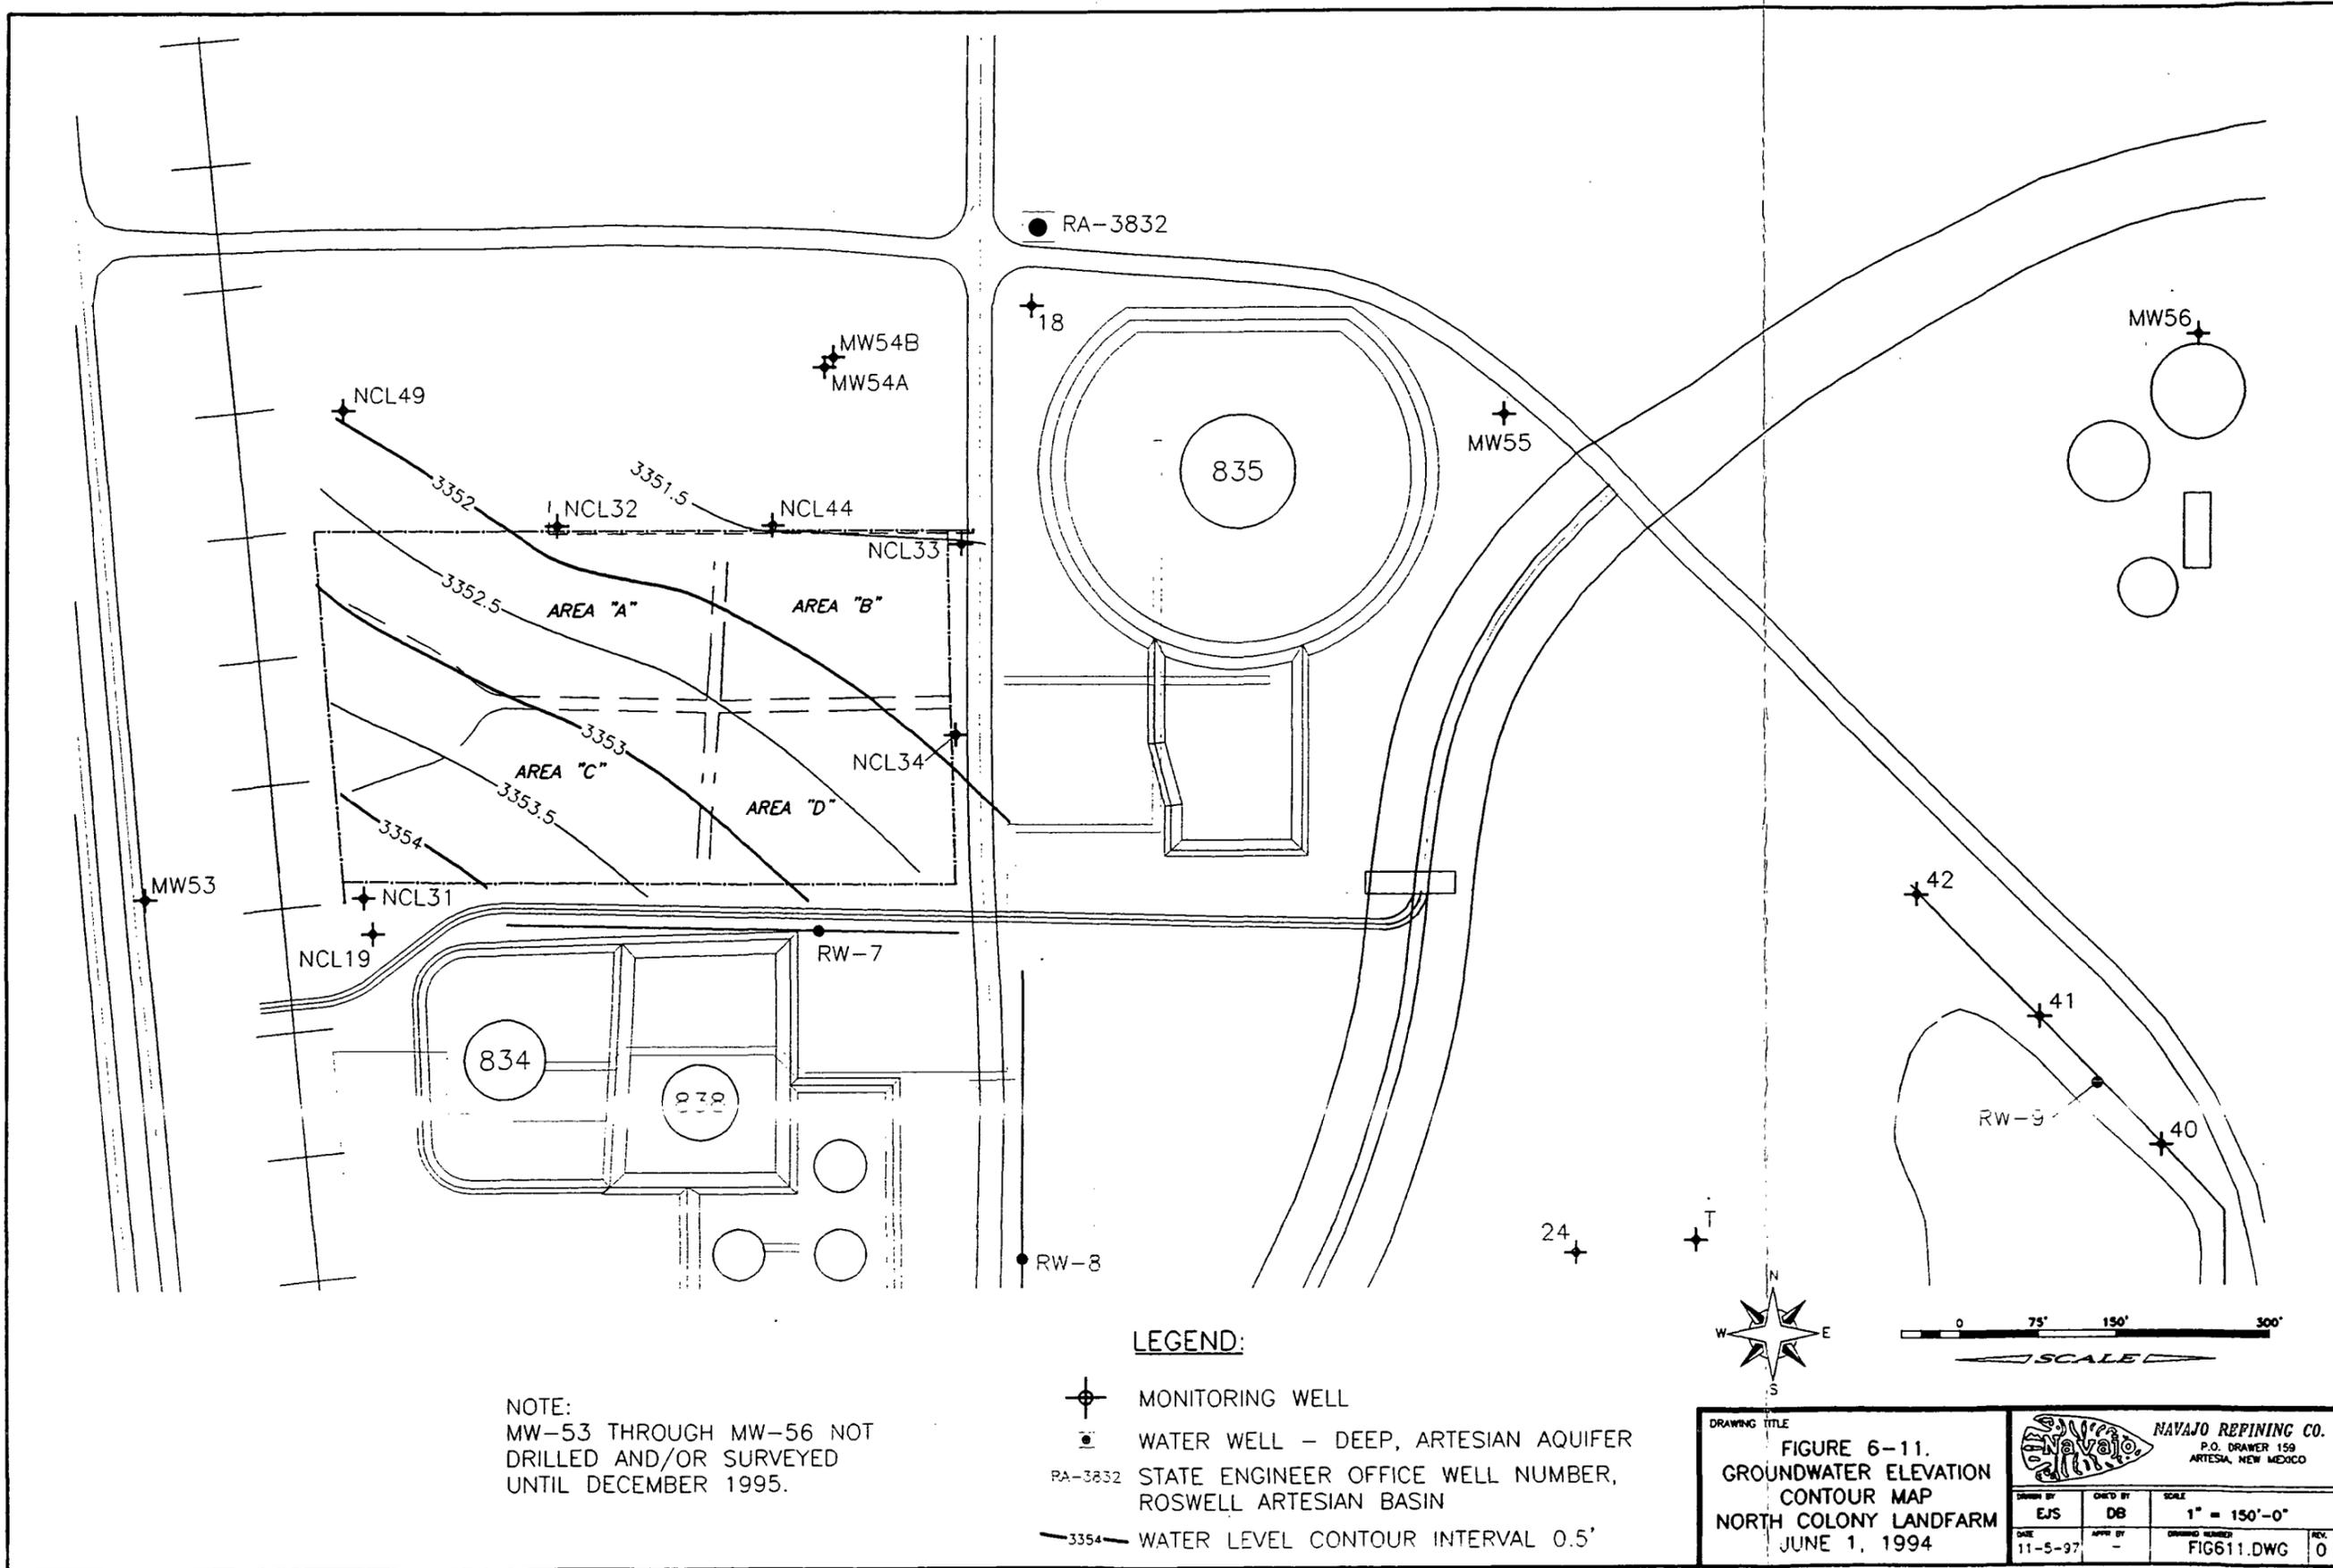
DRAWING TITLE		NAVAJO REPINING CO. P.O. DRAWER 159 ARTESIA, NEW MEXICO	
FIGURE 6-11. GROUNDWATER ELEVATION CONTOUR MAP NORTH COLONY LANDFARM JUNE 1, 1994		SCALE 1" = 150'-0"	REV. 0
DRAWN BY EJS	DATE 11-5-97	DATE -	DRAWING NUMBER FIG611.DWG

NOTE:
 MW-53 THROUGH MW-56 NOT
 DRILLED AND/OR SURVEYED
 UNTIL DECEMBER 1995.

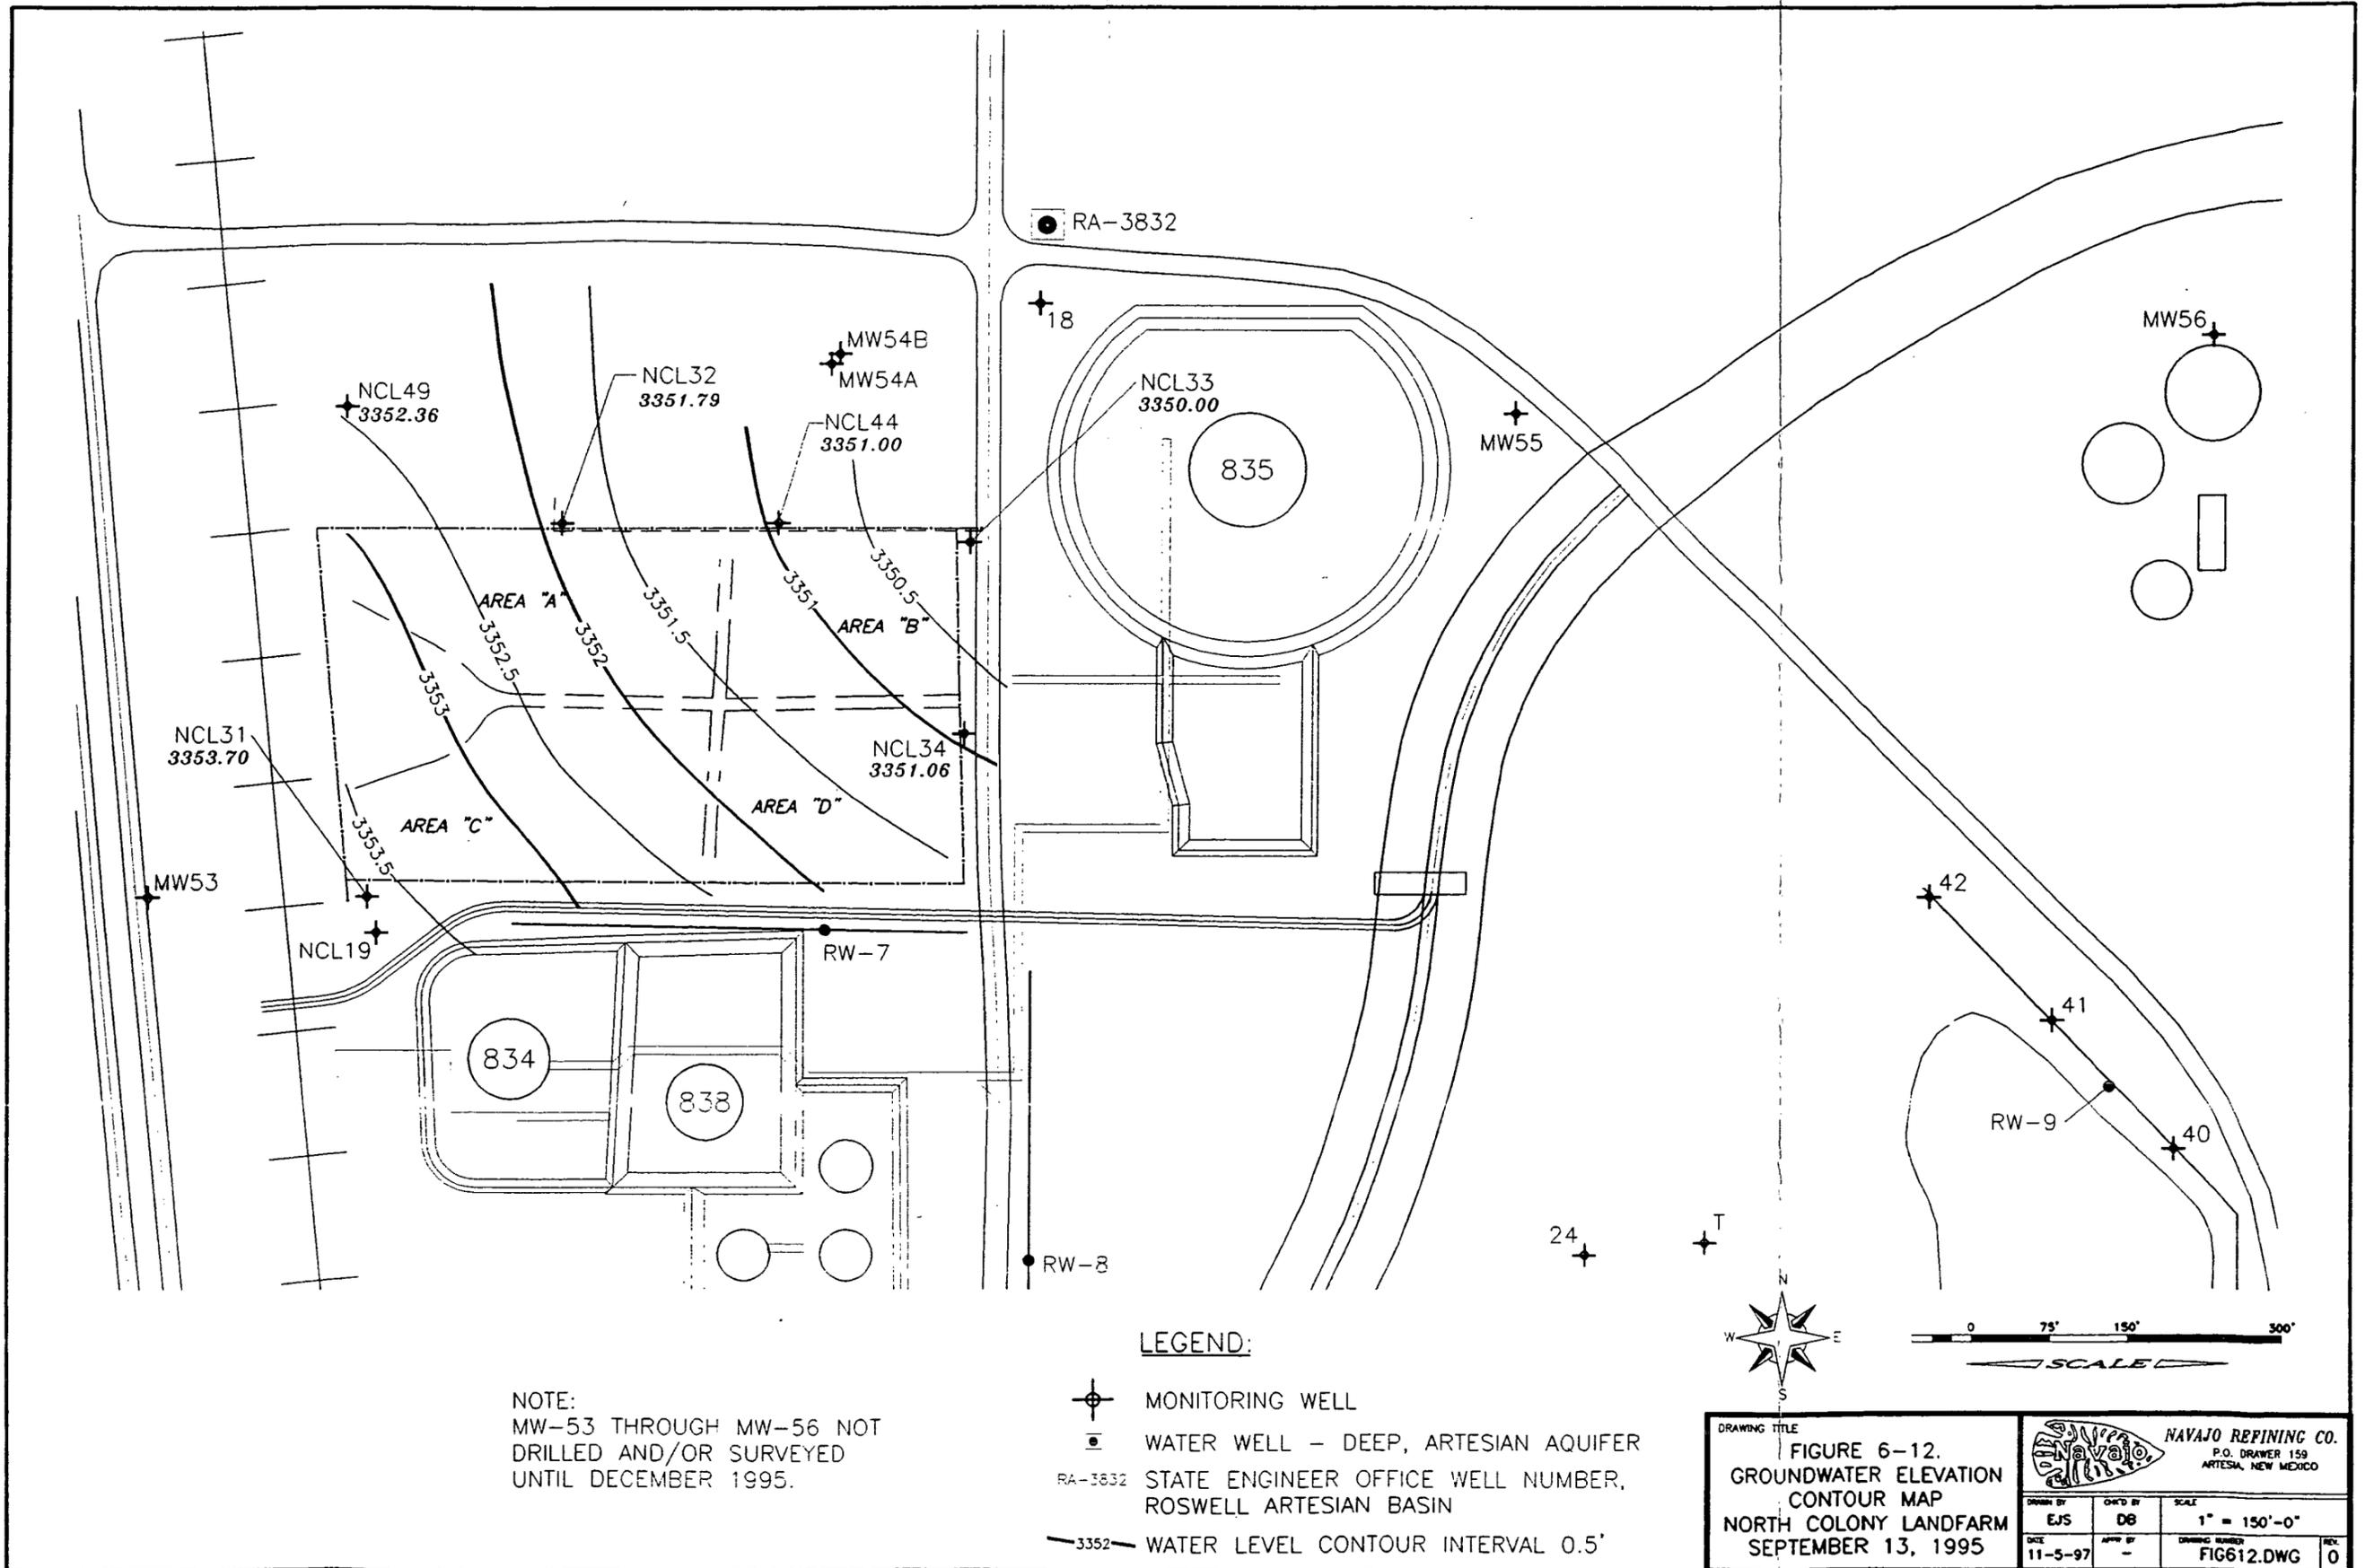
NAVAJO REFINING CO. P.O. DRAWER 159 ARTESIA, NEW MEXICO	
FIGURE 6-12. GROUNDWATER ELEVATION CONTOUR MAP NORTH COLONY LANDFARM SEPTEMBER 13, 1995		DRAWN BY EJS	CHECKED BY DB	SCALE 1" = 150'-0"	REV 0
DATE 11-5-97	APP'D BY -	DRAWING NUMBER FIG612.DWG

NOTE:
 MW-53 THROUGH MW-56 NOT
 DRILLED AND/OR SURVEYED
 UNTIL DECEMBER 1995.

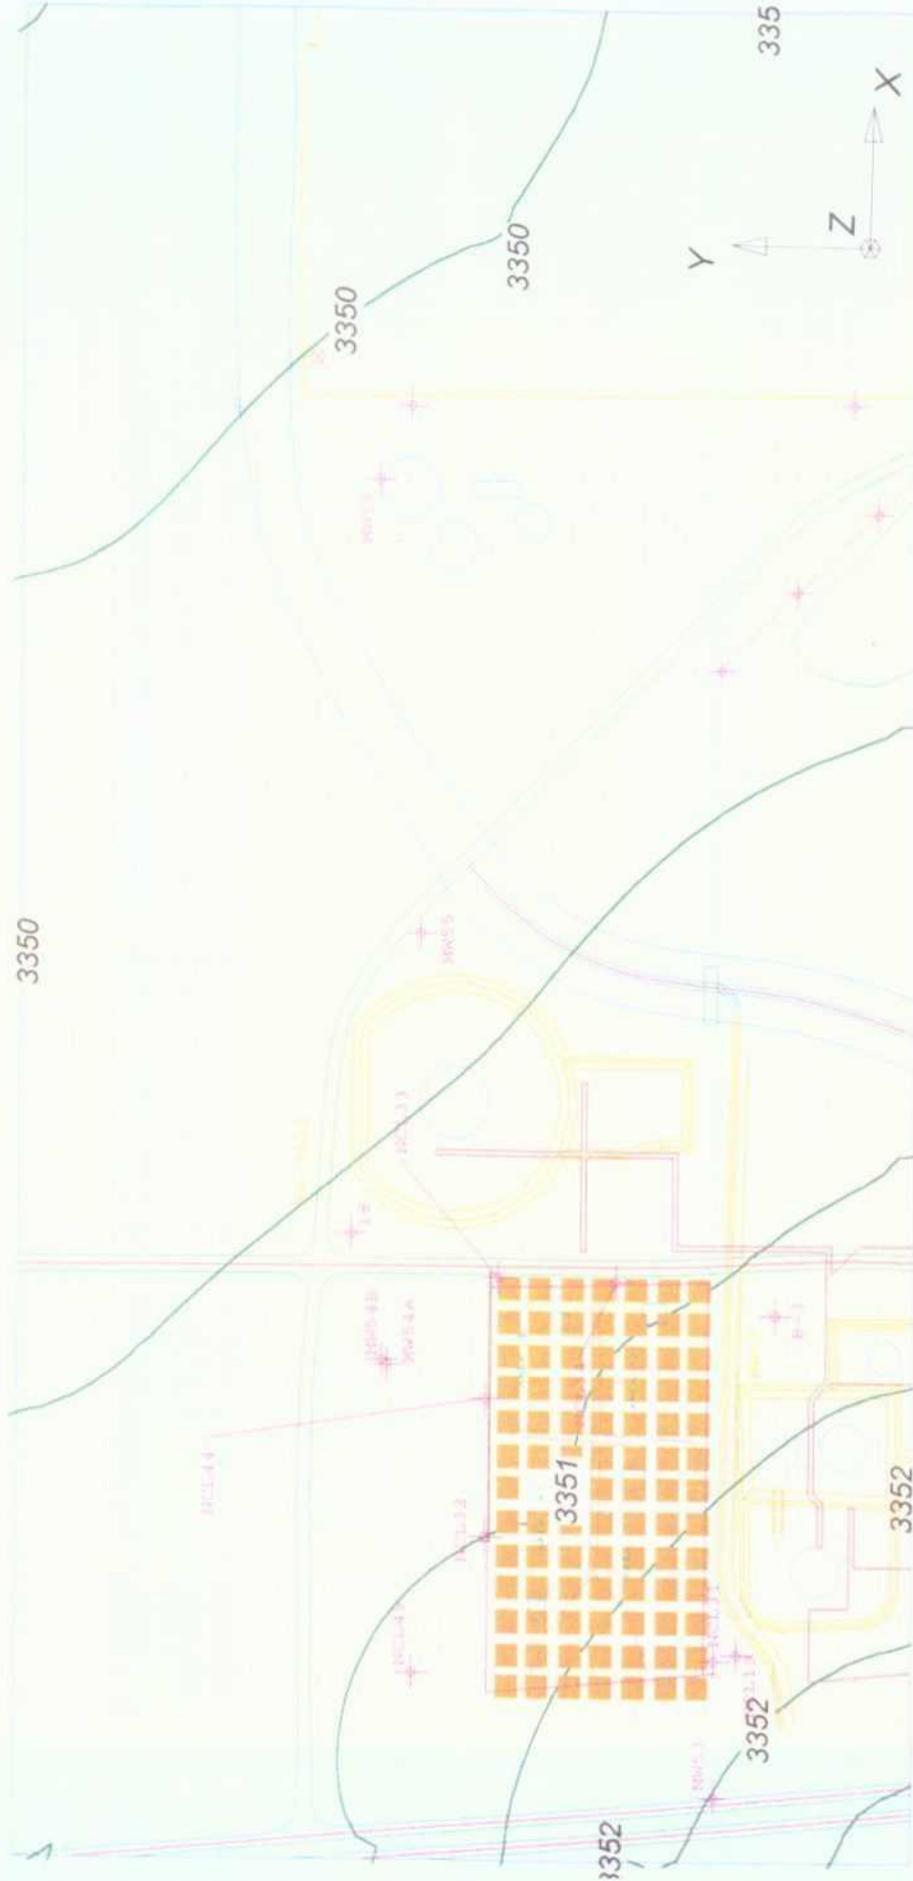
Figure 6-16. Steady State Groundwater Flow Model Simulation, North Colony Landfarm

Parameter	Modeled Value or Range
Hydraulic Conductivity (K, 10^{-3} cm/s):	2.8 feet/day
Coefficient of Storage (dimensionless):	0.01
Porosity (dimensionless):	0.35
Dispersion (feet):	
Longitudinal	10 feet
Horizontal	0.2 feet
Vertical	0.02 feet
Source and Concentration (ug/L):	Benzene, 2.6 ug/L
Layer Thickness (feet):	5 feet

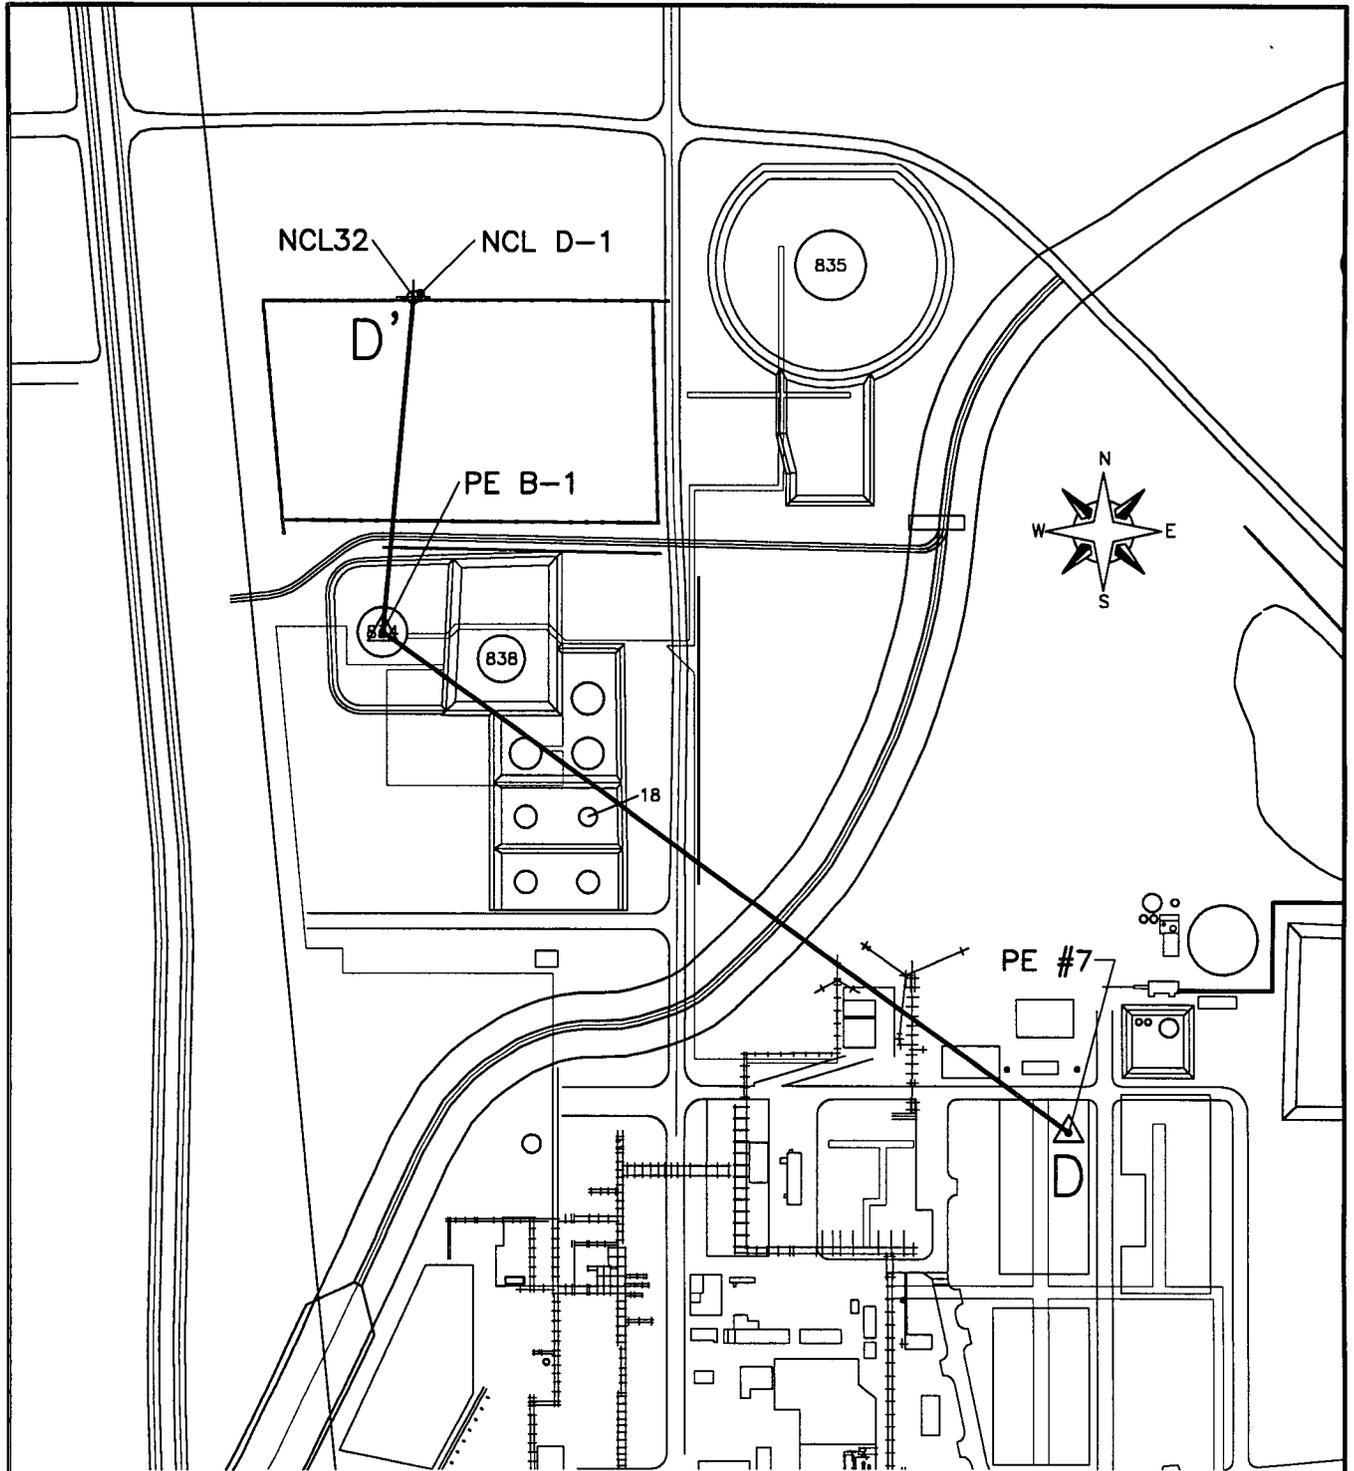
DRAWING TITLE
**FIGURE 7-5.
 LOCATION OF GEOLOGIC
 CROSS SECTION D-D'
 NAVAJO DEEP BORINGS**

Based on lithologic information obtained from the deep geotechnical boring drilled during the Phase I RFI and the two earlier deep borings discussed in Section 6.1.3, a location map (Figure 7-5) and cross-section (Figure 7-6) were prepared to illustrate deeper subsurface relationships in the vicinity of the NCL. Based on review of the available data, in the immediate area of the landfarm, the next major water bearing zone beneath the NSSZ is at a depth in excess of 100 feet. Also, the lithologic information provided by the three boring logs strongly supports a conclusion that deeper groundwater in the vicinity of the deep boreholes is isolated from the shallow NSSZ in the area beneath the landfarm.

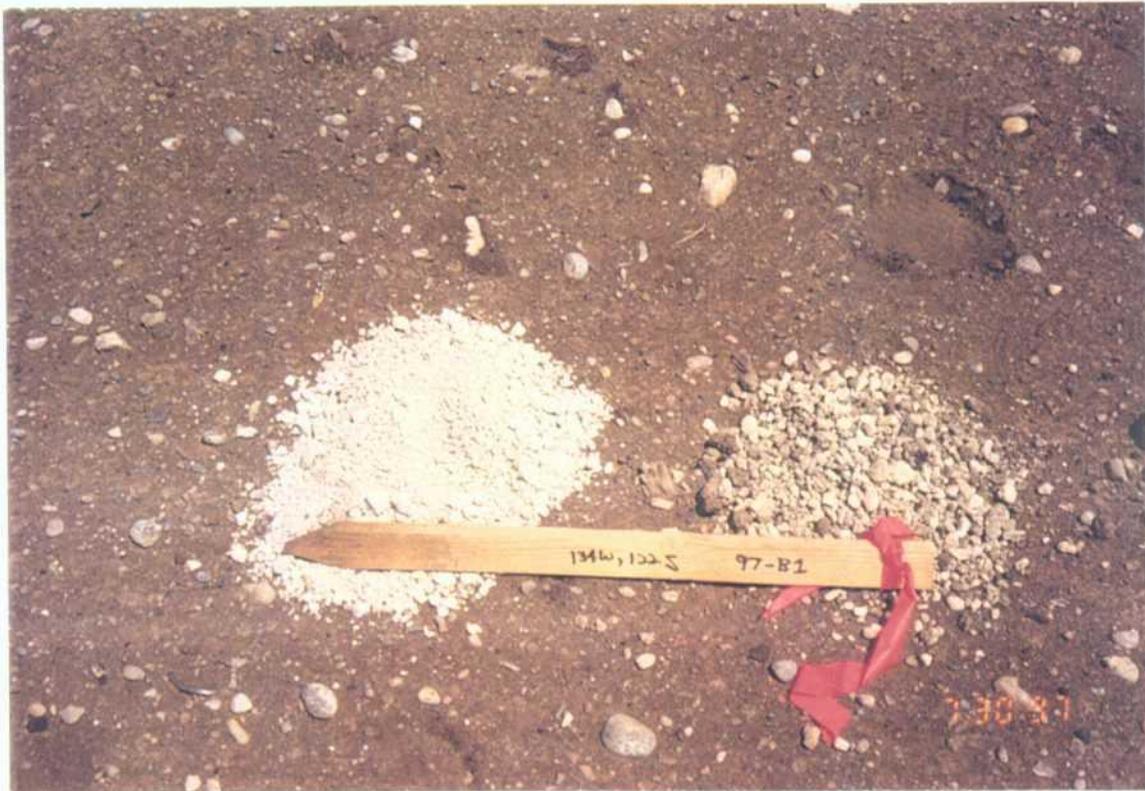
Photograph A-19: Boring 97-B1, left 13-15 ft.; right 10-13 ft.

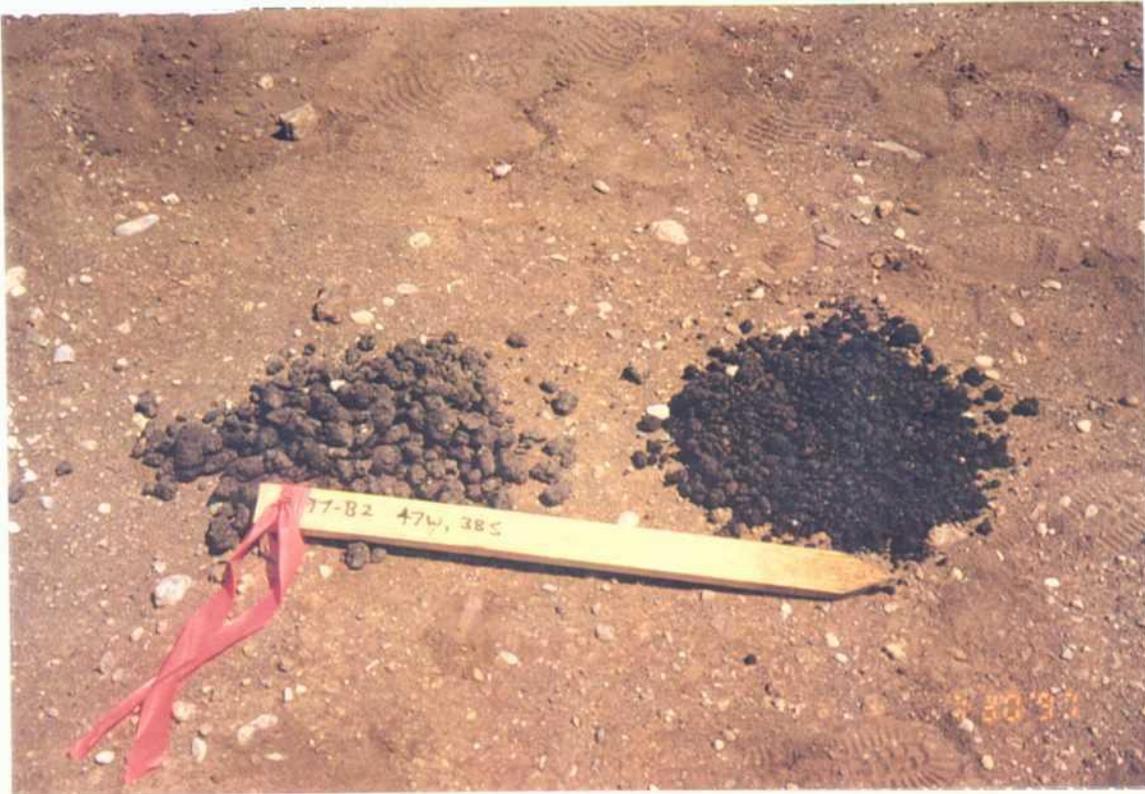
Photograph A-21: Boring 97-B2, left, 3-5 ft.; right, 0-3 ft.

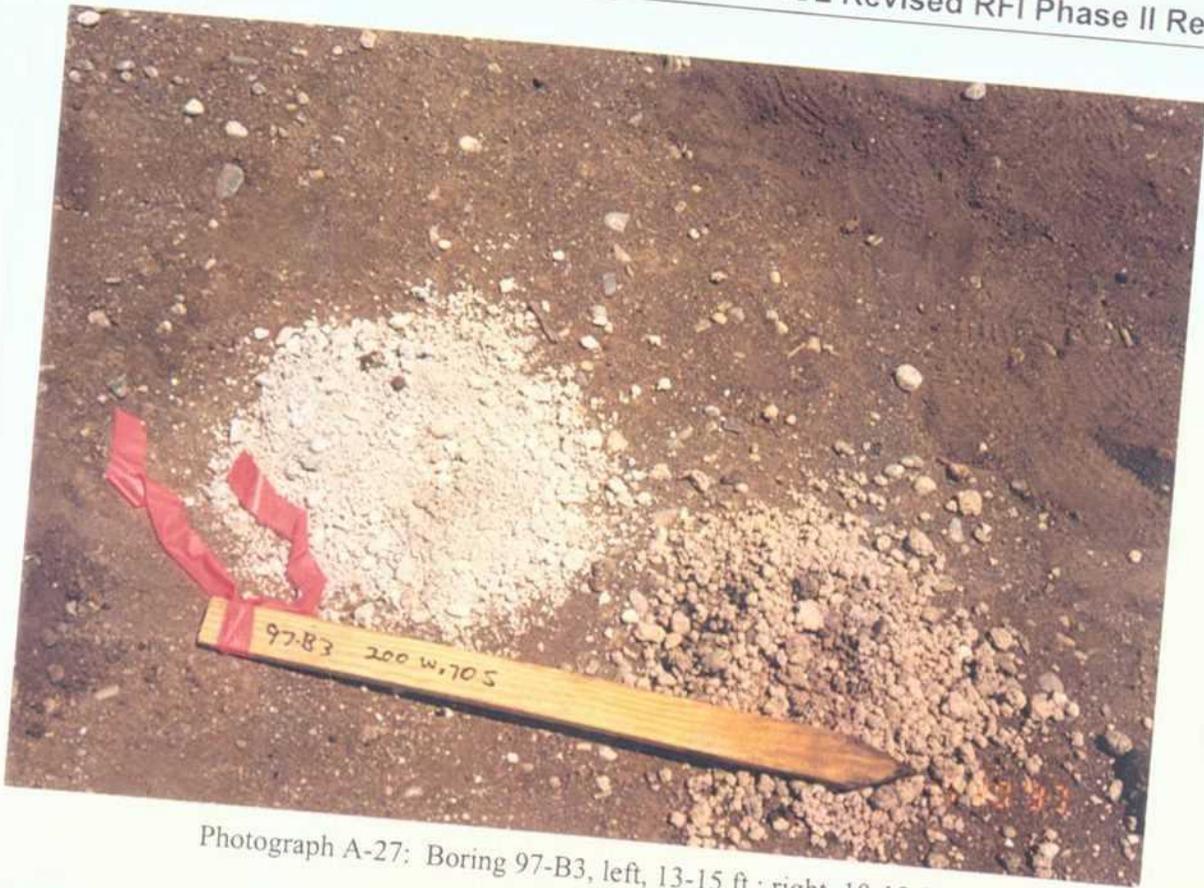
Photograph A-27: Boring 97-B3, left, 13-15 ft.; right, 10-13 ft.

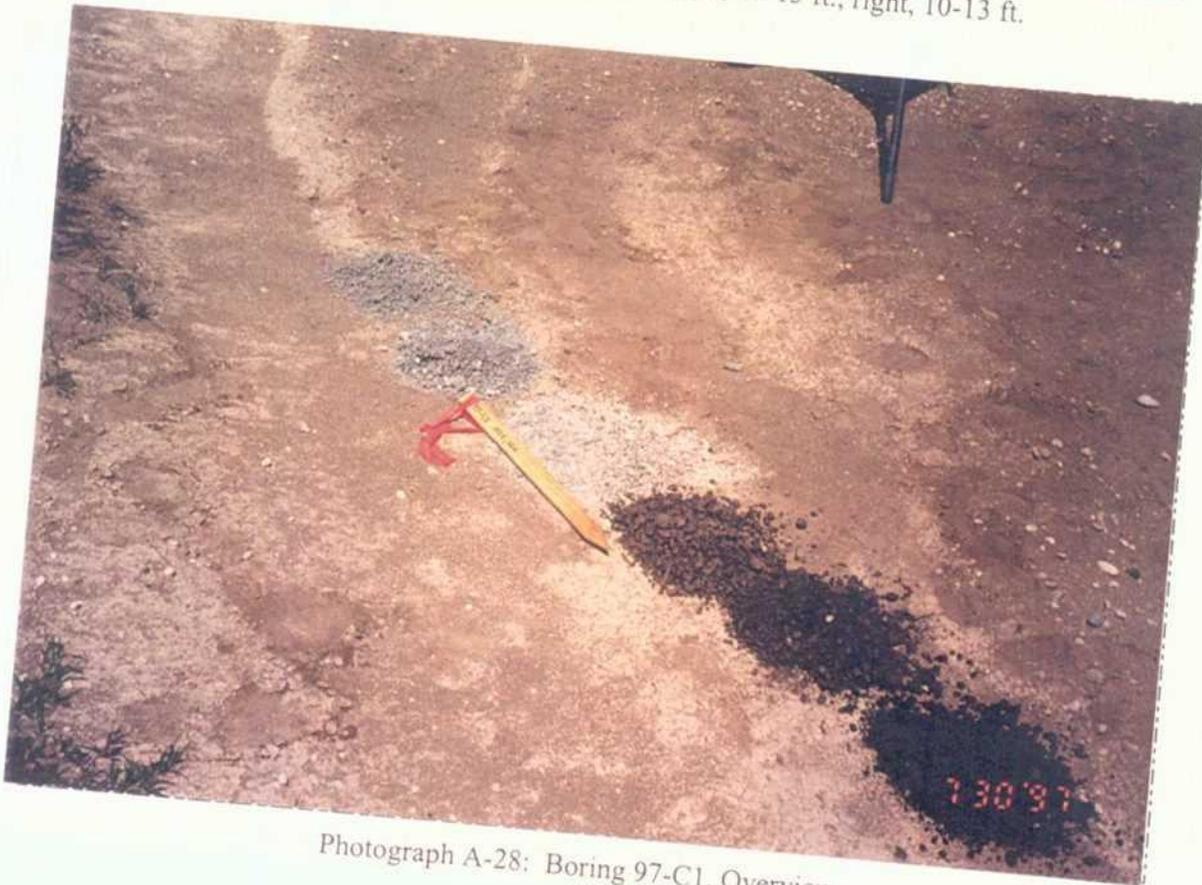
Photograph A-28: Boring 97-C1, Overview

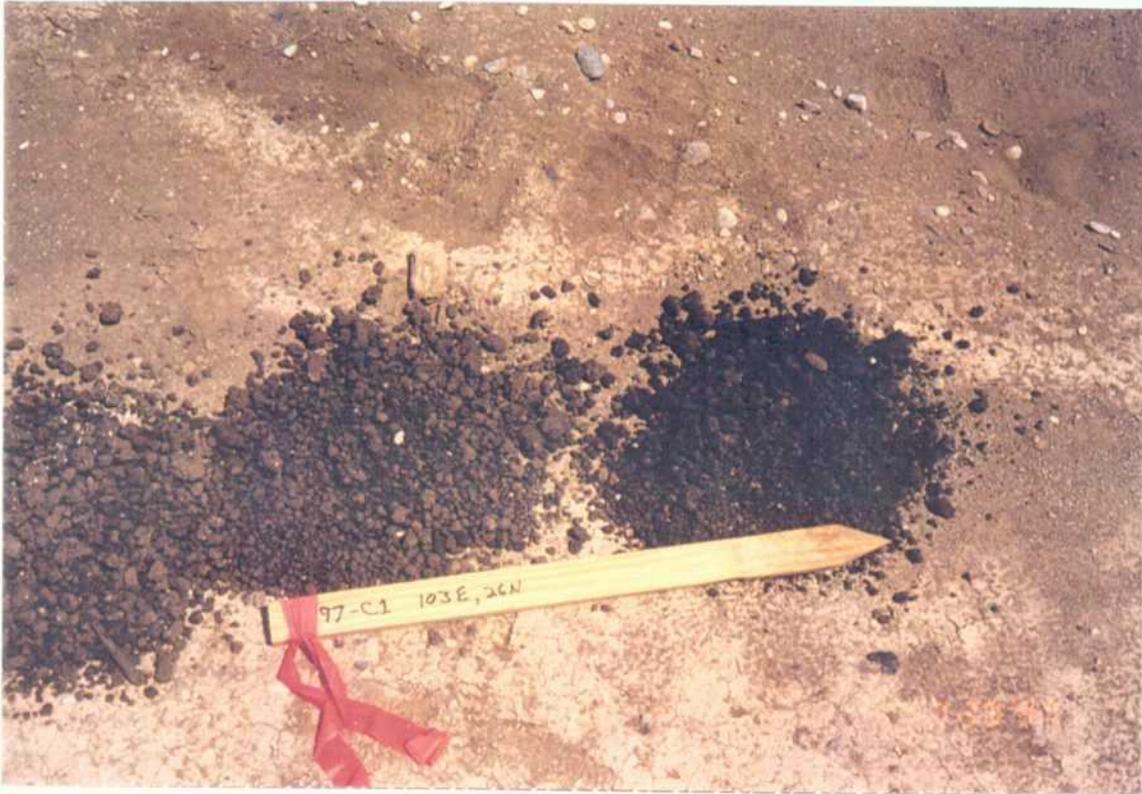
Photograph A-29: Boring 97-C1, left, 5-8 ft.; center, 2-5 ft.; right, 0-2 ft.
