**Revised RCRA Facility Investigation
Phase II Report
North Colony Landfarm
Navajo Refinery, Artesia, New Mexico**

**Navajo Refining Company
501 East Main Street
P. O. Drawer 159
Artesia, New Mexico 88210**

November 1997

COVENANT TECHNICAL ASSOCIATES, INC.

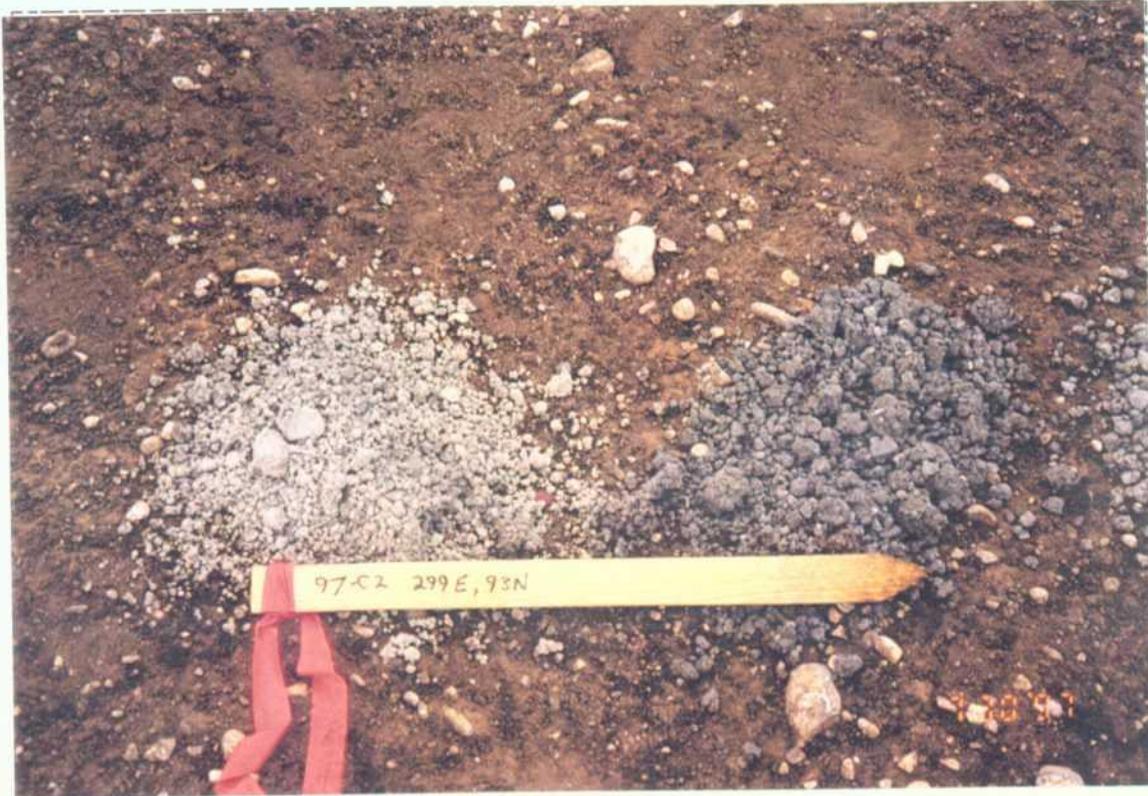
Photograph A-35: Boring 97-C2, left, 13-15 ft.; right, 9-13 ft.

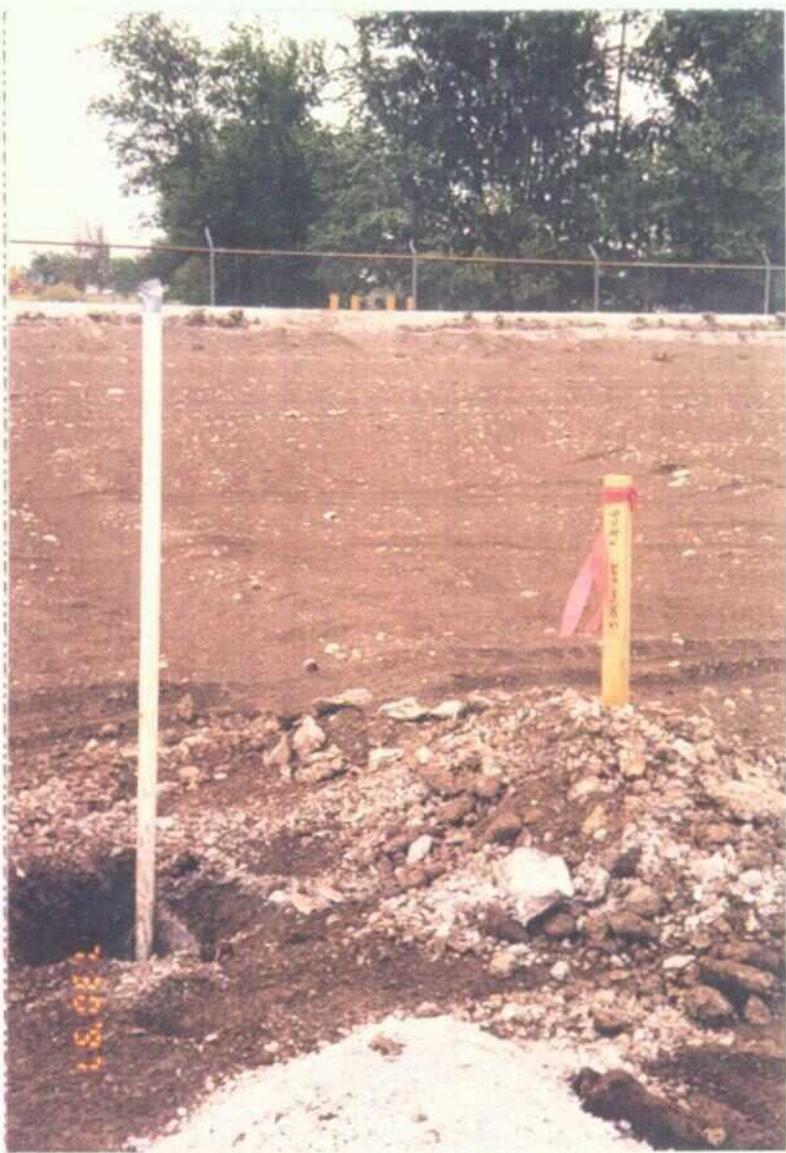
Photograph A-43: Temporary well installation at 97-B3, NCL-44 in background
