# FIELD TRIP, MONUMENT AREA

4/20/91

ARCO Empire Abu Unit F  
Well #351  
2550' FNL, 1650' FEL  
SEC 34 T17S, R28E  
Eddy County

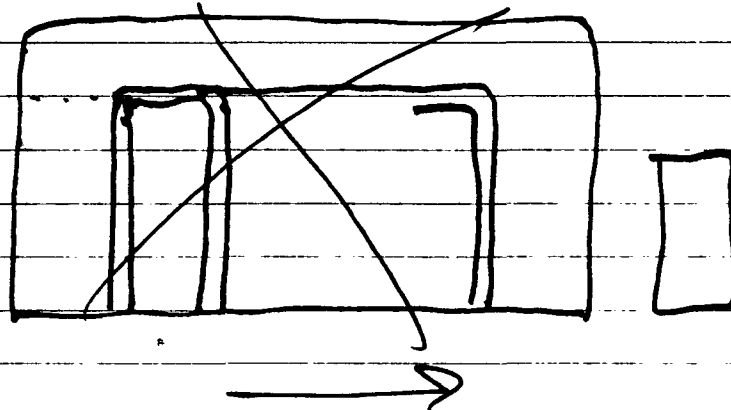
Just S/WELL #351 + tanks

\* SLUDGE PITS:

excavation

- no standing water

- garbage - bag thick pale plastic  
liner evident in westernmost cell

- Rusted ~~can~~ steel pipes strewn around pits

- Recent grading evident: muddy,  
truck tire tracks, denuded,  
areas graded, uneven

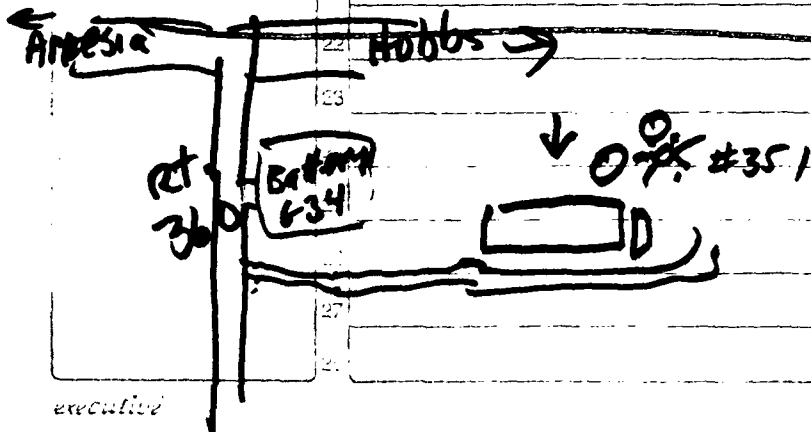
→ ARCO Empire ABO unit  
Battery 634  
SE 1/4 NW 1/4 SEC 34 T7S 28E  
Eddy

4 <sup>separators</sup> ~~lg heat treaters~~ (cylinder type)  
1 lg heat treater

pipeline meters & ~~separators~~ -  
ground pipes

NA Relatively clean & new site
