# FINAL REPORT

**RICE OPERATING COMPANY  
JUNCTION BOX FINAL REPORT**

## EME E-2 Jct. Box Upgrade

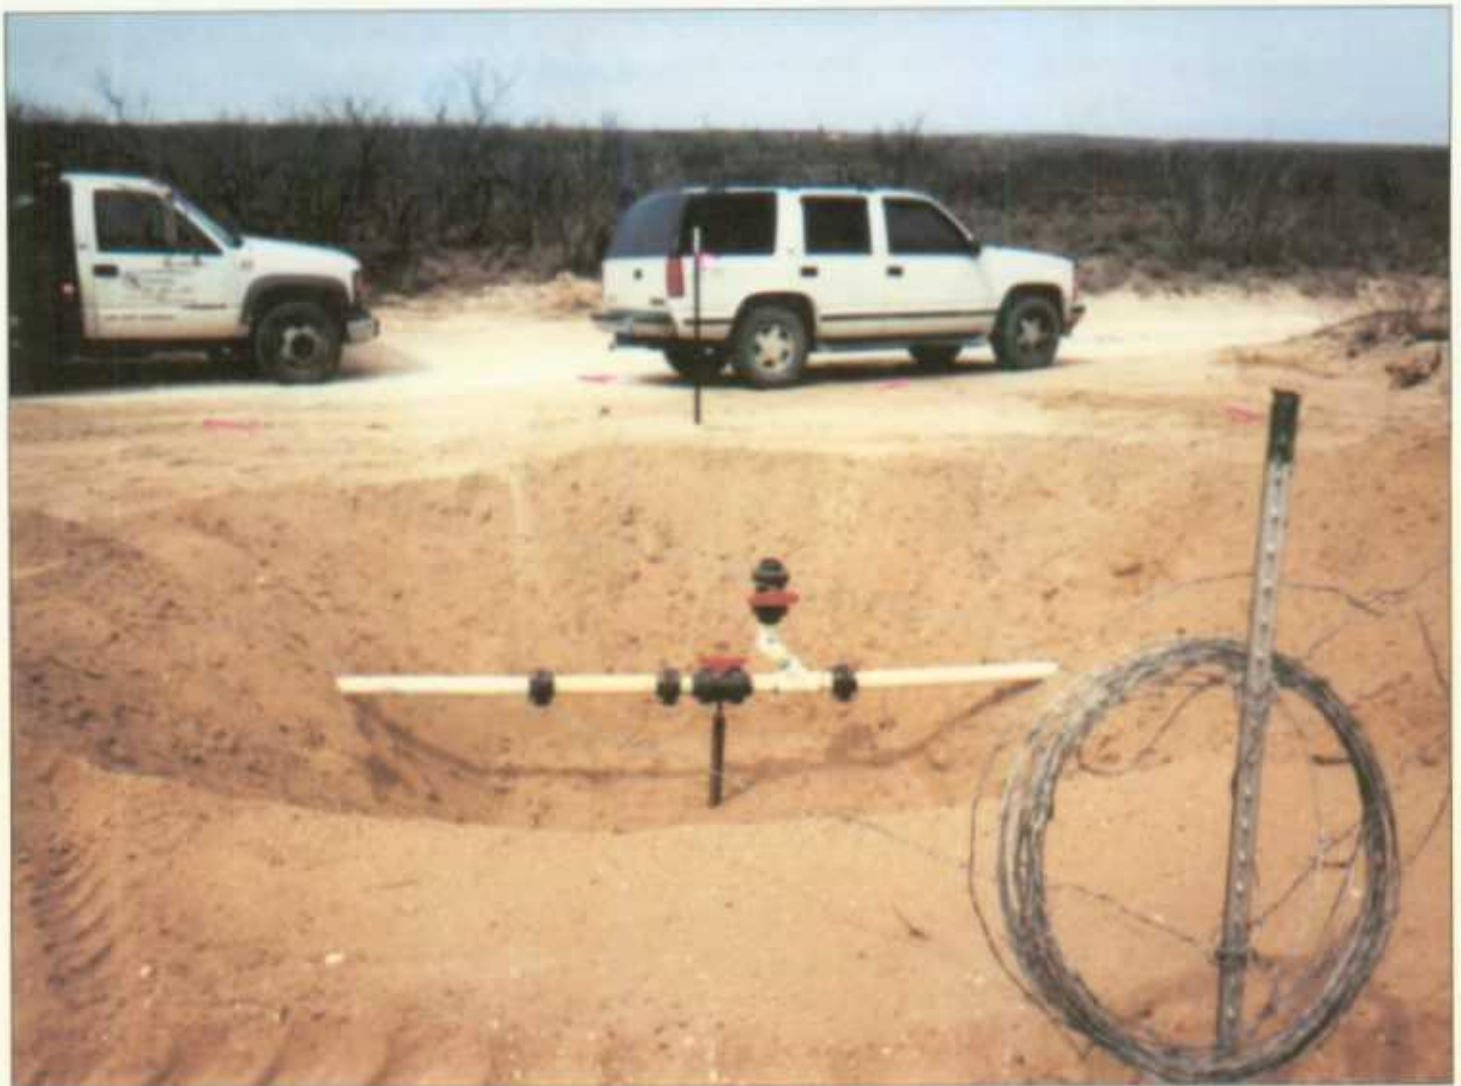
Remediation
