**RICE OPERATING COMPANY  
JUNCTION BOX DISCLOSURE REPORT**

## EME O-33 Jct. Box Upgrade

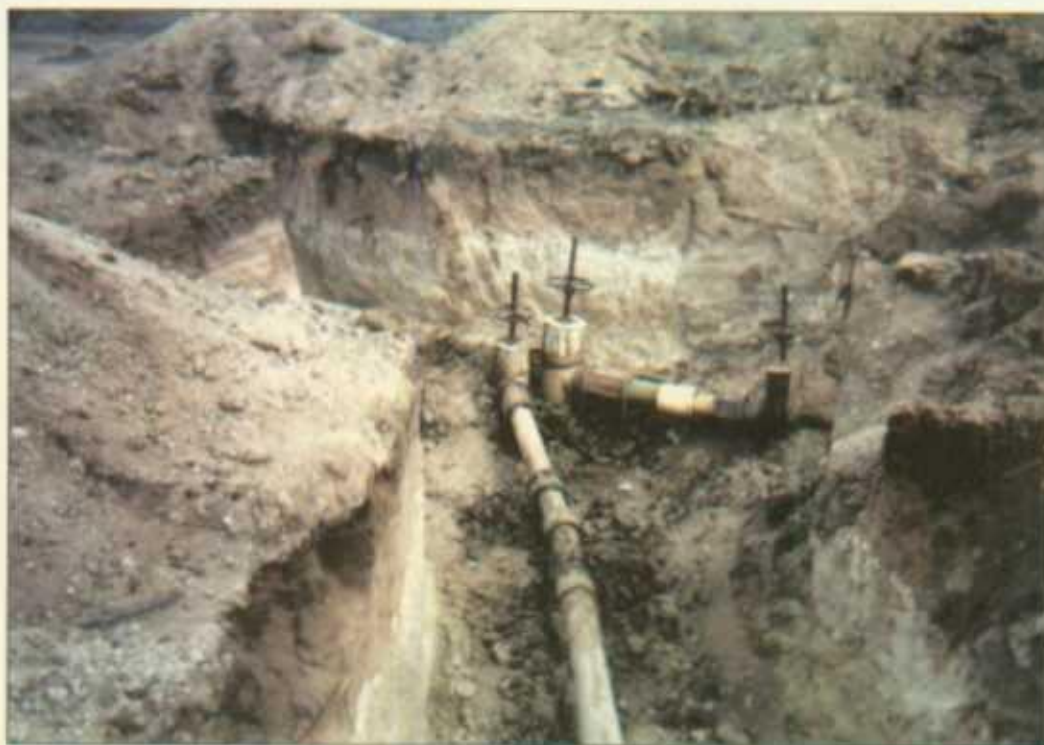
NORM Removal

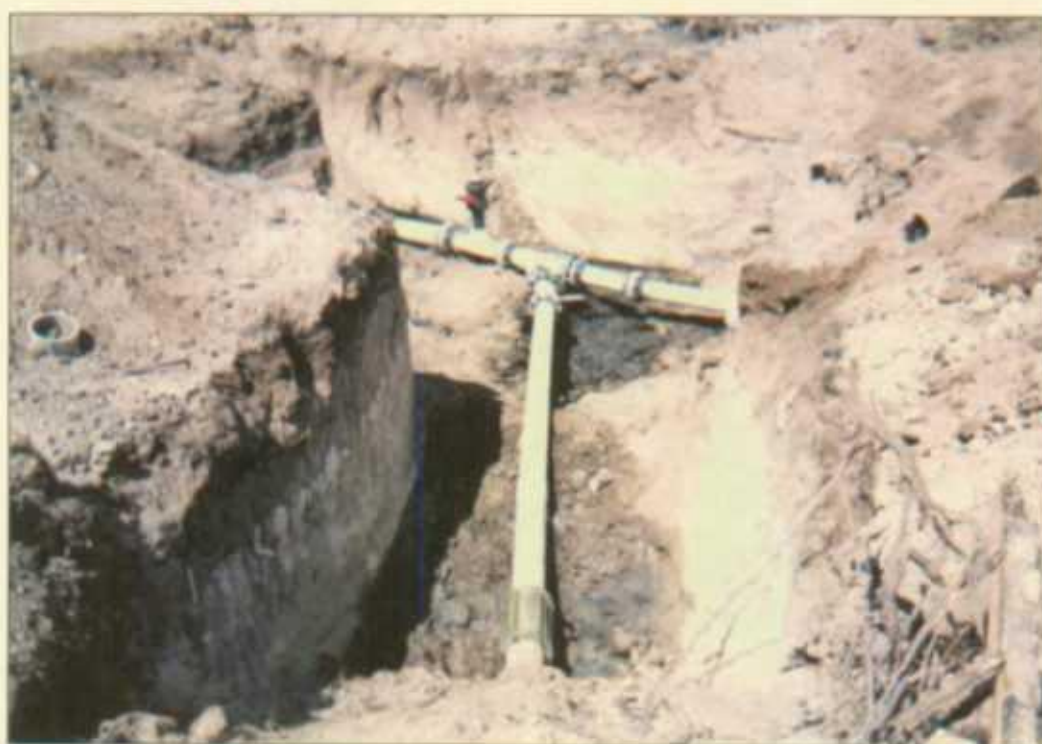
New Plumbing

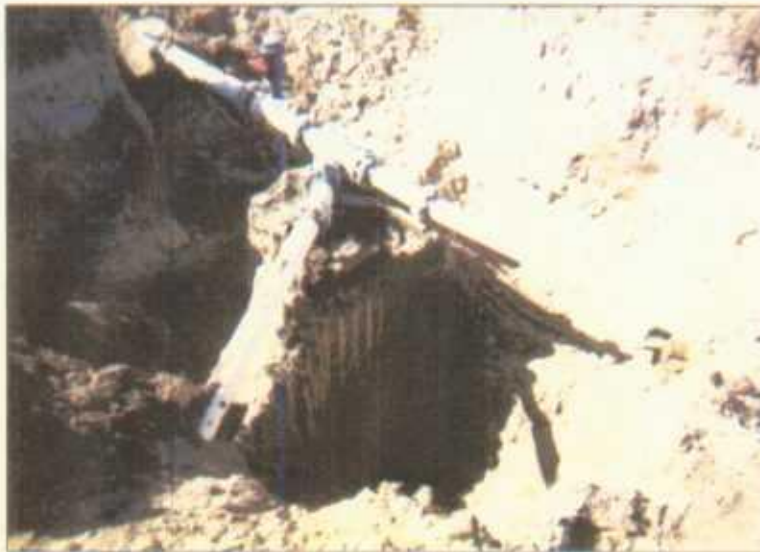
↓ Environmental Remediation ↑

The walls were excavated to 400 ppm chlorides. A compacted clay barrier to vertical transmissivity was installed on the bottom and walls. A water tight junction box was also installed. The high impact soil was hauled to a permitted disposal facility and the site was backfilled with fresh soil. Natural attenuation will remediate the remaining hydrocarbon.

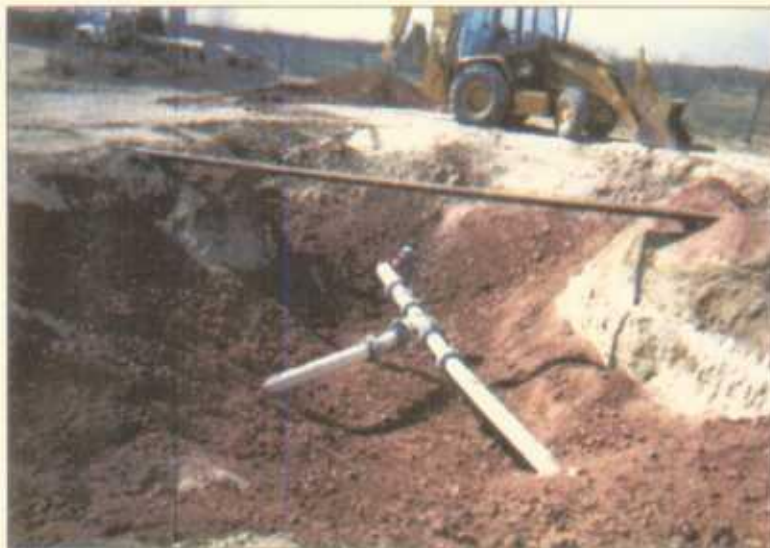
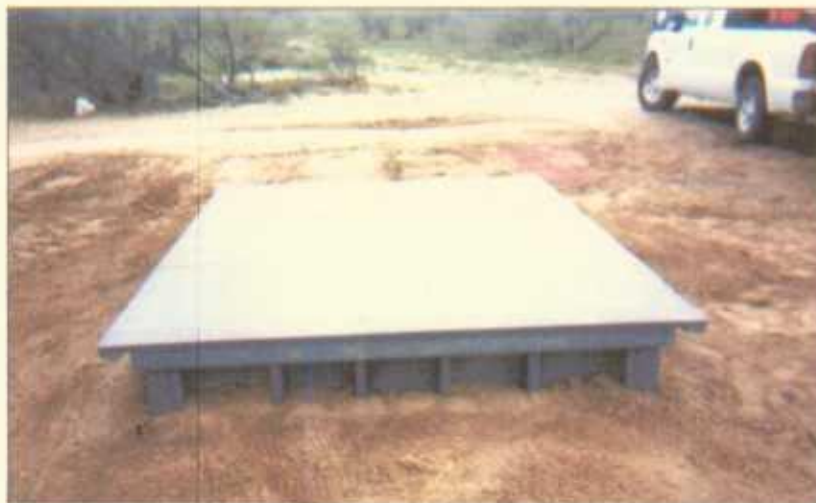
Completed Junction Box
