**RICE OPERATING COMPANY  
JUNCTION BOX FINAL REPORT**

| SWD SYSTEM | JUNCTION | UNIT | SECTION | TOWNSHIP | RANGE | COUNTY | BOX DIMENSIONS - FEET | | |
|---|---|---|---|---|---|---|---|---|---|
| BD | J-21-2 | J | 21 | 21 S | 37 E | Lea | No Box | | |

# BD jct. J-21-2

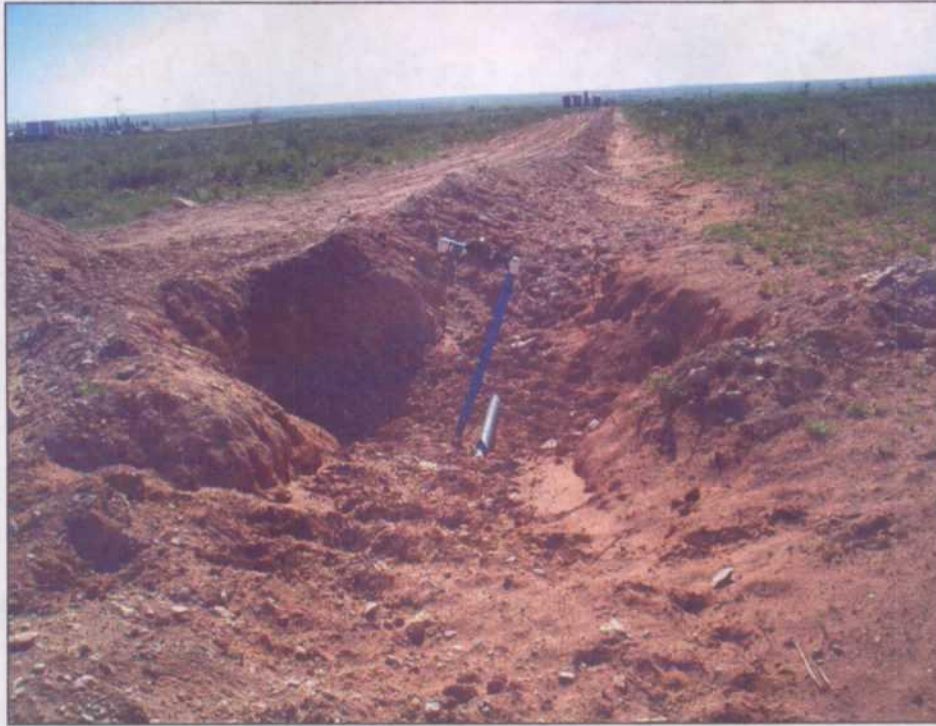
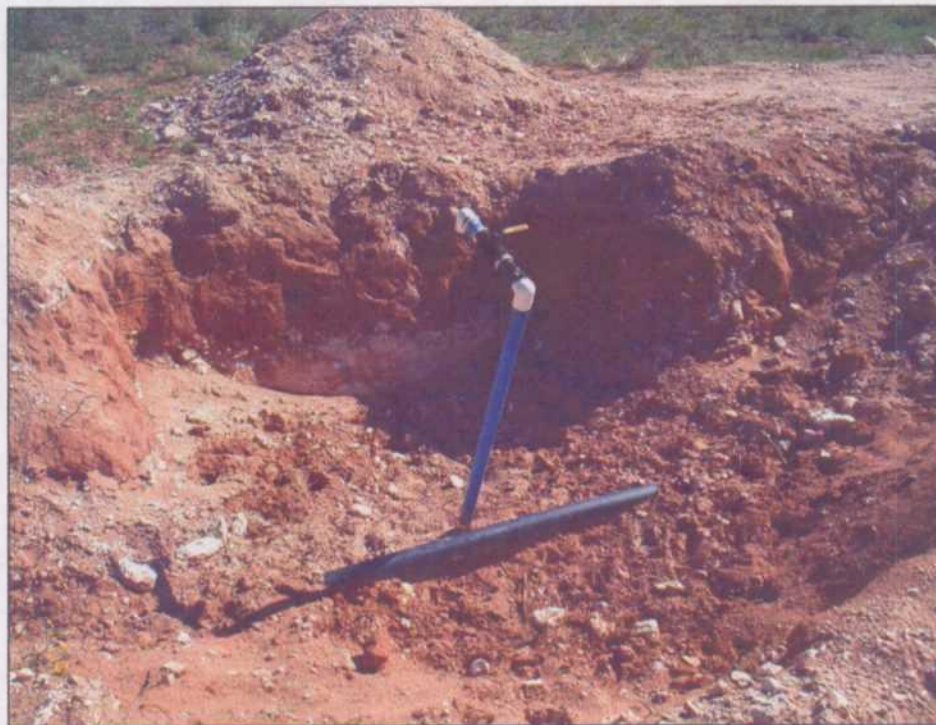
General Description of Remedial Action: Strong, healthy vegetation surrounded  
the box. The line is to be re-plumbed straight through and the box abandoned. Field testing indicated no TPH or chloride impact and lab results confirmed. No remediation activities are required. The hole will be backfilled and contoured and the surface is expected to re-vegetate at a normal rate.
