# FINAL REPORT

**RICE OPERATING COMPANY  
JUNCTION BOX FINAL REPORT**

BD jct. L-1  
T22S, R36E

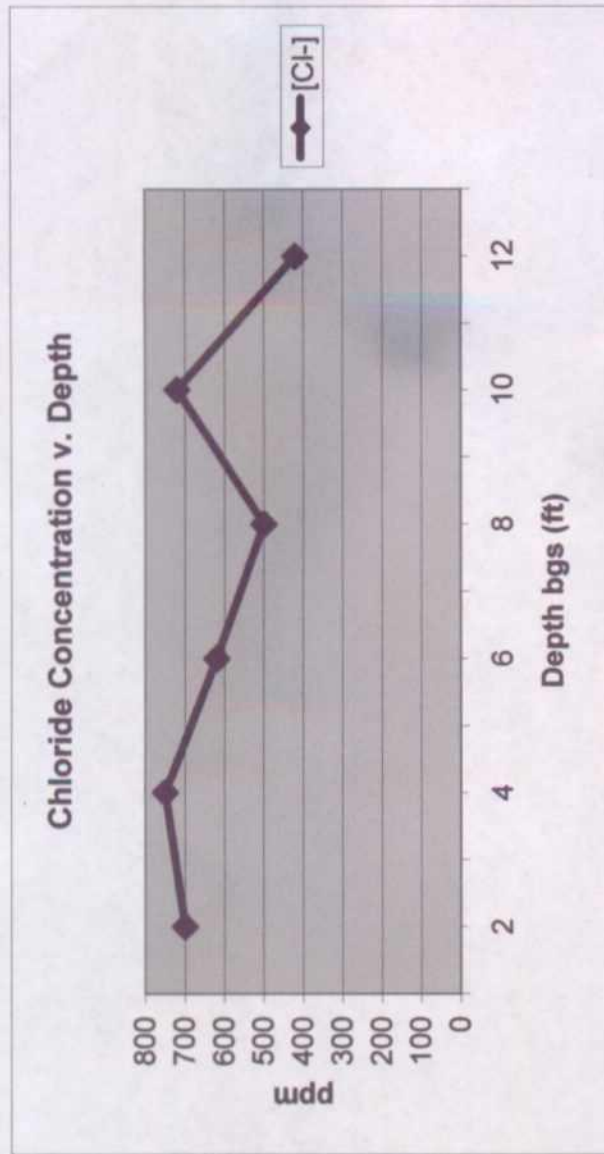
# CHLORIDE CONCENTRATION CURVE

| Depth bgs (ft) | [Cl-] ppm |
| 2 | 700 |
| 4 | 750 |
| 6 | 620 |
| 8 | 500 |
| 10 | 720 |
| 12 | 420 |

Groundwater = 125 ft

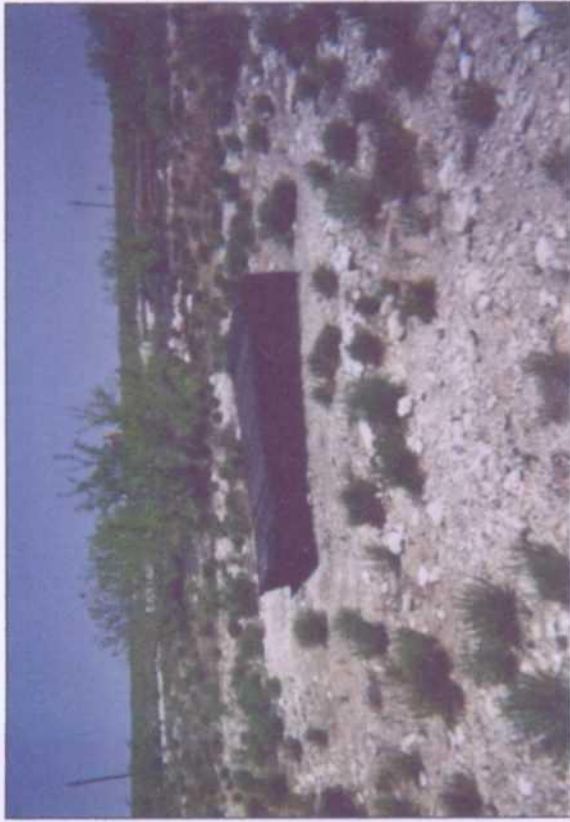
Old Jct. Box (May 2003)

**General Description of Remedial Action:** The site was delineated vertically and laterally producing a 25' x 20' x 12' bgs excavation. Chloride impact was minimal throughout and TPH concentrations exhibited a significant decline vertically and laterally below NMOCD guidelines. The excavated soil was landfarmed on site and then backfilled into the excavation. TPH and chloride concentrations left in place are not threatening to groundwater at 125 below the surface. The disturbed surface has been re-seeded with native vegetation and is expected to recover at a normal rate.

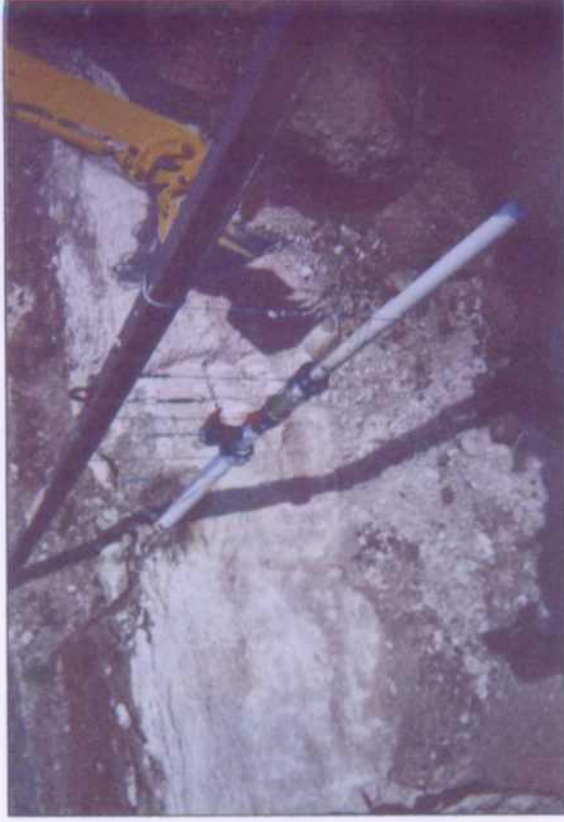
25 ft x 20 ft x 15 ft deep Excavation (June 2003)

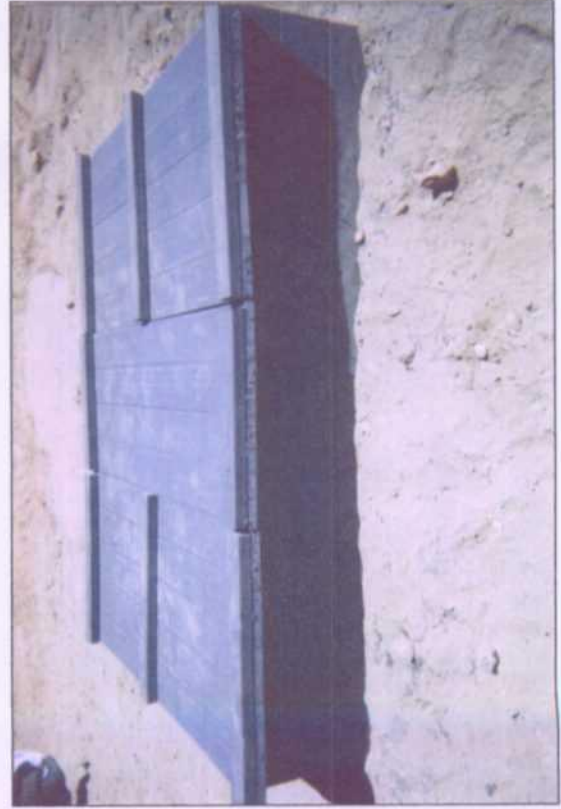
New Watertight Junction Box (July 2003)

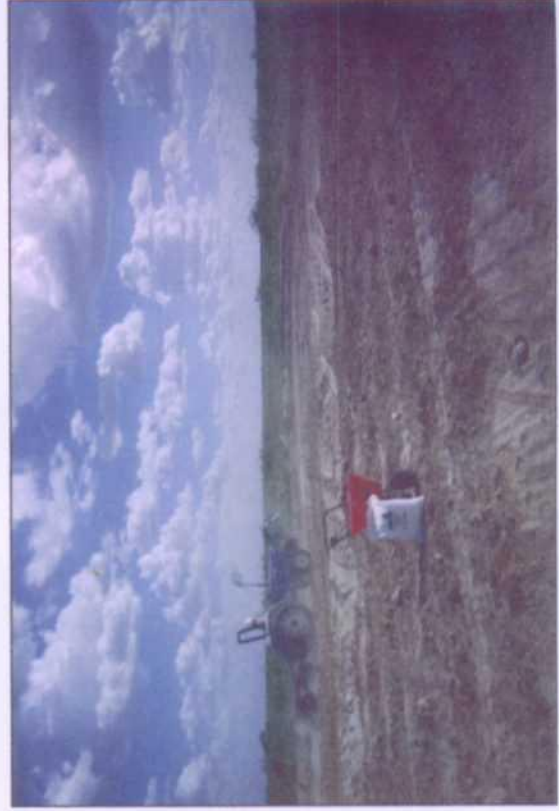
Seeding & Fertilizing Surface (July 29, 2003)
