# FINAL REPORT

**RICE OPERATING COMPANY  
JUNCTION BOX FINAL REPORT**

**BD Wagner & Brown EOL**

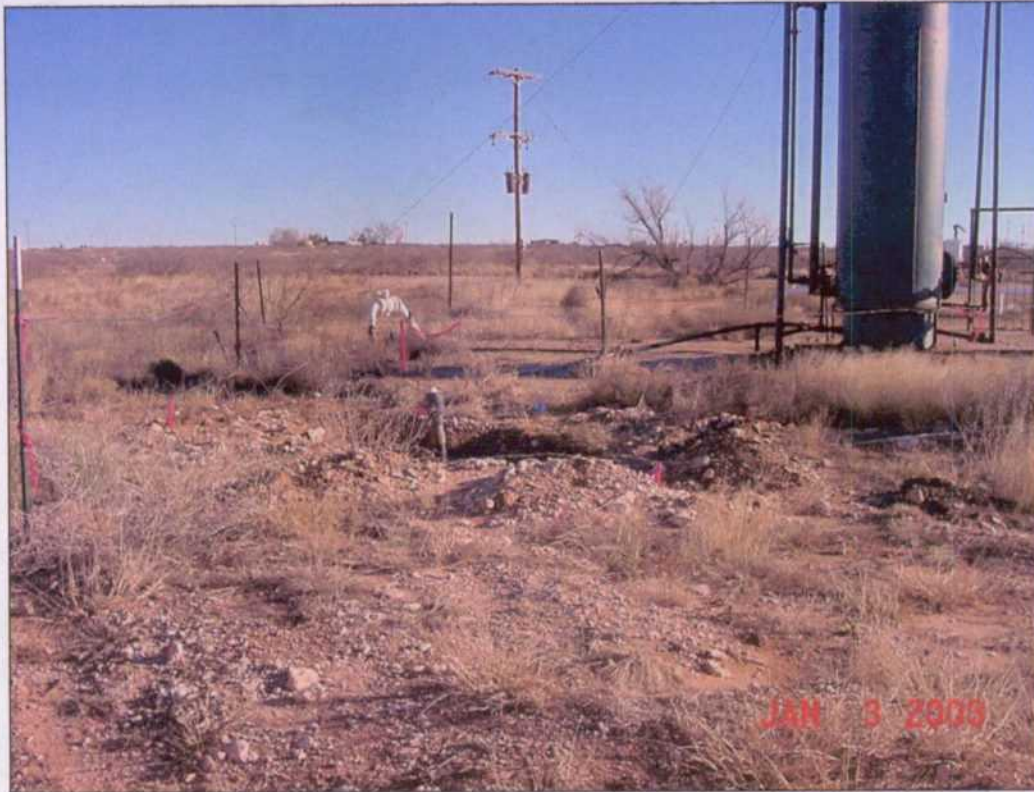
that chloride impact was minimal, lab results confirmed this. There was no visual indication of TPH impact so excavation was not required. The amount of chloride impact left in place will not adversely affect the groundwater or public health and remaining TPH is expected to naturally attenuate. A water-tight junction box has been installed over the location. The junction box is surrounded by healthy vegetation.

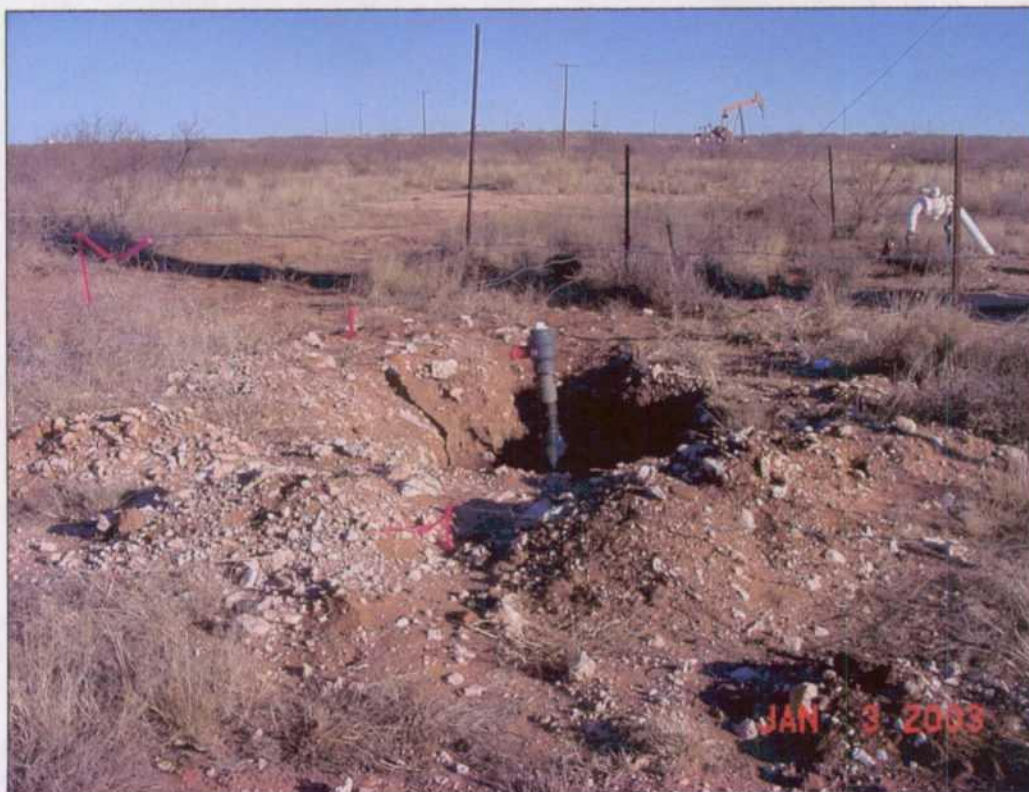
**No Excavation Required**
