1R - 427-08

# DISCLOSURE REPORT

**RICE OPERATING COMPANY  
JUNCTION BOX DISCLOSURE REPORT**

## EME jct. D-25

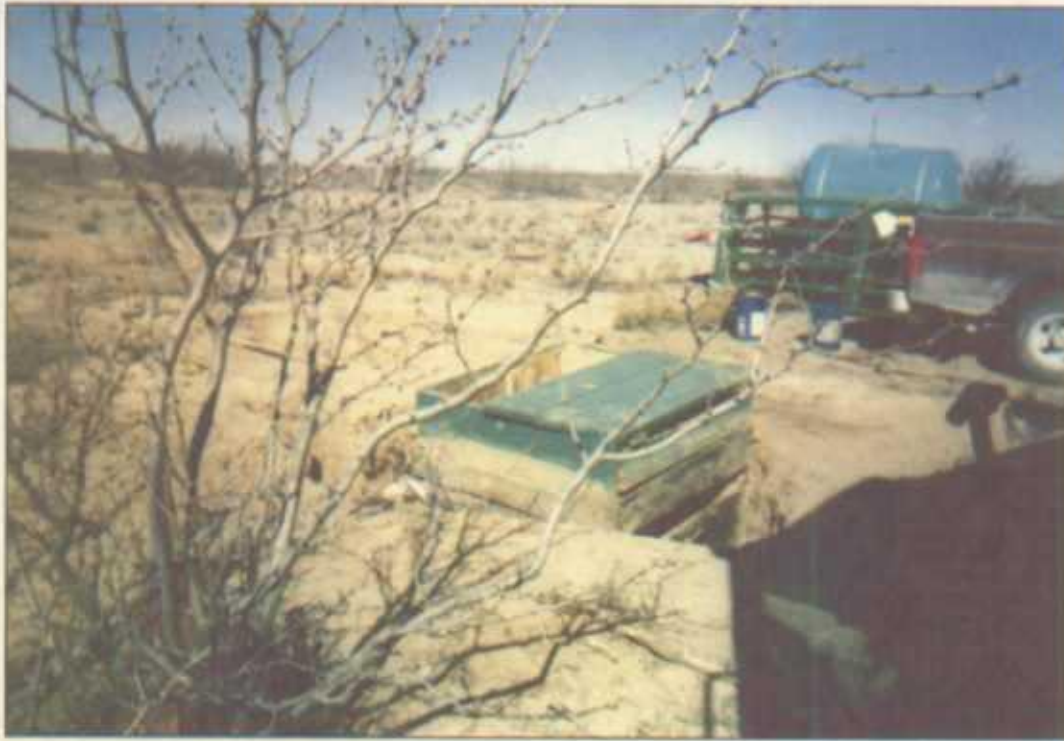
Old jct. box (NORM removal)

A junction box was no longer required at this location.

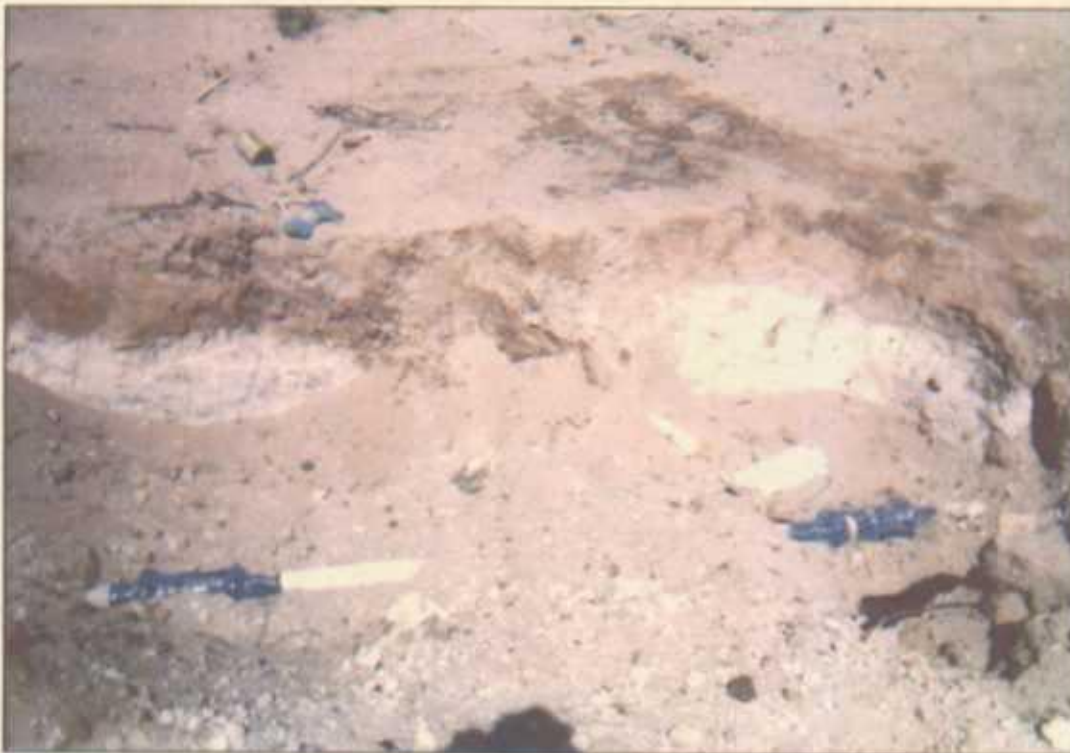
New plumbing after NORM removal

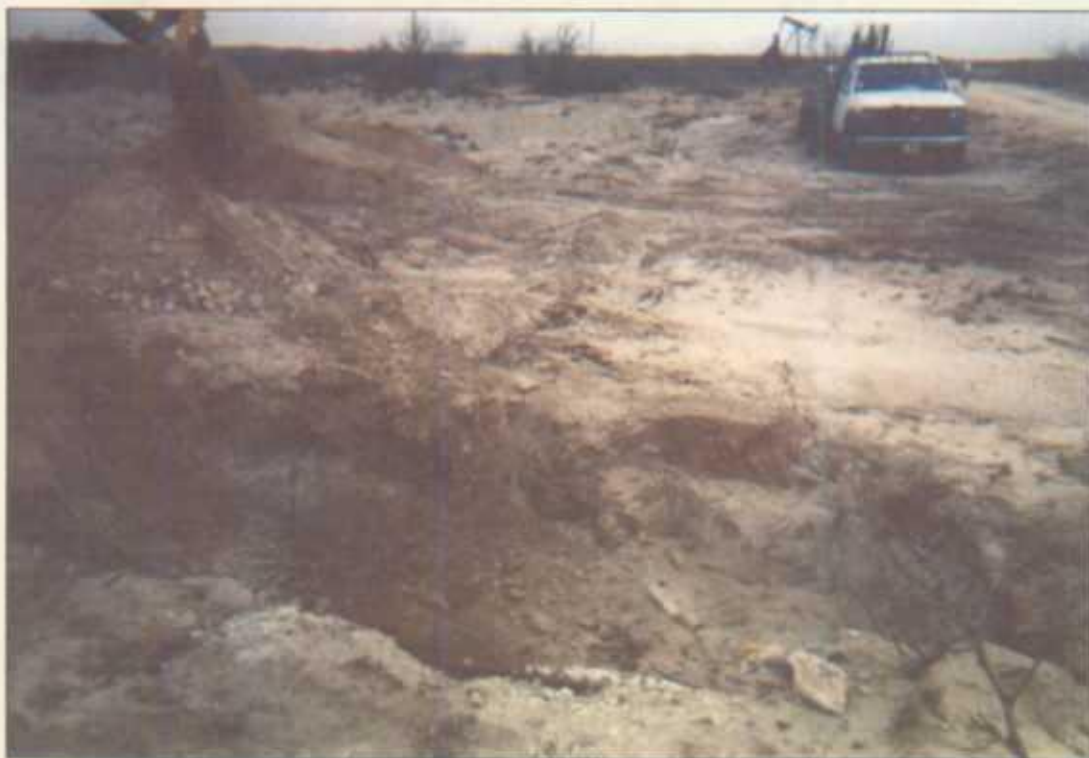
General Description of Remedial Action: A 40' x 33' x 15' excavation exhibited

relatively consistent chloride impact vertically and TPH concentrations did not meet NMOCD

Excavation

guidelines so a compacted clay barrier was installed at the bottom of the excavation and the soil

was blended and backfilled. Because the concentrations did not meet guidelines,

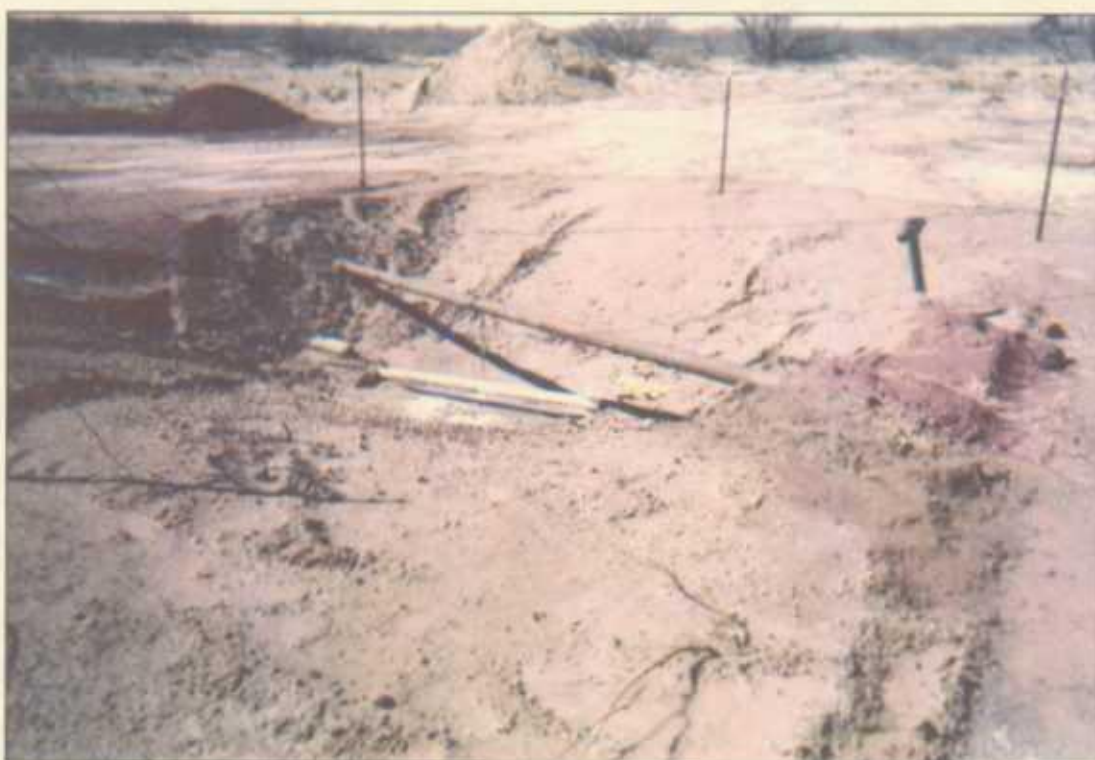
Backfilling

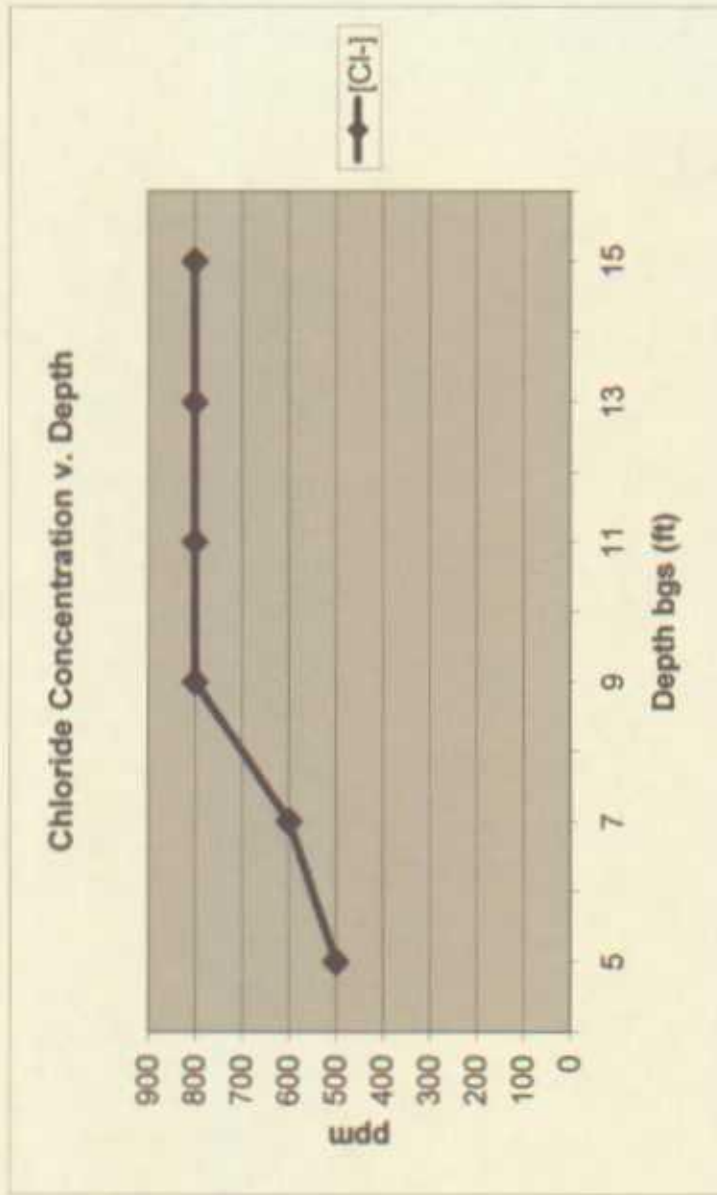
# CHLORIDE CONCENTRATION CURVE

| Depth bgs (ft) | [Cl-] ppm |

Groundwater = 68 ft

**CHLORIDE FIELD TESTS**
