IR0427-58

**RICE OPERATING COMPANY  
JUNCTION BOX FINAL REPORT**

EME jct. H-2

## EME H-2 jct. box upgrade

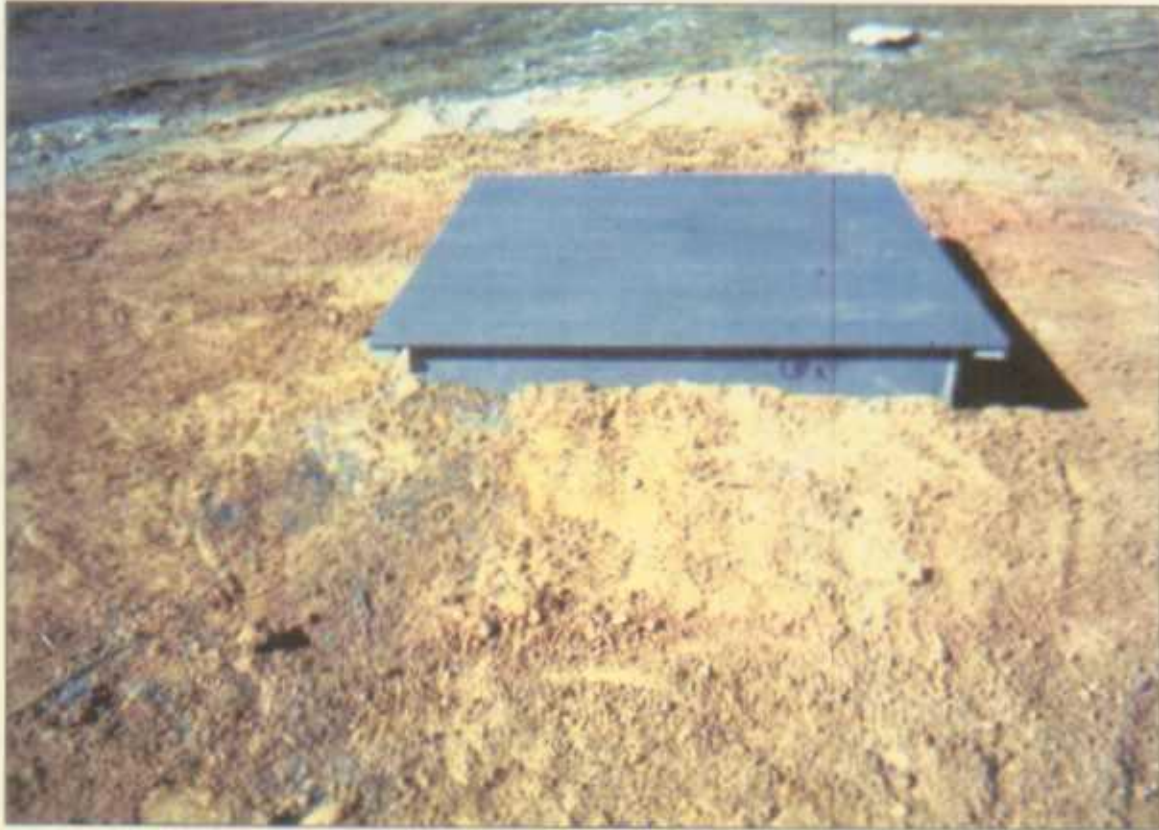
new junction box

threat to public health. A water-tight junction box has since been built at this location.
