# FINAL REPORT

**RICE OPERATING COMPANY  
JUNCTION BOX FINAL REPORT**

# BD K-4 North & South 20' x 25' x 12' Excavation

BD jets, K-4 North & K-4 South  
T22S, R37E

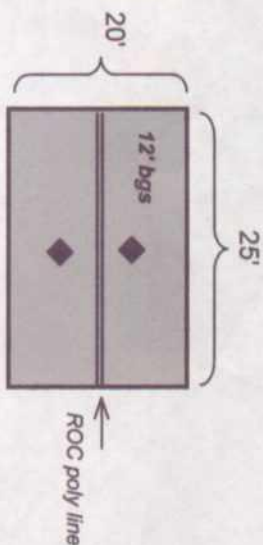
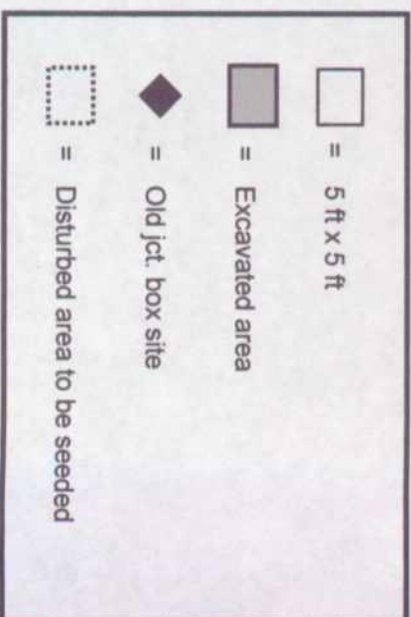
ROAD

NEW K-4  
JCT. BOX

VEGETATION

located next to one another. The pipeline was re-plumbed and the boxes were removed. The box sites were combined to form one 25' x 20' x 12' bgs excavation. Chloride impact dissipated with depth, as did TPH concentrations. The excavated soil was landfarmed onsite and then backfilled into the excavation. Although TPH concentrations in the remediated backfill did not meet NMOCD guidelines, ROC contends that these concentrations do not pose a threat to groundwater at 81' below. The disturbed surface has been re-seeded with native vegetation and will be monitored for growth.

A new watertight junction box has been built 50' west of this site.

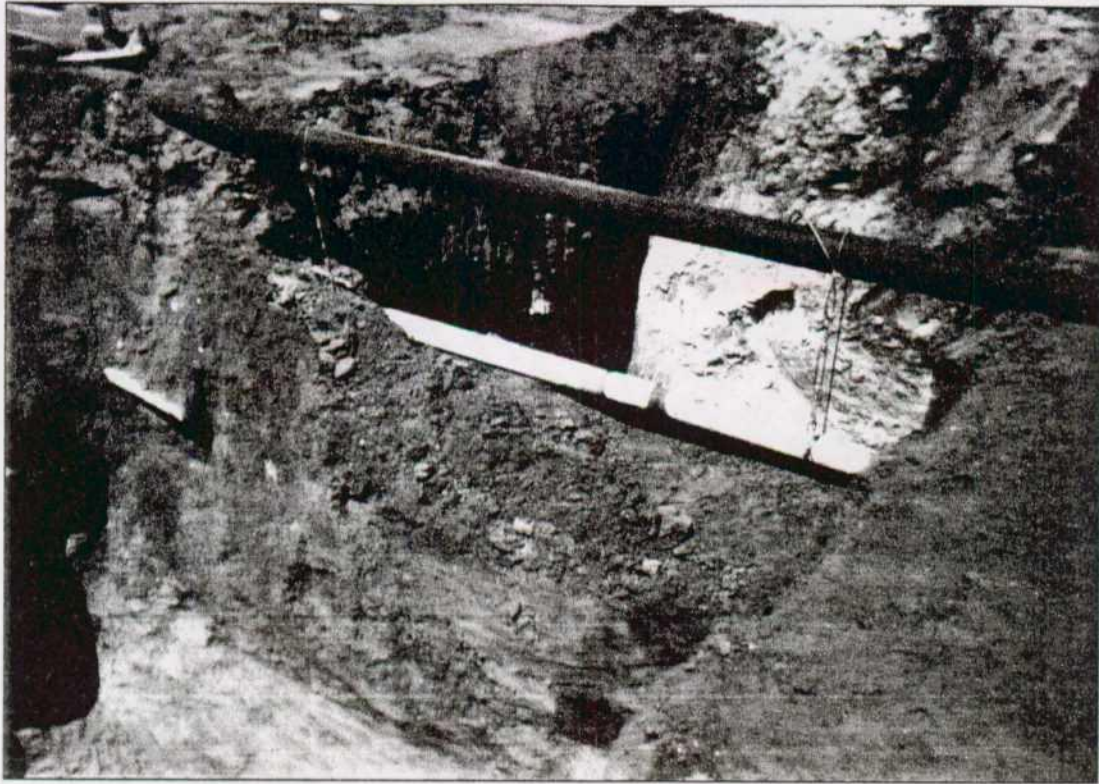
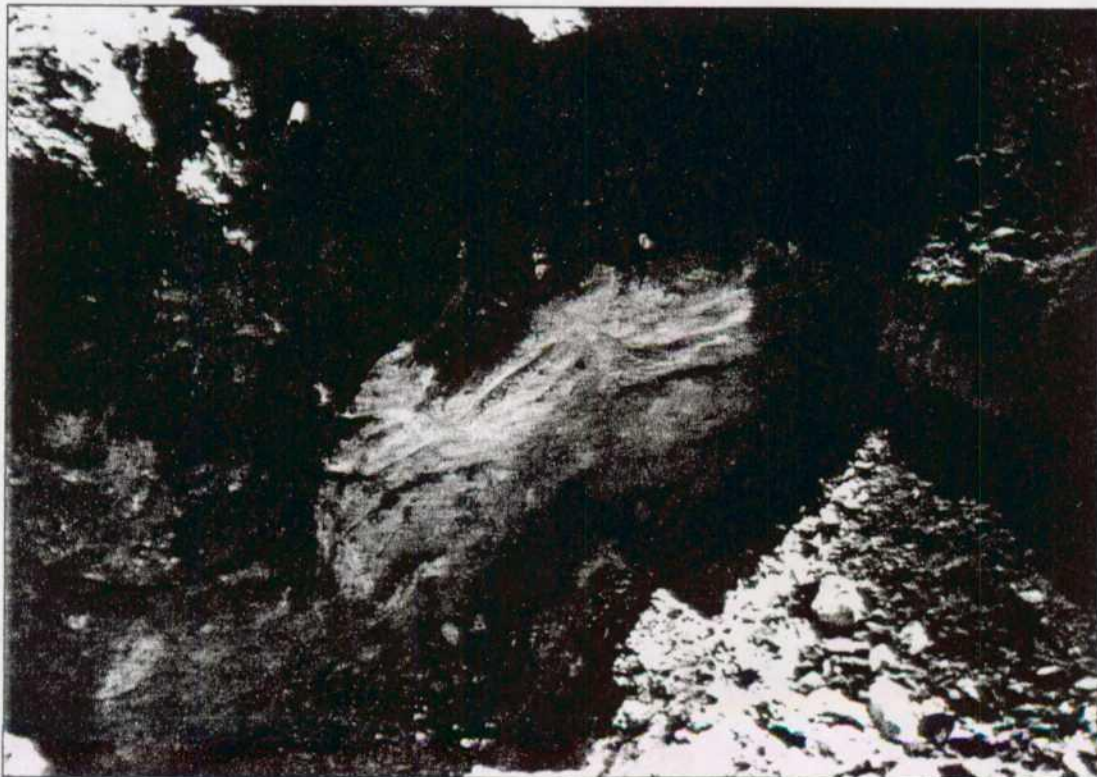
## BD jct. K-4 North & jct. K-4 South

↑ Impact Excavation ↓

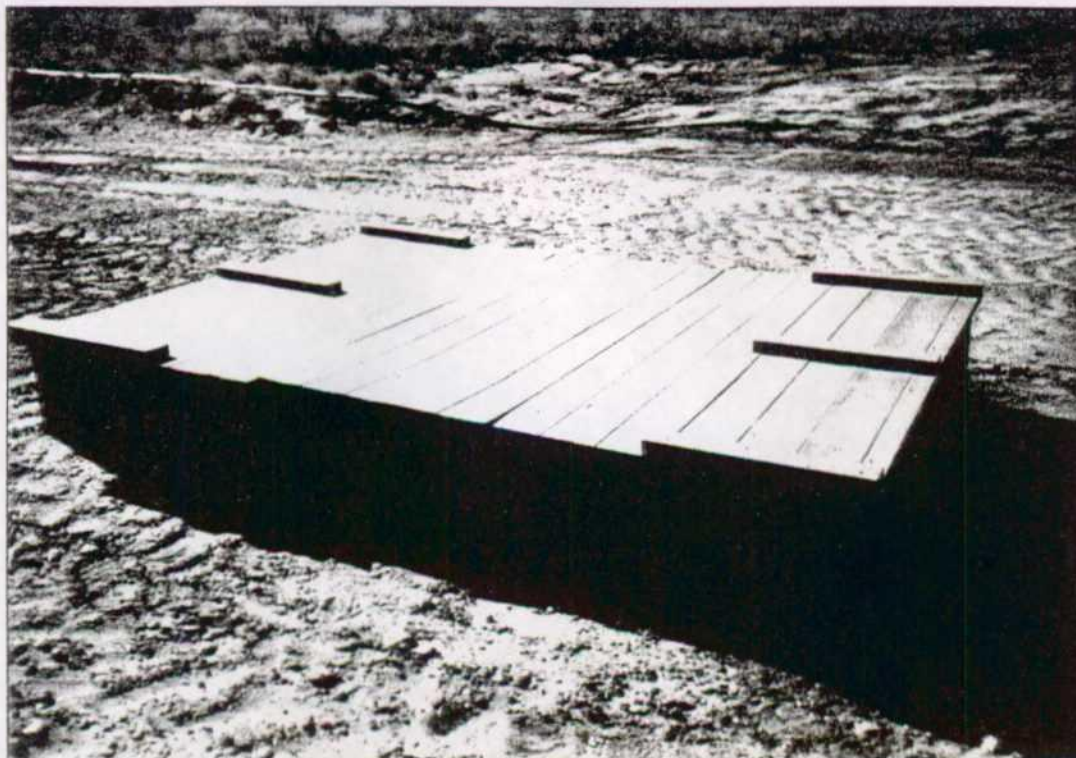
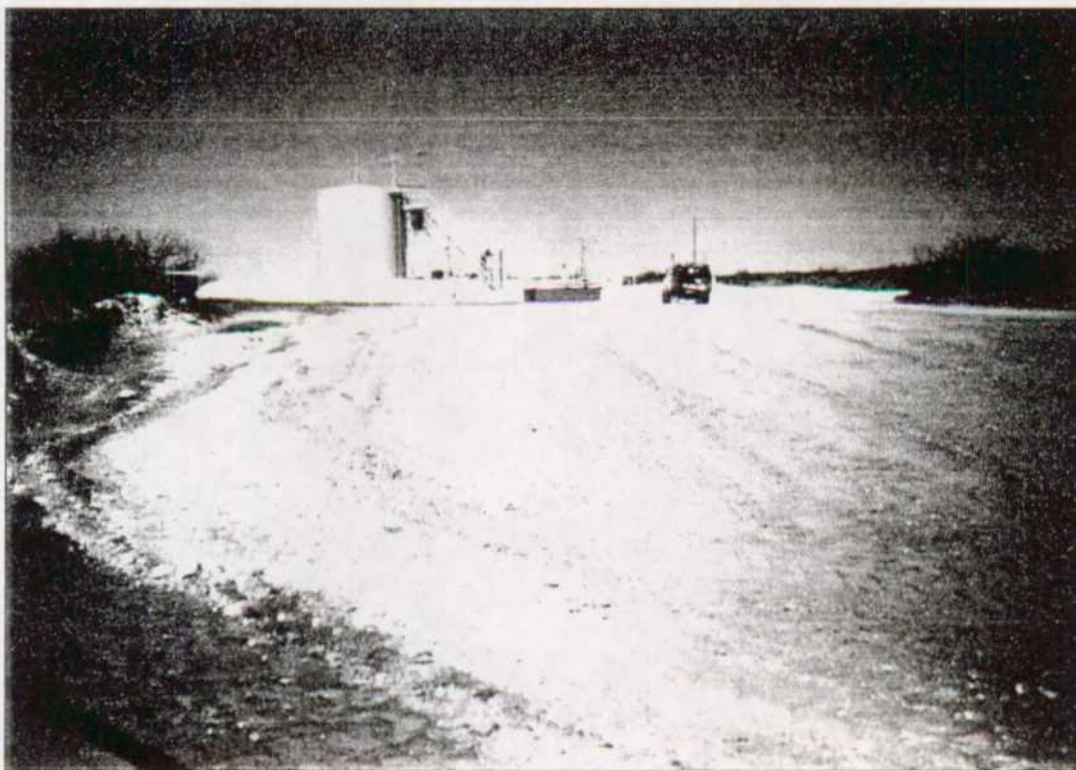
## BD jct. K-4 North & jct. K-4 South

New K-4 Junction Box Located 50 ft West of Old Box Locations

Barren Area That Will Be Re-Seeded (new K-4 box in background)

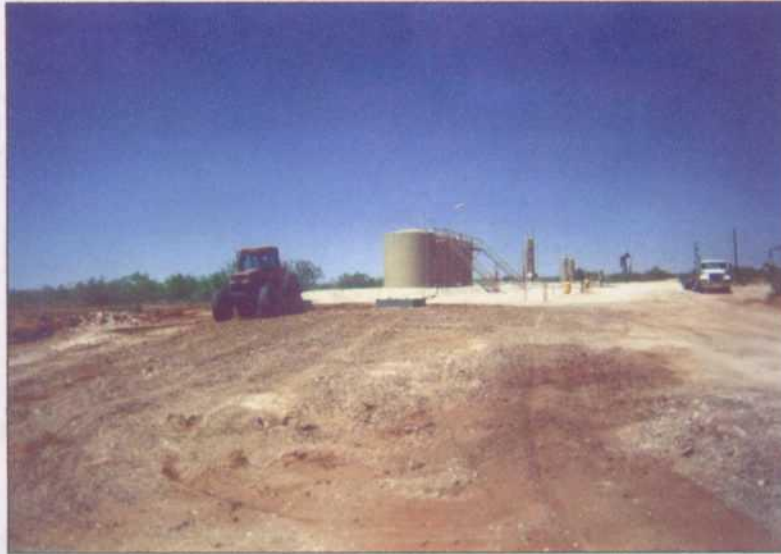
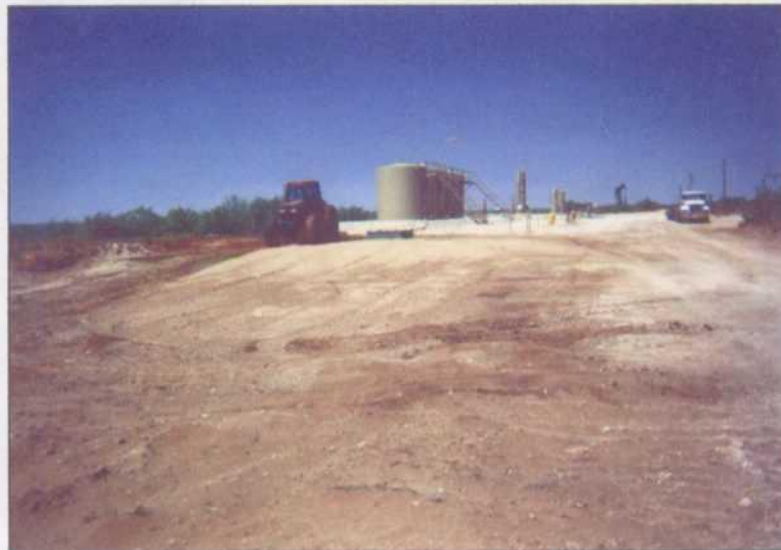
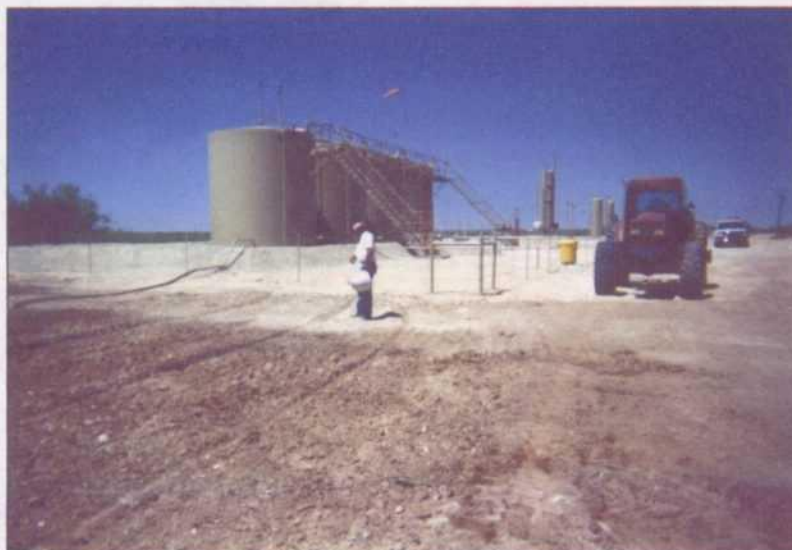
## BD jct. K-4 North & South SEEDING

May 16, 2003

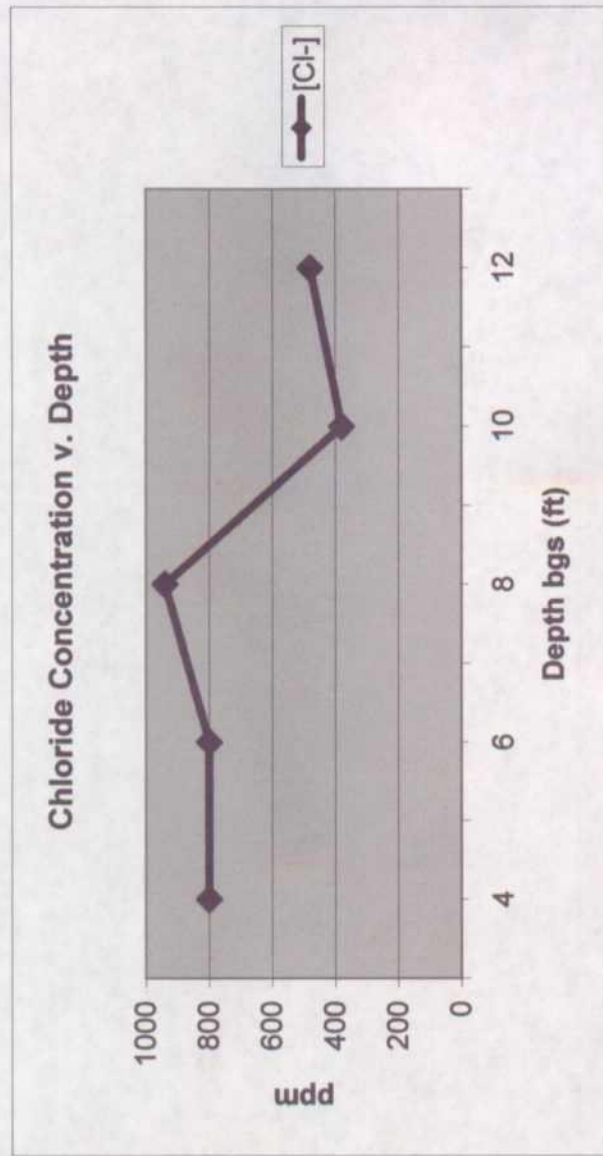
# CHLORIDE CONCENTRATION CURVE

| Depth bgs (ft) | [Cl-] ppm |
| 4 | 800 |
| 6 | 800 |
| 8 | 940 |
| 10 | 380 |
| 12 | 480 |

Groundwater = 93 ft
