**RICE OPERATING COMPANY
JUNCTION BOX FINAL REPORT**

SWD SYSTEM	JUNCTION	UNIT	SECTION	TOWNSHIP	RANGE	COUNTY	BOX DIMENSIONS - FEET		
							Length	Width	Depth
EME	C-12-1	C	12	20 S	36 E	Lea	No Box

EME jct. C-12-1

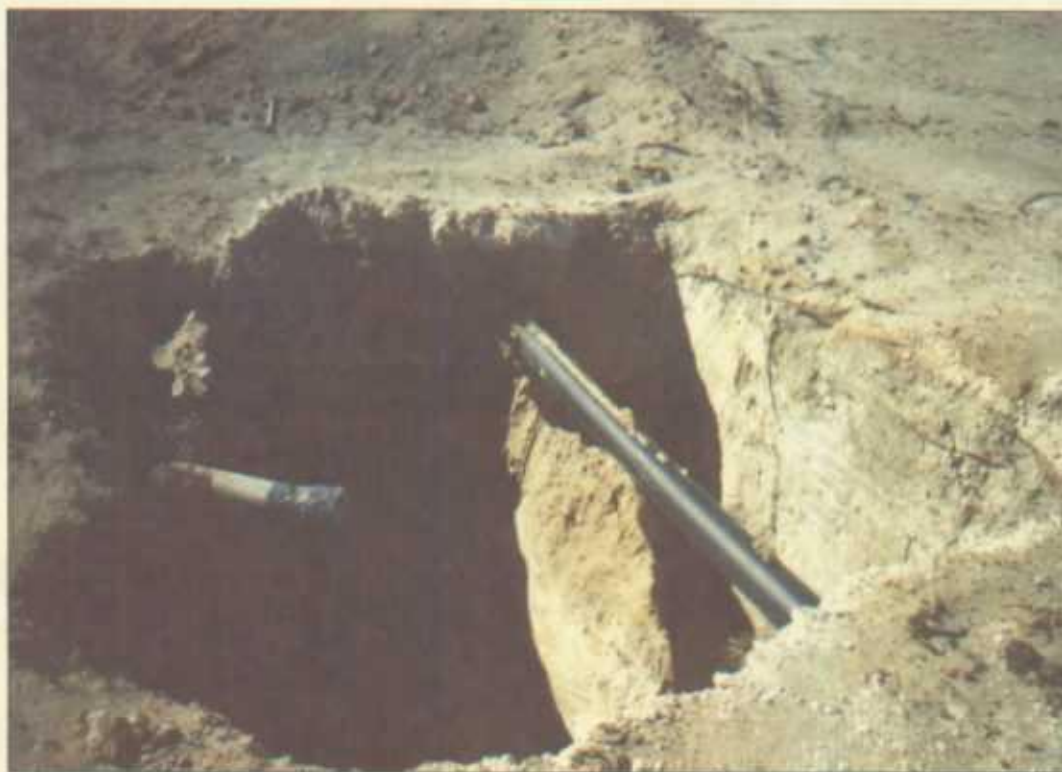
Impact Excavation

General Description of Remedial Action: Chloride and TPH impact were minimal at this box location. Both parameters exhibited a vertical decline. Excavation produced a 8' x 8' x 6' hole that tested clean on the walls and bottom at 6'bgs. The excavated soil was landfarmed on location and then backfilled and contoured to the surrounding area.
These activities are not a threat to groundwater, livestock, or public health.

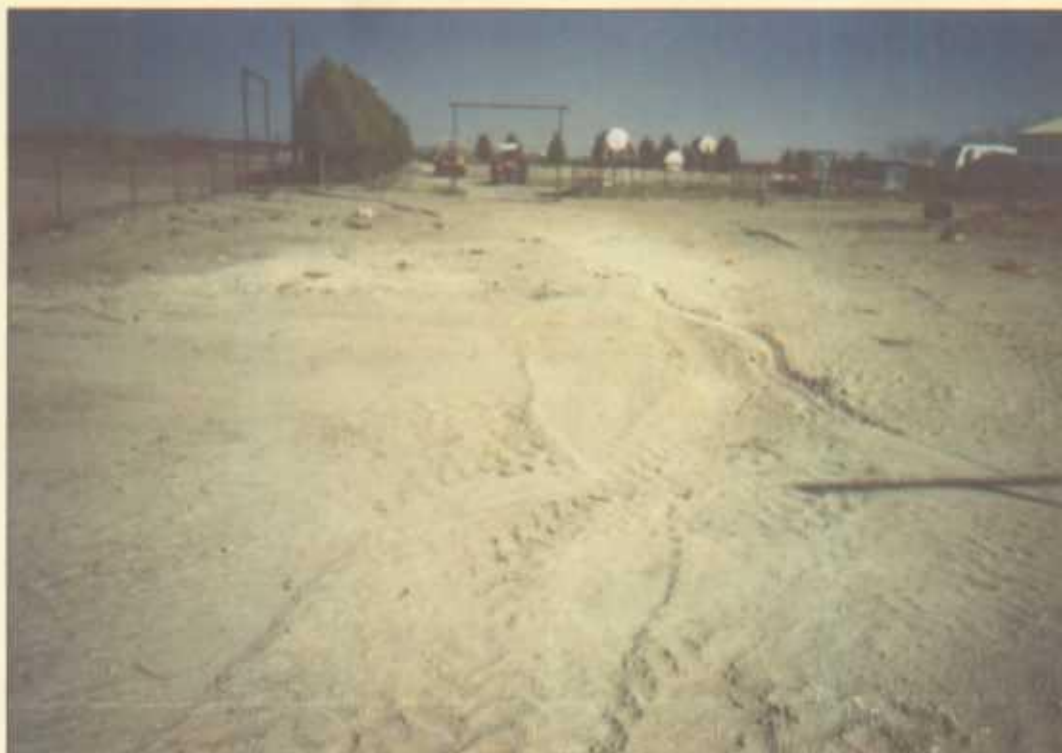
Backfilled (no box required)
