EME B-13 boot

1R0427-41

# FINAL REPORT

**RICE OPERATING COMPANY  
JUNCTION BOX FINAL REPORT**

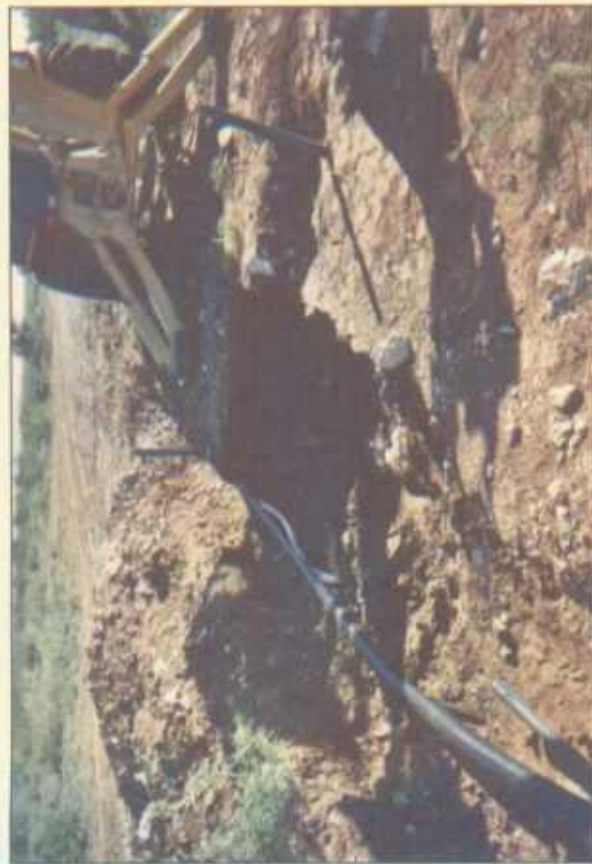
Before Excavation at Old Box Site July 2003

General Description of Remedial Action: The box once contained a boot. The pipeline was re-plumbed and the box was moved 30 ft south. The old location was delineated with a backhoe producing a 10 x 10 x 12-ft deep excavation in which a sufficient decline in chloride concentrations was not observed. TPH and BTEX concentrations were well below NMOCD guidelines. The excavation was then backfilled. On 9/15/03, soil bores were conducted at this site to determine the vertical extent of chloride impact. The soil bores did exhibit a conclusive trend of decline (see graphs). A 30 x 30 x 6-ft excavation was produced in order to install a 1.5 ft thick compacted clay barrier at 6 ft to inhibit further chloride migration. The remainder of the hole was backfilled with remediated soil and excess dirt was disposed of at a permitted facility.

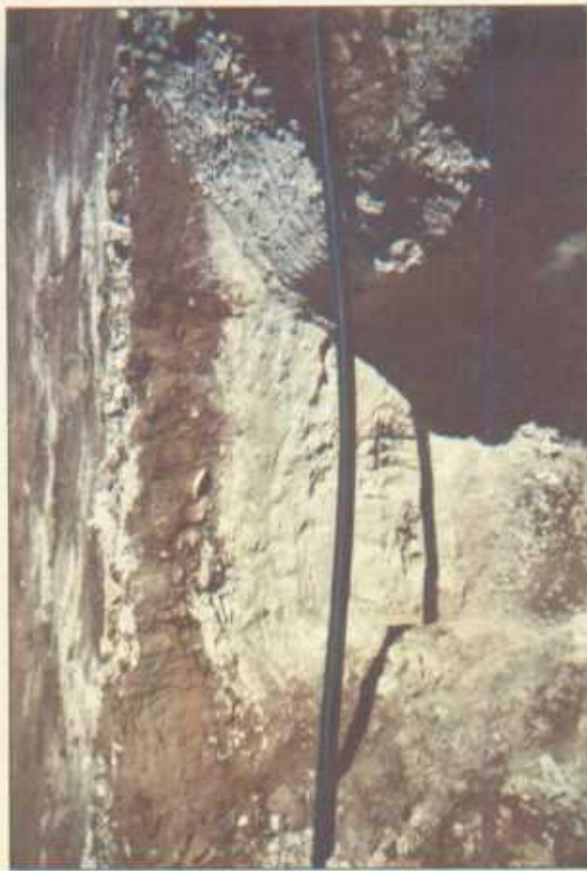
10 x 10 x 12-ft-deep Excavation July 2003

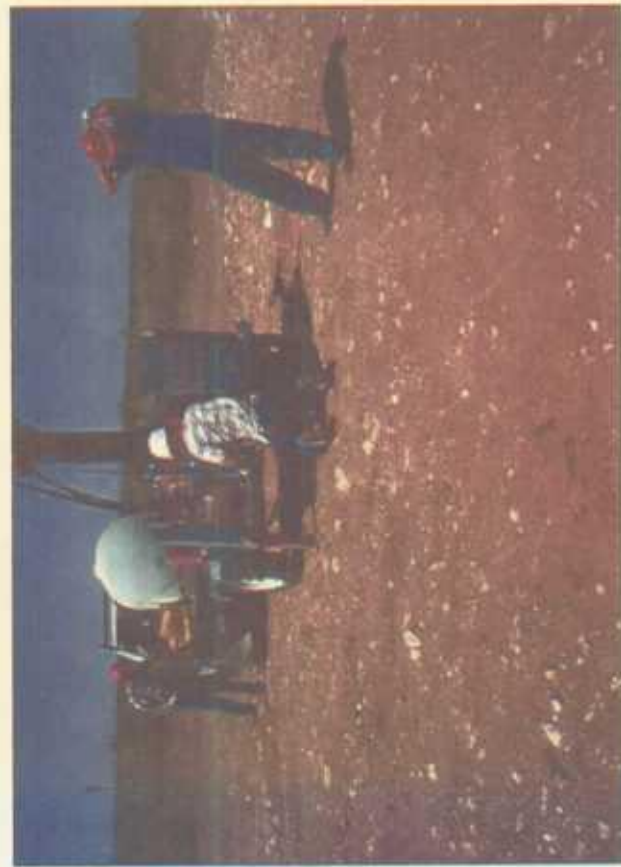
Delineation Drilling 9/15/2003

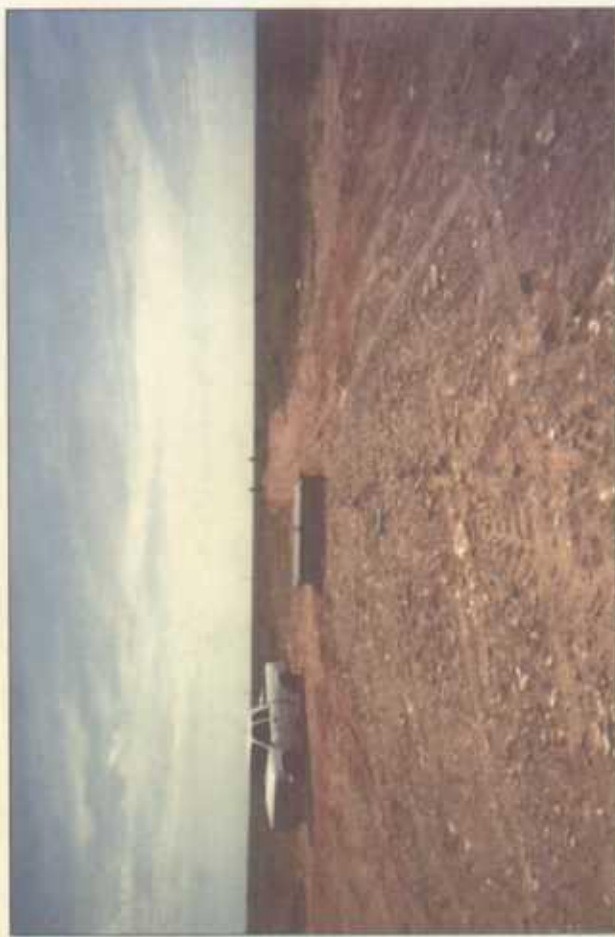
Looking South: New watertight jct. box with ID plate in foreground marking clay barrier below
